Field Report Page 1 of 4

SP&A Project No: 22.331 Report Date: 1.03.2025 Time: 9:30AM Project: Gales Ferry School 1854 CT-12 Gales Ferry, CT 06335 General Contractor: The Imperial Company, Inc. Weather Site Conditions Day of Week Temp. Range: 32°	Field Report No.:												ort No.:	17		
Concrete Site of Nasony 10 Flooring 15 Steel/Misc. Metals 11 Pool Flooring 15 Steel/Misc. Metals 11 Pool Flooring 16 HVAC 22 Tester (Tri-state) Flinishes Temperature 23 Audio Vis/Low Volt SPA in areas where the underside decking is not visible. Name & Location 18 Acceptable SPA SPA in areas where the underside decking is not visible. Roof Ac Cale and Pools and the vertical end points at both sides of the cricket. See attached photo.	SP&A Project No: 2			22.331							Report Date	e: 1.03	.2025		Time:	9:30AM
Temp. Range: 32°		(Gales Ferry School 1854 CT-12 Gales Ferry, CT 06335 General Contractor:									·			
Clear															of Week

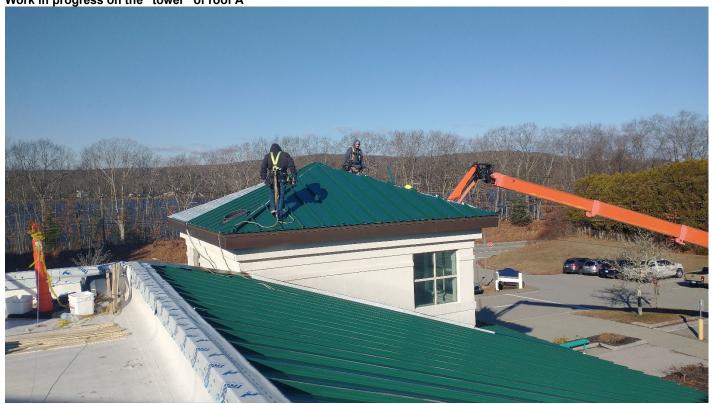
Work in progress on the "tower" of roof A
