## DAM SAFETY PROGRAM DAM INSPECTION REPORT FORM – FOR REGULATORY INSPECTION

| Dam Name: | Pine Swamp Brook Pond Dam | Inspection Date(s): | December 18, 2024 |
| Alternate Dam Name(s): | none | CT Dam ID #: | 7212 |
| Location (Municipality): | Ledyard | Temperature / Weather: | ±32°, Clear, calm |

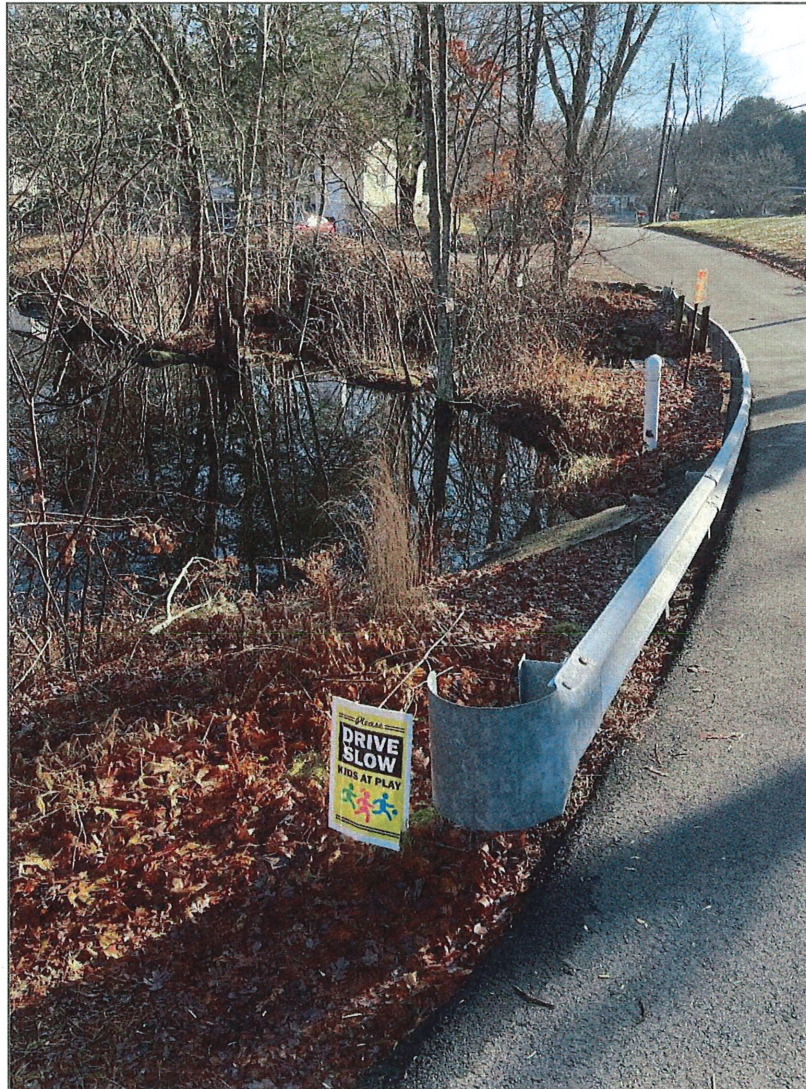
**Vegetative Cover:** Heavy growth of trees and brush on dam embankment

Photo 1: Upstream face of embankment

1. Clear vegetation from dam and  $\pm 25$  beyond. Grubbing of trees requires Dam Safety permit.
2. Replace or repair failing auxiliary spillway pipe.
3. Monitor principal spillway grouted stone walls, and repoint grout as needed.
4. Monitor principal spillway inlet for blockage

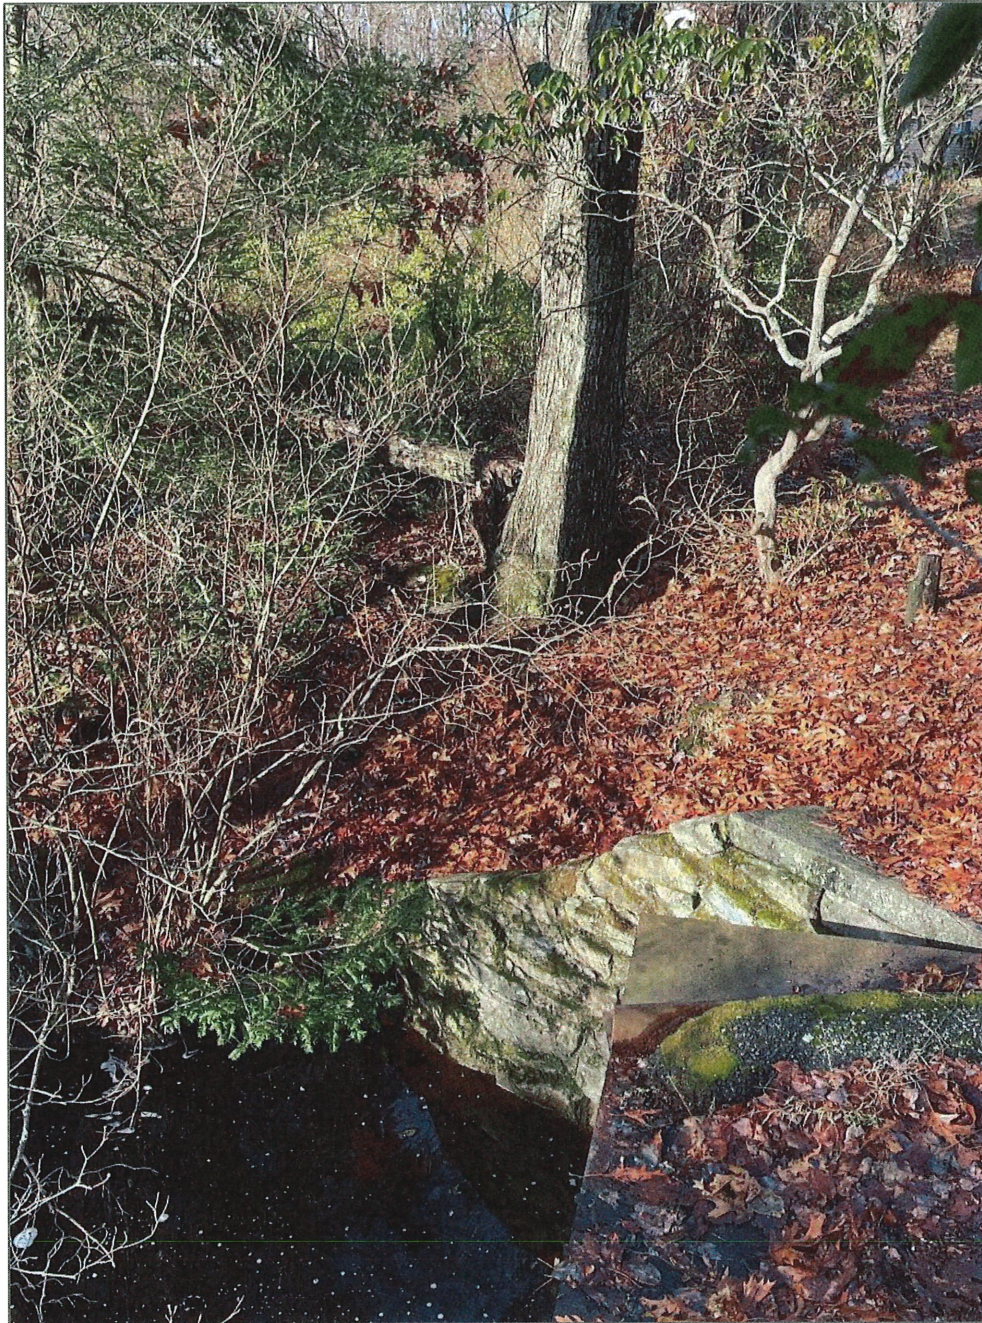
Photo 2: Downstream face of embankment

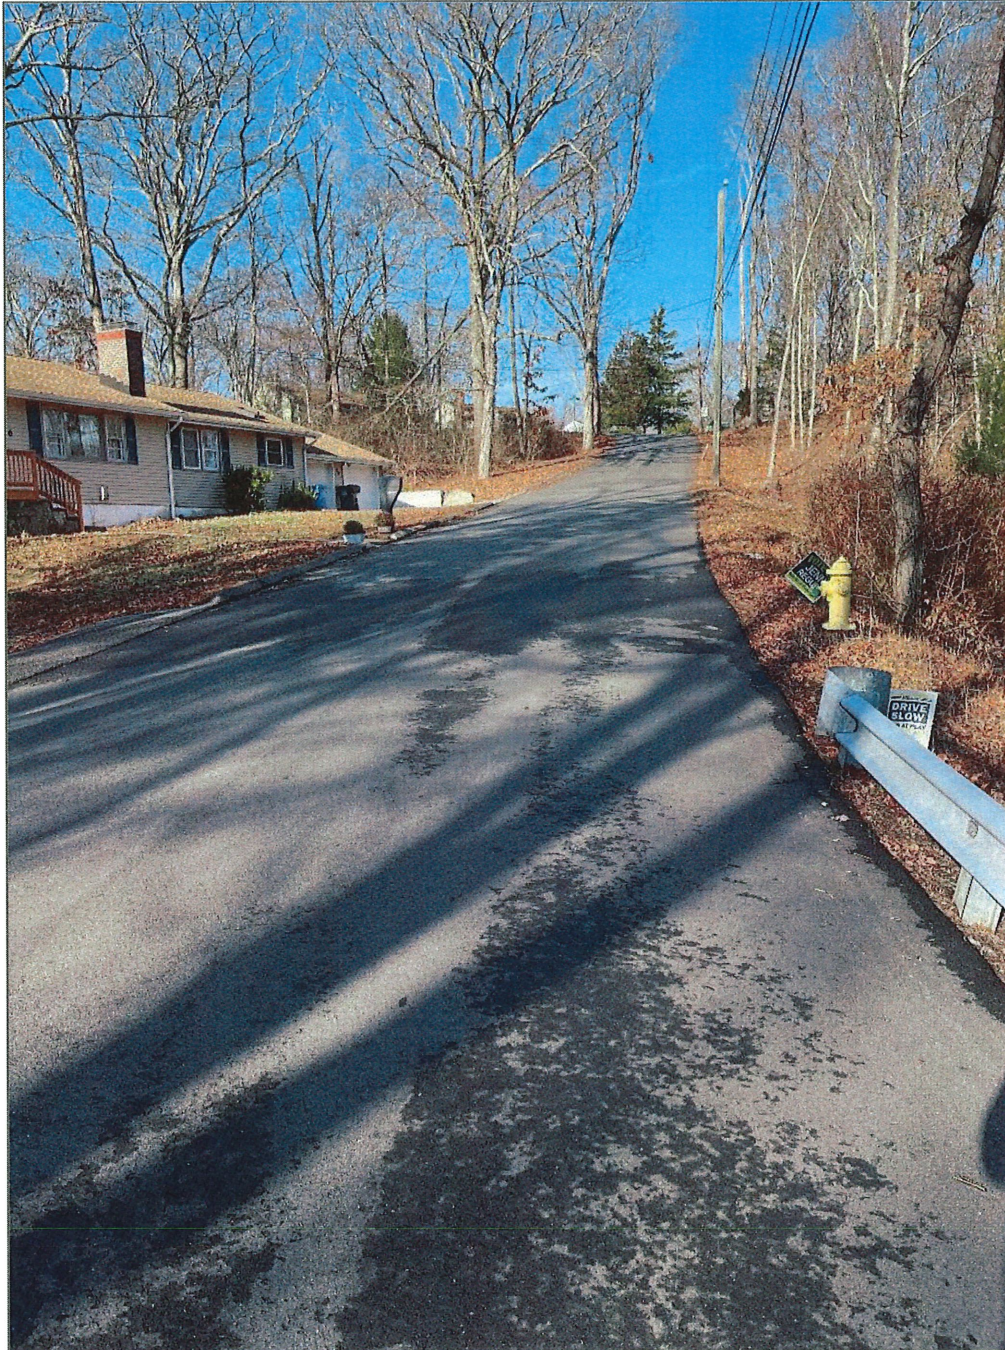
Photo 3: Roadway approach to right abutment and hydrant position

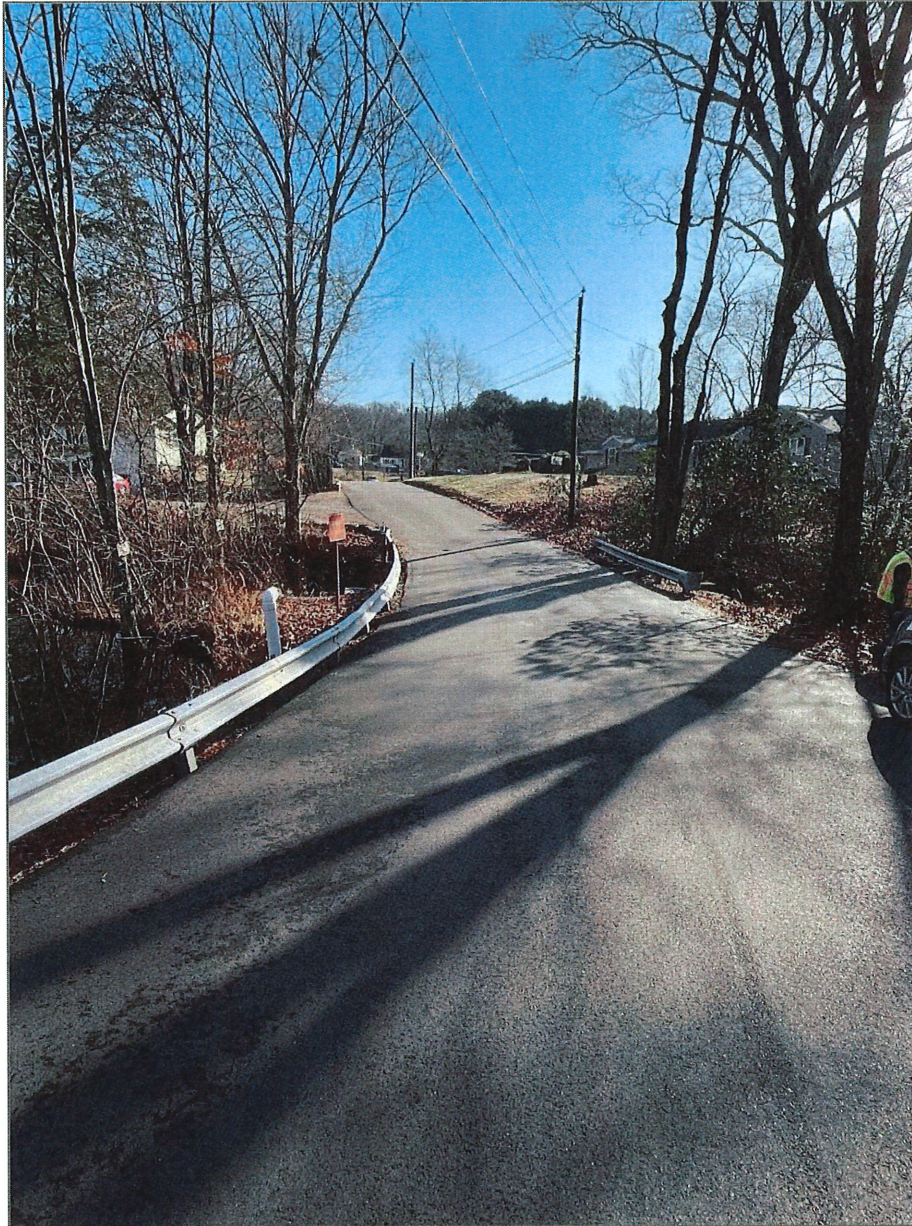
Photo 4: Roadway across dam embankment and beyond left abutment

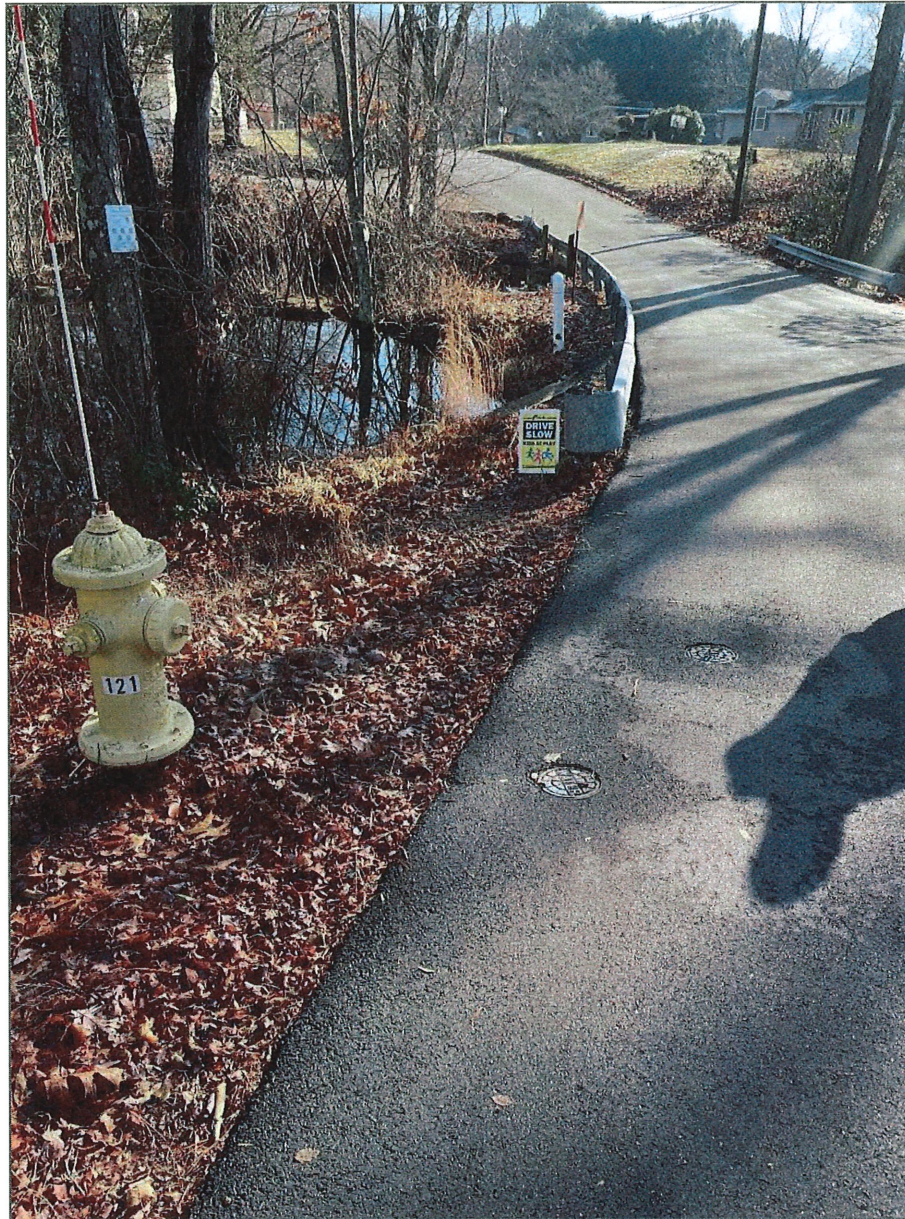
Photo 5: Water shut-off for hydrant and pipe crossing dam.  
Similar arrangement at left abutment

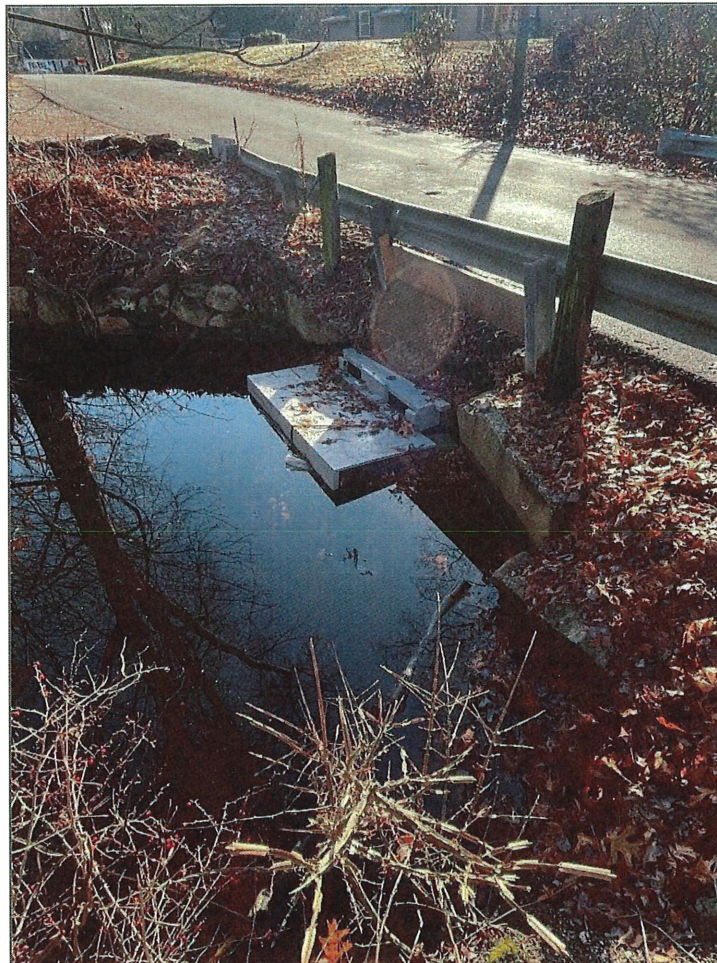
Photo 6: Principal spillway inlet with cover

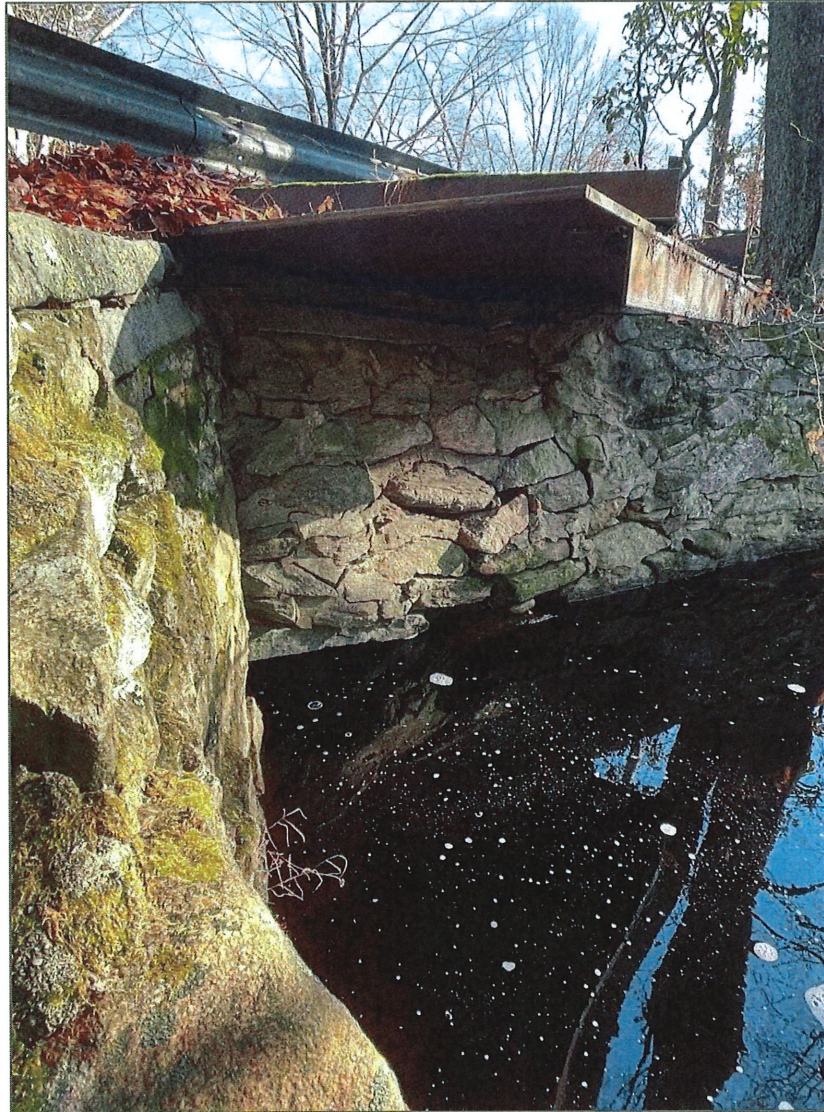
**Stone Masonry:** Some grout missing near outlet end of culvert

Photo 7: Principal spillway outlet

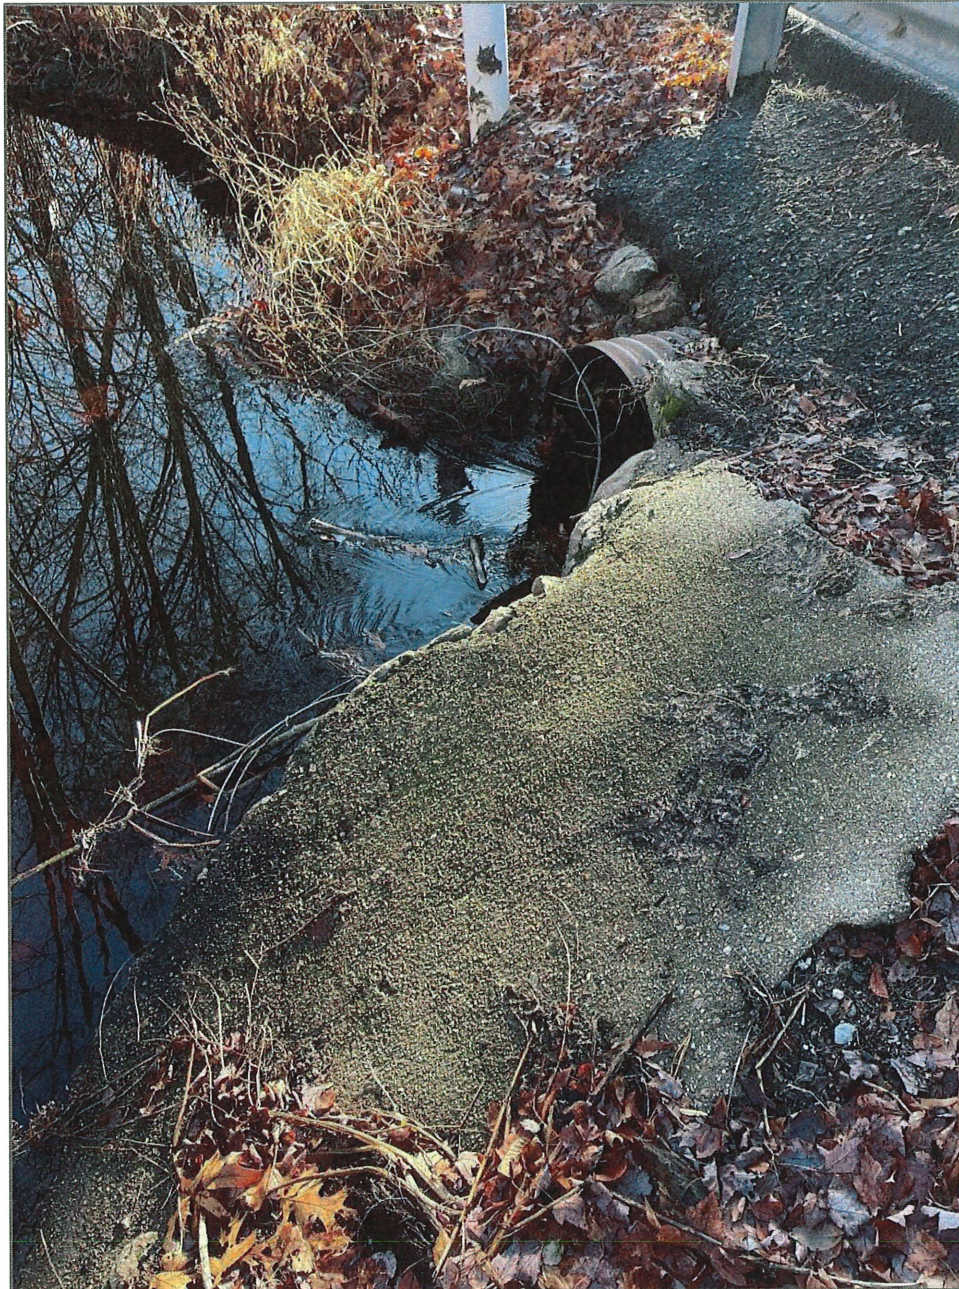
Photo 8: Auxiliary spillway inlet

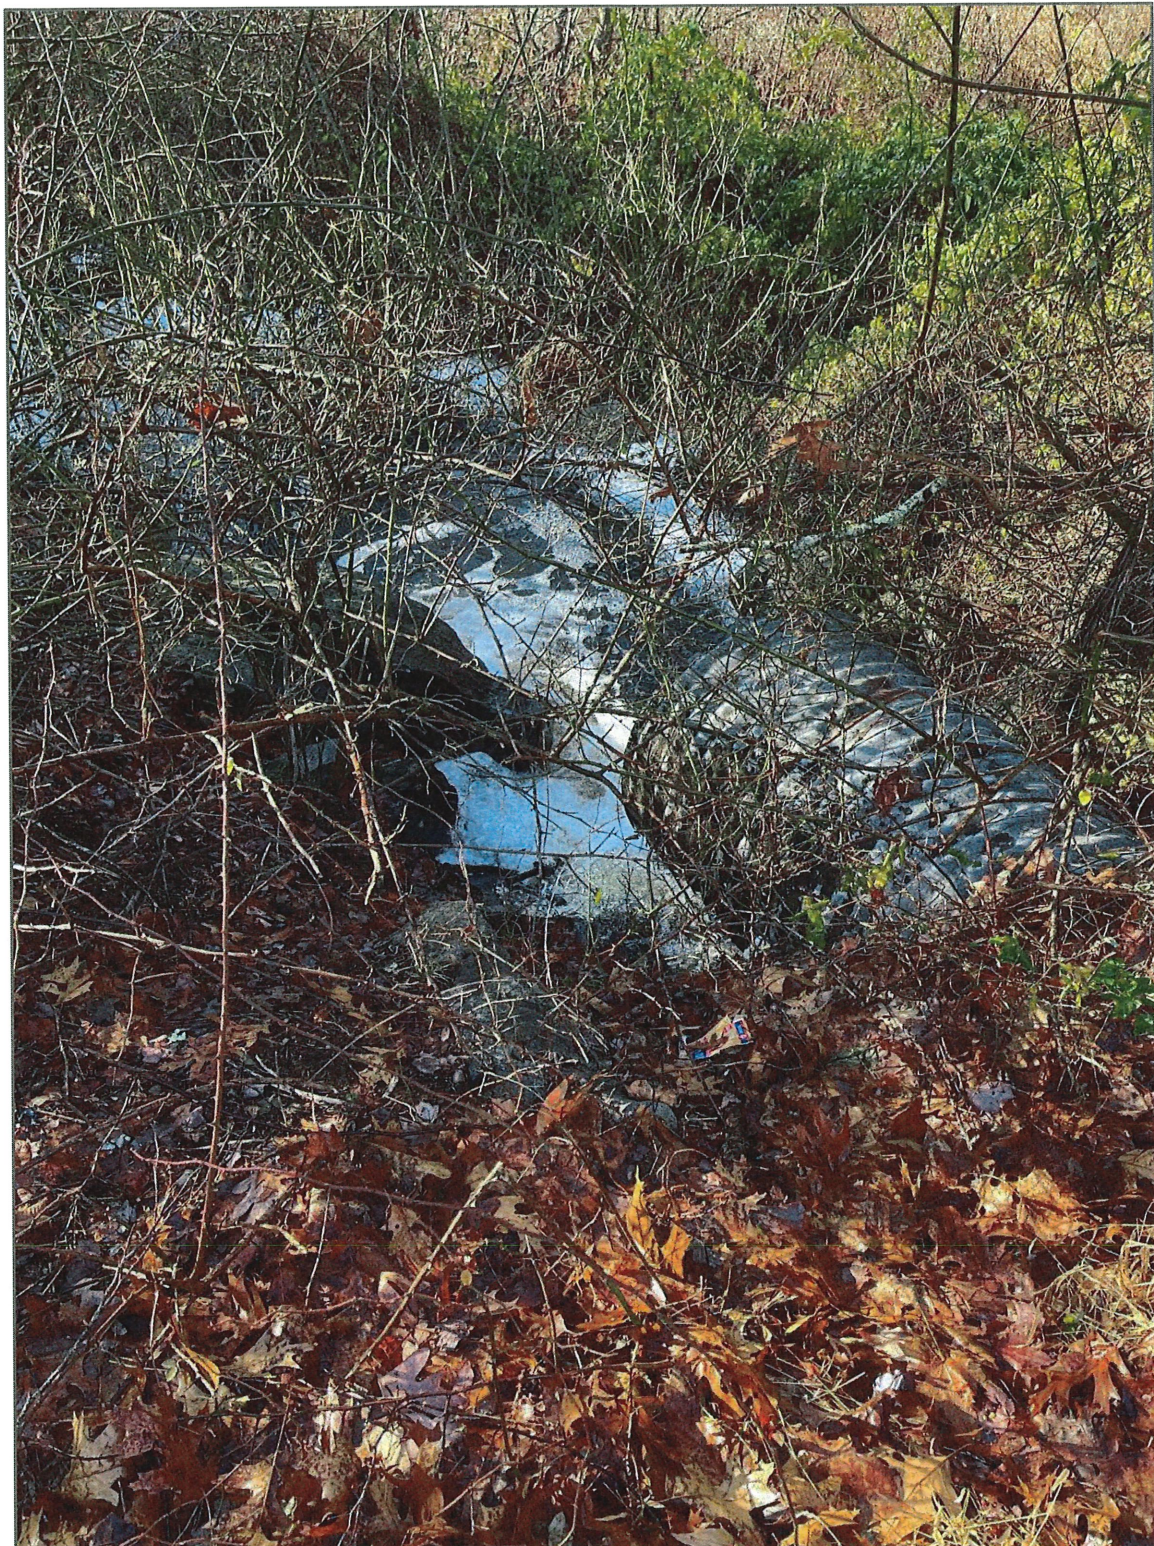
**Scouring/Undermining:** Scouring on downstream embankment

**Other:** Downstream invert of CMP has rotted through and flow spills out onto dam embankment before it exits at the outlet. Also, there is no scour protection at outlet.

Photo 9: Auxiliary spillway outlet

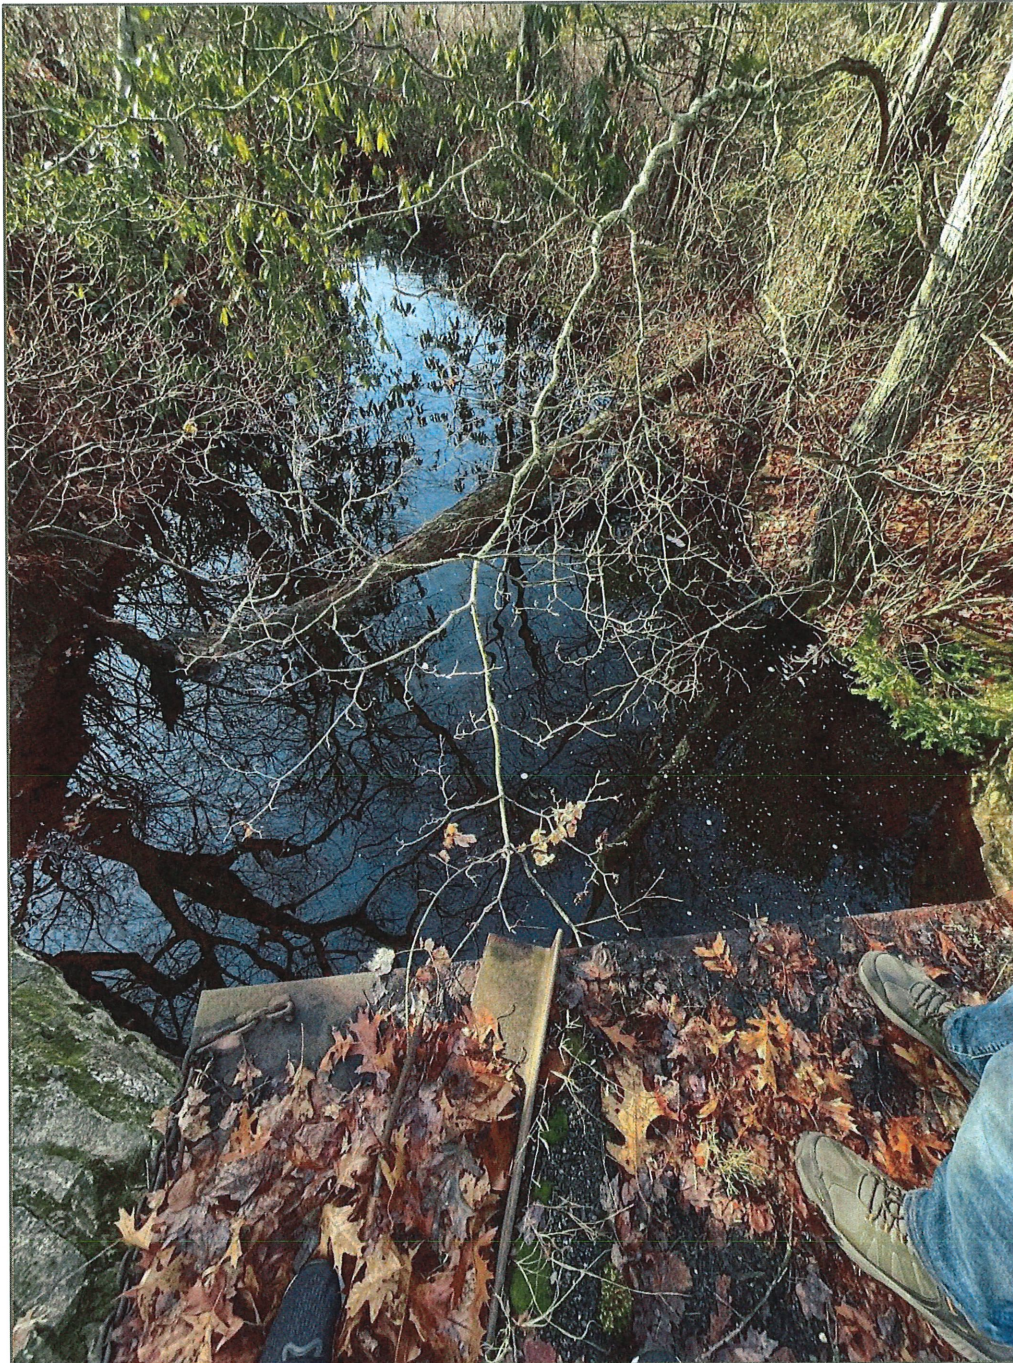
Photo 10: Downstream channel of Pine Swamp Brook

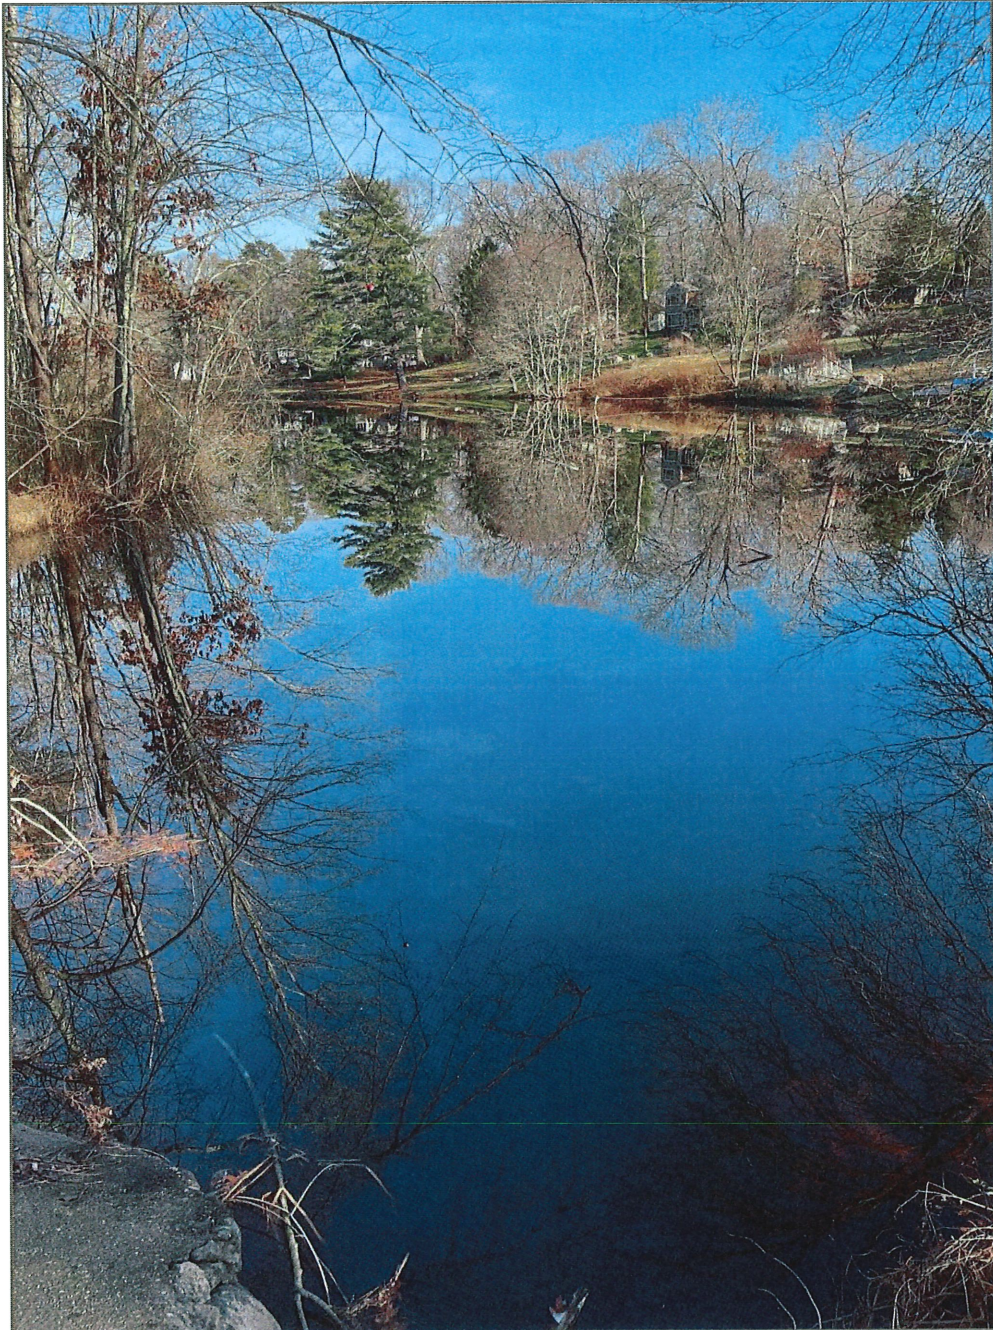
Photo 11: Pine Swamp Brook Pond

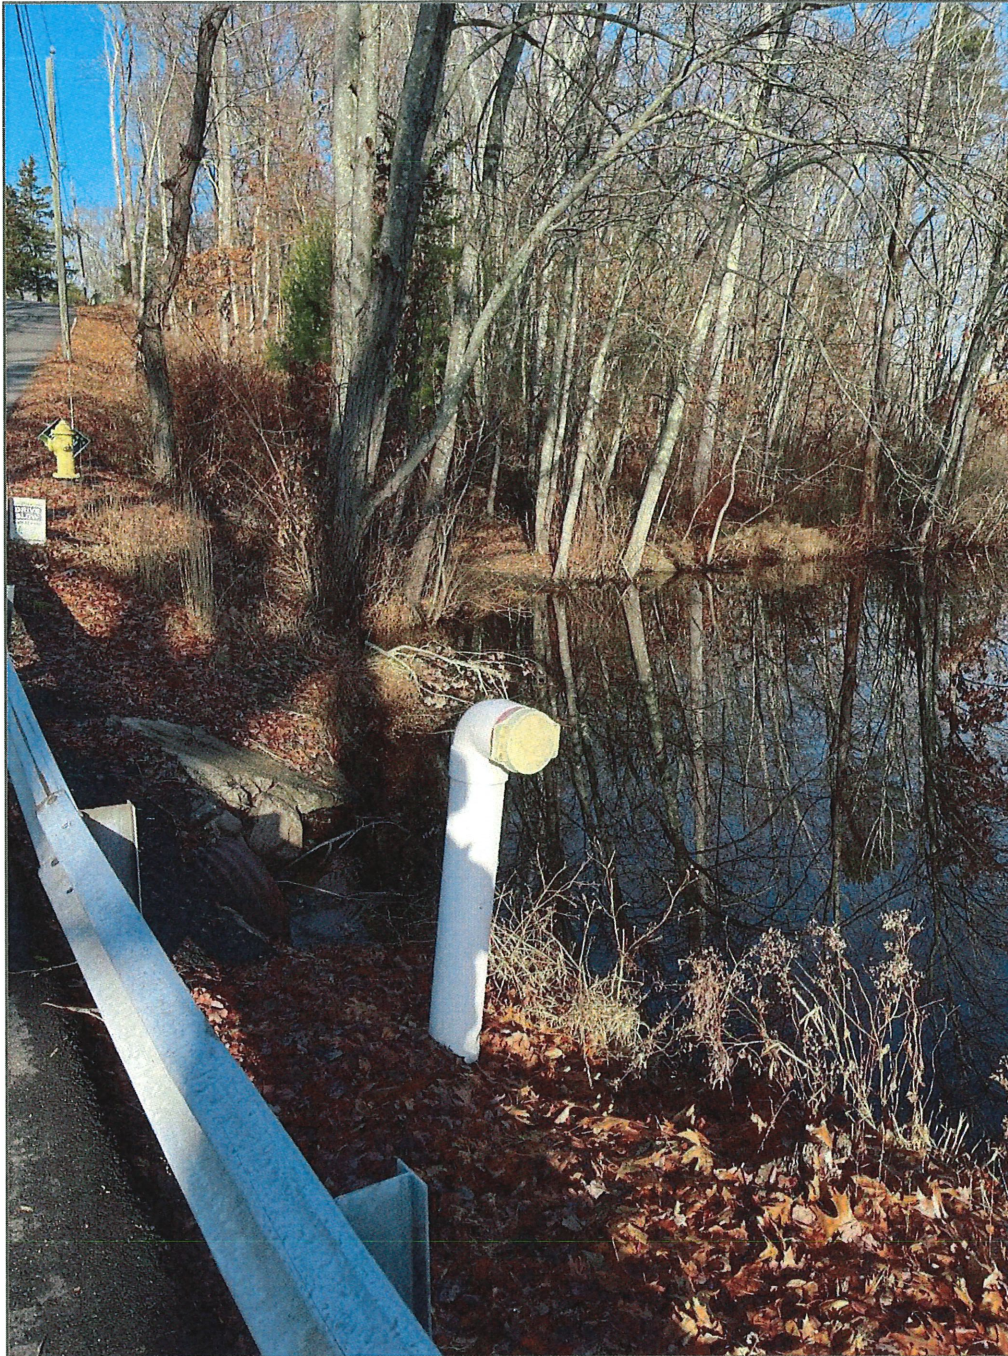
Photo 12: Dry hydrant and potable water hydrants
