Field Report No.: 01														01	
SP&A Project No:			22.331					Report Date: 09-13-202						Time:	9:30AM
Project: Ledyard Board of Educ (Name & Location) 4 Blonders Boulevard Ledyard, CT 06339							ation								
			General												
		14/	The Imp	erial	Com	ipany,		0	4	_				- 6 \A/ 1-	
Weather □ Temp. Range: 75°						Site Site	Site Conditions					Day of Week

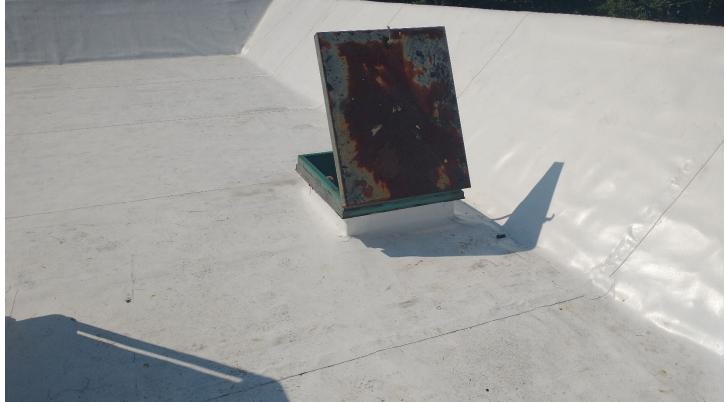
Roof B – New hatch needs to be replaced with guards

- Roof hatch needs to be replaced with guards. See attached photo.															
- Roof membrane for vertical penetrations (i.e. hatch, roof top units etc.) has been installed.

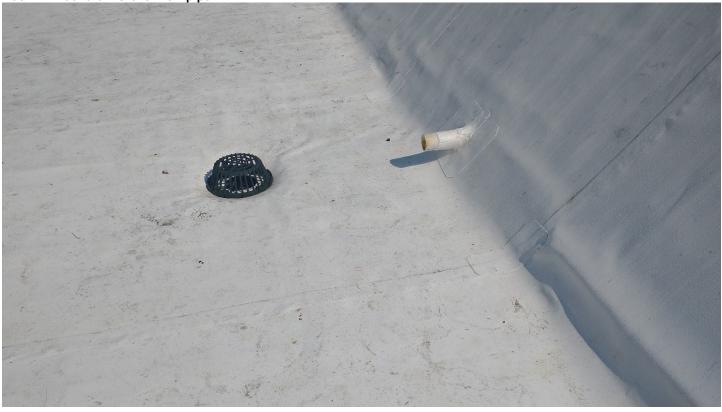
- Approximate number of workers on site – 0 - No workers on site														
General Remarks: - Installing of the metal roof on roof A still needs to take place.															
					still	needs	to take place.								
<ul> <li>Roof B has peel &amp; stick installed.</li> <li>Over flow pipe has been installed with new plywood covering old cavity for the overflow pipe.</li> </ul>

## Roof B – Roof drain & over flow pipe

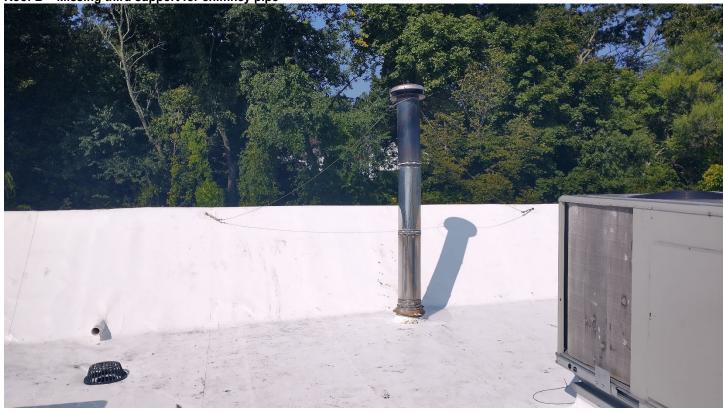
## Roof B – Missing third support for chimney pipe
