Progress Report

LEDYARD SD
4 BLONDER PARK RD
LEDYARD, CONNECTICUT 06339

FACILITY: Gales Ferry School	ROOF SECTION: ALL	DATE: 11/18/2024
-------------------------------------	--------------------------	-------------------------

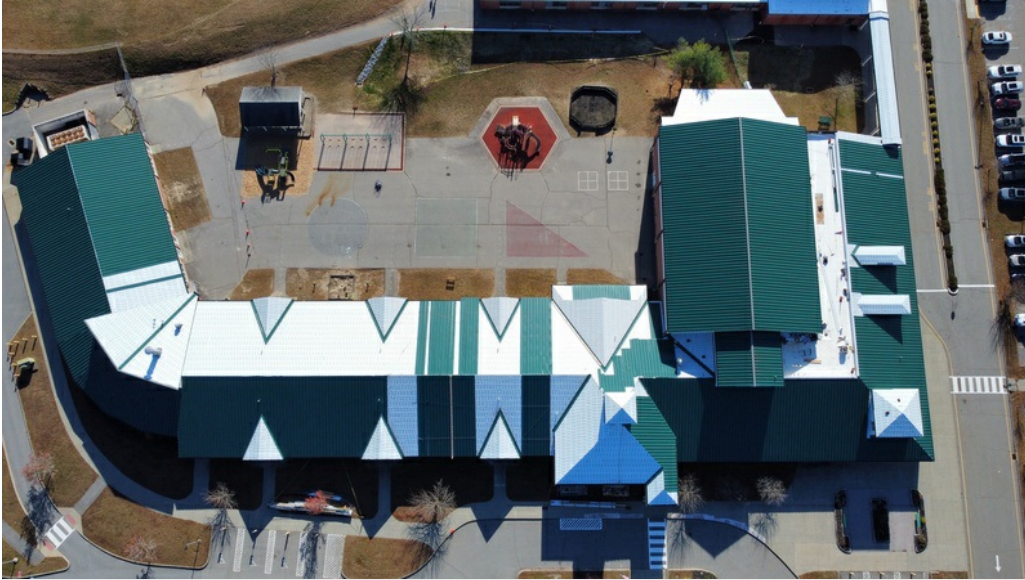
1

Overview- 11/14/24

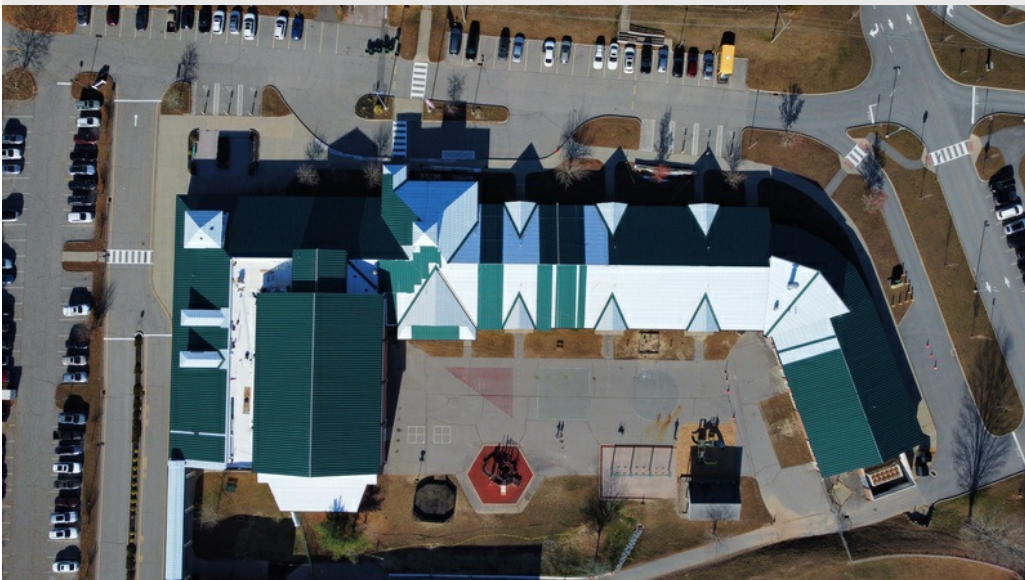
2

Overview- 11/14/24

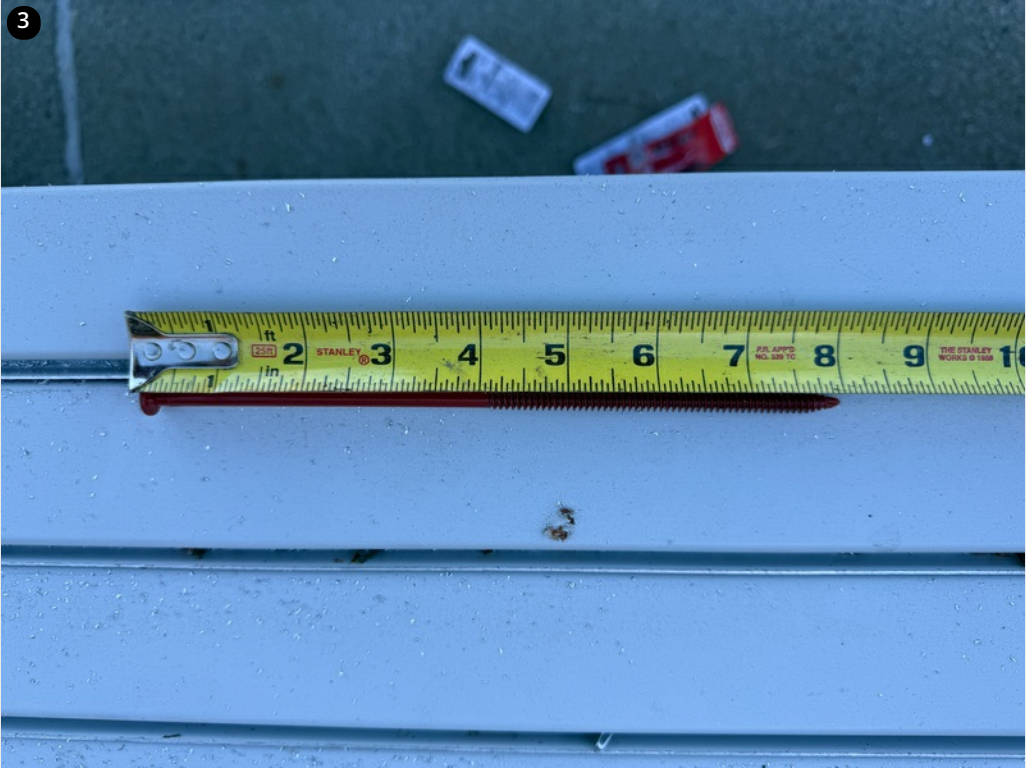
3

8" red fasteners

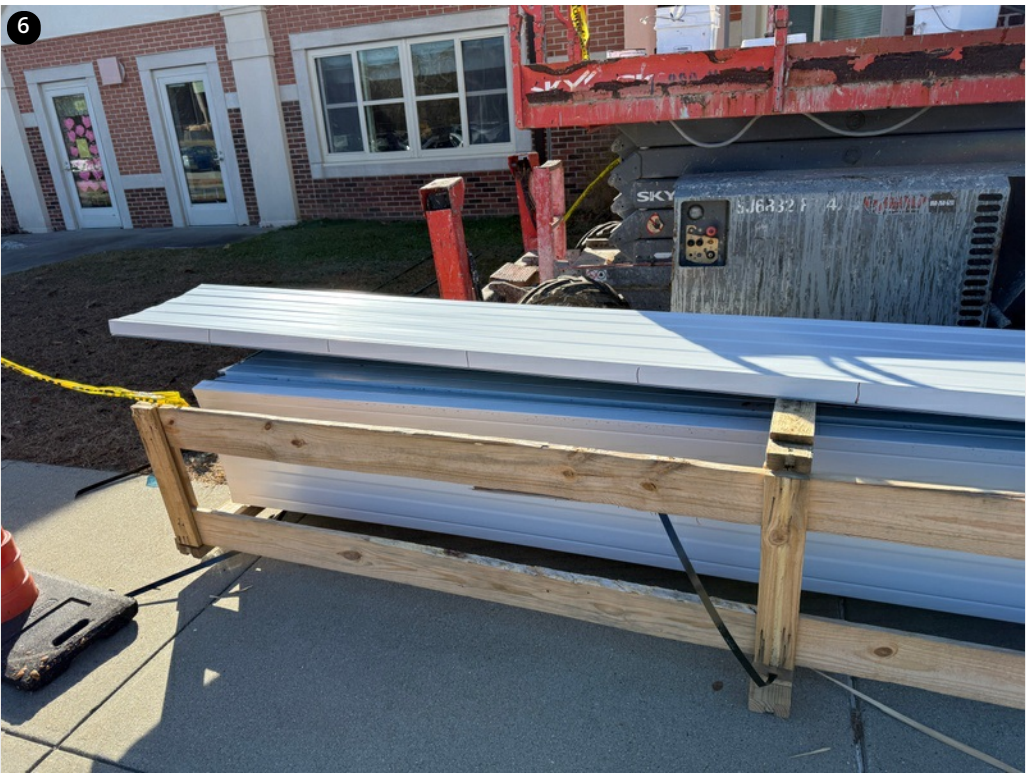
6

Clip spacing marked out on panels prior to install

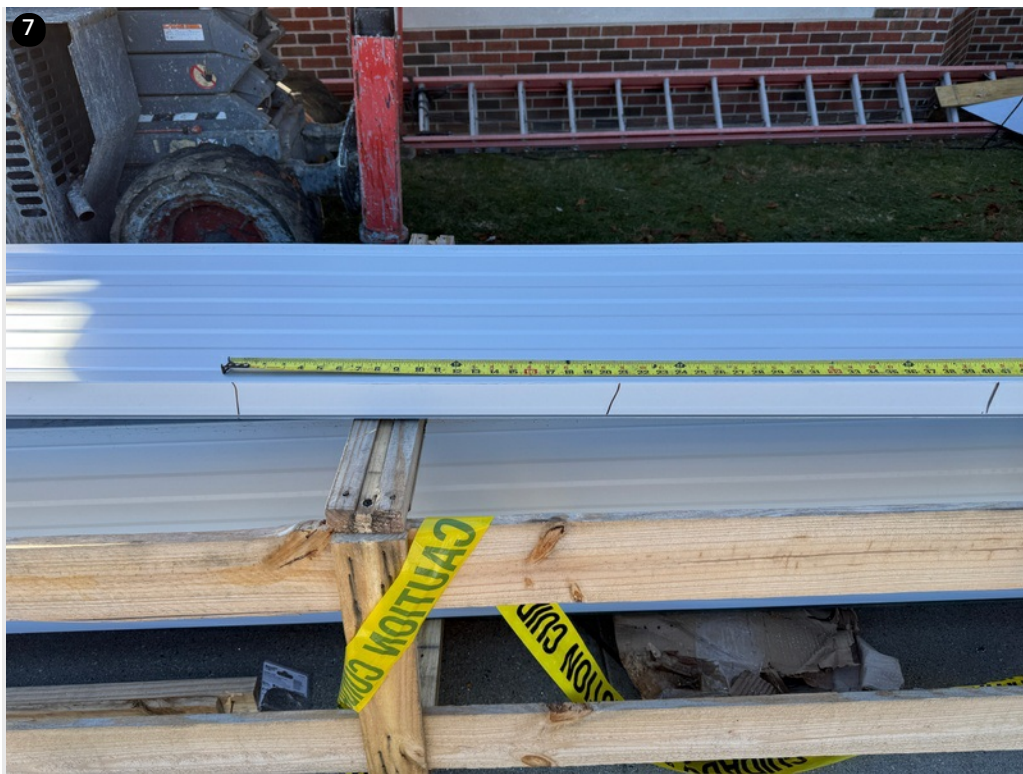
7
Clip spacing marked on panels according to zone

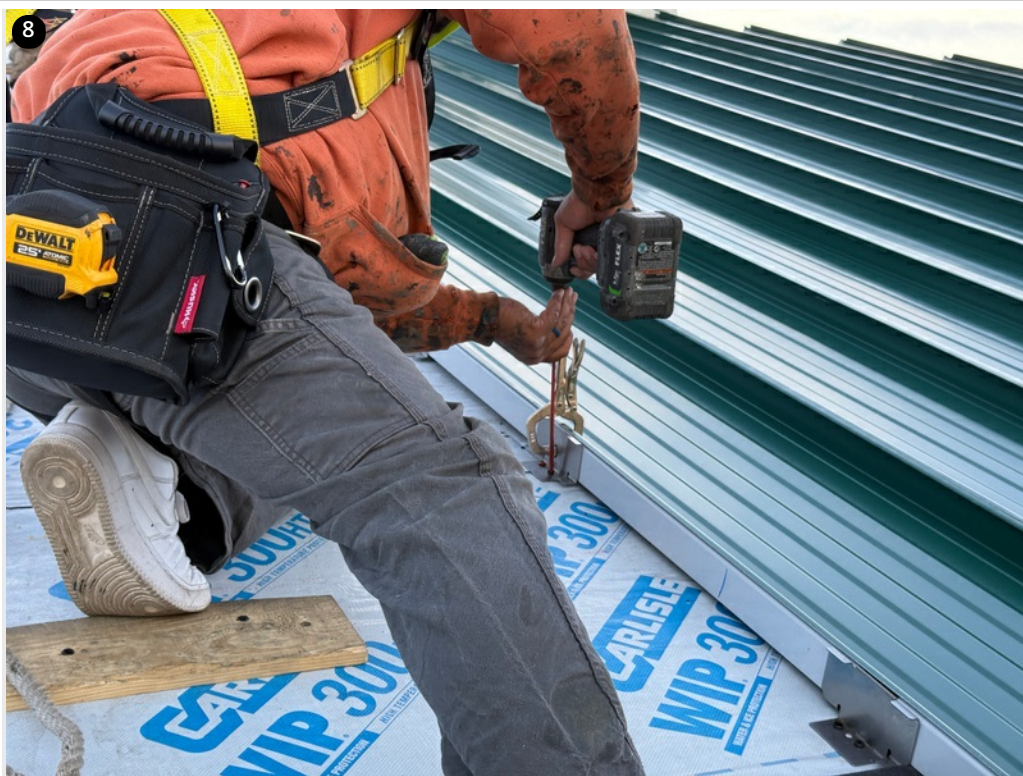
8
Crew fastening clips spaced at 1'8" using 8" red fasteners- 11/14/24

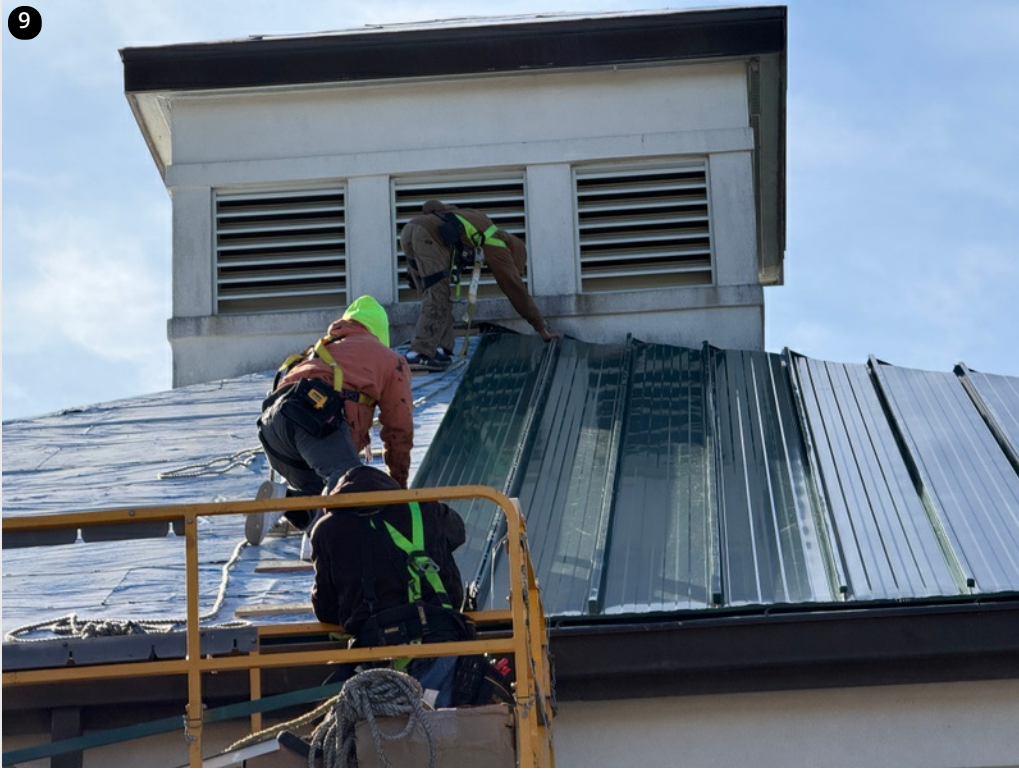
9

Crew installing panels and securing to fastened clips- 11/14/24

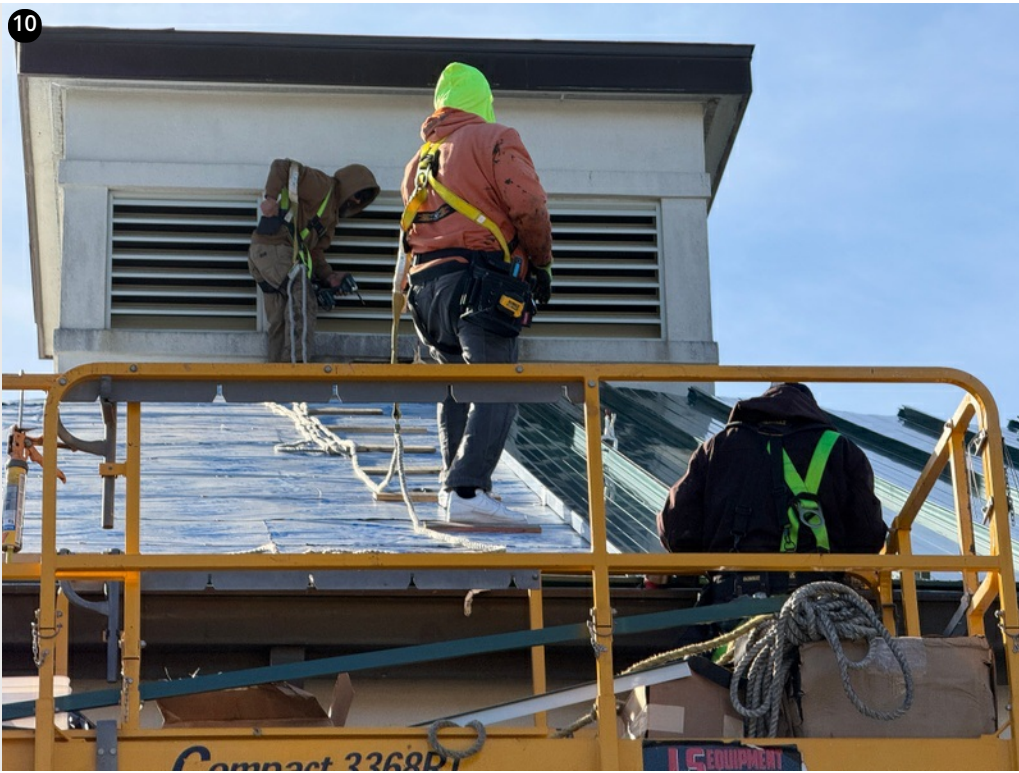
10

Crew fastening clips in front of cupula- 11/14/24

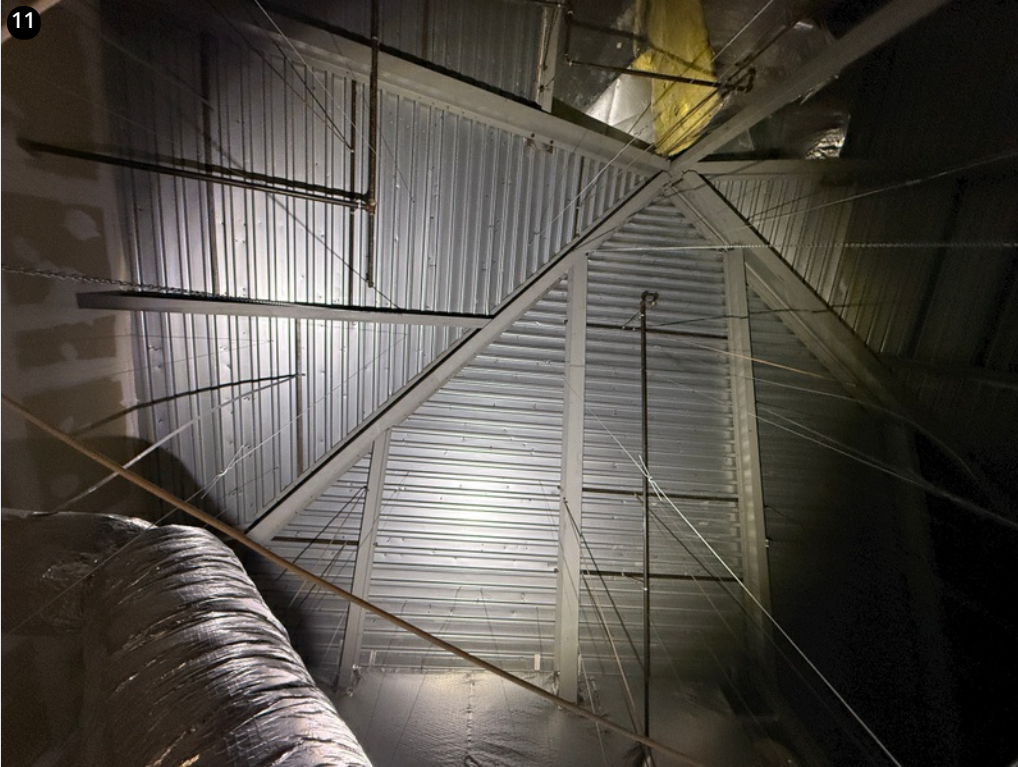
11 Fasteners seen through deck- 11/14/24

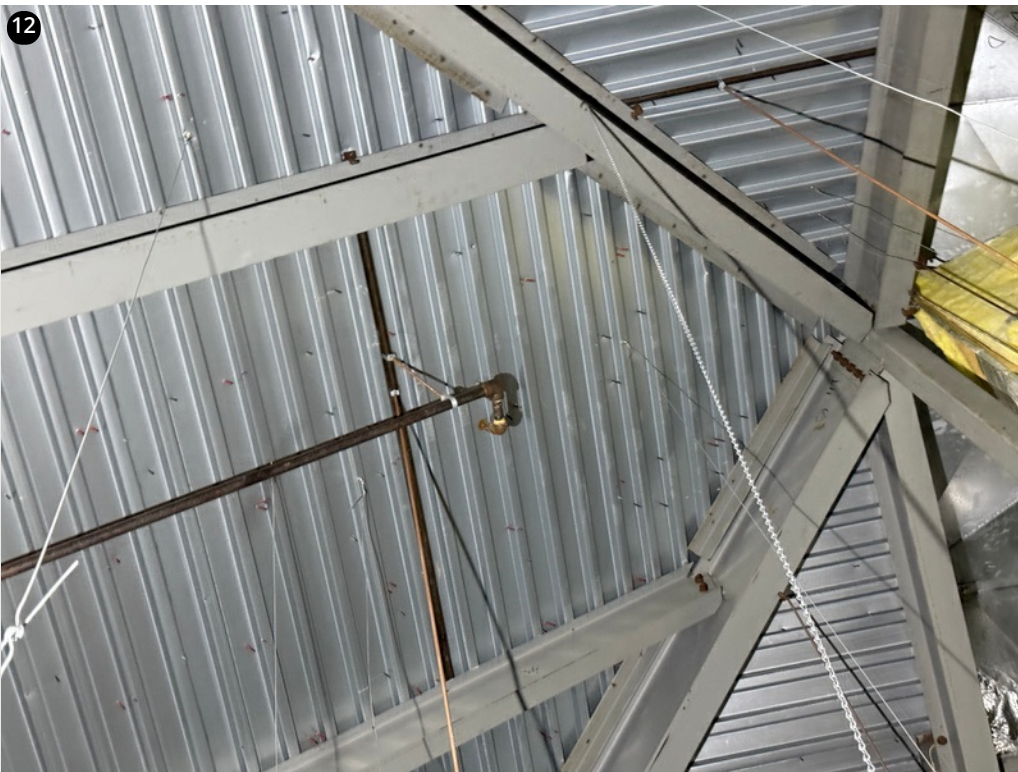
11/14/24- Fasteners observed properly penetrating deck

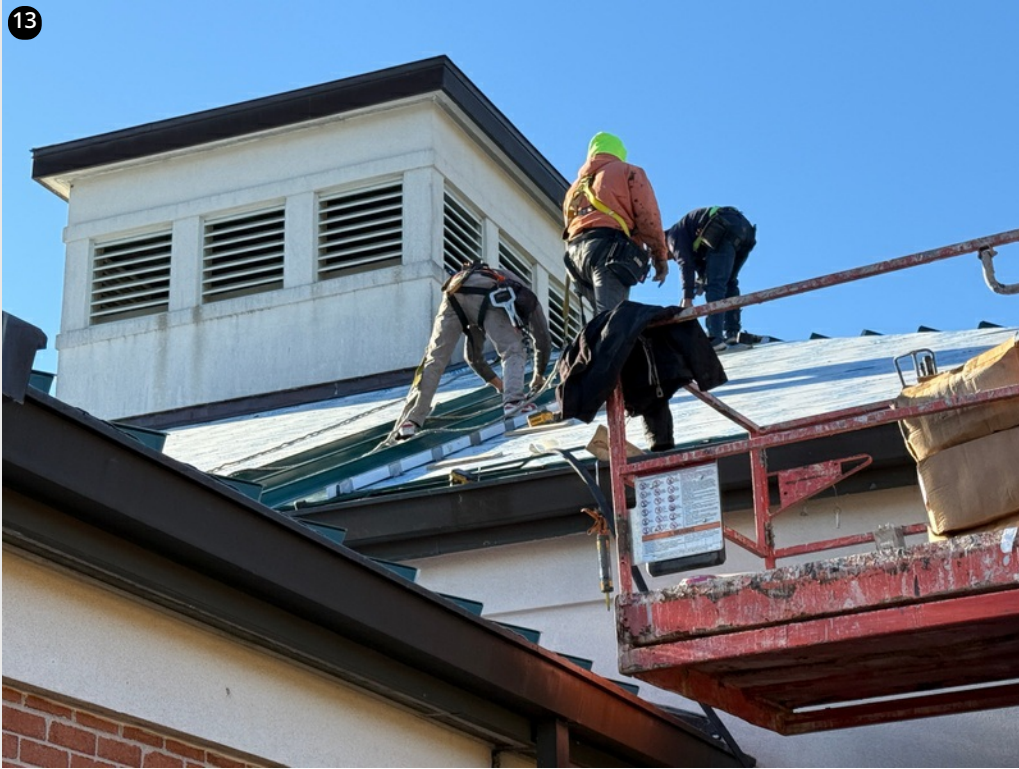
13

Crew fastening clips using 8" red fasteners- 11/15/24

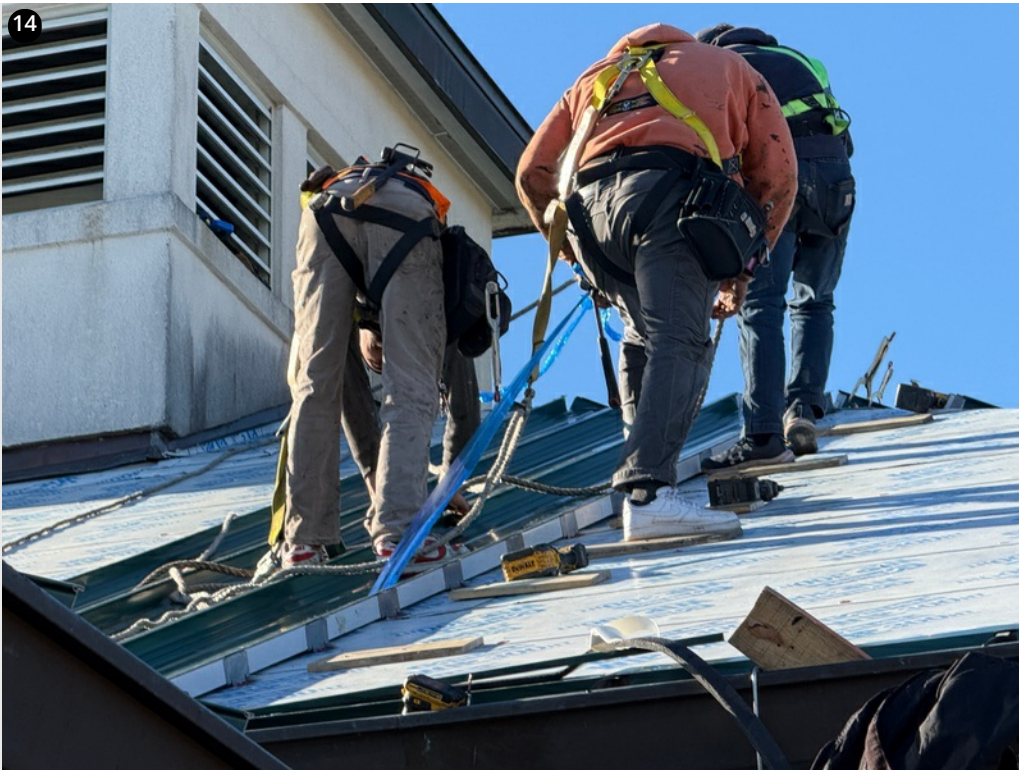
14

View of clip spacing- 11/15/24

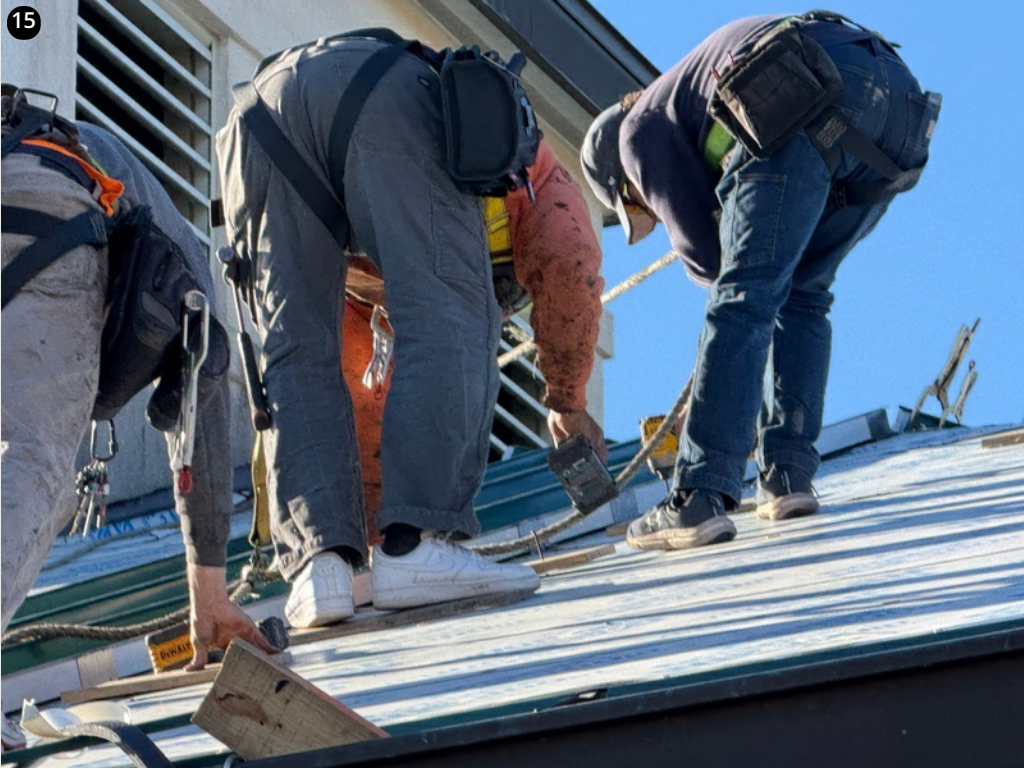
Crew fastening clips using red 8" fasteners- 11/15/24

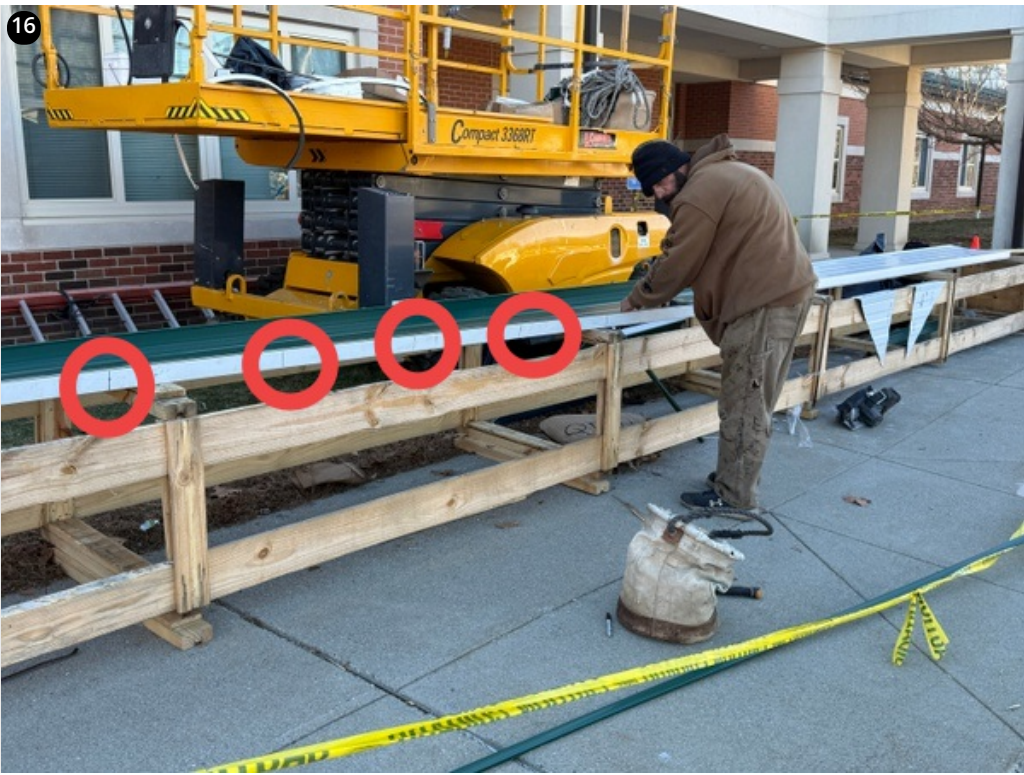
Crew marking out clip spacing per zone on panels prior to install- 11/15/24

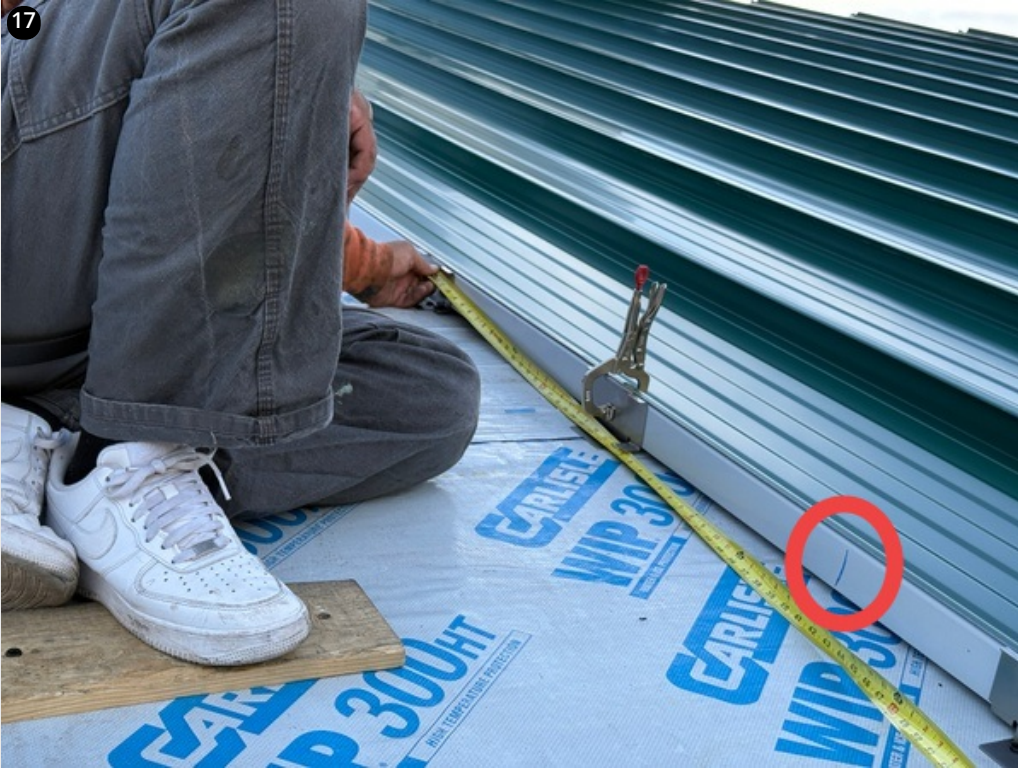
Clips spaced at 1'8" according to zone

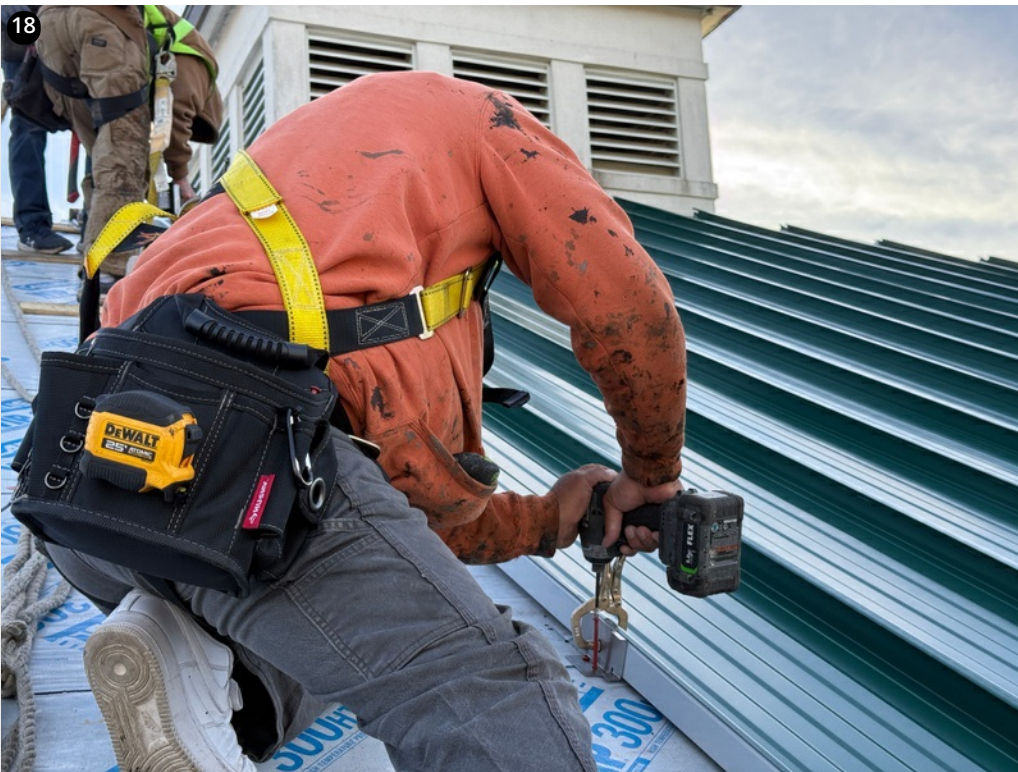
Crew fastening clips using red 8" fasteners

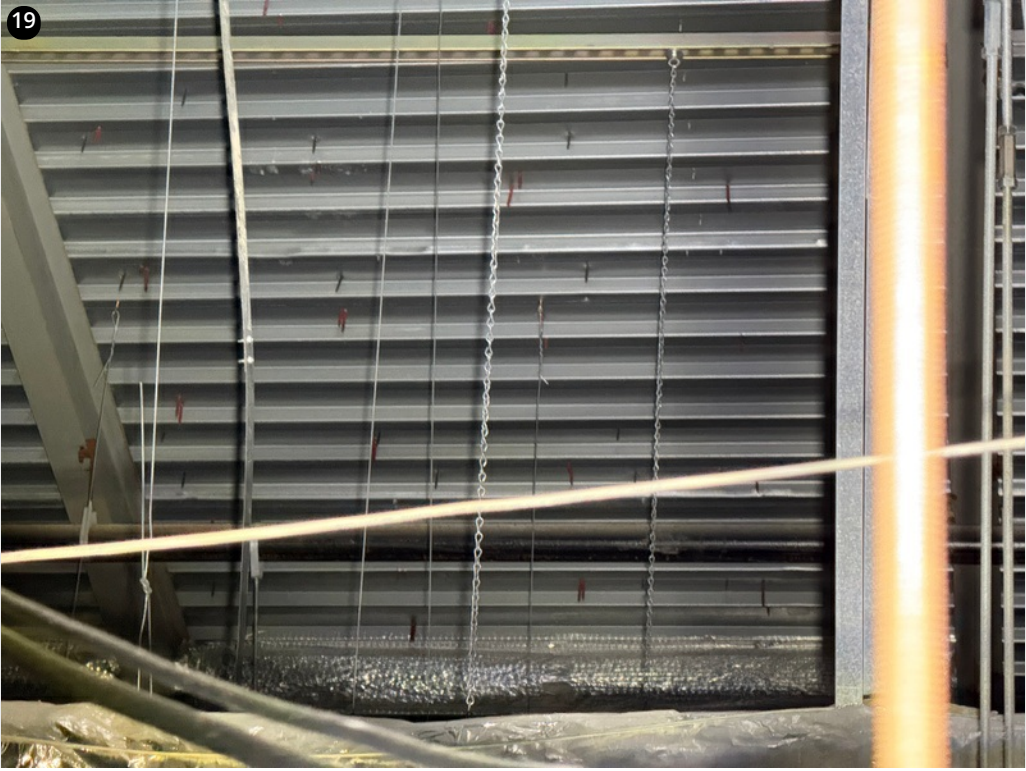
11/15/24- Fasteners observed properly penetrating deck

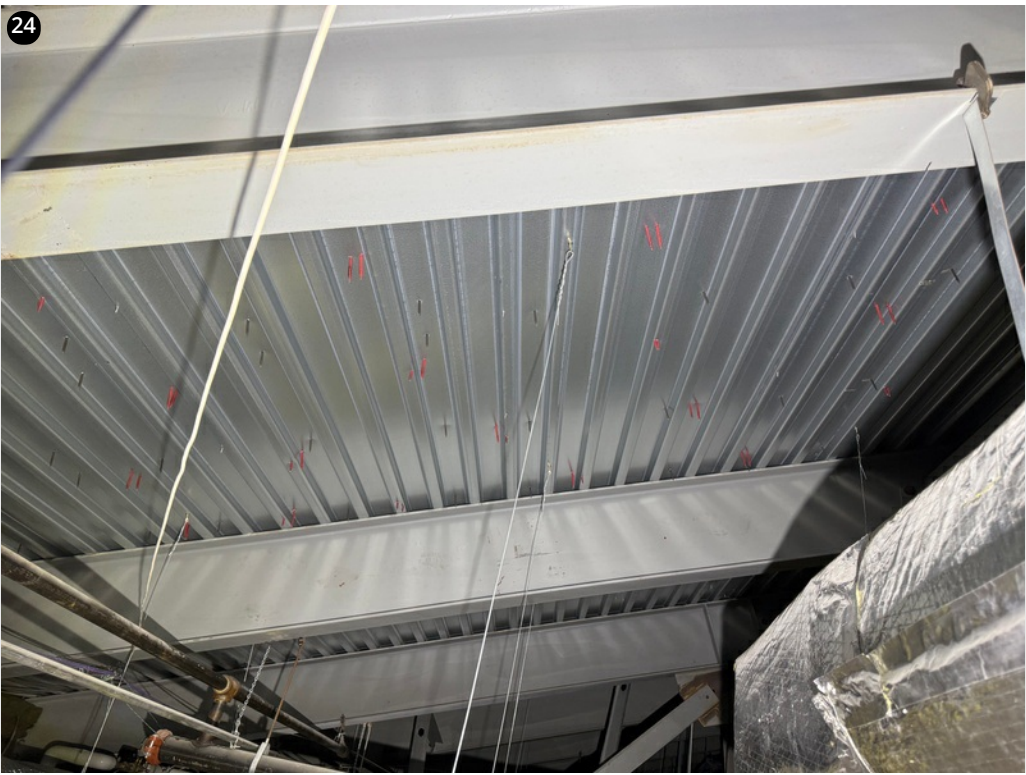
24

11/16/24- Fasteners observed properly penetrating deck

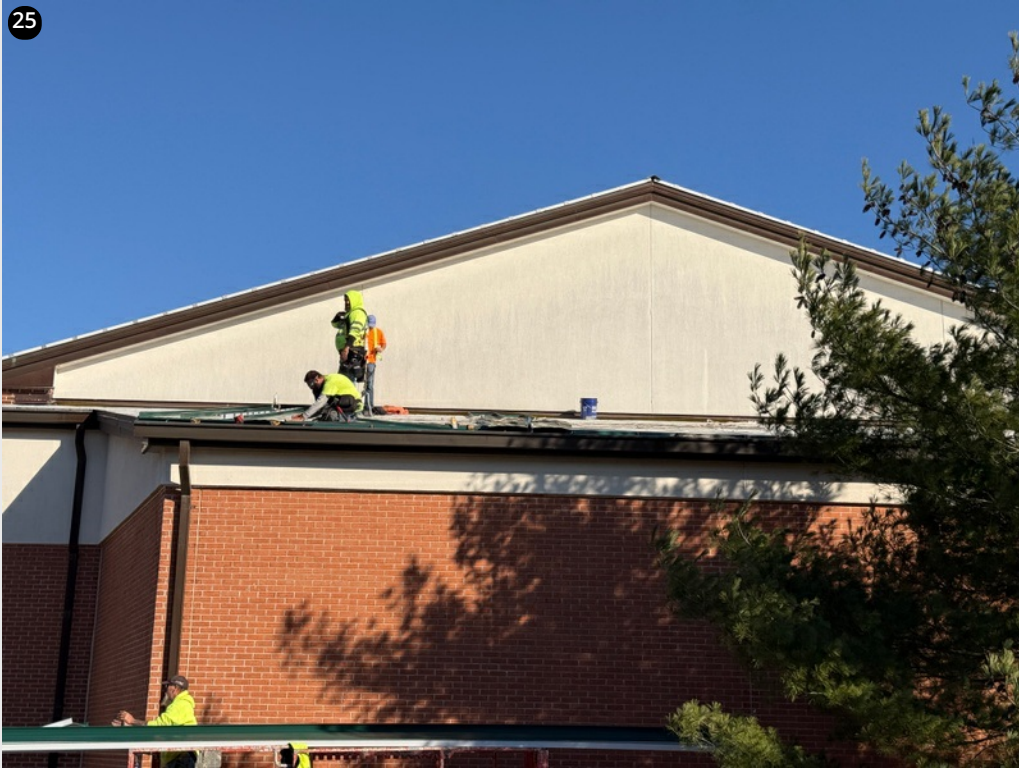
25

Crew fastening clips- 11/18/24

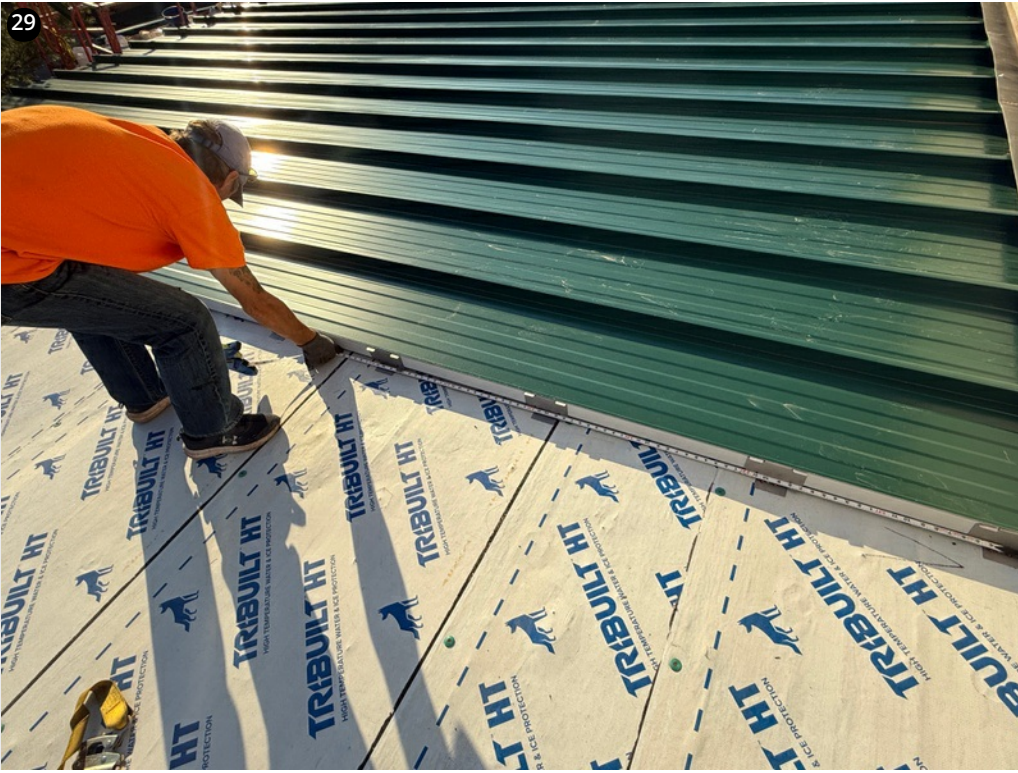
29

Clips spaced at 1'8" and 2'4" according to zone- 11/18/24

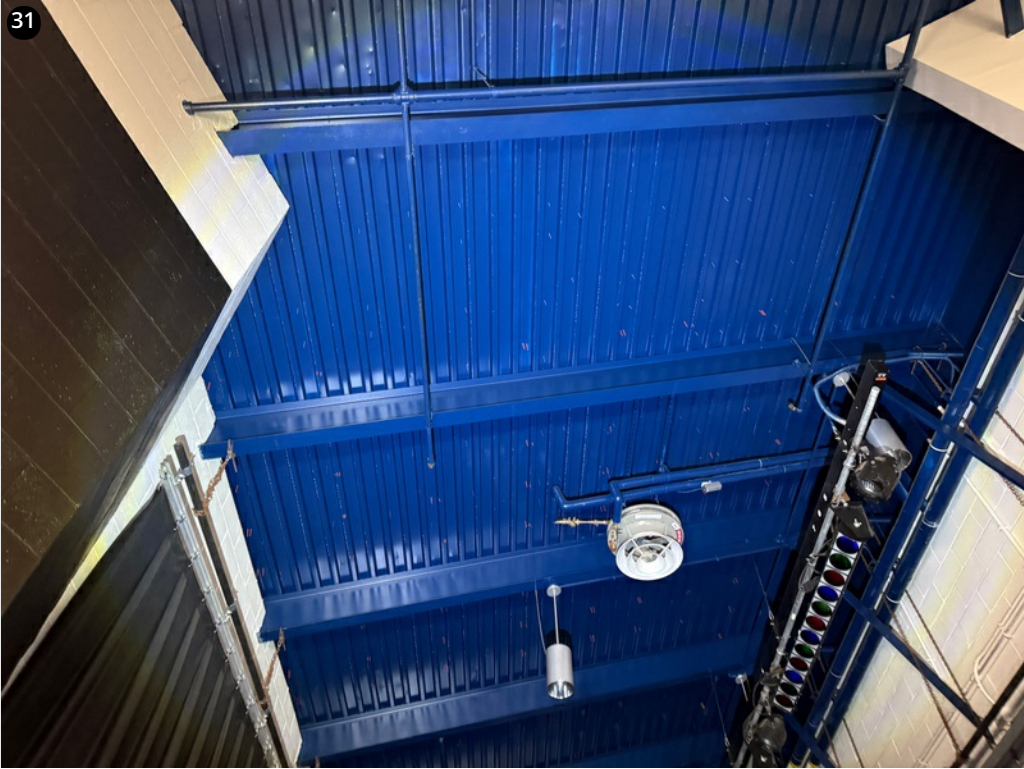
11/18/24- Fasteners visible properly penetrating deck

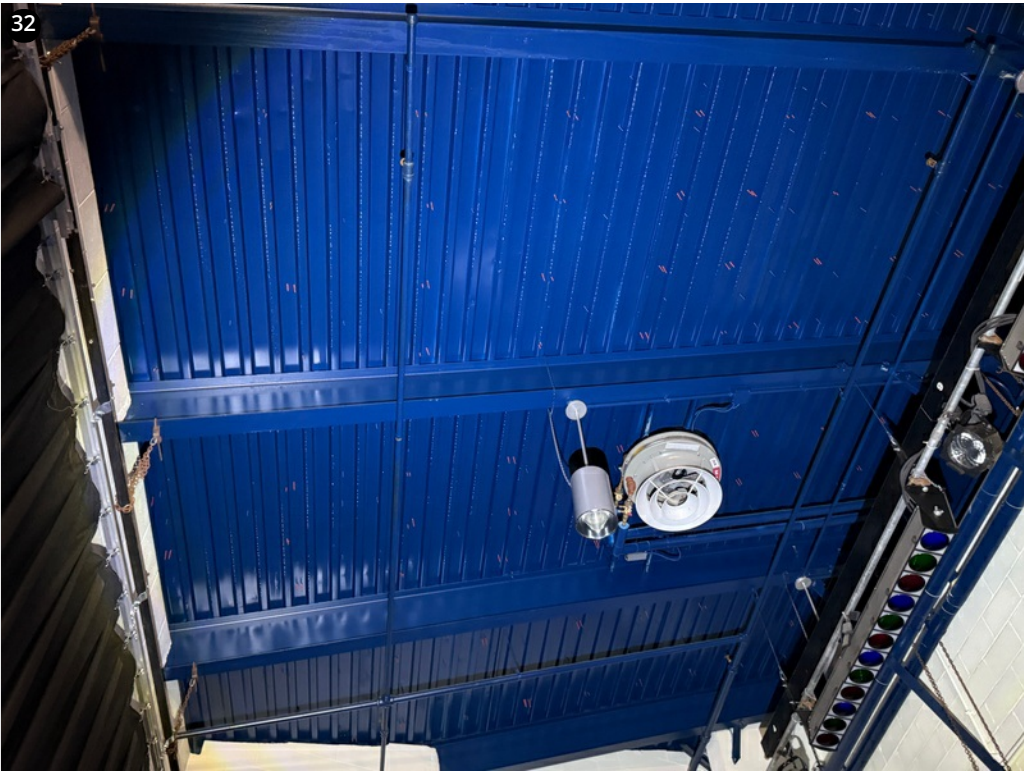
11/18/24- Fasteners observed properly penetrating deck
