MEMORANDUM

Date: May 15, 2025

Re: Visual Dam Evaluation
Lee Brook Pond Dam (CT Dam ID #7219)
Ledyard, Connecticut

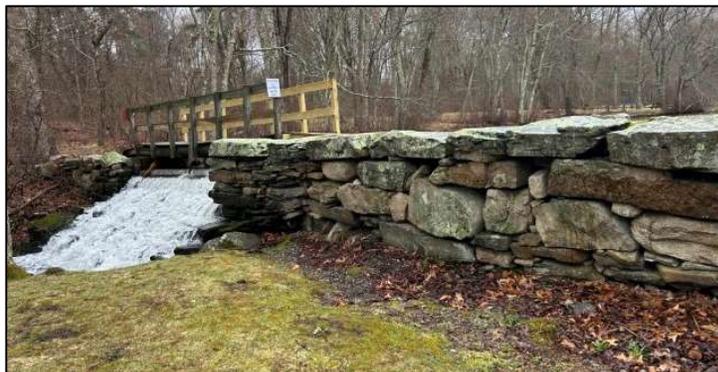
The spillway is located at the right abutment and consists of an approximate 16.5-foot long, stone masonry broad crested weir with stone steps on the downstream side. At the time of the inspection, approximately 5.5-inches of wooden flashboards were installed. There was approximately 8 and 12 inches of freeboard between the top of the boards and the top of embankment to the left and right of the spillway, respectively.

Photograph 1- Spillway and Typical Embankment Section

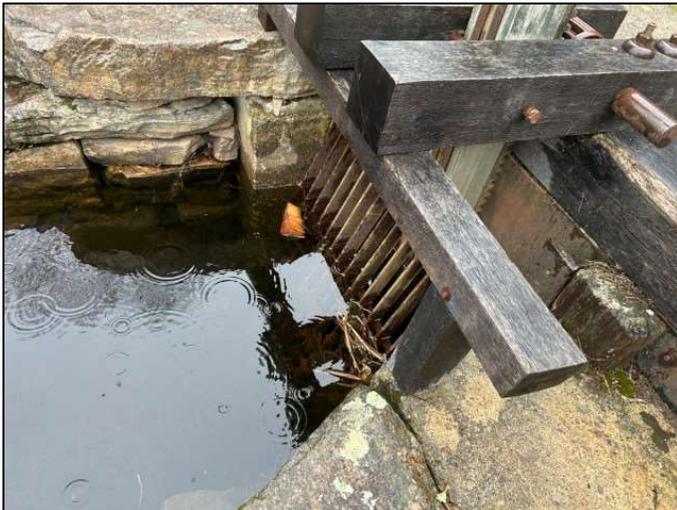
Photograph 2- Wooden gate at penstock

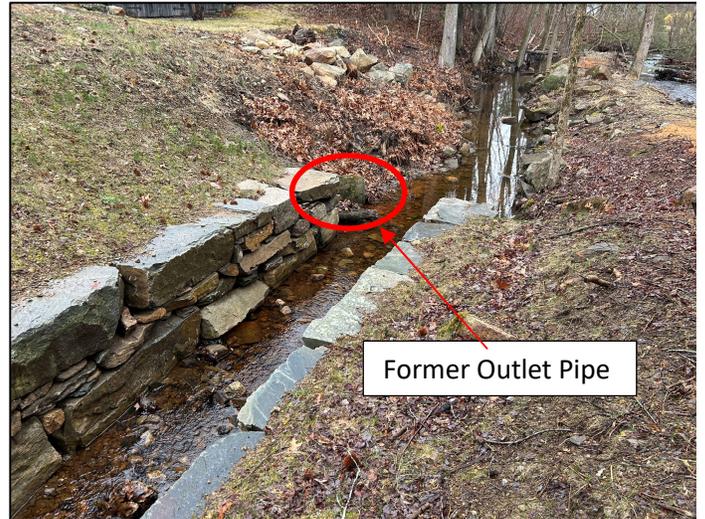
Photograph 3- Tailrace with former outlet pipe

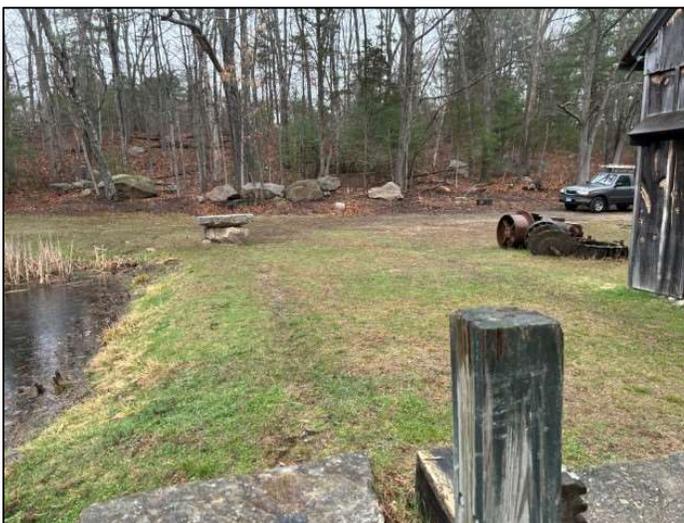
Photograph 4- Abandoned intake at the left abutment (where the rocks are stacked).

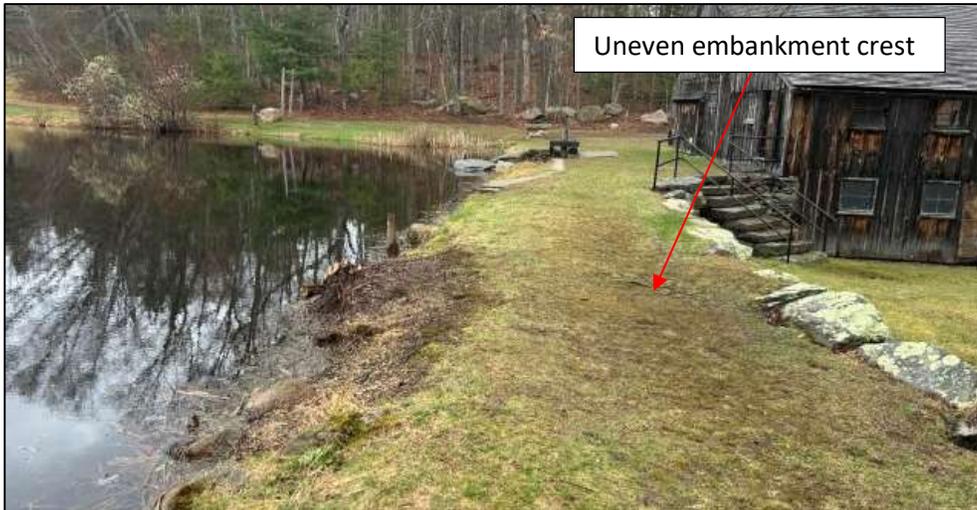
The crest of the embankment was uneven with apparent settlement along the downstream slope of the masonry wall. The downstream masonry wall had displaced stones, which caretakers during the Site visit indicated was progressively worsening and likely a result of overtopping. Gravel repair areas were observed at the toe of the masonry wall from overtopping scour. The tailrace and tailrace masonry walls were in good condition. The spillway appeared in good condition. Caretakers indicated the concrete training walls on either side of the spillway appeared to be shifting downstream, which could be a result of ice damage or excessive flow over the spillway.

Photograph 5- Embankment crest from the Left side of the Spillway

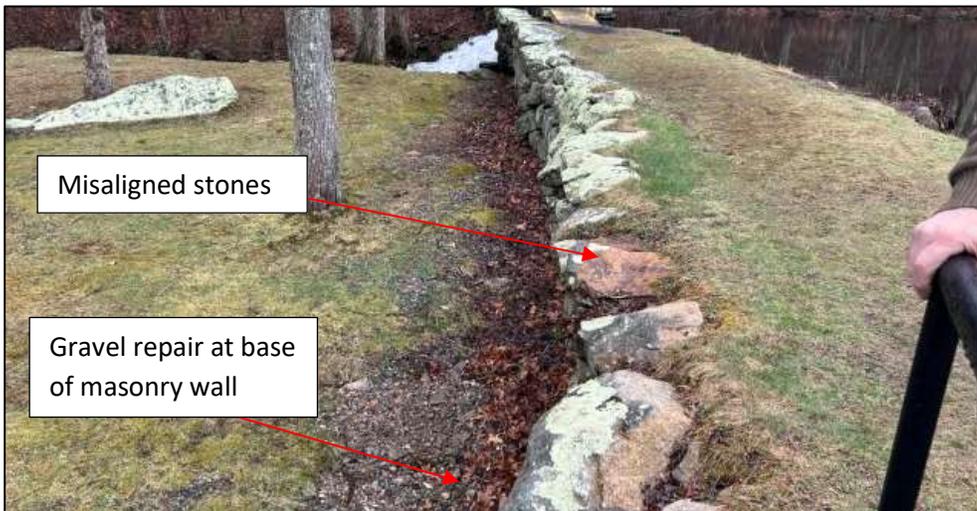
The dam has reportedly overtopped 8 to 10 times in the past 25 years, including twice during the winter of 2023-2024. At least 3 times since 2000, the overtopping water has flowed through the foundation of the mill building which has resulted in voids in the downstream embankment wall / building foundation. During an overtopping event in March 2010, water reached the door of the sawmill building.

Photograph 6- Downstream Masonry Wall Looking from the Right side of the Penstock

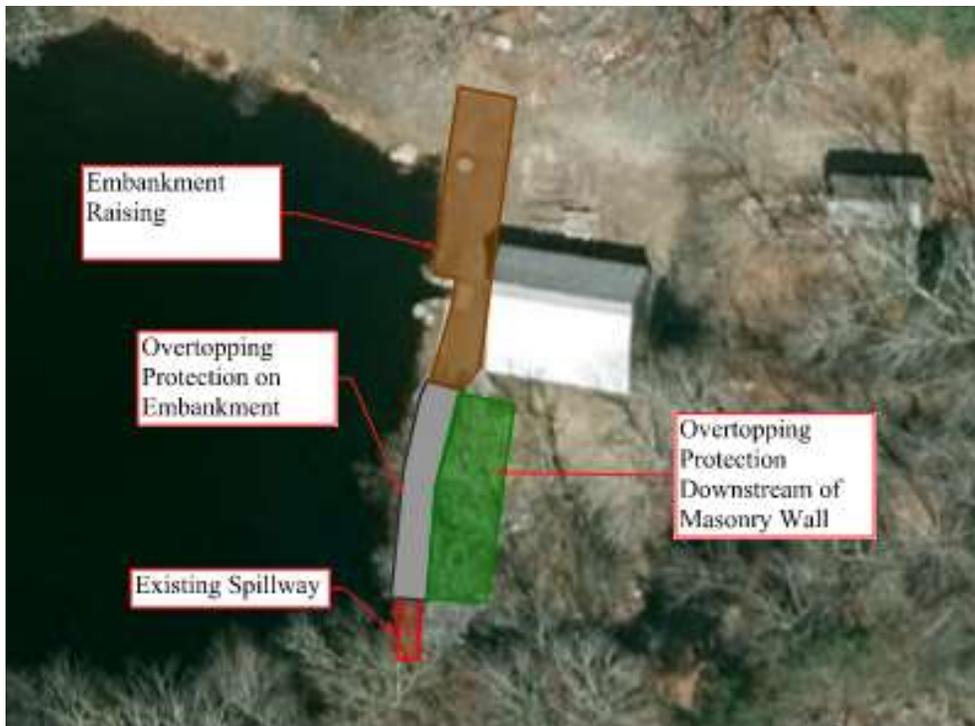
Photograph 7- Proposed overtopping concept.

Potential overtopping protection would consist of grouted riprap or articulated concrete blocks (ACBs) on the embankment crest and extending 10 to 15 feet downstream of the masonry wall. During the construction of the overtopping protection, the embankment crest should be regraded to a consistent elevation. The portions of the embankment at the mill building could be raised higher to keep overtopping away from the building. Trees within 25 feet of the dam would be removed and the downstream masonry wall would be reset during construction. A concept plan of the overtopping protection is shown below.

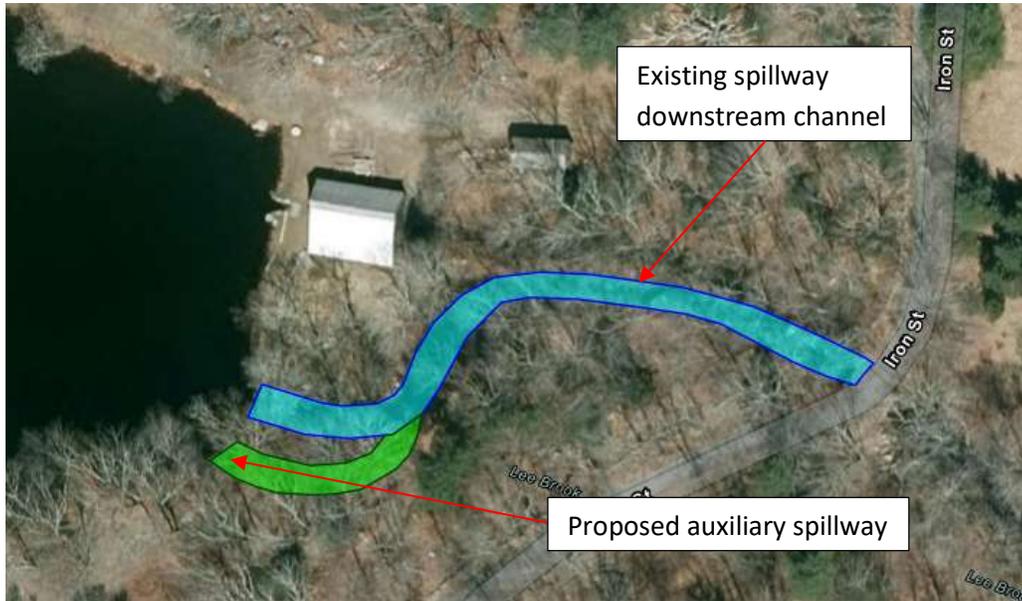
Photograph 8- Proposed auxiliary spillway concept.

An auxiliary spillway could be constructed at the right abutment to supplement flow. The embankment crest would be regraded to a consistent elevation and the auxiliary spillway would be set approximately 6-inches above the current top of flashboards. Conceptual auxiliary spillway sizes are provided in **Table 2**. The analyses included raising the existing grade of the embankment to reduce the proposed auxiliary spillway length.

During construction, a new downstream channel would be constructed between the auxiliary spillway and existing spillway downstream channel. A conceptual plan of the auxiliary spillway is shown below. In addition to the spillway construction, trees would be removed from the proposed auxiliary channel and within 25 feet of the dam and the displaced stone masonry would be reset. Note this alternative will require additional study to confirm that the auxiliary spillway does not worsen downstream flooding.
