## DAM SAFETY PROGRAM

### DAM INSPECTION REPORT FORM – FOR REGULATORY INSPECTION

Dam Name:	Pine Swamp Brook Pond Dam	Inspection Date(s):	December 18, 2024
Alternate Dam Name(s):	none	CT Dam ID #:	7212
Location (Municipality):	Ledyard	Temperature / Weather:	±32°, Clear, calm
Registered? Yes or No <small>If yes, provide the 9 digit registration number found on the notification letter.</small>	Y, not available	Pool Level: <small>See Instructions</small>	±1-inch
Emergency Action Plan? Yes or No <small>If Yes, see instructions</small>	No	Impoundment Use: <small>use options listed in instructions</small>	Recreation
Hydraulic and Hydrologic Analysis? Yes or No <small>If Yes, see instructions</small>	No	Stability Analysis? Yes or No <small>If Yes, see instructions</small>	No
Overall Condition of Dam: (refer to <a href="#">Appendix A</a> located at the end of this form) <b>Fair</b>

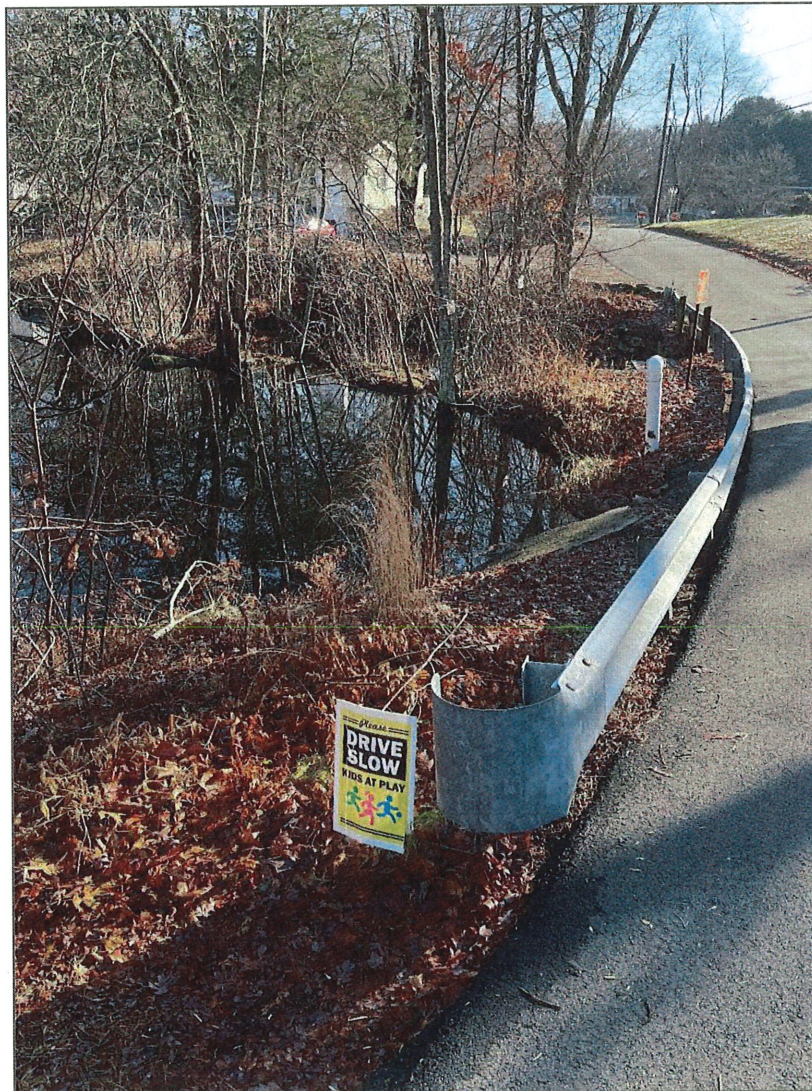
**Vegetative Cover:** Heavy growth of trees and brush on dam embankment

Photo 1: Upstream face of embankment

1. Clear vegetation from dam and  $\pm 25$  beyond. Grubbing of trees requires Dam Safety permit.
2. Replace or repair failing auxiliary spillway pipe.
3. Monitor principal spillway grouted stone walls, and repoint grout as needed.
4. Monitor principal spillway inlet for blockage

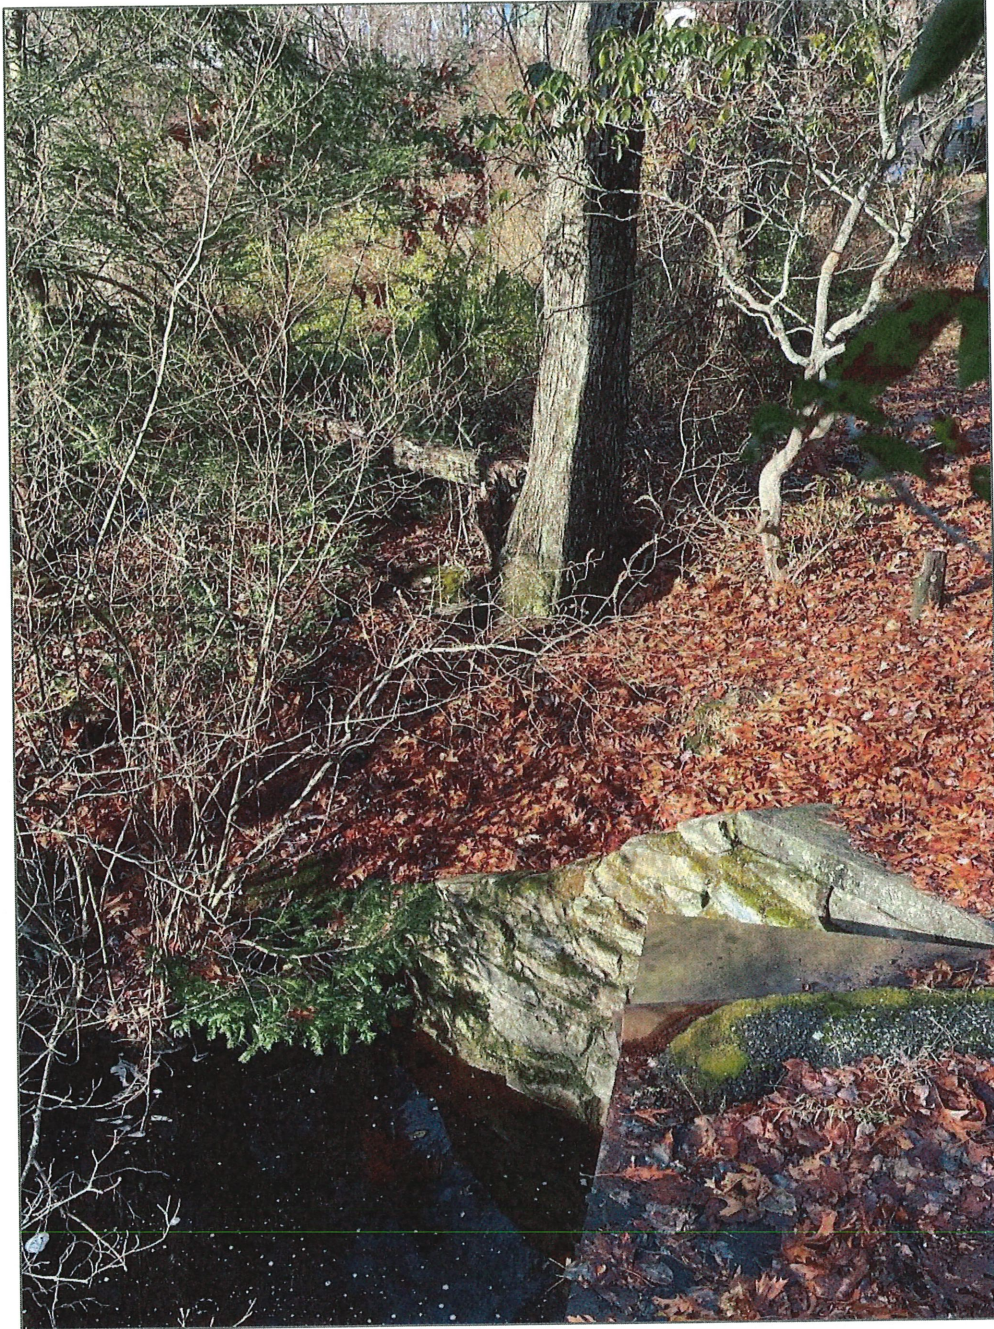
Photo 2: Downstream face of embankment

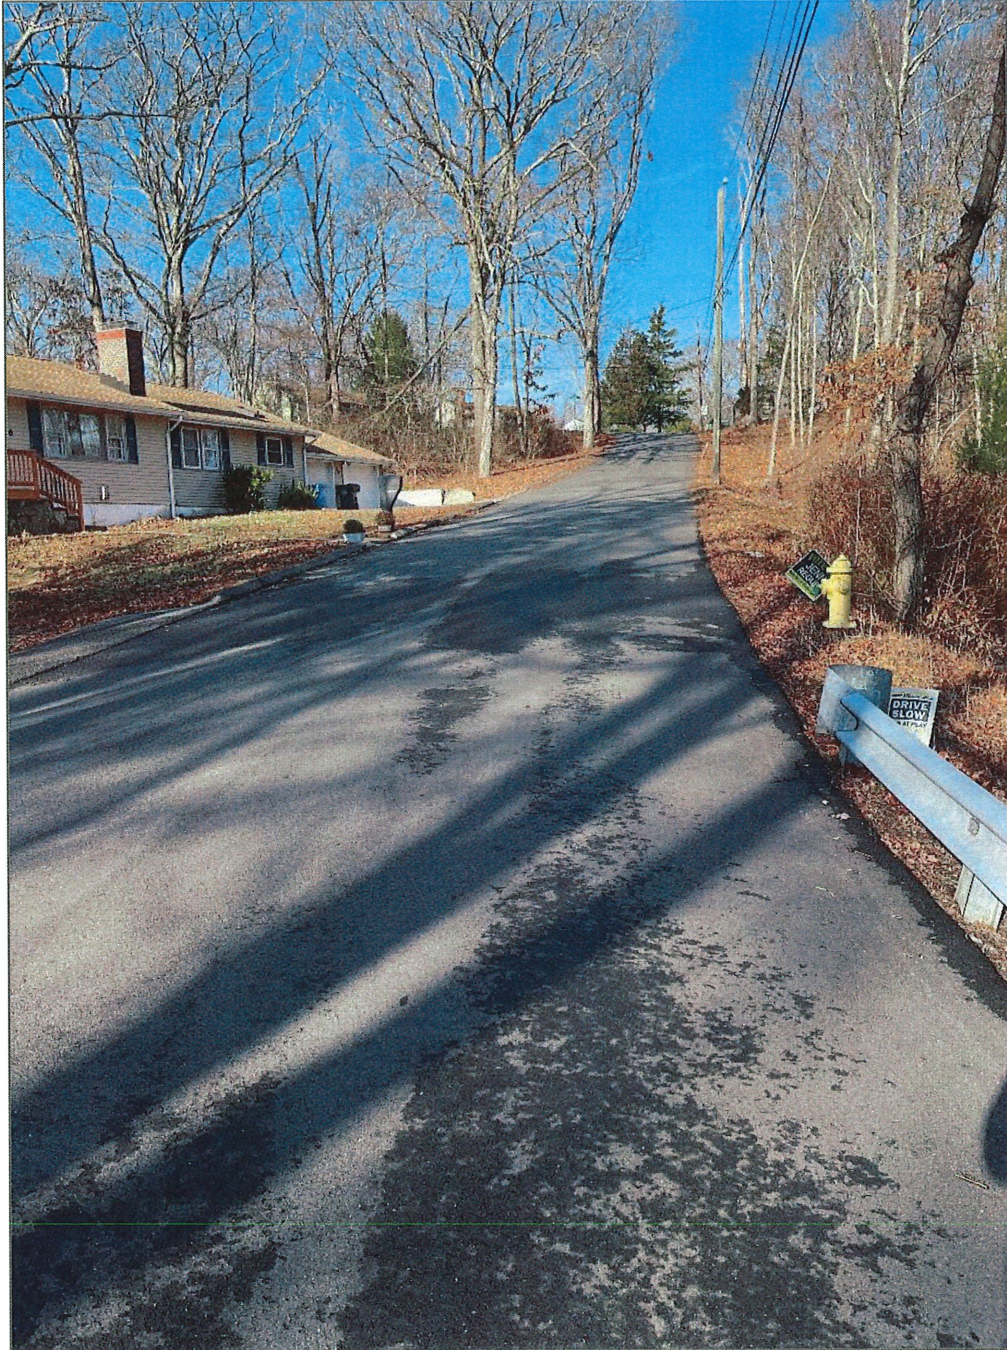
Photo 3: Roadway approach to right abutment and hydrant position

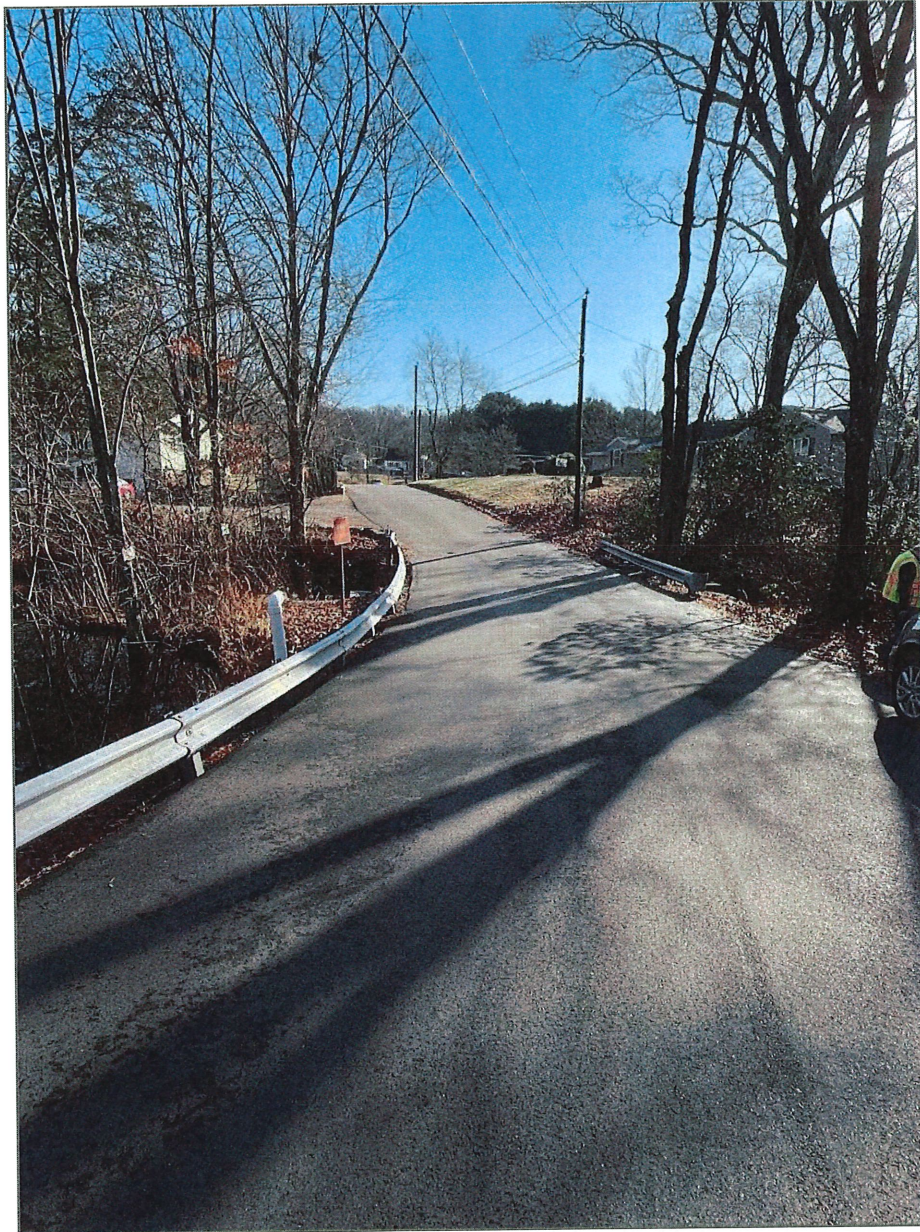
Photo 4: Roadway across dam embankment and beyond left abutment

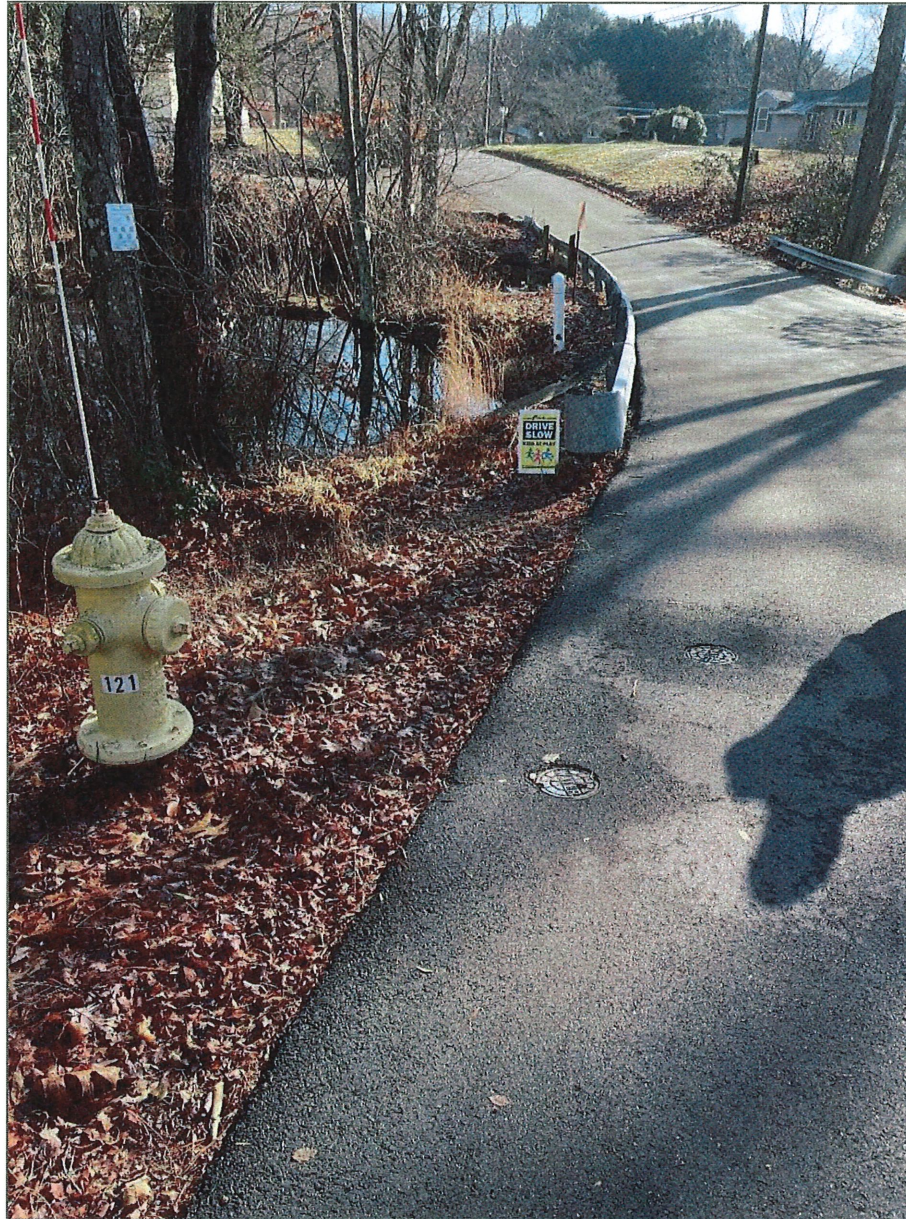
Photo 5: Water shut-off for hydrant and pipe crossing dam. Similar arrangement at left abutment

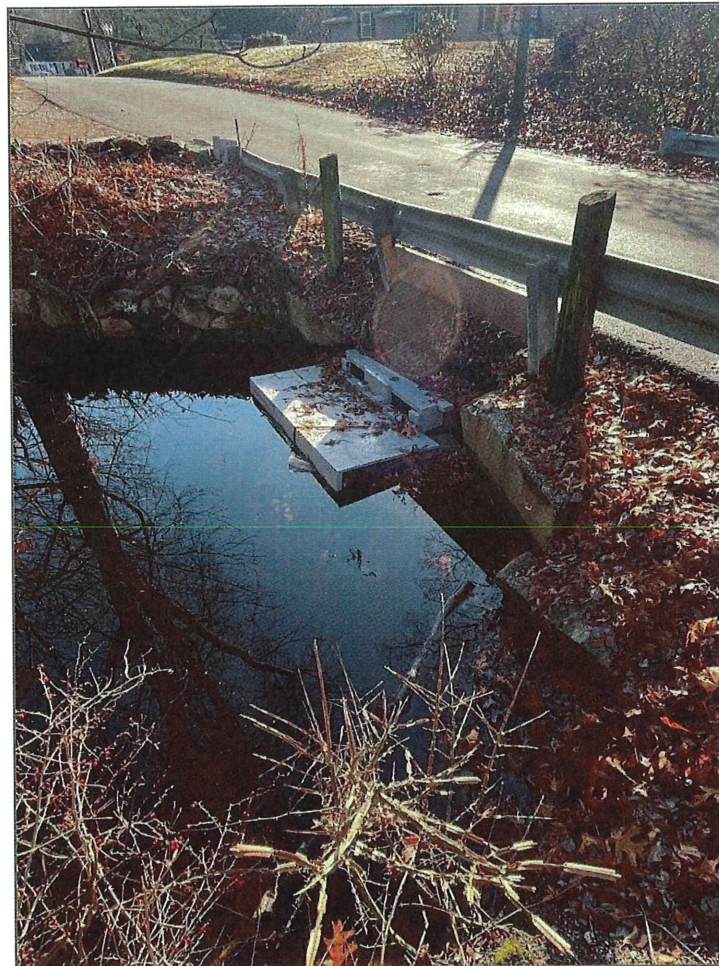
Photo 6: Principal spillway inlet with cover

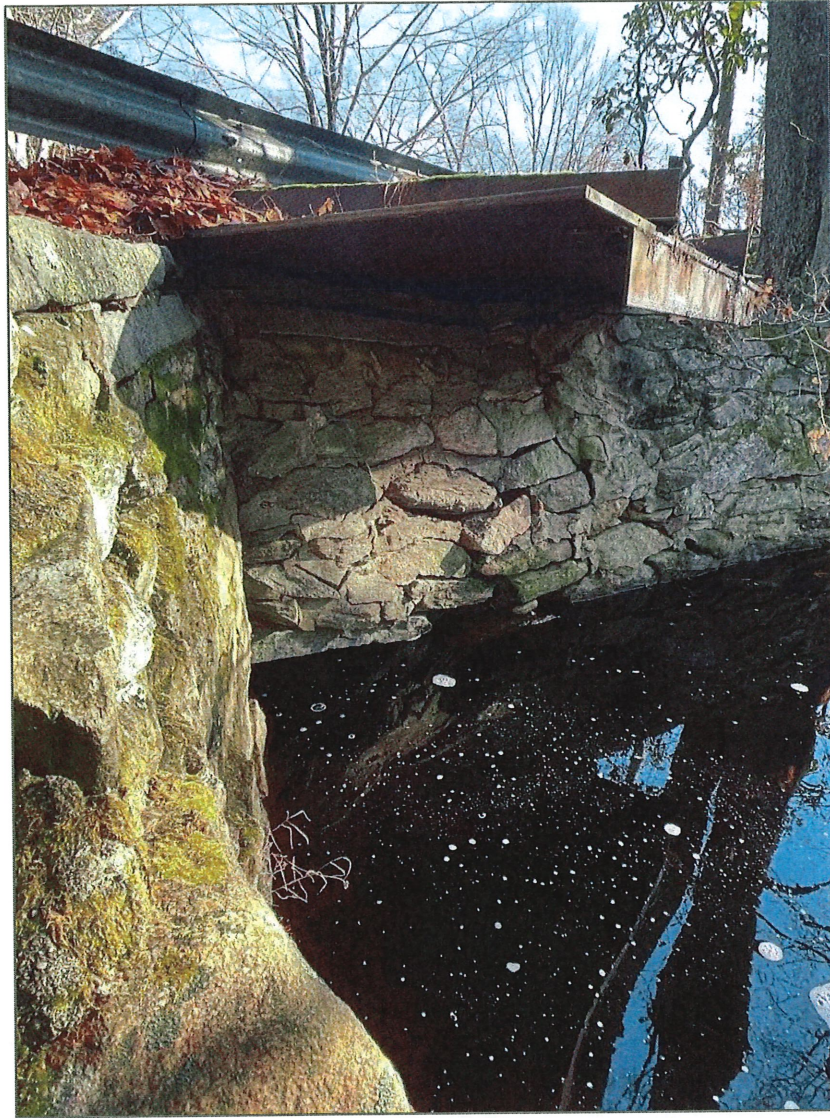
**Stone Masonry:** Some grout missing near outlet end of culvert

Photo 7: Principal spillway outlet

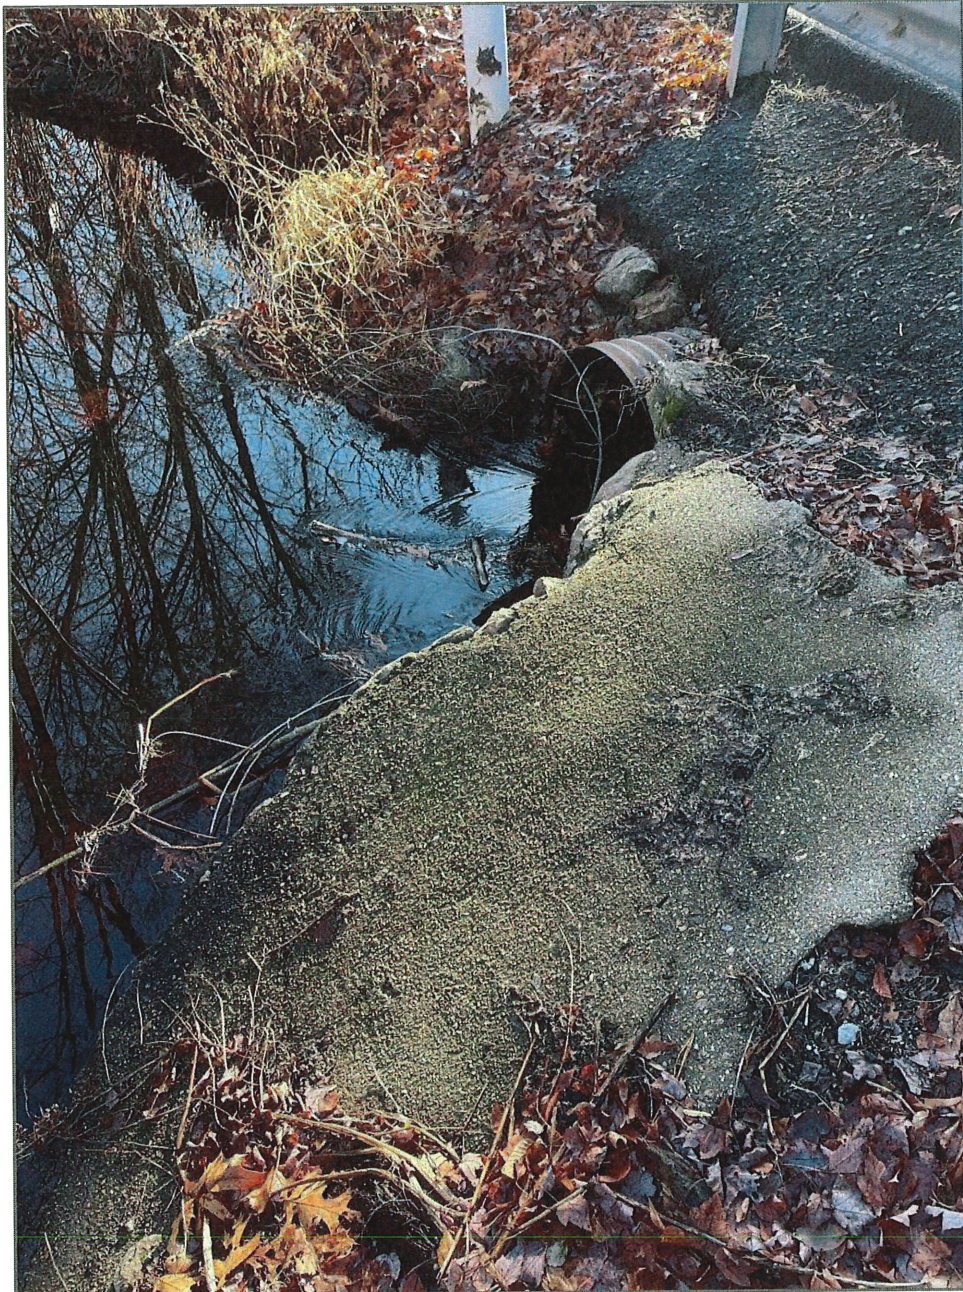
Photo 8: Auxiliary spillway inlet

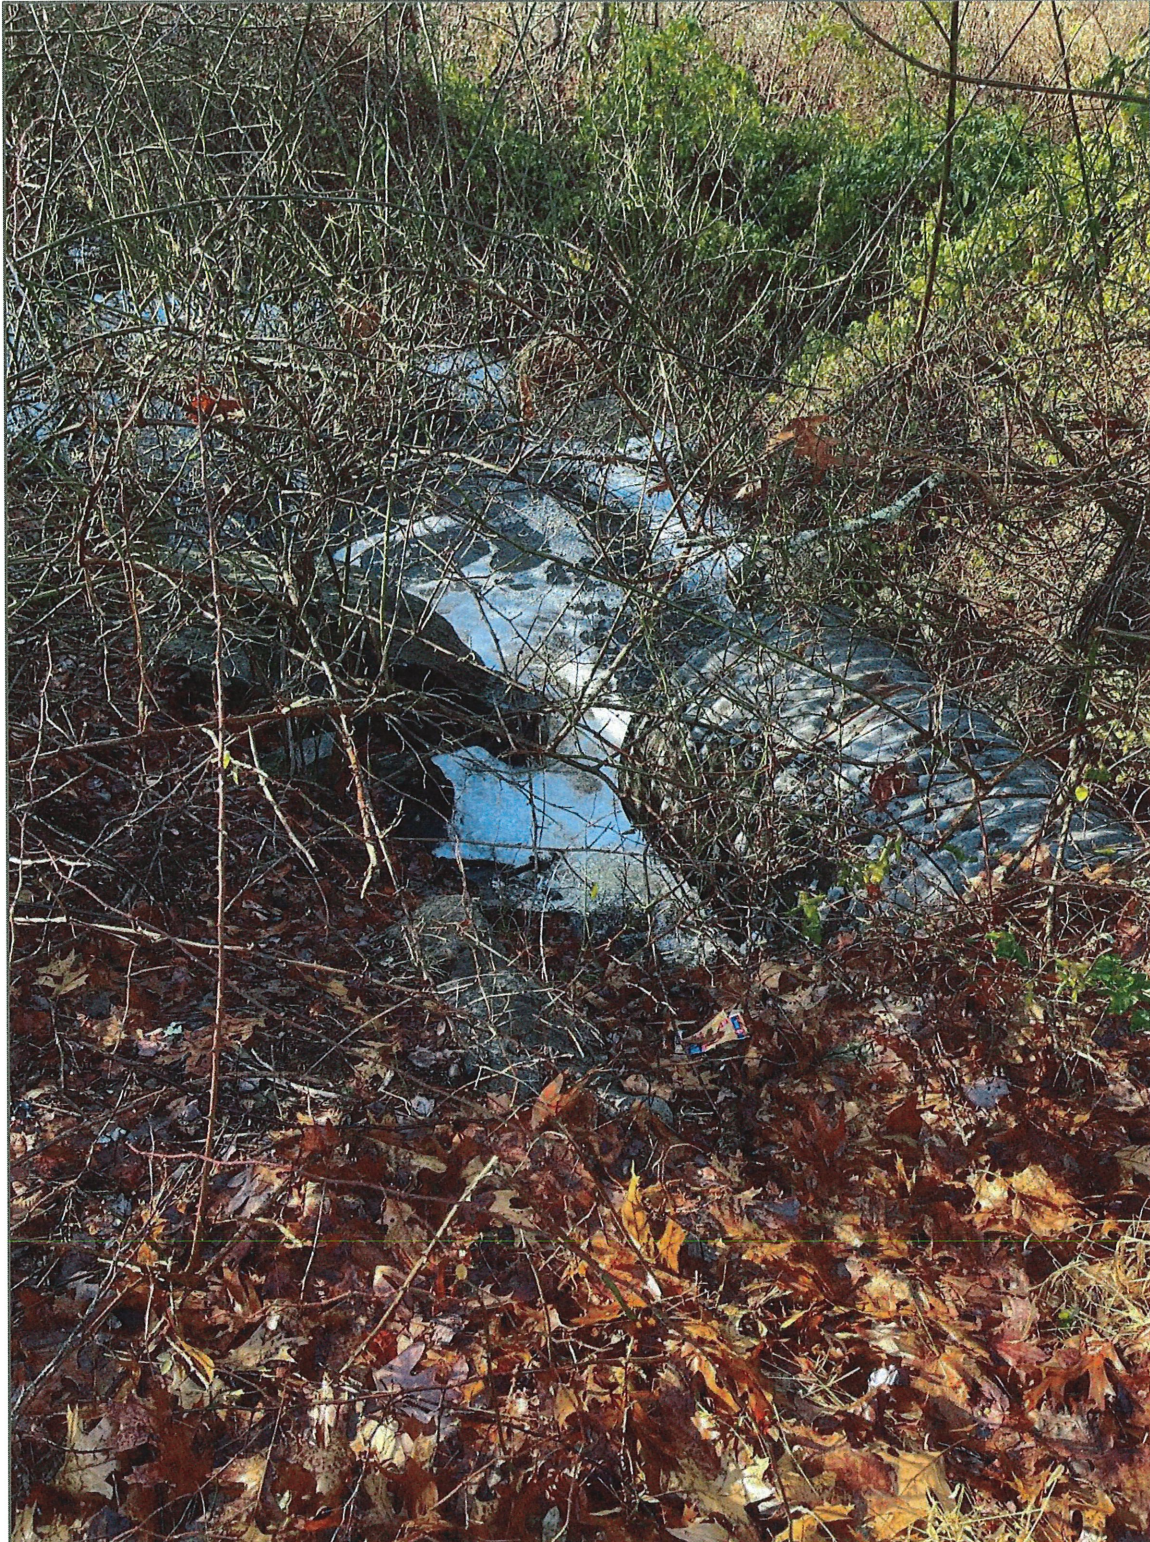
**Scouring/Undermining:** Scouring on downstream embankment

**Other:** Downstream invert of CMP has rotted through and flow spills out onto dam embankment before it exits at the outlet. Also, there is no scour protection at outlet.

Photo 9: Auxiliary spillway outlet

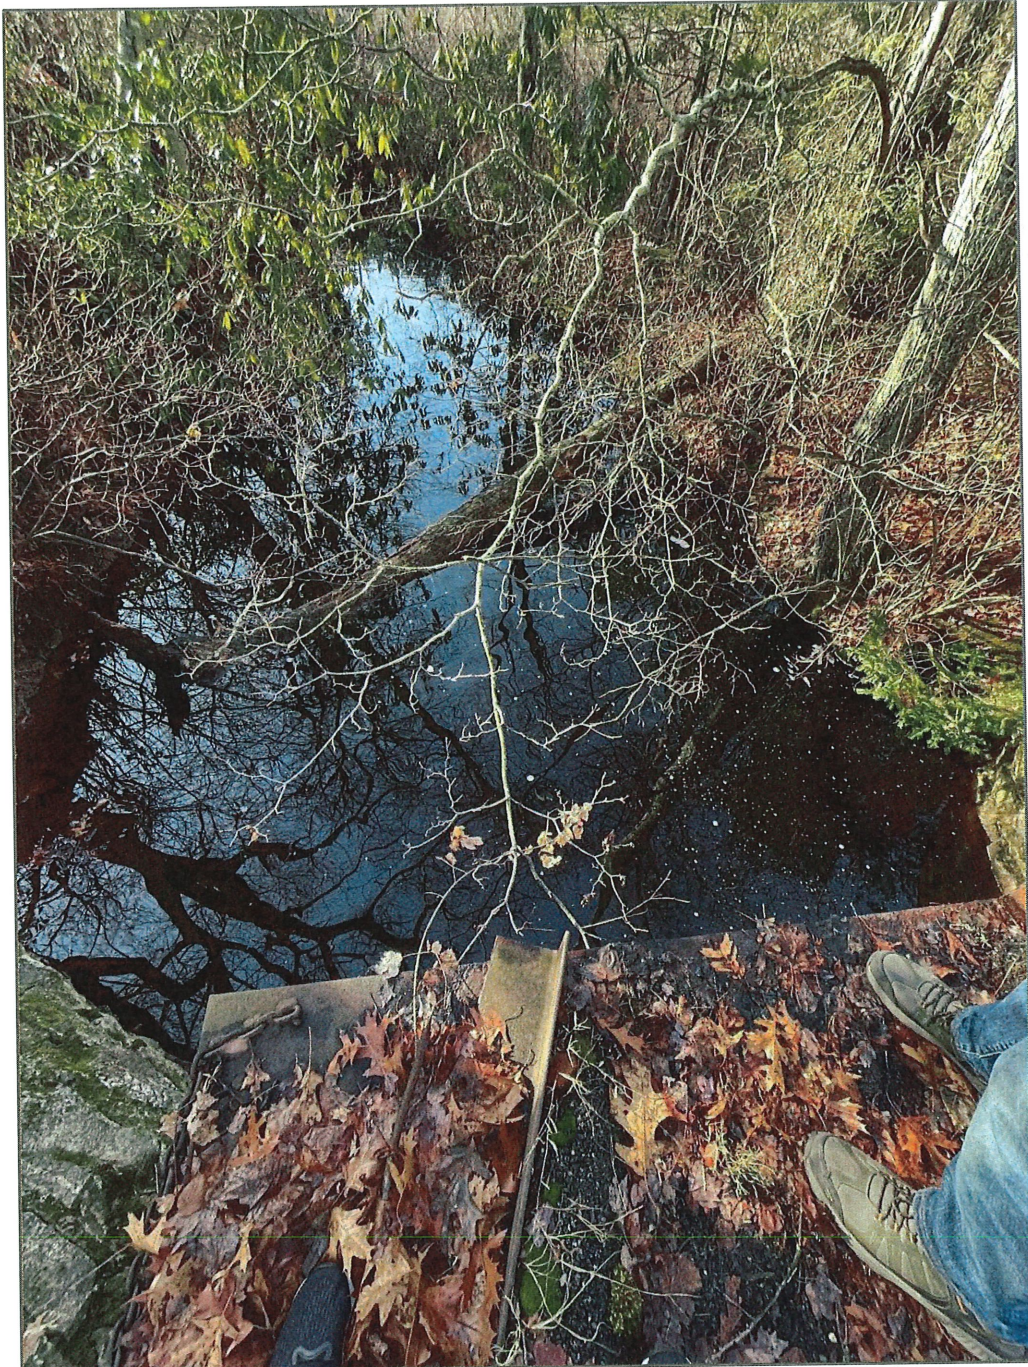
**General Description:** Natural stream channel with dense vegetation on banks, sand-cobble bottom

Photo 10: Downstream channel of Pine Swamp Brook

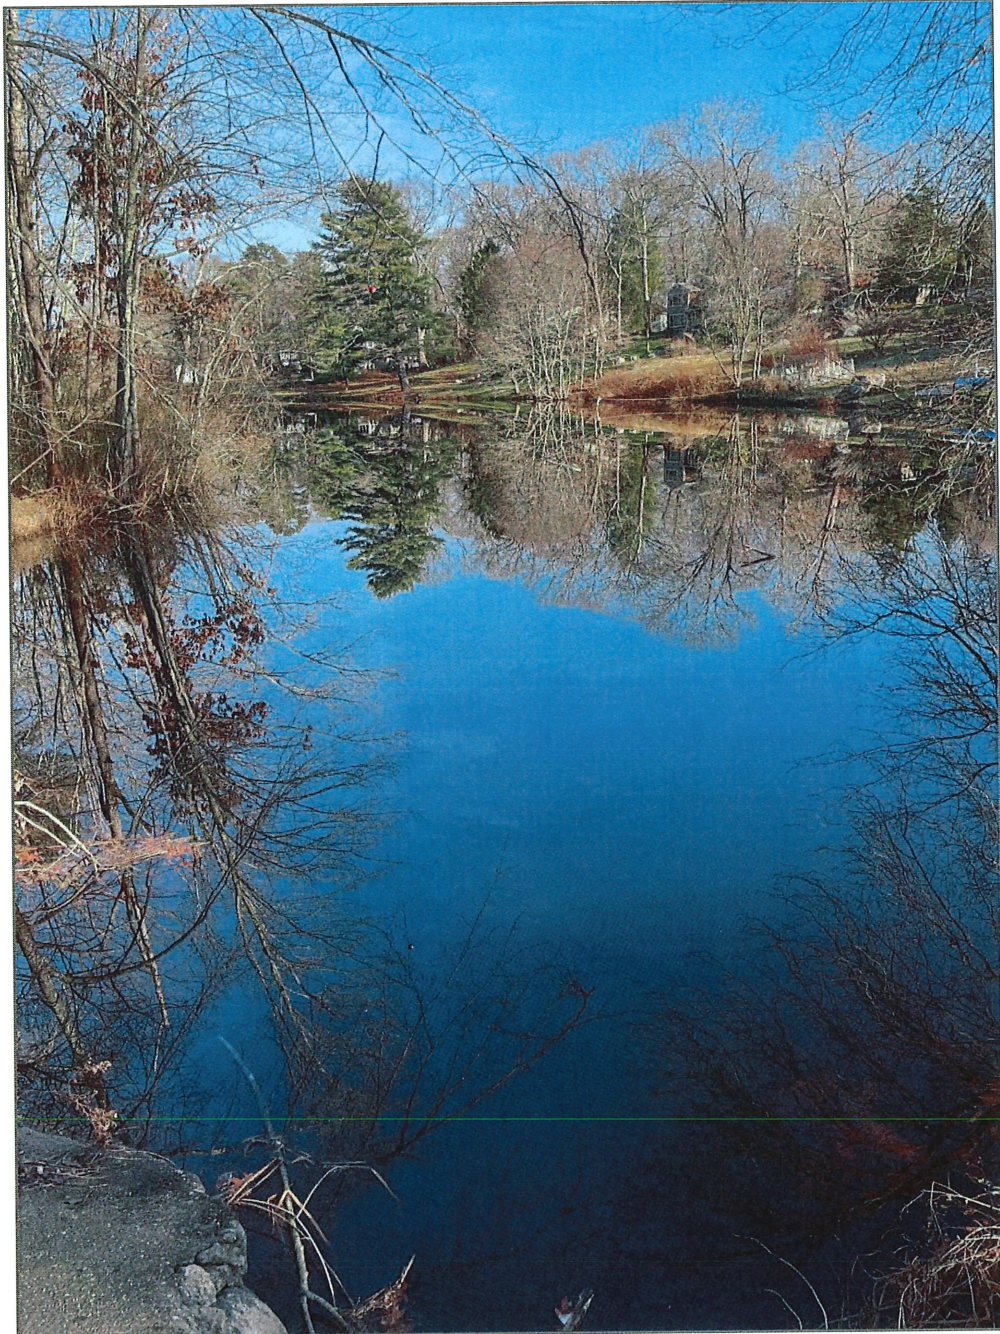
Photo 11: Pine Swamp Brook Pond

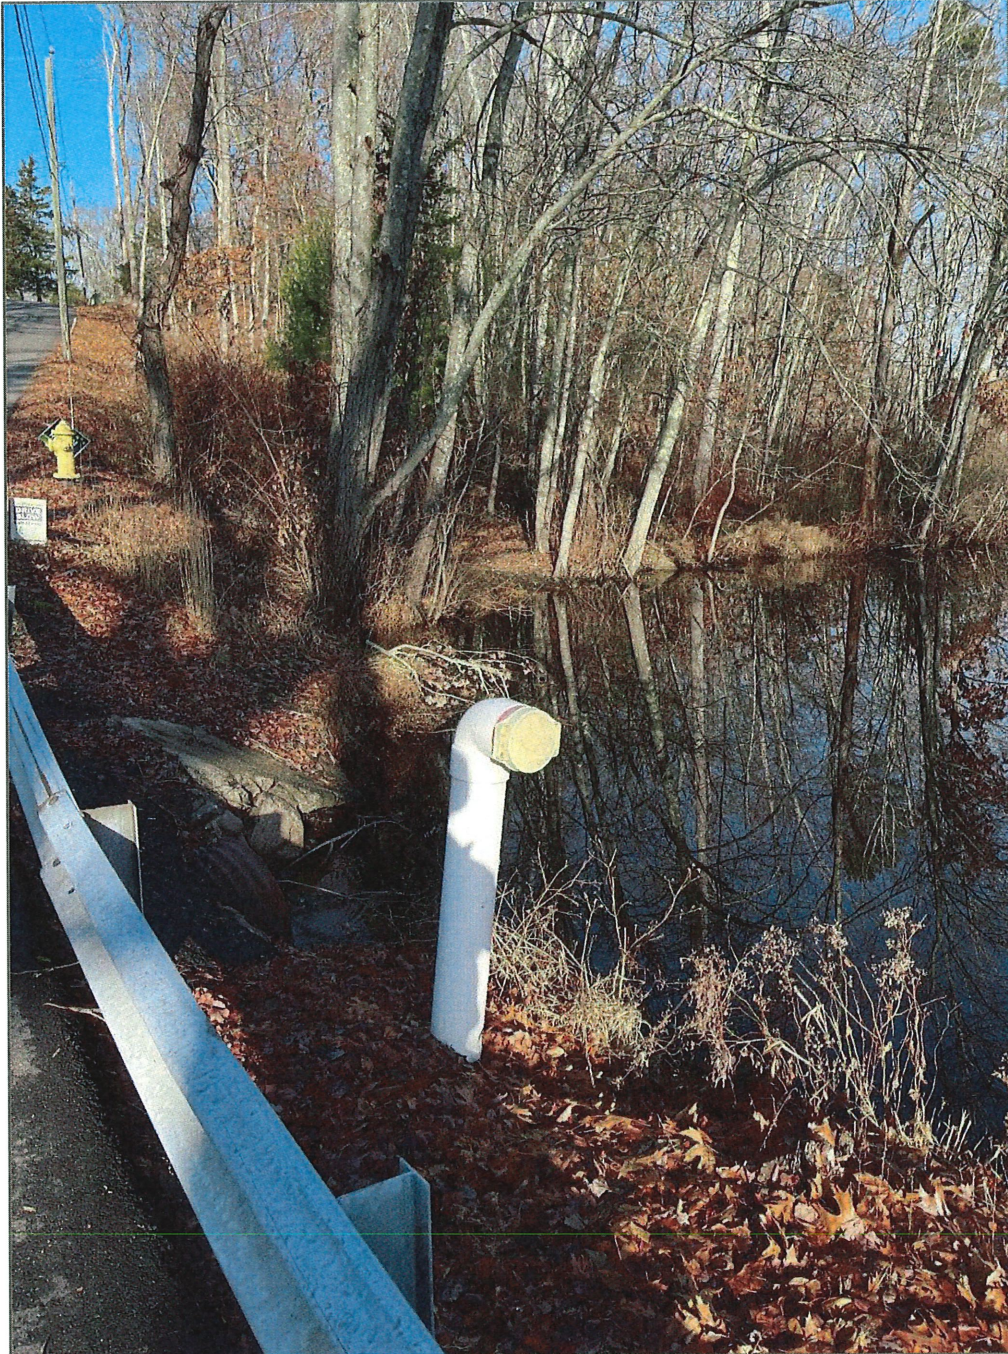
Photo 12: Dry hydrant and potable water hydrants
