# DEP/INLAND WATER RESOURCES DIVISION

## DAM INSPECTION CHECKLIST

DAM NAME & NUMBER: Tribrook Pond  
#07216

INSPECTION DATE: 5/7/93

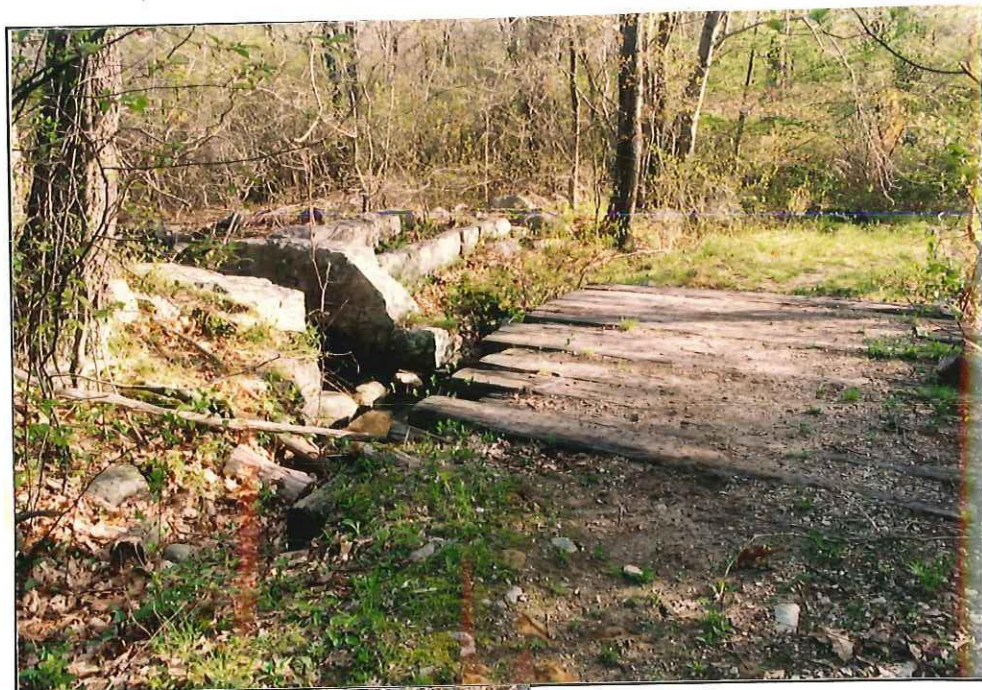
Overall view of the  
dam from the right  
dam abutment on the  
downstream side

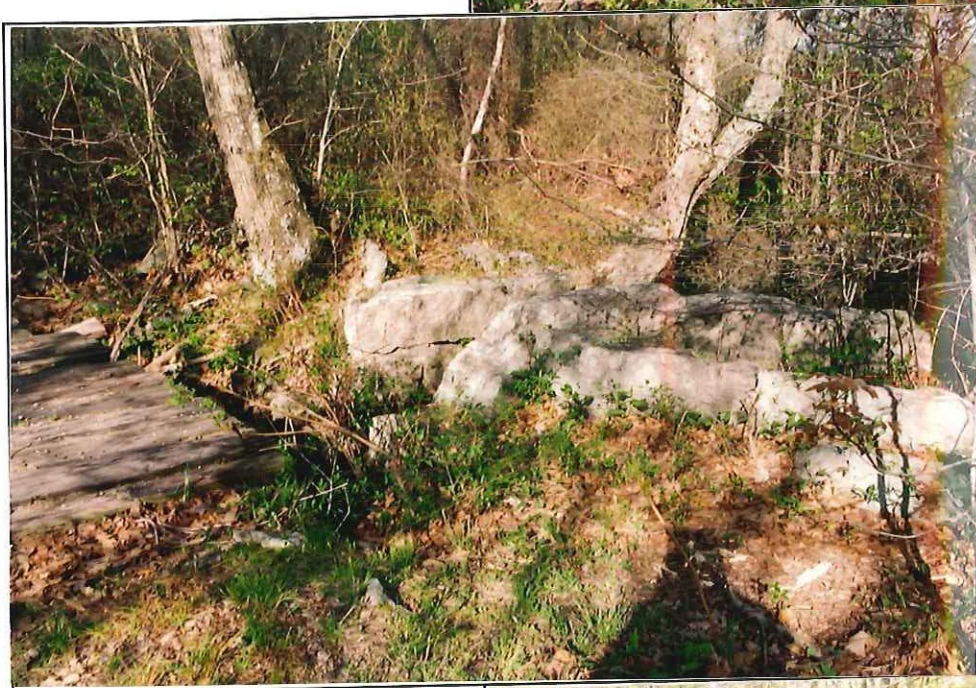
Overall view of the  
dam from the left  
dam abutment

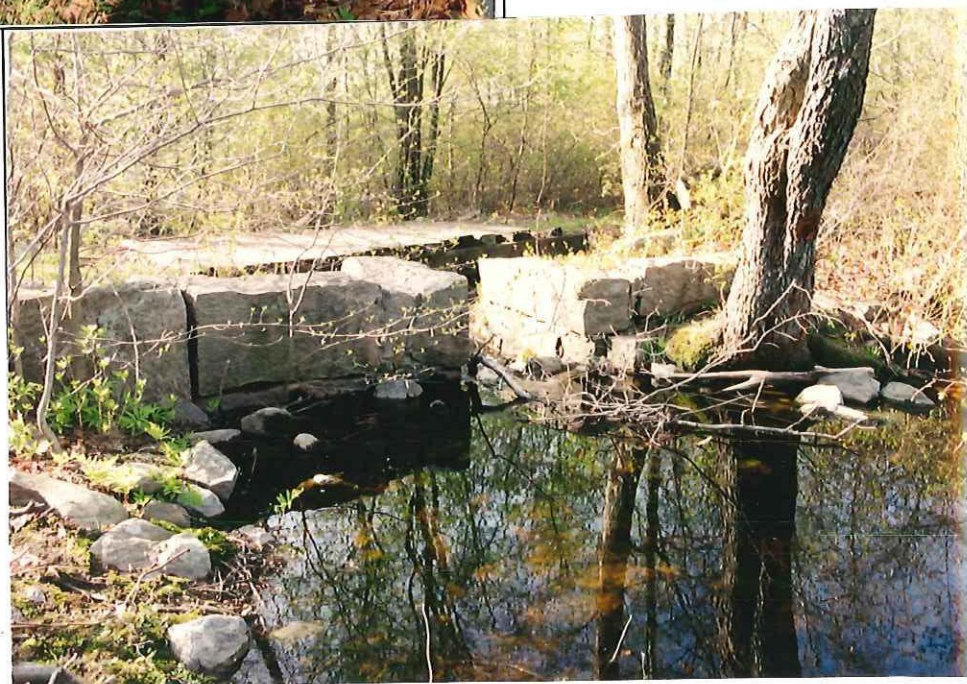
View of the upstream  
side of the dam

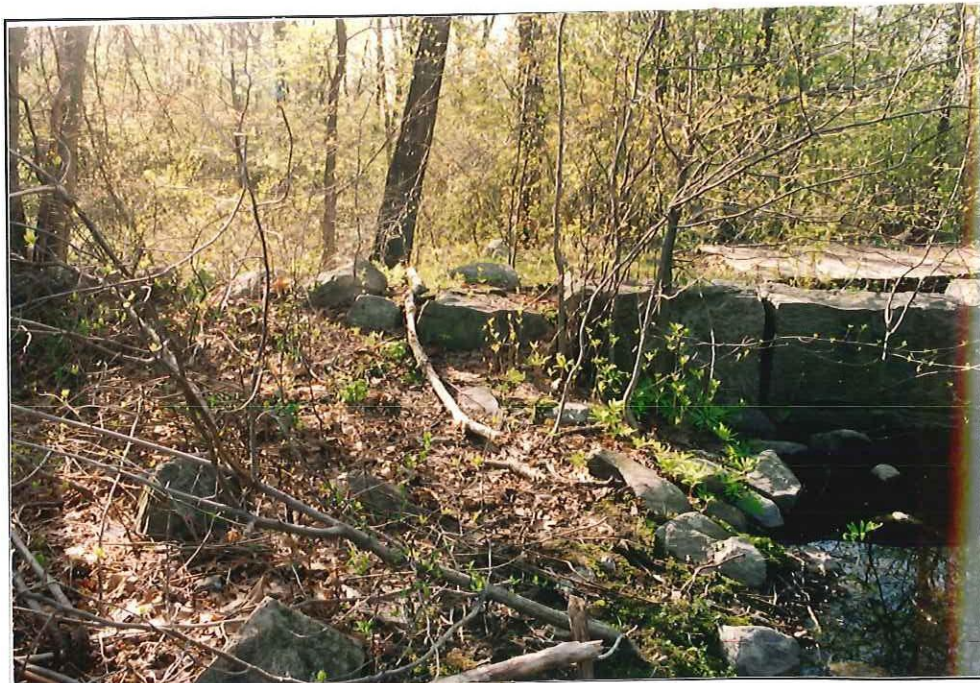
View of the left  
upstream side of the  
dam

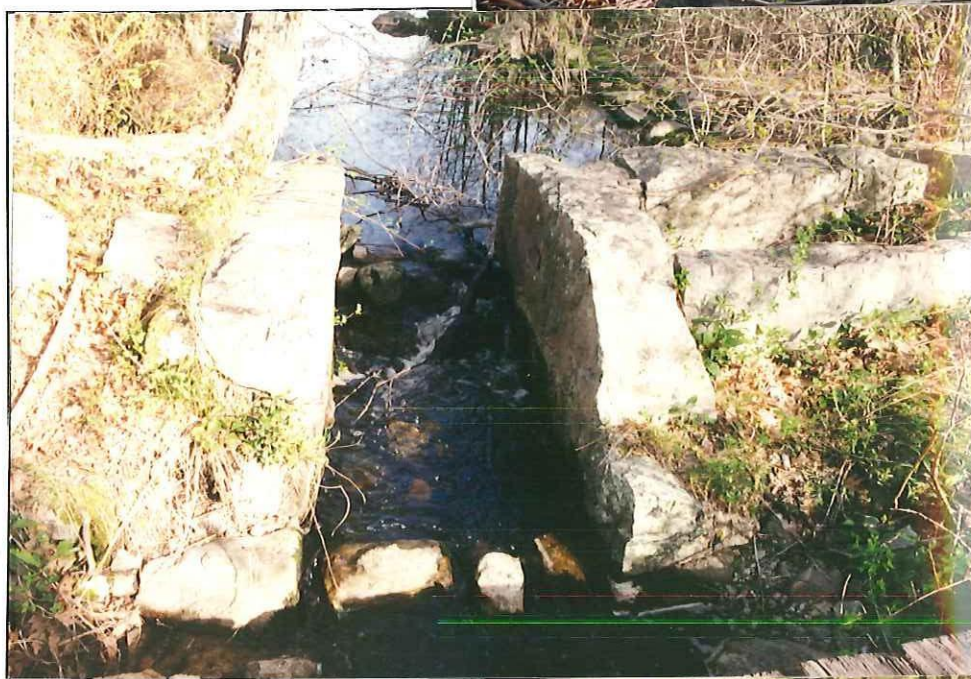
GENERAL CONDITION: Fair. The spillway weir consists of placed riprap.

STONE MASONRY: A few stones are missing from the downstream spillway training walls on both the left and right sides.

View of the spillway  
from downstream

1. Remove trees and brush from the left and right embankments and the area downstream of the dam.
2. Fill the eroded and washed out areas at the left and right dam embankments. Provide a uniform crest elevation and provide embankment stabilization (i.e., establish a good grass cover).
3. Maintain the spillway and downstream channels free of debris and woody vegetative growth.
4. Fill masonry voids by chinking.

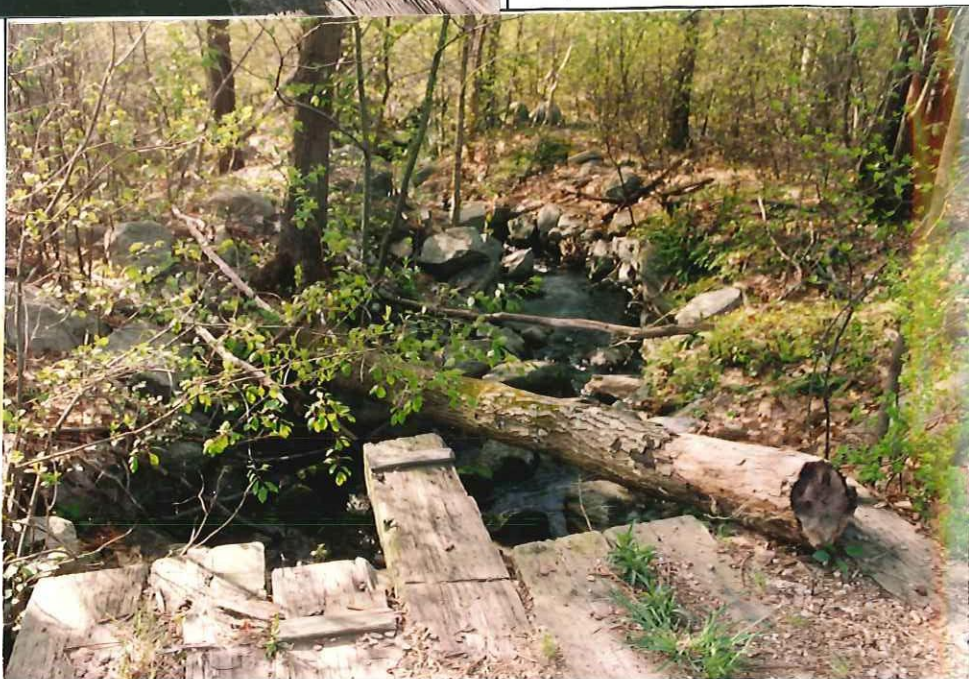
DEBRIS: Some trees and brush were observed in the channel including a tree which has fallen over.

View of the  
downstream channel
