Field Report No.: 11															
	SP	&A Project No:	22.331							Report Date	4	Time: 9:30AM			
	(	Project: Name & Location)	Juliet Lo 1854 CT- Gales Fe General	12 rry, (	СТ 0	6335									
			Gold Sea	al Ro	ofin	g, LLC							_		
Weather							Site Conditions					Day of Week			
		Range: 70°					⊠ Clear			Dusty	□ Monday □ Thursday				
☐ Clear ☐ Rain ☐ Fog ⊠ Overcast ☐ Snow ☐ Co							☐ Muddy □ Other		L	Windy	5			⊠ Friday	
☑ Overcast         □ Snow         □ Cold         □ Hot         □ Other           Type of Work Observed Being										🛛 🗆 Wednesday 🛛 Saturday					
4		Cite weath	1					a Bein 13			Feed	19		Onvinkler	
1		Site work 7				General Trades/Drywall		13		Specialties/ Food Service		19		Sprinkler	
2		Demolition	8			ows & Doors	14		Elevators		20	$\boxtimes$	Finish metal		
3		Concrete				Roofi	ng	15		Plumbing		21		Iron workers	
4		Masonry	10		Floor	ing	16		HVAC		22		Tester (Tri-state)		
5		Steel/Misc. Metal	11		Pool		17		Electrical		23		Audio Vis/Low Volt

FIELD REPORT

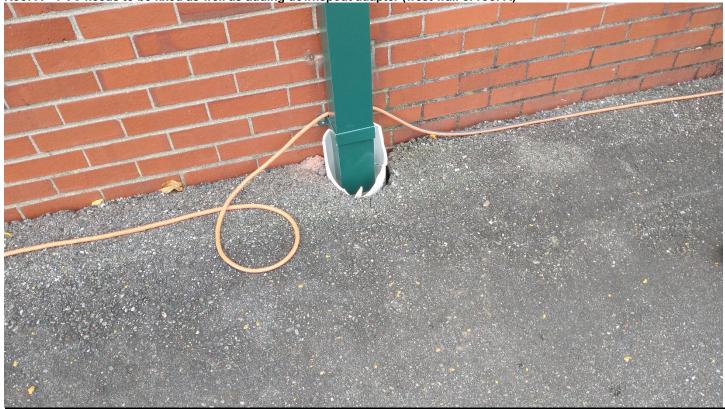
Roof A – PVC needs to be fixed as well as adding downspout adapter (west wall of roof A)

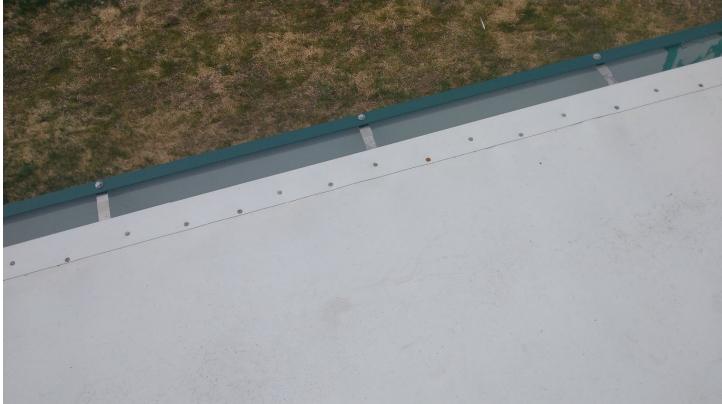
Roof A - Nail heads need to be covered with covered sheet

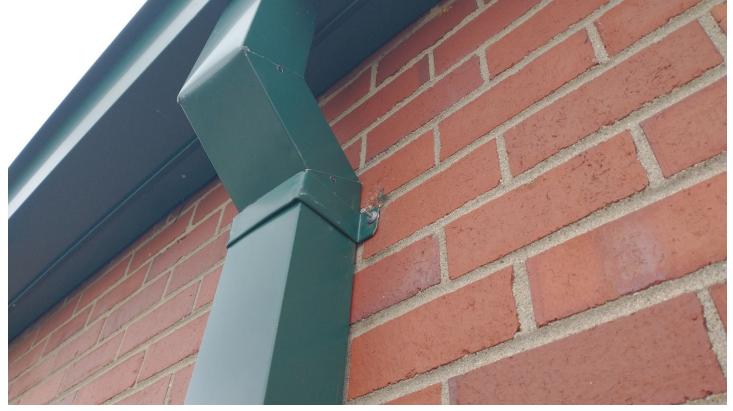
Roof A - Rivets for downspouts - Mandrel head (pin) needs to be flush with the primary head (ring)
