# Ledyard Up-Down Sawmill Dam Condition Assessment

- In spring 2025, the Historic District Commission contracted with GZA GeoEnvironmental, Inc. to evaluate the condition of the dam, provide an overview of risks, and outline options to reconfigure the dam to address risks.

## Inspection and report (April/May 2025)

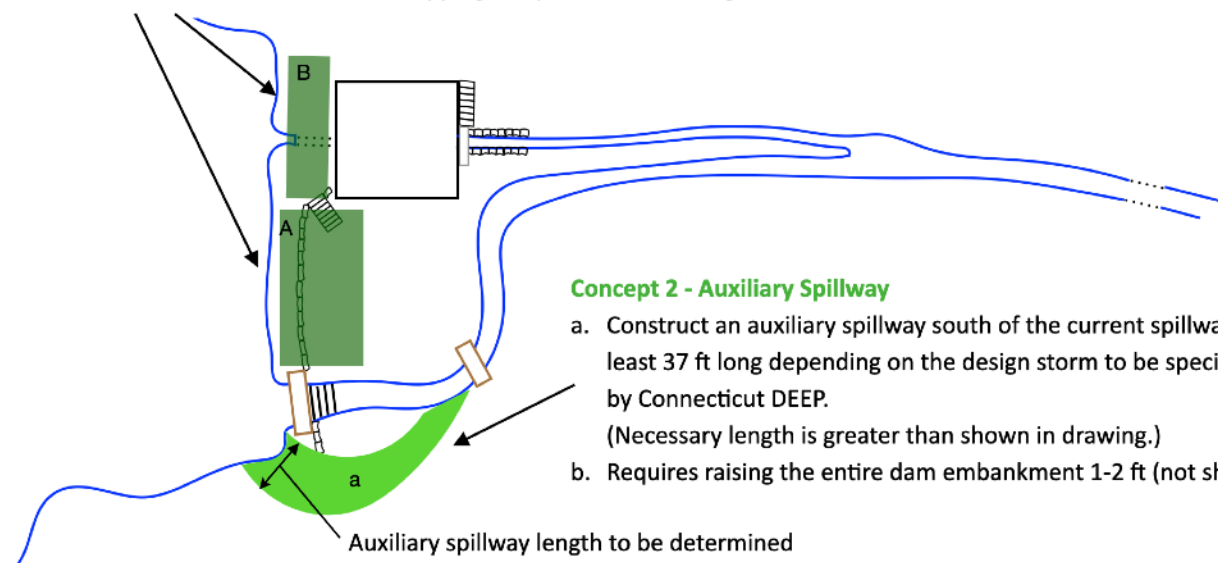
### Concept 1 - Overtopping Protection

- Overall the dam is in good condition (although at risk from floods that lead to overtopping).
- The crest of embankment is uneven with settlement apparent along downstream stone wall (included misplaced stones). Spillway is in good condition.
- Dam is at risk from overtopping which is the most common cause of failure for similar dams.
  - “deficiencies included an uneven crest, erosion at the masonry wall downstream toe, misaligned stones in the wall, and voids in portions of the downstream wall at the sawmill building.” (GZA report page 5)
  - “Overtopping of an earthen and stone masonry dam is a serious dam safety concern that, left unaddressed, is likely to lead to dam failure.” (GZA report page 3)
  - “With a 1 foot of water over the dam, I think the potential for failure is high, at least partial failure.” (J. Davis 6/24/2025 email)

A. Add grouted riprap or concrete blocks to top of embankment crest and 10-15 feet downstream of the masonry wall. B. Raise embankment at the mill building and add berm added around the sawmill to divert overtopping away from the building
