Field Report
Page 1 of 4

| | | | | | | | | | | | _ | | _ | | |
|--|--|---|--|---|--|---|---|---|---|---|---|---|---|---|---|
| SP&A Project No: | | | 22.331 | | | | | | | Report Date | .2025 | | Time: | 9:30AM | |
| | (I | Project: Name & Location) | Gales Ferry School 1854 CT-12 Gales Ferry, CT 06335 General Contractor: The Imperial Company, Inc. | | | | | | | | | | | | |

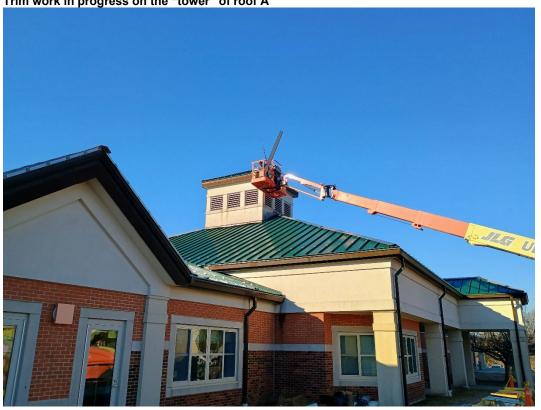
Trim work in progress on the "tower" of roof A

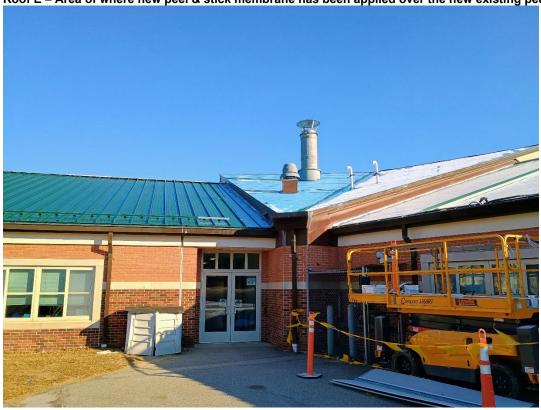
Roof E - Area of where new peel & stick membrane has been applied over the new existing peel & stick

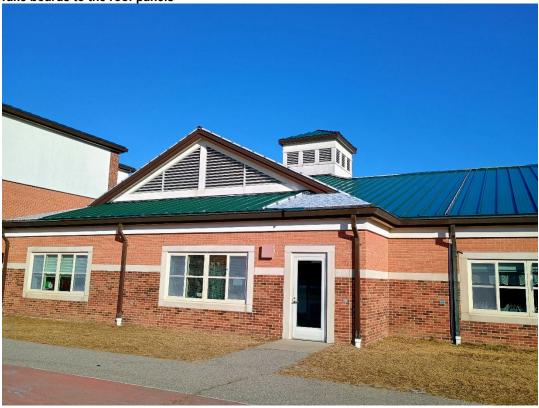
Roof A - One of the areas where Garland needs to produce a solution for the meeting of the rake boards to the roof panels
