| <b>Field Report No.:</b> | | | | <b>21</b> | |
| <b>SP&amp;A Project No:</b> 22.331 | | <b>Report Date:</b> 1.28.2025 | | <b>Time:</b> 9:30AM | |
| <b>Project:</b> Gales Ferry School<br>(Name & Location) 1854 CT-12<br>Gales Ferry, CT 06335<br><br><b>General Contractor:</b><br>The Imperial Company, Inc. | | | | | |

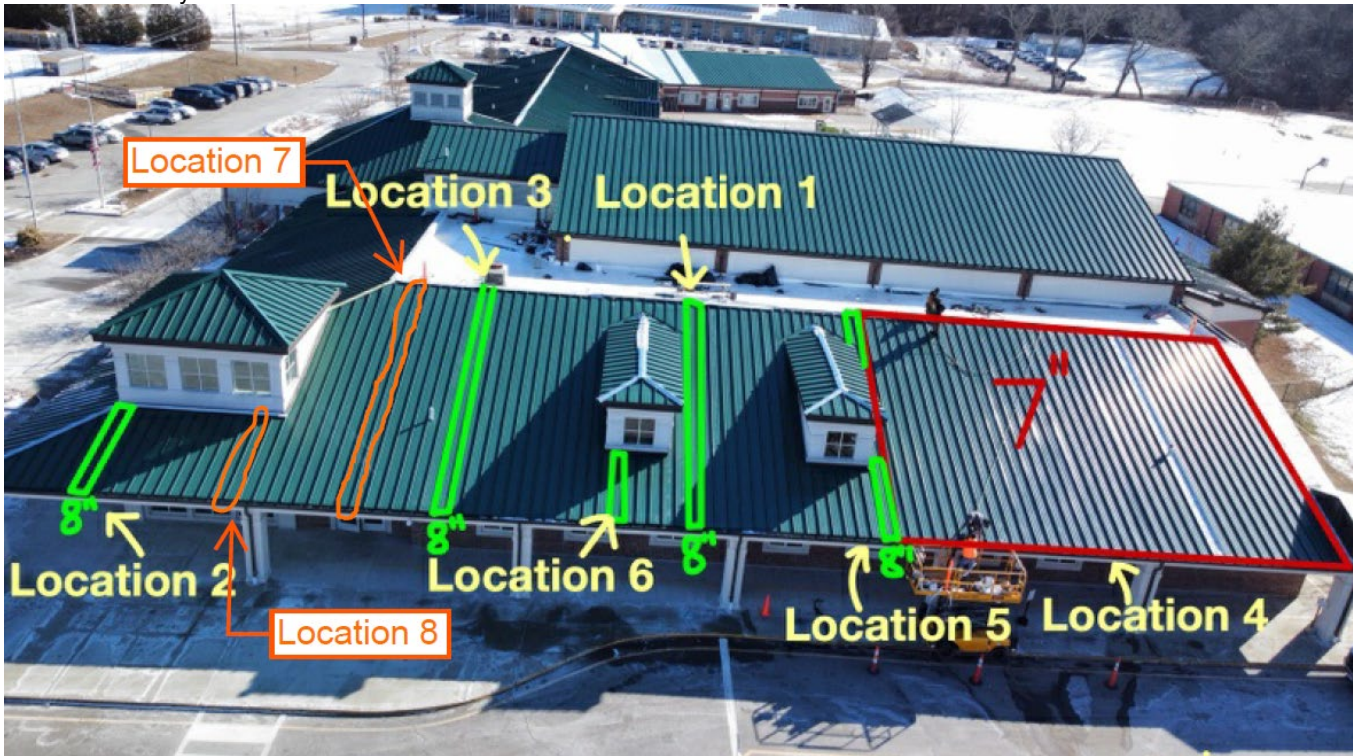
**Roof A - West Elevation –**

Locations marked as locations 7 & 8 were found to have 8" screws and were picked by random by SPA for verification. Other locations were reviewed by Garland -

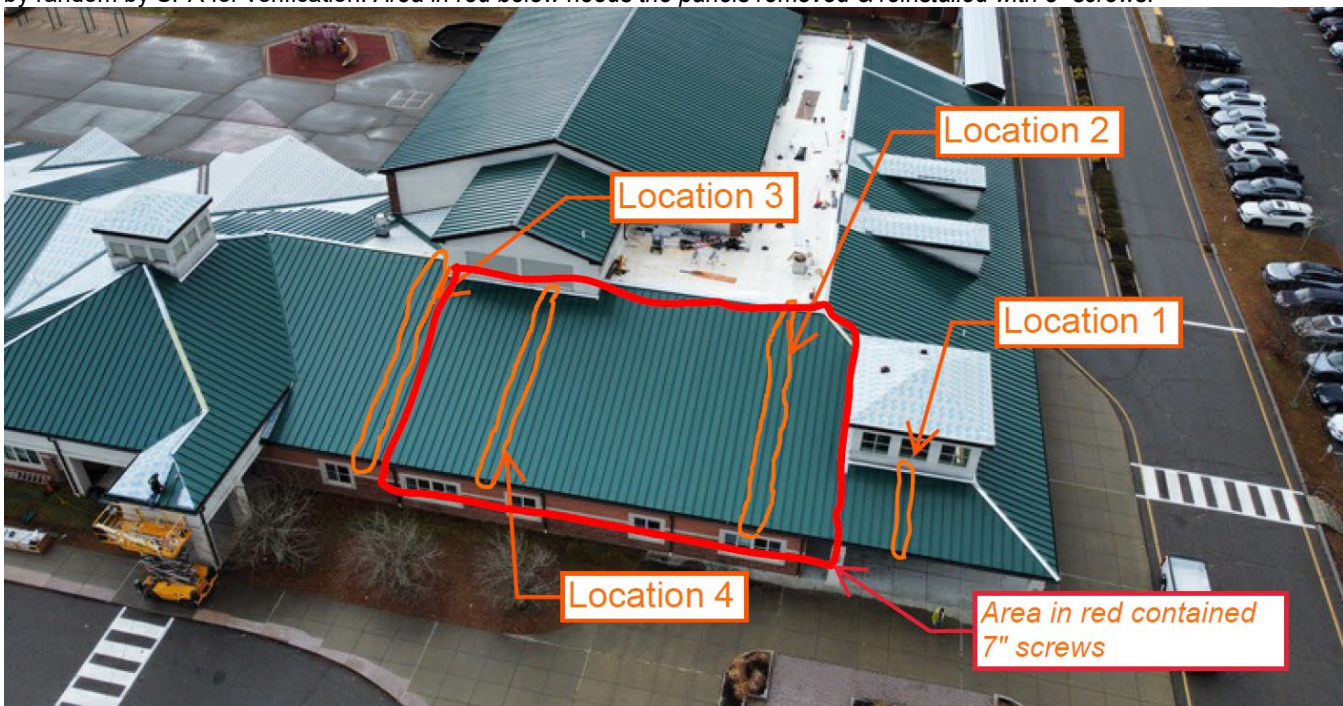
**Roof A - North Elevation –**

Locations marked as locations 1 & 3 were found to have 8" screws and locations 2 & 4 were found to have 7" screws and were picked by random by SPA for verification. Area in red below needs the panels removed & reinstalled with 8" screws.

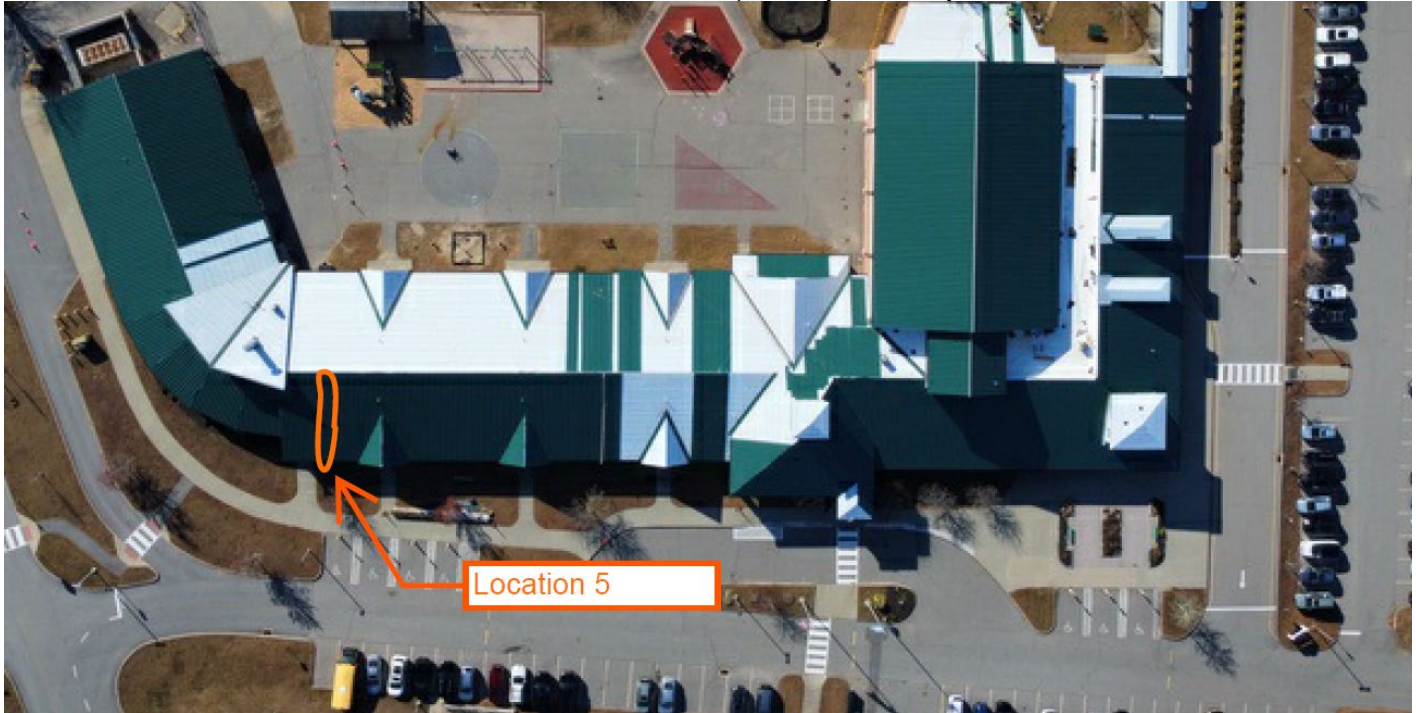
### Roof D - North Elevation –

Location marked as location 5 was found to have 8" screws and was picked by random by SPA for verification -
