Holmbers Orchard Concrete Reservoir 2024 Inspection Report

CorrTech Report No. 16805-FOR-01-1

Groton Utilities
295 Meridian Street
Groton, CT 06340

2/12/2024

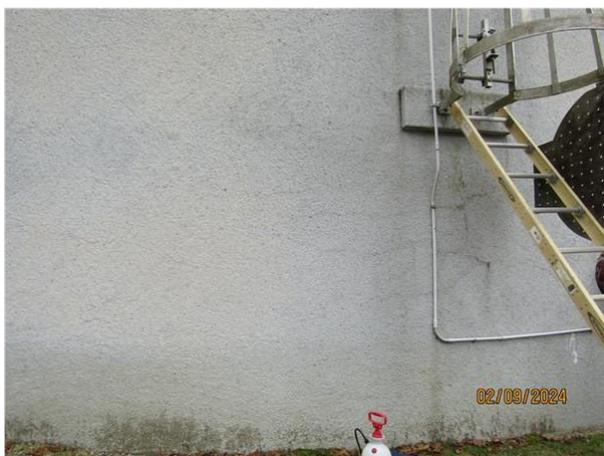
The exterior shell of the tank has a gunite like surfacing material over the concrete substrate. One area of cracking was noted beneath shell mounted ladder. This cracking appears to be strictly in the top surfacing layer and does not extend into the substrate of the shell. The remainder of the shell is completely intact with not visible cracking, spalling, corrosion, efflorescence, or adhesion loss of the surfacing material.

9) Cracking located beneath the shell ladder

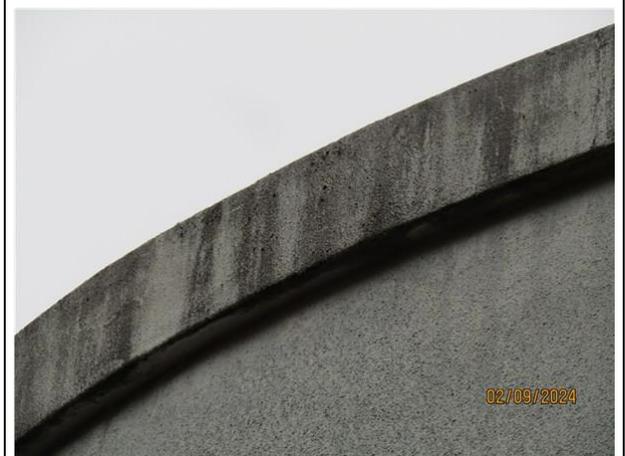
The exterior roof of the tank is an uncoated concrete structure. Slight weathering and biological staining have formed on the roof and roof perimeter. No spalling, cracking, corrosion, or efflorescence was noted during the inspection.

12) Biological staining along the rim of the roof

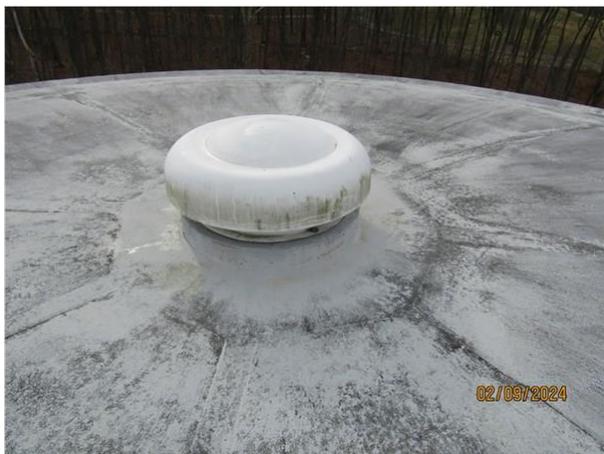
This tank vents through a singular central finial mushroom style roof vent. The vent opening is screened completely with intact fine mesh screen. It should be noted that the use of fine mesh screen without any form of vacuum relief can lead to damage to the tank structure in the event the screen becomes clogged.

14) Central finial mushroom style vent

AWWA compliant vent should be installed.

Roof vent does not meet current AWWA D100 standard or the generally accepted Ten States Standard for sanitary protection. Insect screens are now part of the normal sanitary standard and in order to use these fine screens. Fine mesh screens are subject to clogging due to freeze up in the winter so a special vent assembly is needed. Vents should be installed which can relieve both a positive or negative pressure should the fine mesh screen become clogged. An AWWA vacuum/pressure relief vent provides for the safe use of insect screen and should be designed for easy inspection and maintenance of the screens.

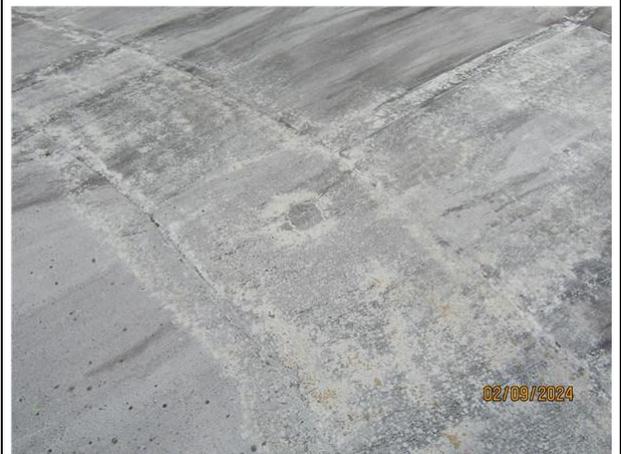
17) Biological staining of the exterior roof

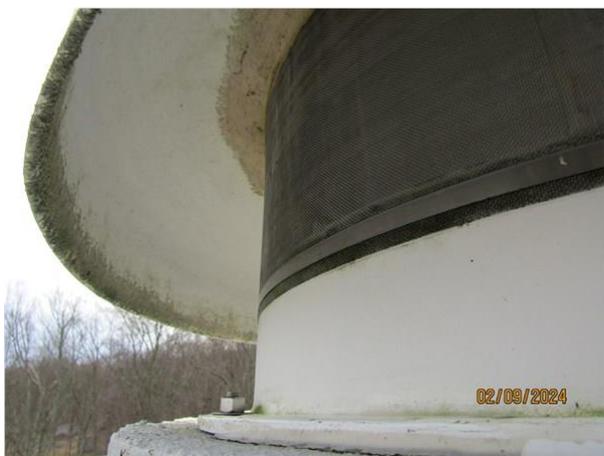
15) Intact fine mesh screening

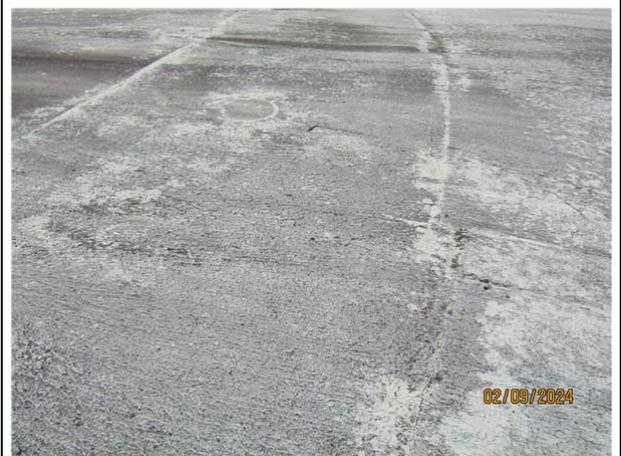
18) Weathering of exterior roof surfacing material

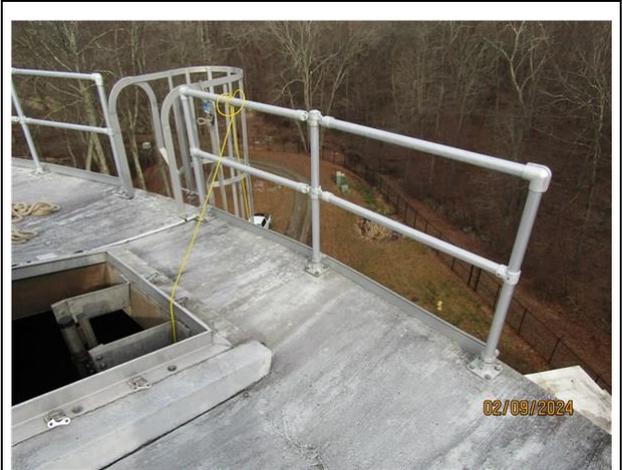
Handrails are installed to either side of the shell ladder. These railings meet all current OSHA standards and are free of corrosion and section loss.

22) Perimeter roof railings flanking the shell ladder

Self-Closing Swing Gate should be installed if the Owner wants to be compliant with current OSHA Fall Protection requirements.

In order to be in compliance with OSHA Standard 1910.23(a)(2) all railing openings or platform pass through openings should be equipped with a self-closing swing gate. Although this standard strictly addresses new construction after 11/19/2018 it is advisable to modify existing tanks with this safety device. If existing ladders are substantially modified or replaced on an existing tank then this new standard would apply.

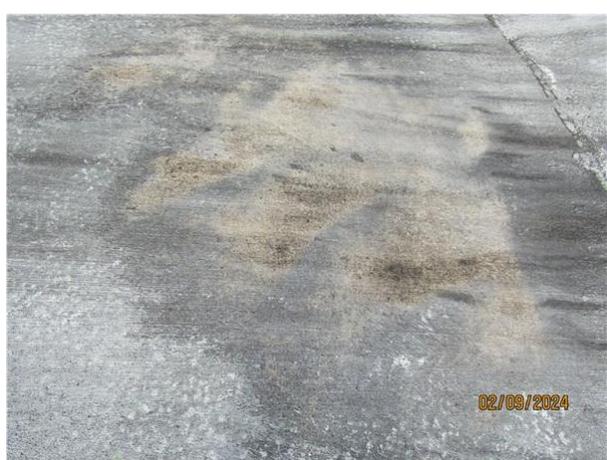
21) Area of discoloration on the exterior roof

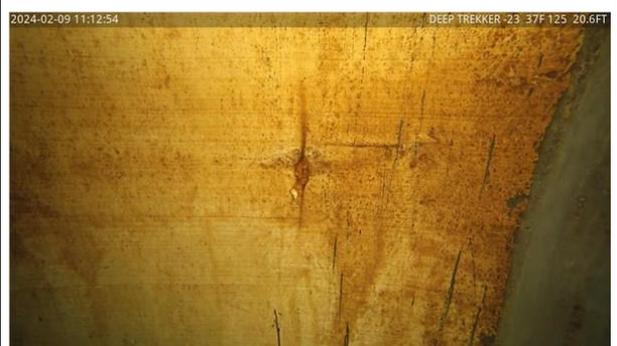
The shell is an uncoated concrete structure with seam sealer material applied to the vertical joints or seams. No cracking or spalling was found throughout the internal inspection. One isolated area of corrosion was found due to some exposed rebar tie ins.

42) 8:50 - Corrosion cell from exposed rebar tie in

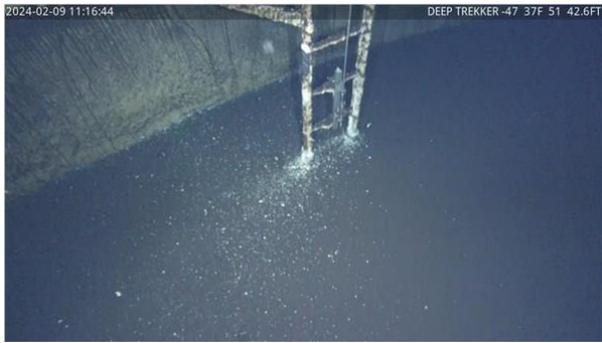
Directly below the roof hatch and each lower shell manhole are section of straight interior ladders. Currently all the ladders are free of section loss and metal loss. However, reduction can be observed on all three ladders due the use of dissimilar metals throughout the tank. The worst case is on the roof hatch ladder where a stainless steel ladder safety climb has been attached directly to the ladder.

43) 12:40 - Oxidation of interior ladder due to dissimilar metals used on the safety climb

The use of dissimilar metals within the tank should be addressed to prevent further corrosion/reduction from taking place and eventually leading to metal loss or section loss of the interior structures.

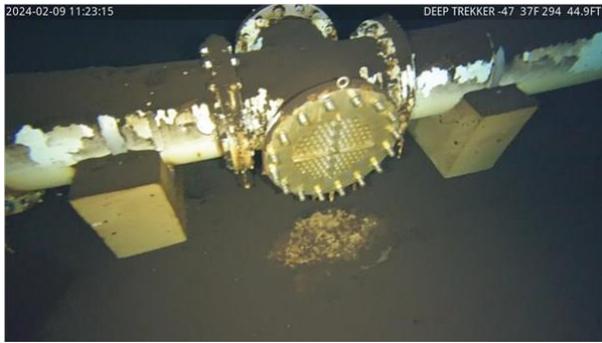
A combination inlet and outlet pipe tree runs horizontally across the floor of the tank. The tank fills through rubber duck bills and drains through lower valves. Due to the use of stainless steel screens over the outlet valves galvanic corrosion can be observed forming along the length of the piping.

49) 19:10 - Stainless steel outlet grate causing galvanic corrosion on the piping

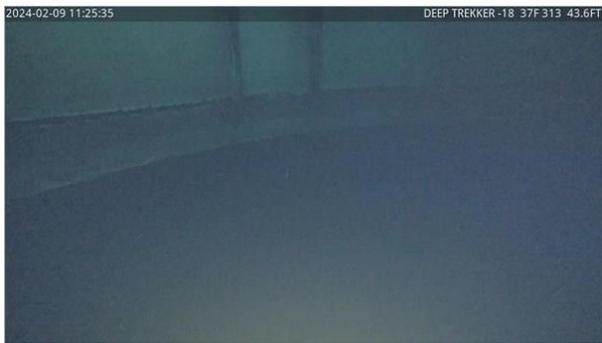
A light layer of loose sediment has accumulated across much of the floor. There was no visible spalled material or foreign debris found within or under the sediment layer. This small amount of sediment is not a risk of being pulled into the outlet pipe of the tank.

50) 21:31 - 1/4-in layer of sediment forming across the floor of the tank
