LEDYARD UP-DOWN SAWMILL

HISTORIC PROPERTY STRUCTURAL AND CONDITION ASSESSMENT

Ledyard Up-Down Sawmill
172 Iron Street
Ledyard, Connecticut

March 2, 2023, *Revisions April 14, 2023 (noted in blue text)*

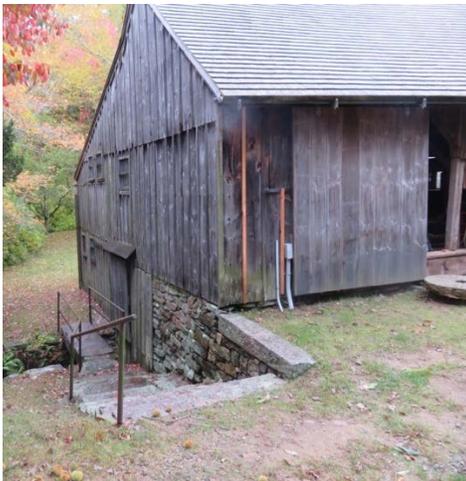
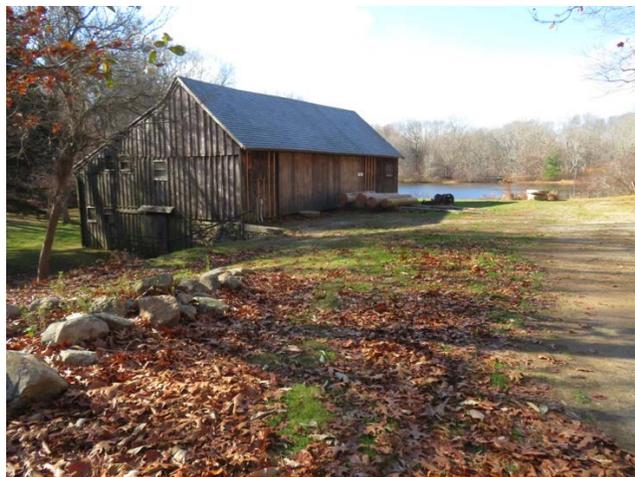
Description: The east exterior stone stairs provide access across the tailrace embankment. A small retaining wall extends north of the east mill wall to support the upper grade for the top 3 steps. Erosion has occurred below the bottom three steps allowing them to rotate out of place. The lowest step has settled into a significant hole. A substantial bulge and dampness are apparent in the masonry foundation wall of the mill at approximately the fourth step from the top. In 2021, the area just to the north of the stairs was regraded to create a small berm near the top of the stair and to direct site drainage to the southeast of the stairs.

Images from the northeast show the uphill site grading at the stairs and overall.

Recommendation: In addition to managing gutter discharge water (see section below), and maintenance of recent site grading that now directs water to the southeast of the stairs, the authors recommend the resetting of the bottom 3 steps. In addition, some additional probing into the foundation wall is recommended to determine if the full thickness of it has bulged or just the outer stones below the gutter. Local rebuilding of the bulged stone might be considered, the extent to which can be determined by the further probing.

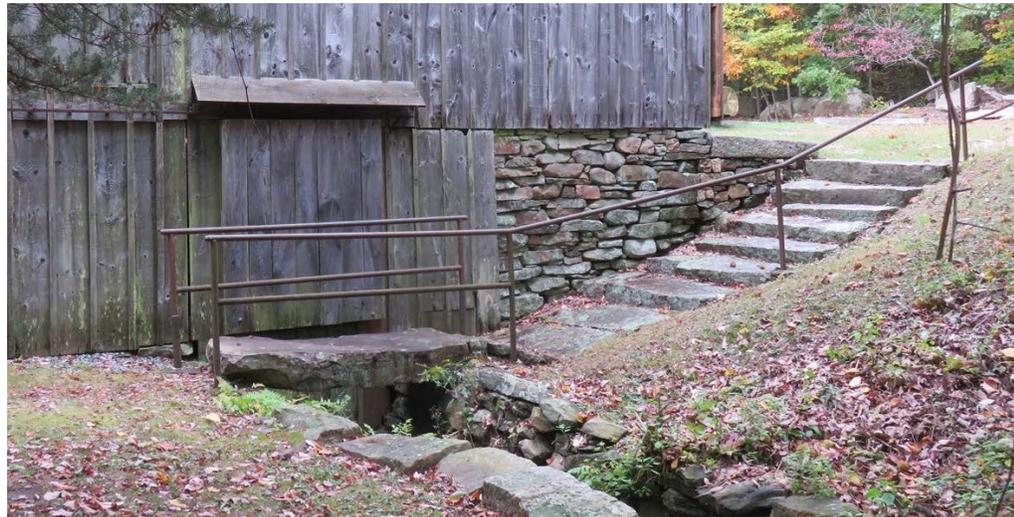
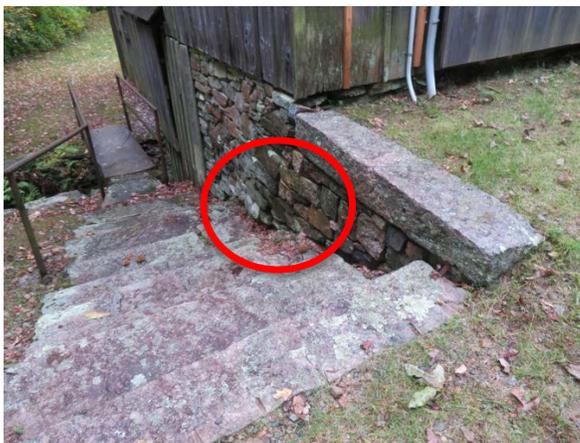
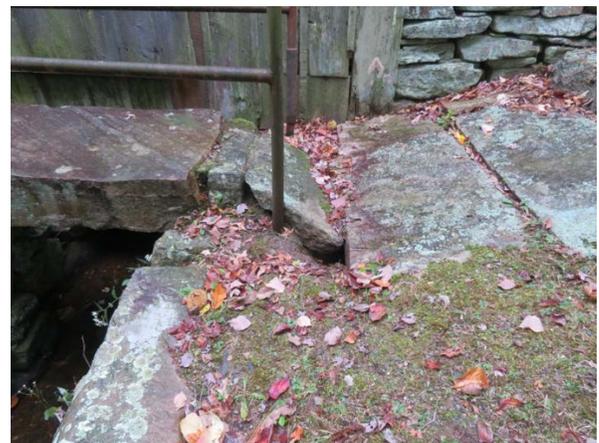
Analysis: A geotechnical boring was performed slightly northwest of the area during this project, and the soil material found to have suitable properties for bearing without the propensity for foundation settlement. Long standing issues with site drainage and gutter discharge onto the east exterior stairs are apparent based on information from the town and mill volunteers. The issues noted in the stairs and foundation wall are consistent with erosion that might occur due to washout of soils from water flowing through and below the affected components. The bulge in the foundation wall is likely caused by movement of the individual dry-laid stones in response to pressure from discharging gutter drainage water.

Top: Overall view of damage; Bottom Left: Bulge in foundation wall; Bottom Right: Shifting and movement of bottom 3 steps due to erosion of soil below.

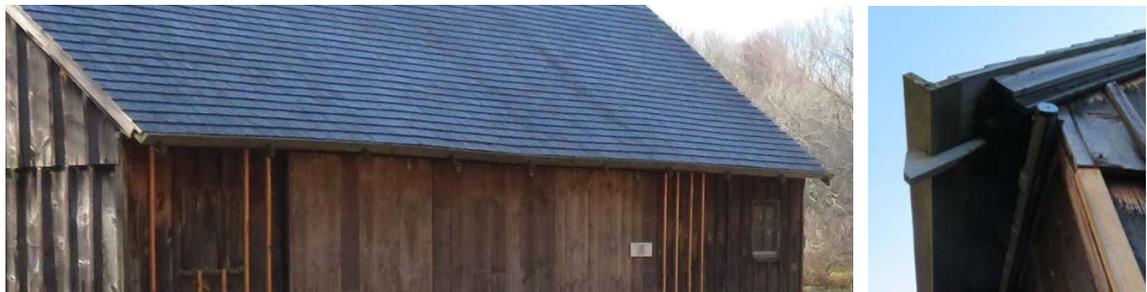
Analysis: The wood V-gutter on the north side appears to be in good condition. Biological growth and general weathering appear on the south box gutter. The gutter pitches east, but dips down perhaps due to a missing bracket about 10' from east end. The gutters do not appear to be lined, which leaves them vulnerable to deterioration and a relatively short life-span. It is not known how the joints in the gutters are treated.

North gutter overall and profile of V-shape and bracket.

Recommendation: At the north gutter, the authors recommend adding a leader and below-grade drainage to the east end to manage flow of water away from the building on that side. A similar approach or at least a splash block should be considered on the west side. The south gutter is due for replacement relatively soon (within 5 years). In the meantime, the dip should be investigated and gutter re-supported as needed. A V-gutter shape should be considered when replacement occurs, along with linings and/or joint treatment. The leader should be tested to confirm that it is working.

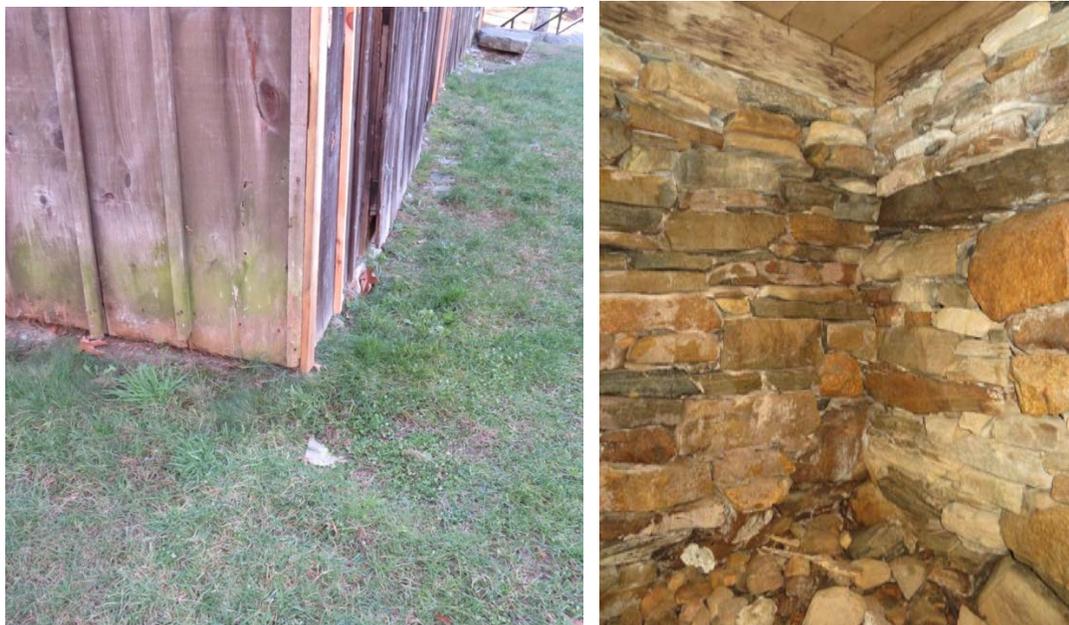
North gutter, west end; Left: grade where gutter is discharging; Right: inside face of foundation wall at northwest corner showing dampness and fungal growth on sill above.

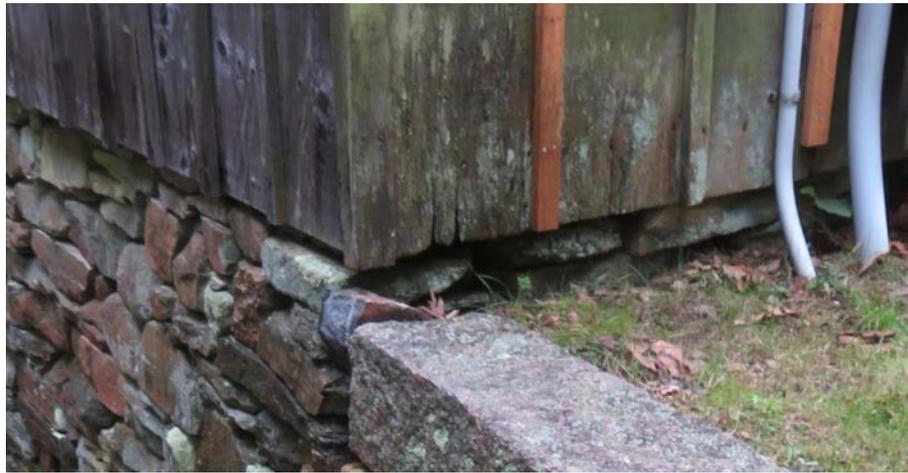
North gutter, east end, showing deteriorated board siding and erosion in masonry.

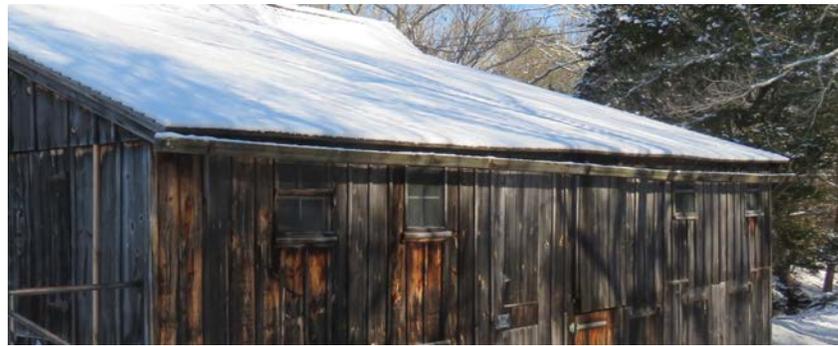
South gutter showing dip (likely missing bracket) toward east end.

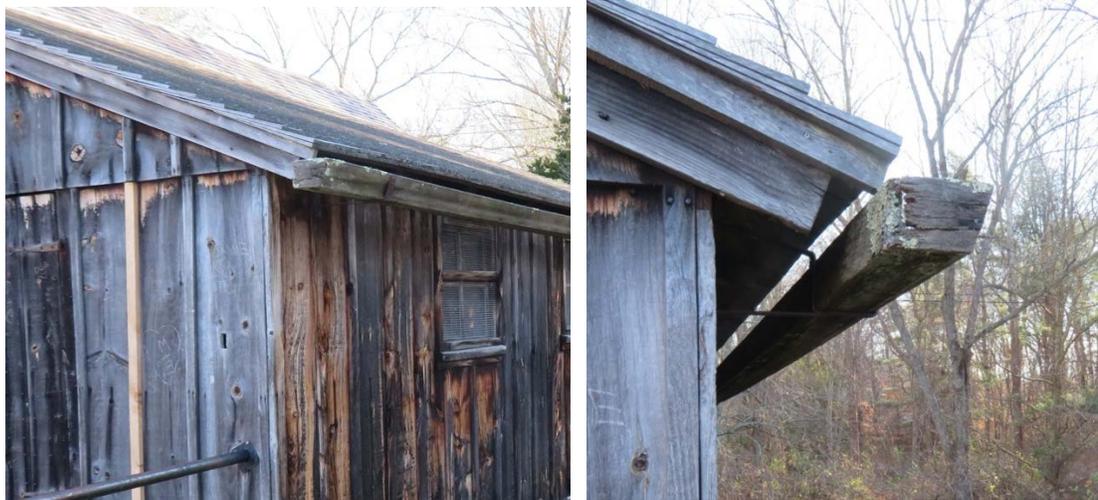
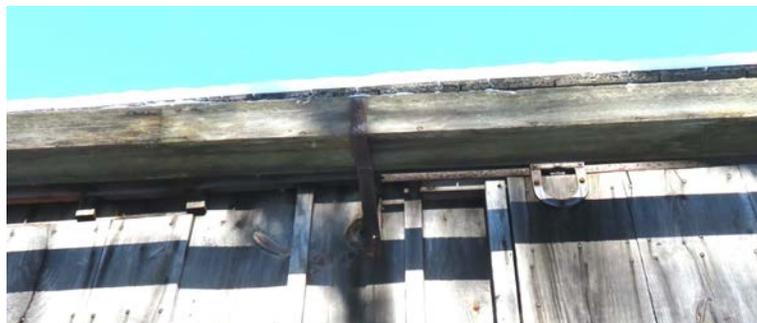
South gutter showing box gutter shape, weathering, biological growth and brackets.

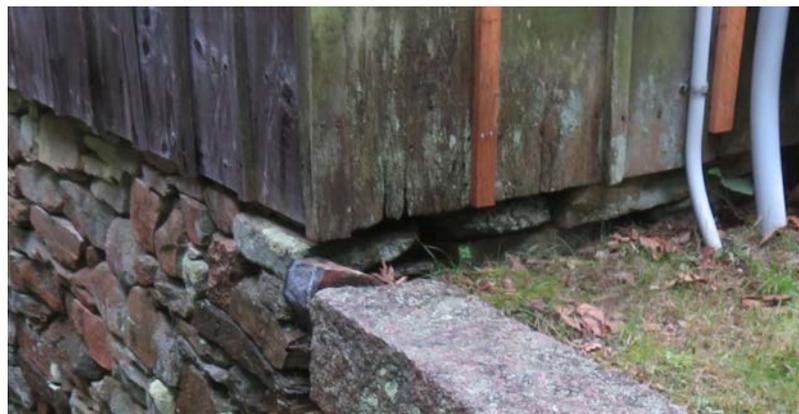
Analysis: Movement in the foundation wall from the water issue noted in Item 1 is likely the main cause of the floor settlement; however, the irregular geometry of the stone walls made it difficult to directly correlate the two. It is also likely that the causes of the deflection are multifactorial and cumulative based on a number of issues observed including a shear crack at the east end of the northern-most beam. Based on the gutter discharge in the area and biological growth and deterioration of the siding, sill deterioration may also be a likely contributor, although not yet extensive. Some of the deflection may have also been caused by former beams and sills, which have now been replaced, but may not have been installed in flush / level condition. The deteriorated post base could also be contributing.

Exterior of northeast corner showing siding deterioration.

Recommendation: Once funds are raised to address the northeast corner, the authors recommend a holistic look at both further investigation and treatment, which might include local wall rebuilding, local sill replacement, post base repairs (dutchman) and beam hangers.

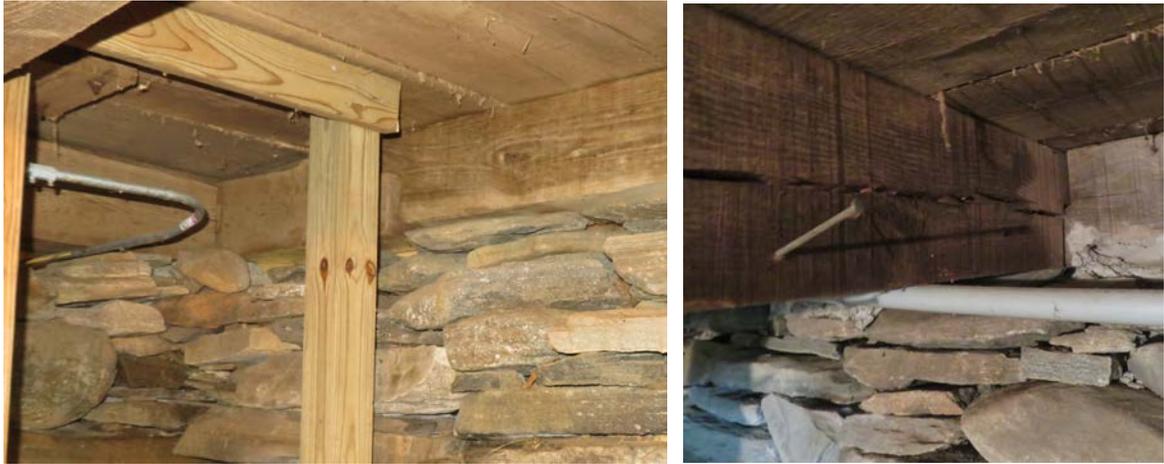
Left: Northeast corner from basement showing sill corner tenon (possibly bent); Right: East end of north beam show shear crack parallel with tenon (stress concentration).

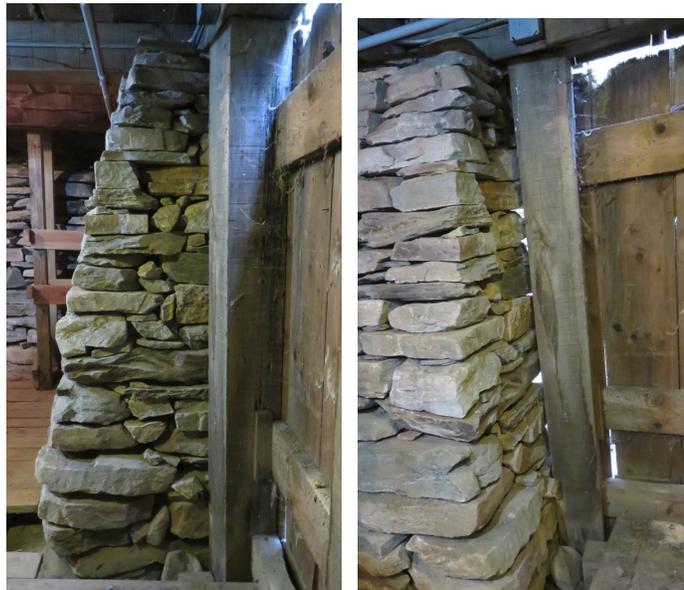
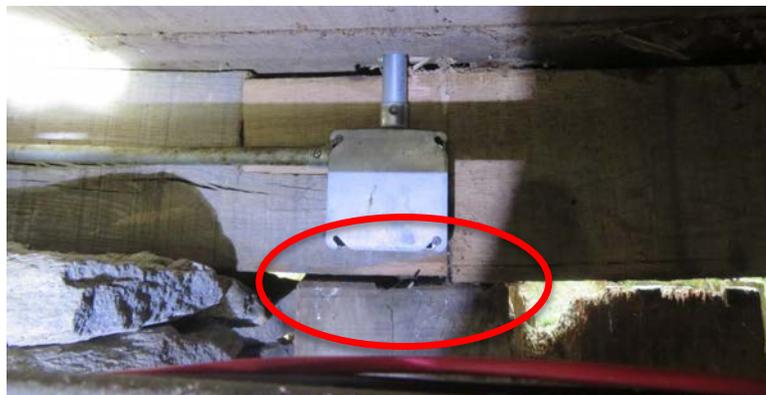
Top: East wall post from south and west respectively; Bottom: gap between top of post and beam/sill.

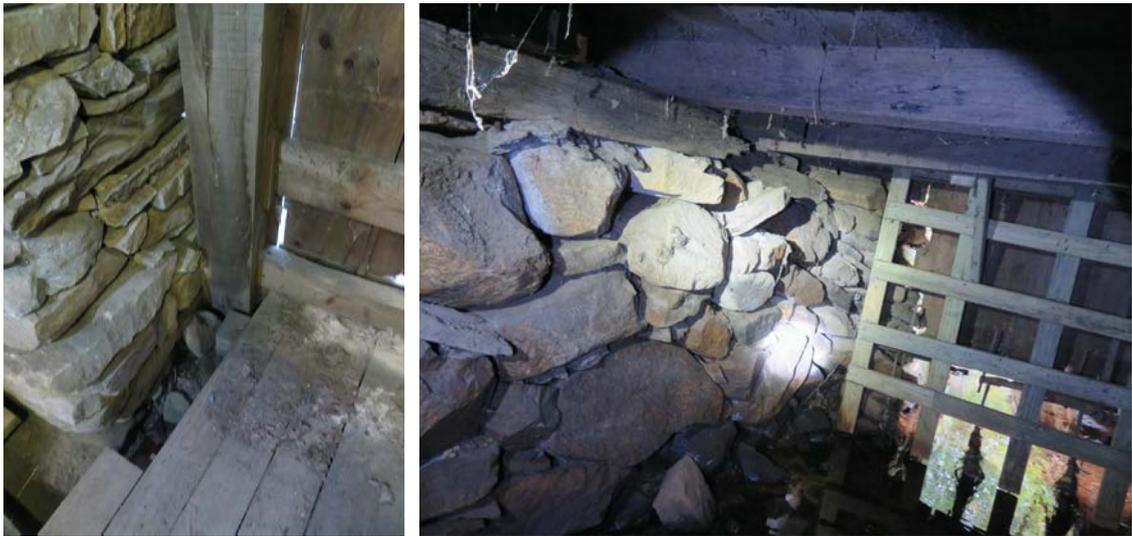
Left: Bottom of east wall post just above decking over raceway, post base is concealed below decking; Right: Deterioration of east end of decking sill over north wall of raceway looking east to gate to tail race, the post base is not apparent in this image but deterioration of deck sill is suggestive.

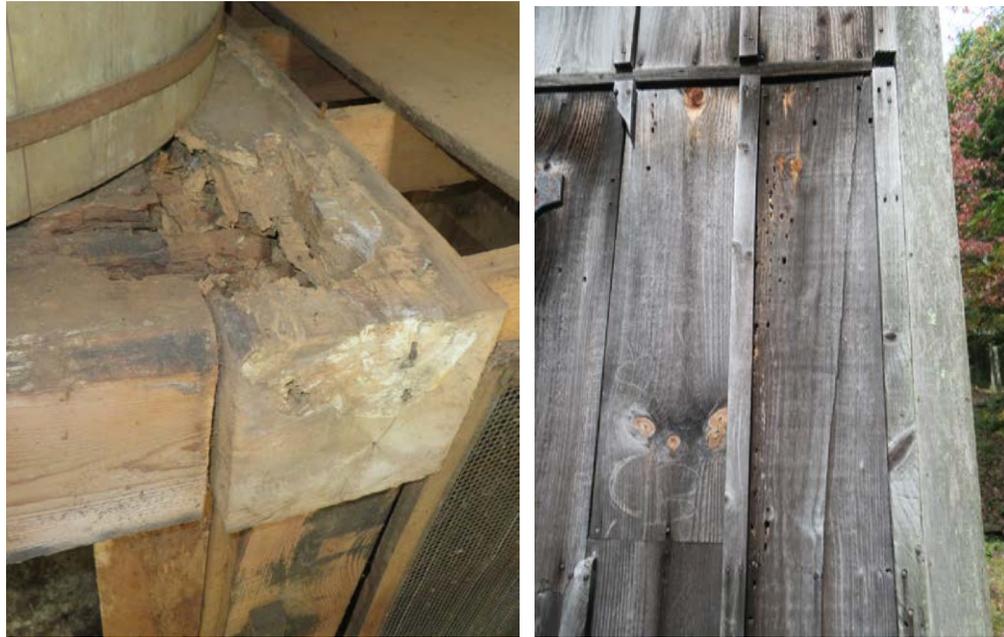
Analysis: On the exterior, the only visible sign of sill deterioration is at the central part of the south elevation (lean-to portion) below the double doors. As viewed from the basement, where visible, sills do not show any obvious deterioration; however, black staining is apparent on the surfaces in northwest and southeast corners suggesting that damp conditions due to proximity to grade and/or gutter discharge is allowing for fungal growth on wood. Sills were installed on a solid bed of mortar which may prevent bottom of sills from drying encouraging deterioration. The lower level framing on the south side is also in close proximity to grade leaving it vulnerable to deterioration. A former termite infestation occurred in the grist mill area but was caught and treated. Evidence of termite borings in the boards in the southeast corner suggest that the corner post may have been attacked.

Left: Termite damage at the grist mill frame; Right: tell-tale termite trails / holes at siding at the east end of the south elevation.

Recommendation: A deeper investigation is recommended to determine sill damage at areas of known exposure to water, primarily at the corners. If siding work is planned in the next 5 years, sill investigation and repairs / replacements could be performed as part of that work.

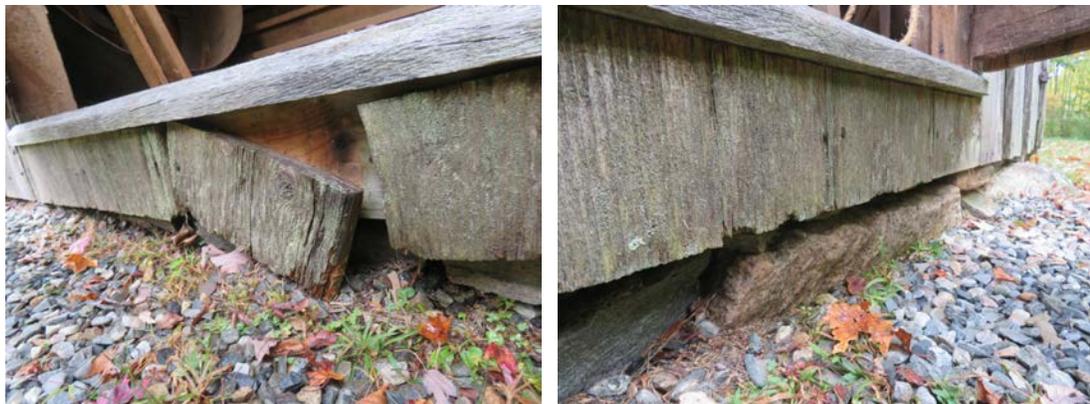
Siding and foundation below grist mill exterior doors. Siding nails have failed, but sill behind appears to be in good condition.

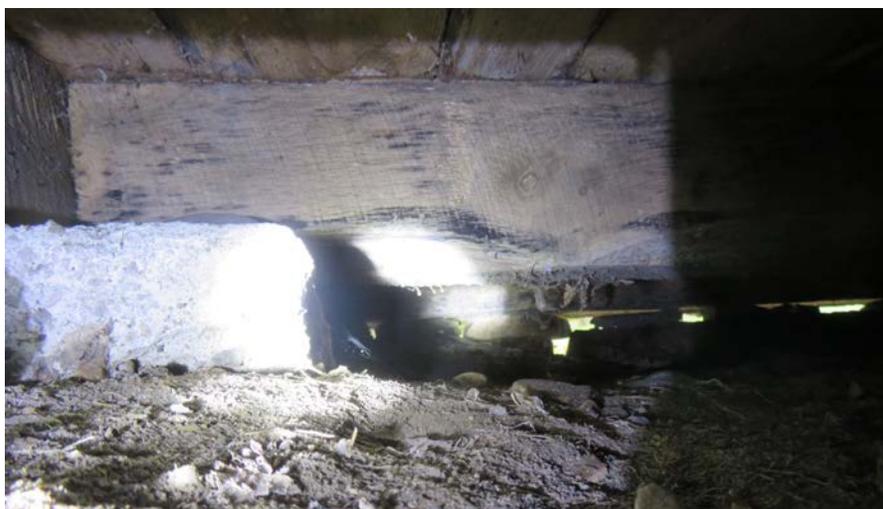
East end of joist in grist mill floor (crawlspace) showing black staining and close proximity to grade, but not visible deterioration.

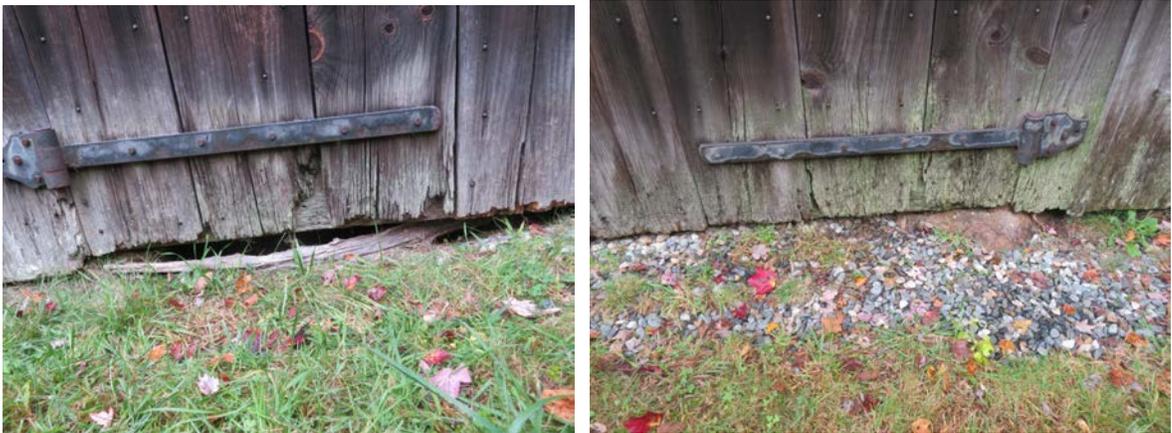
Central double doors at south elevation (lean-to) showing siding deterioration and sill / threshold deterioration behind.

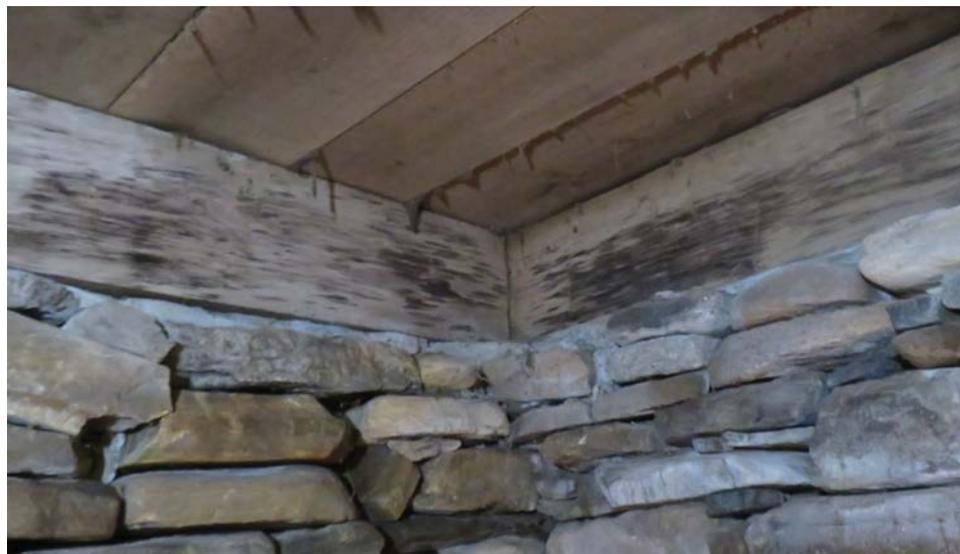
Northwest corner of sills from the basement showing black staining presumed to be fungal growth.

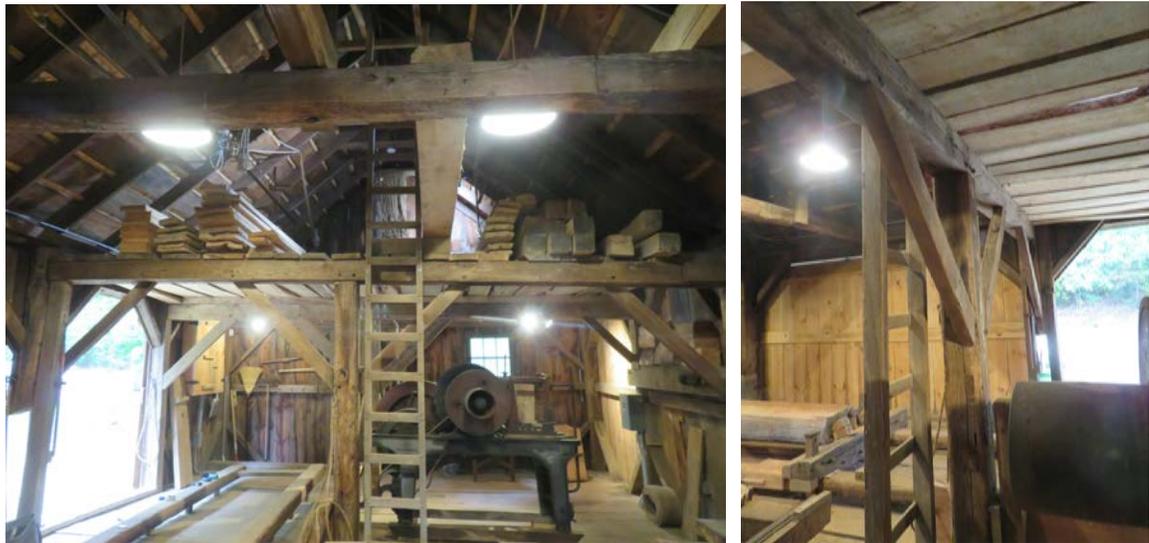
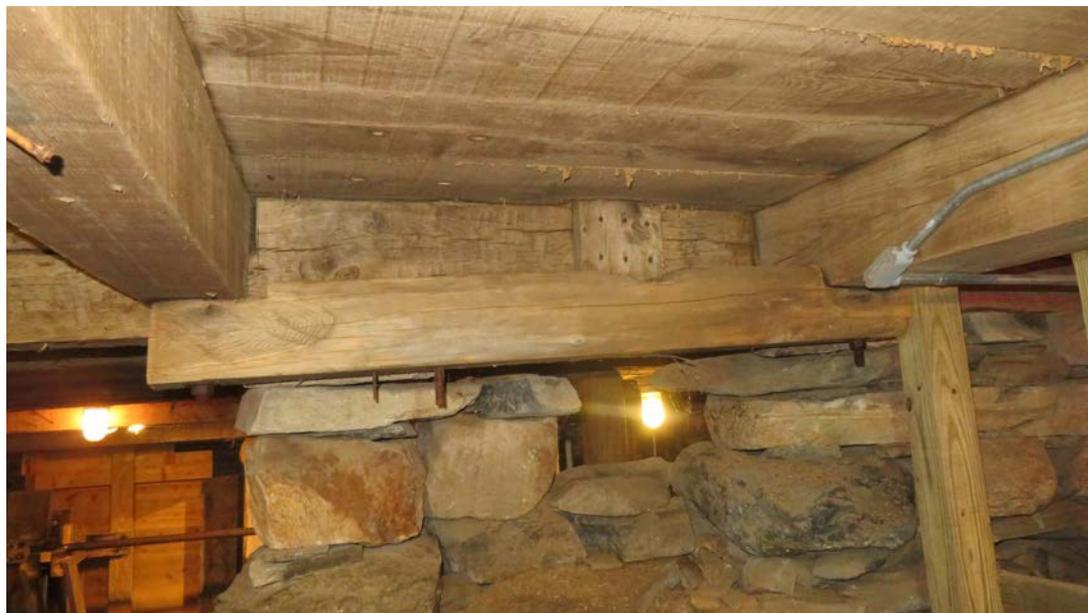
At loft-west, middle post, the north-south beam to support the post was hung from the adjacent east-west beams. While unconventional, the authors did not observe any obvious signs of distress at the beam or its connections.

Overall Loft and Loft-West support line. Left: Loft-West north bay showing replacement post; Right: Loft-West middle post with hung beam support below.

Recommendation: See Section E below for discussion of loft capacity. In addition, the authors recommend improving the connections noted above to meet industry standards in terms of strength and durability. To do this, we recommend that retrofit designs for each of the noted connections be developed by a preservation structural engineer (we'd be happy to provide this service) to ensure that load paths are safely transferred through the joint. Retrofits will likely include structural screws or bolts, galvanized or stainless steel hardware

(concealed to the extent possible) and wood blocking or bracing. The designs will be shown on sketches with material specifications that can be bid out for the work or completed by town personnel or volunteers.

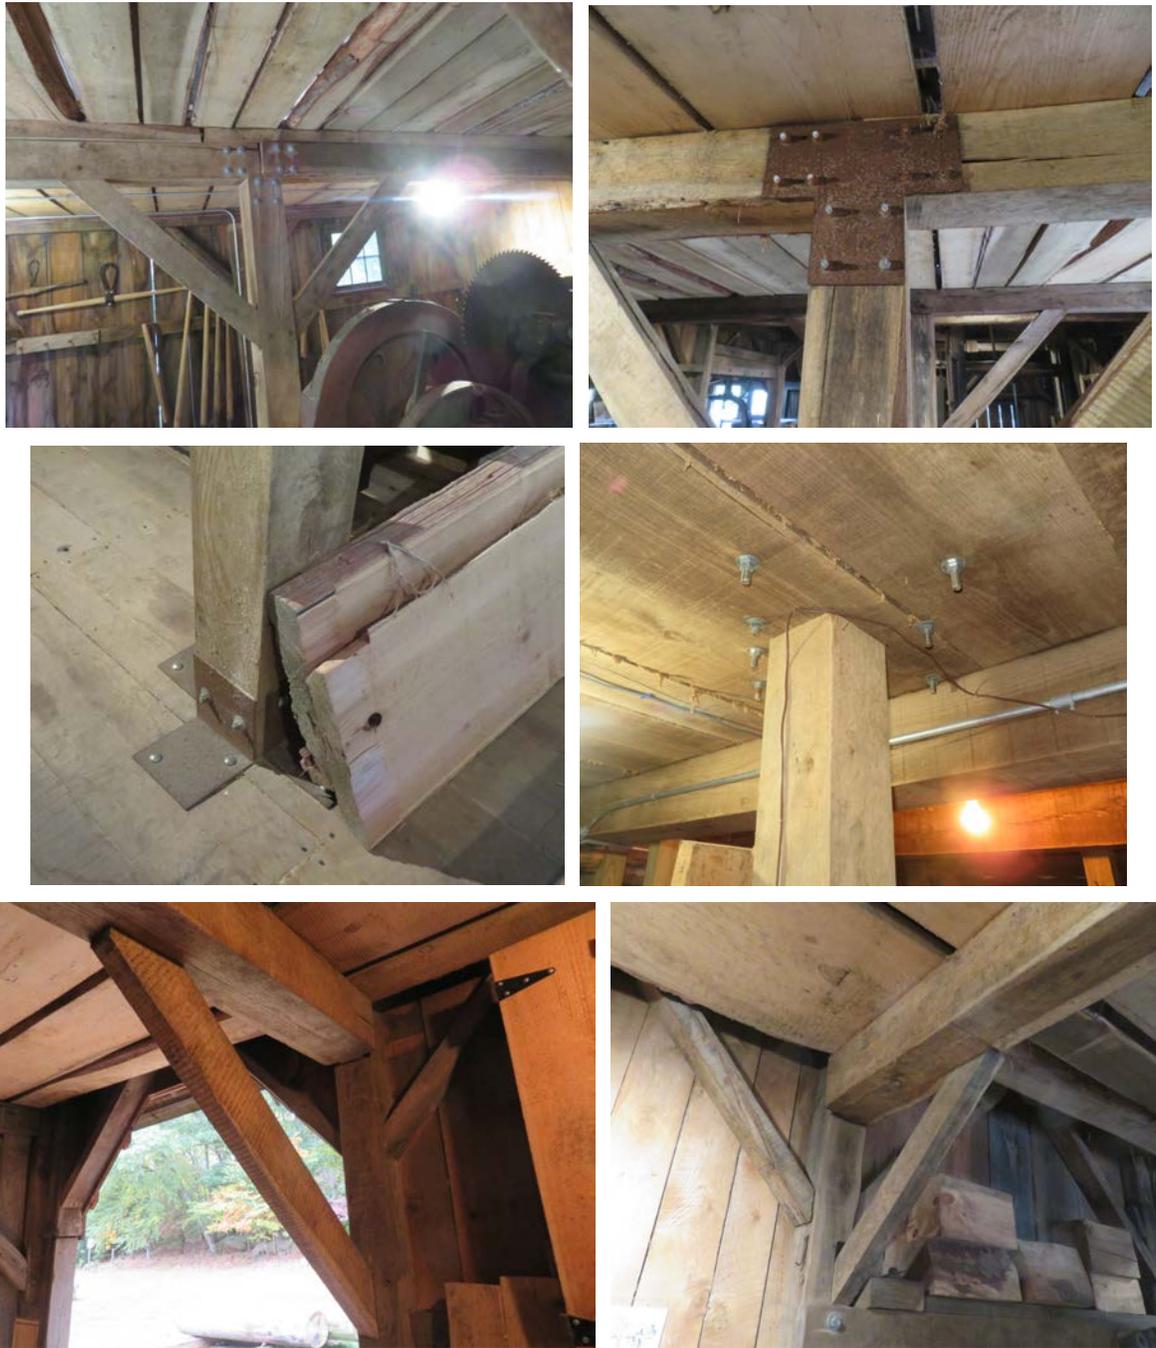
Analysis: The "new" loft-central tie-beam was installed in two pieces, with a new post supporting the middle at the joint between the pieces. Steel plates and bolts were used to make connections at the top and bottom of the post in lieu of traditional joinery causing it to stand out as visually new. The plates in both locations are plain steel and not protected from corrosion, thus showing signs of surface rust. A lower level post was also added at the

Loft-Central support line. Top: Middle post and beam connections at top; Middle: Middle post connection at bottom; Bottom: Beam connections into end post using historic joinery.

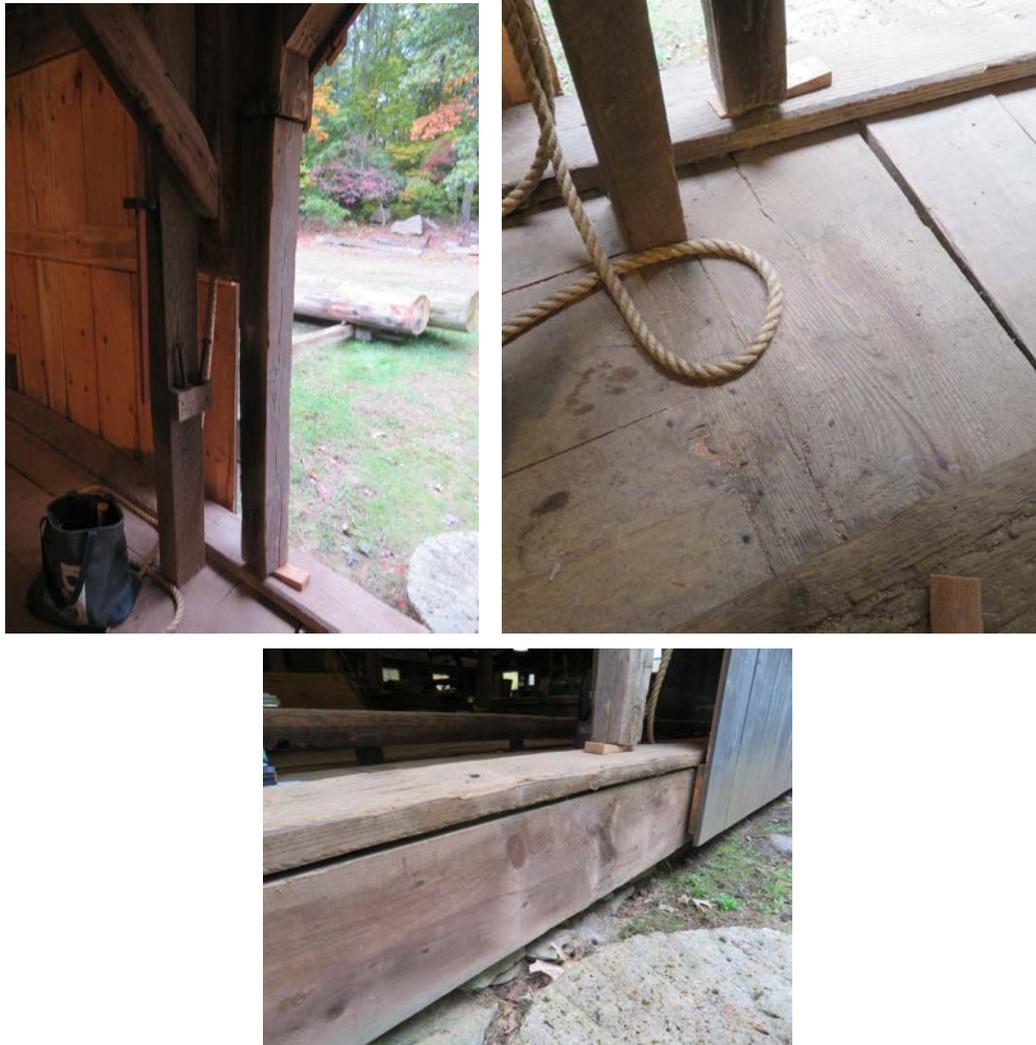
Loft-west, north post. Top: “new” offset post overall and zoomed in view at base supported by decking as well as deflection of deck board relative to adjacent one; Bottom: exterior view showing gap between door sill and skirt board suggesting lifting of door sill by decking.

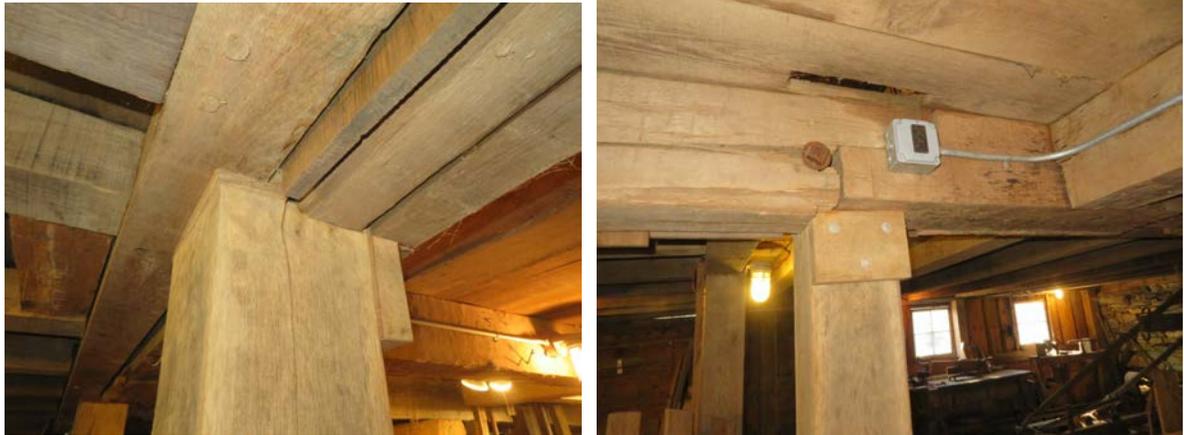
Analysis: The “crack” at the north beam appears to have started as a natural wood check or possibly a shear crack (if the post was not directly below prior to the addition of the lean-to), but was amplified by the drilling of the through-bolt and possibly expansion forces of corrosion of the through-bolt.

Left: from the southwest showing ledge, board siding and original building sill/beam with deep vertical check, as well as ledger on post to support inner edge of beam; Right: from north showing bolted lap splice over post, split, and ledger on post.

Recommendation: Similar to the previous item, we recommend that retrofit designs for both of the noted connections be developed by a preservation structural engineer to ensure that load paths are safely transferred through the joint. Retrofit designs will likely include vertical screws or bolts across the cracks, steel seat angles or hangers, and possibly epoxy injection.

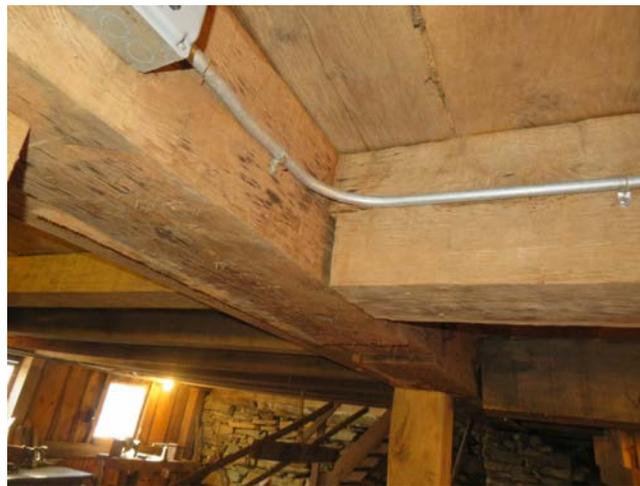
The “crack” at the end of the main building joist is a classic presentation of “shear crack” which occurs due to a shear stress concentration at the mortise joint.

Shear crack in original mill joist framing into the sill / beam (behind the conduit).

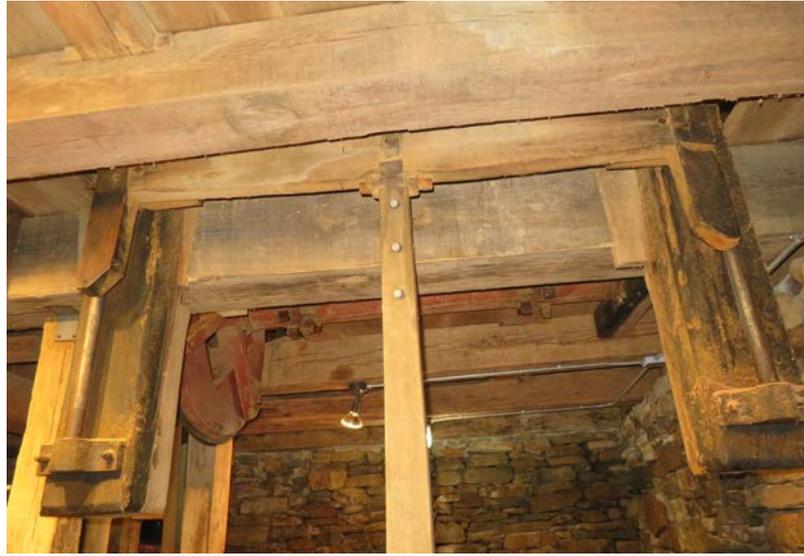
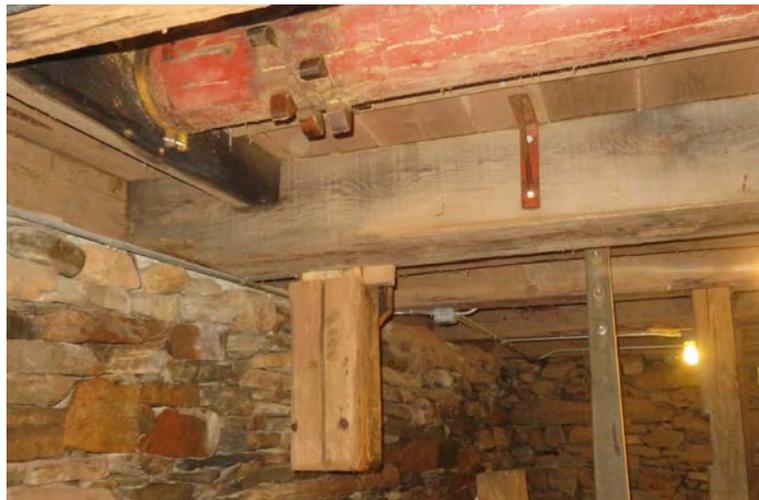
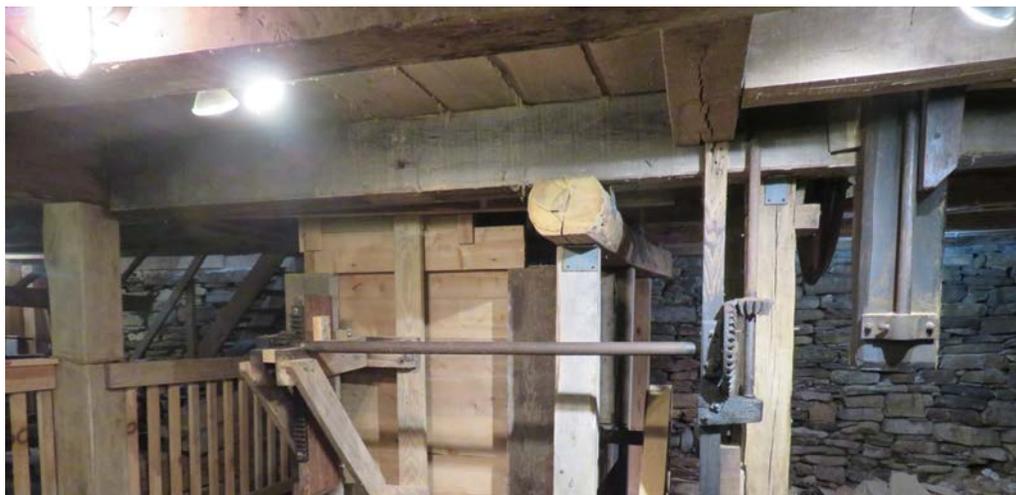
*Top: overall view of fender beam from the east showing two saw guides extending below;
Middle: north end of fender beam; Bottom: south end of fender beam including newer
intermediate post supported on north raceway wall below.*

Recommendation: The authors would be happy to undertake a more rigorous analysis should it be desired.

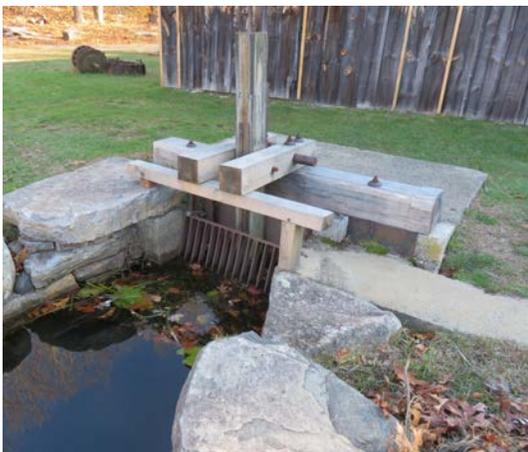
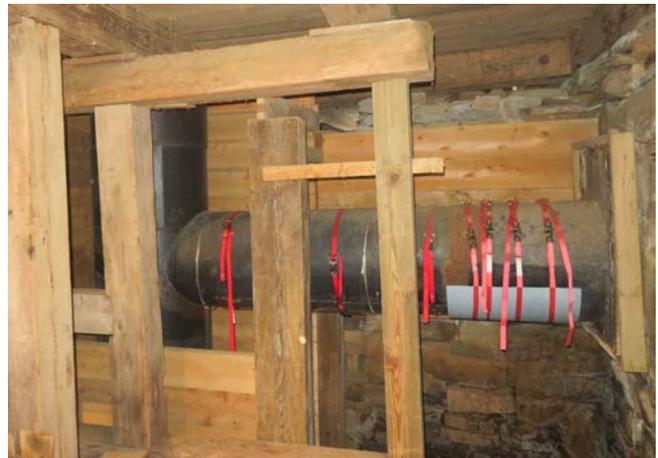
Description: The existing steel penstock and water tank installed circa 1982 connects to a reinforced concrete culvert that travels below grade to the gate at the mill pond. The steel penstock is corroding and has been reinforced with strapping to hold it together. The town would like to replace it, but in a form more historically authentic.

Left: Gate at mill pond; Right: circa 1980s vertical tube and penstock with nylon tension straps reinforcing it.

Recommendation: Per historic examples, the design concept that the group coalesced around is of a rectangular flume (penstock) constructed of 2" or 3" pressure-treated plank with groove edges connected with 3/4" or 1" spline slightly oversized and lined with rubber to make it watertight. The planks would be braced by 4x4 (or bigger) frames every few feet with possible mortise and tenon joints. The frames could be wedged against the planks with shingles to pre-tension / pressurize against water pressure. The bottom of the interior of the flume / penstock would epoxy coated to extend its longevity. The downpipe connecting the flume to the turbine would also be square and of similar construction. We have provided a conceptual sketch of a cross-section through the flume of this assembly below. A full design is outside the scope of this project and would require exact head dimensions and detailed measurements of the area. Tom Kelleher suggests that making the supply 50% bigger than gate offers a less rigorous engineering analysis of the final design.

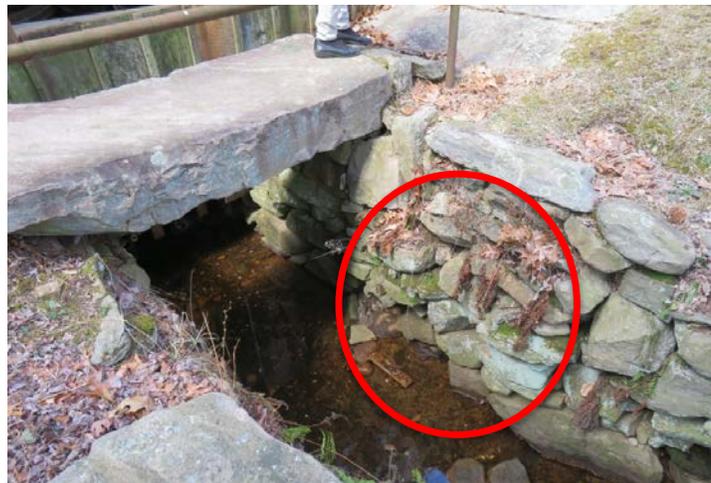
Analysis: The bulge is located at the most downstream end of the water flow and damage described in Item 1 and is likely caused by the same drainage path from the water pressure that builds up behind the wall.

North tailrace wall showing bulge in dry laid masonry

Recommendation: The condition could lead to instability and should be addressed. The most effective solution is to locally rebuild the wall in a plumb condition. This would also allow the opportunity to excavate behind the wall and improve drainage by adding a curtain drain wrapped with filter fabric. Weep holes through the wall could also be added to ensure overflow drainage in case the curtain drain becomes clogged in the future. Installing struts across the tailrace could provide temporary stabilization and/or a lower cost but less effective alternative to rebuilding.

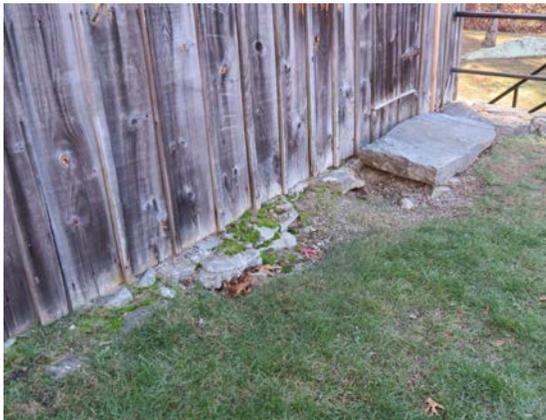
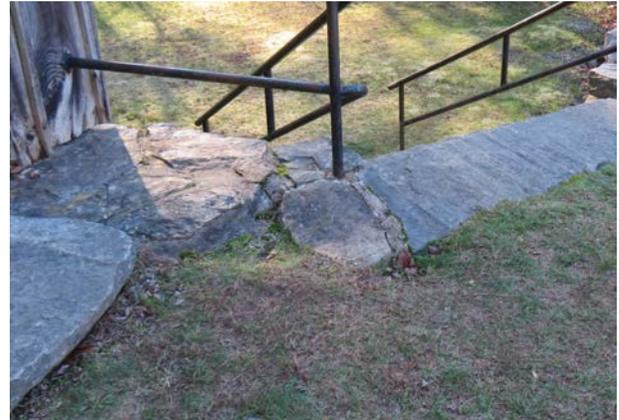
Description: Similar to the east side drainage and erosion issues noted in Items 1 and 9, the west side exhibits similar but milder conditions. Erosion was observed along the foundation wall and above the stair along with displacement of the dry-laid stone retaining wall and stone steps.

Analysis: Unlike the west side, the pitch of the grade on this side of the building is less severe. Floods from the adjacent pond on several occasions in the last decade have been noted when water breached the pond and onto the strip of land between pond and mill building. On these occasions, water flowed into the basement at the southwest corner of the building and caused damage. It is possible that the noted erosion is caused by both land drainage and prior flooding.

Erosion at west side of building, to north and south of door threshold

Recommendation: Excavating below this area to improve drainage by adding a curtain drain wrapped with filter fabric would prevent continued damage due to erosion, particularly if the accessibility / ramp project is undertaken. The drain would need to be routed to drain away from the building, which could prove to be a significant project. Weep holes through the wall could also be added to ensure overflow drainage in case the curtain drain becomes clogged in the future.

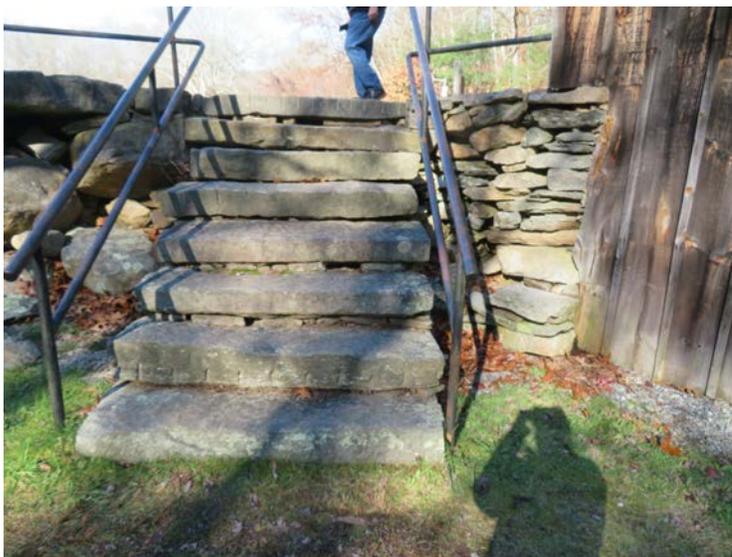
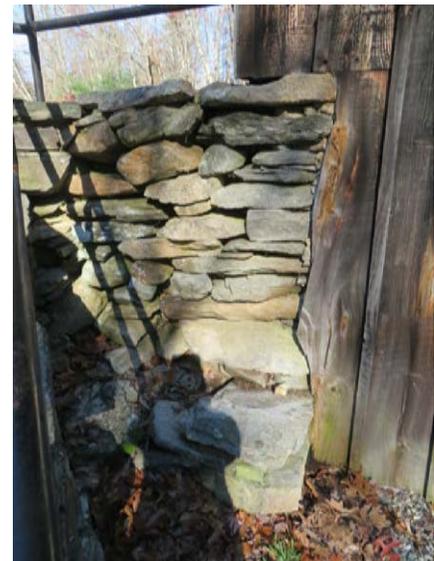
Displacement of steps and dry laid retaining wall at lower level below eroded areas above

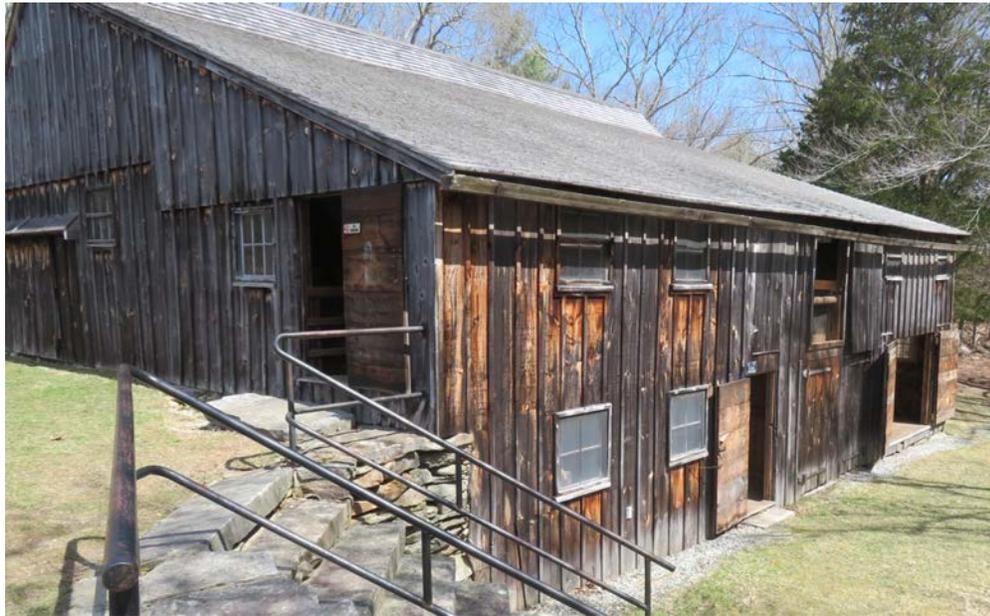
Some battens have been replaced. The base of the boards are warped in areas and exhibit checks or rot in spots. Some cracks/checks are located at areas of nails or where metal tube railings (at the west side south corner) are fastened into the siding. The boards are also generally weathered and discolored.

West and south elevations.

Recommendation: Short term treatment would involve the removal and replacement of any deteriorated sections of siding, and treatment of end grains via sanding and application of preservative treatment. It would also include removal and replacement of the horizontal batten, and if possible the addition of a Z-flashing along the upper surface of the horizontal batten to allow for any moisture that gets behind the siding above to drain out.

For a long term repair, it is recommended that the existing siding be removed and replaced with new wood batten siding, using at least either a pressure treated pine or cedar, and following industry recommended batten siding installation practices. This includes components such as the addition of a water table at the base and Z-flashing along the top. If stacking wood batten siding vertically, it is recommended that a Z-flashing be installed at the upper termination and a space of ¼" left before another piece of siding installed above.

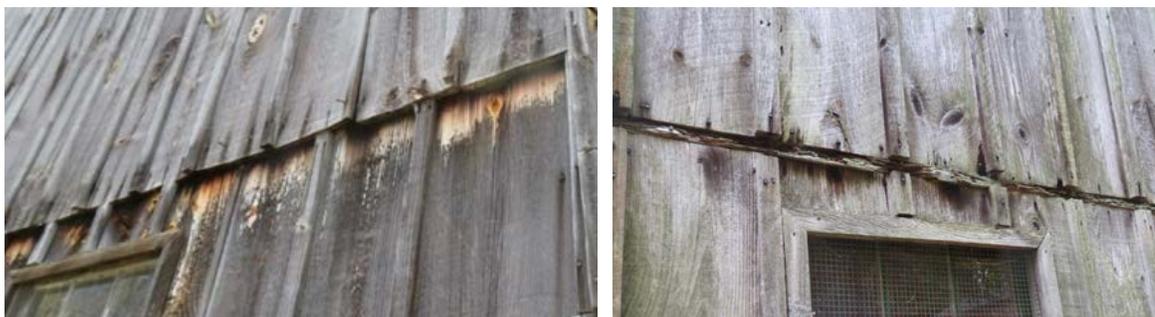
There are several construction details that may have led to premature deterioration of the siding. One of the most significant is the extension of the siding all the way to the ground, resulting in the exposure end grains of the wood making it susceptible to moisture absorption, warping and deterioration. Other details such as the vertical stacking of the boards without intermediary flashing and space for movement is similarly resulting in absorption of moisture via the end grains and deterioration at these locations. The horizontal "batten" at the butt joint details is essentially acting as a shelf for rain water, which is then absorbed by the siding above and below.

Left: Overlapped detail at board joints on west elevation; Right: Butt joint detail at board joints on grist mill portion of east elevation.
