LEDYARD UP-DOWN SAWMILL

HISTORIC PROPERTY STRUCTURAL AND CONDITION ASSESSMENT

Ledyard Up-Down Sawmill
172 Iron Street
Ledyard, Connecticut

March 2, 2023, *Revisions April 14, 2023 (noted in blue text)*

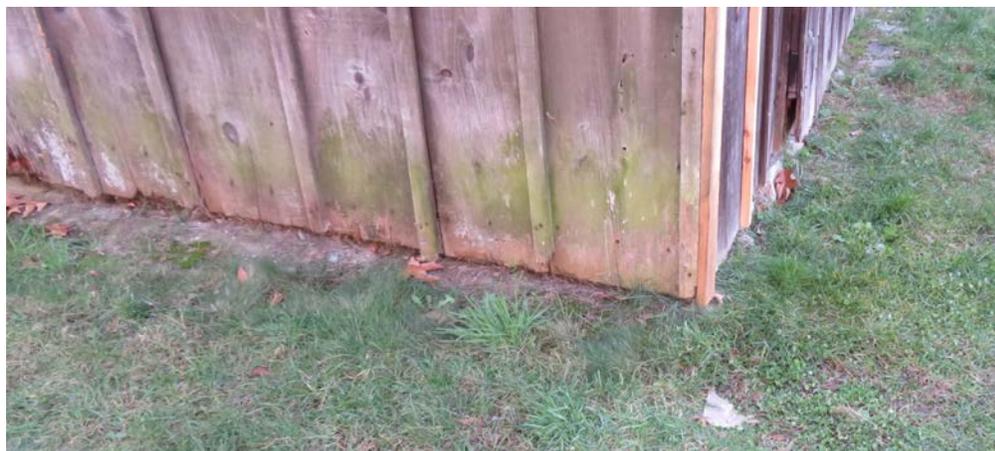
Some battens have been replaced. The base of the boards are warped in areas and exhibit checks or rot in spots. Some cracks/checks are located at areas of nails or where metal tube railings (at the west side south corner) are fastened into the siding. The boards are also generally weathered and discolored.

Biological growth, weathering, deterioration and replacement battens (shown at northwest corner).

Recommendation: Short term treatment would involve the removal and replacement of any deteriorated sections of siding, and treatment of end grains via sanding and application of preservative treatment. It would also include removal and replacement of the horizontal batten, and if possible the addition of a Z-flashing along the upper surface of the horizontal batten to allow for any moisture that gets behind the siding above to drain out.

For a long term repair, it is recommended that the existing siding be removed and replaced with new wood batten siding, using at least either a pressure treated pine or cedar, and following industry recommended batten siding installation practices. This includes components such as the addition of a water table at the base and Z-flashing along the top. If stacking wood batten siding vertically, it is recommended that a Z-flashing be installed at the upper termination and a space of ¼" left before another piece of siding installed above.

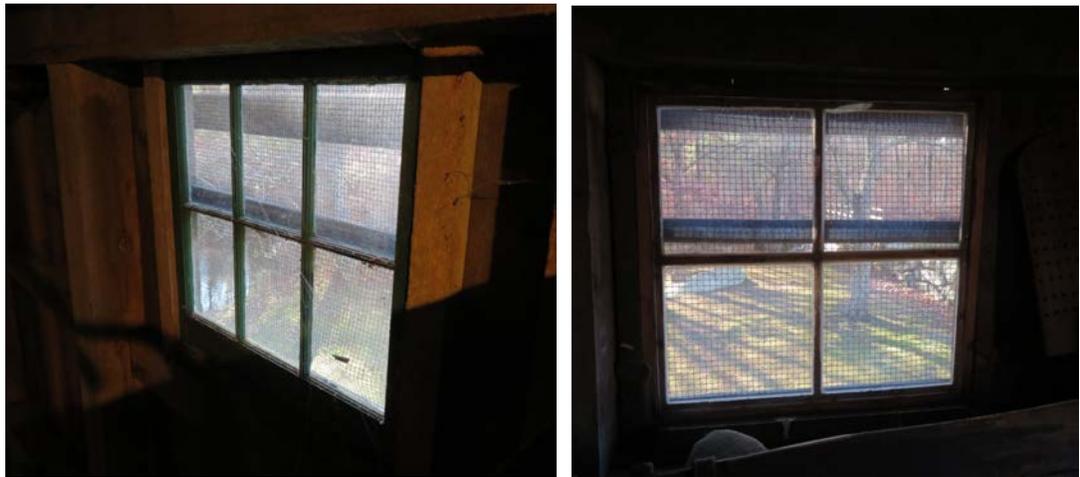
Description: Existing wood windows are a mix of 2/2 and 3/3 single glazed wood sashes that are typically fixed in place. Some of the windows have plexiglass nailed to the interior where they had previously broken mainly at the lean-to on south elevation. Many of the windows have an exterior mounted wood frame with metal screens. The wood sashes vary in vintages which is evident by the variety of styles of muntins.

Interior view; Left: painted salvaged window in grist mill addition; Right: south lean-to window with plexiglass replacement

As part of the window work it is recommended that the existing interior plexiglass enclosures and exterior wood mounted screens be reviewed to assess need for these elements, and whether they should be reinstated, replaced or omitted in the future.

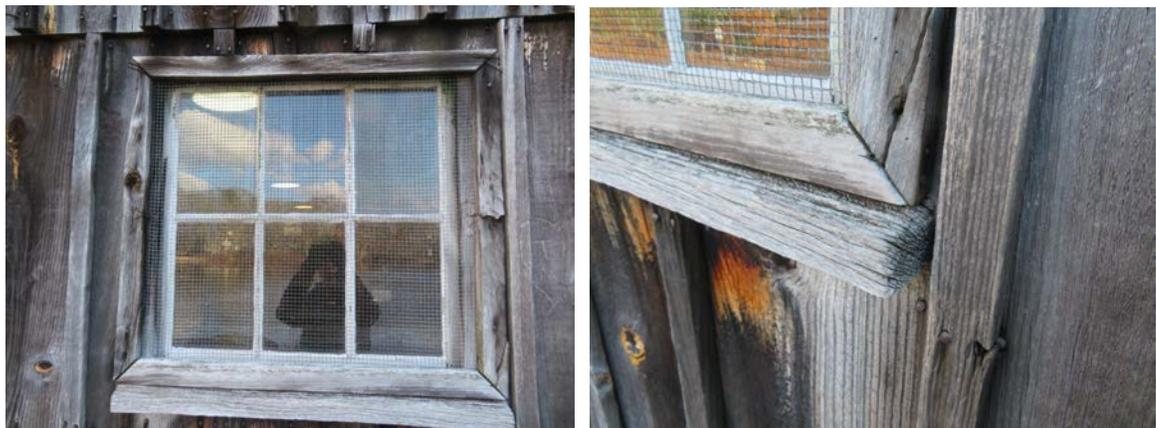
Exterior original mill window with wood mounted screen. Sill is weathered with dry end grain.
