LEDYARD UP-DOWN SAWMILL

HISTORIC PROPERTY STRUCTURAL AND CONDITION ASSESSMENT

Ledyard Up-Down Sawmill
172 Iron Street
Ledyard, Connecticut

March 2, 2023, *Revisions April 14, 2023 (noted in blue text)*

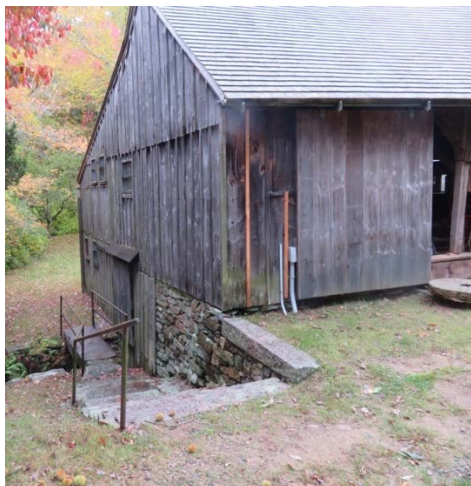
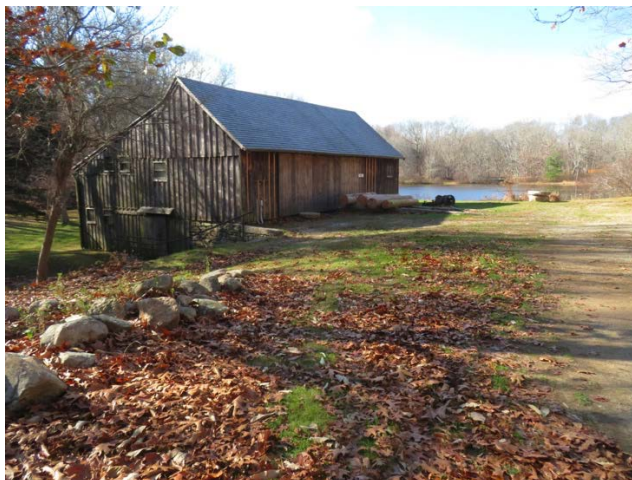
Images from the northeast show the uphill site grading at the stairs and overall.

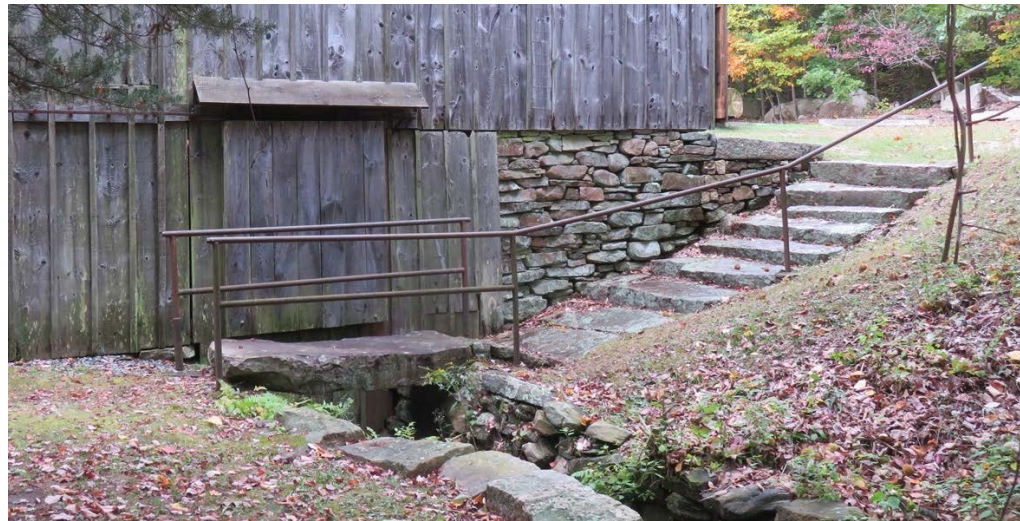
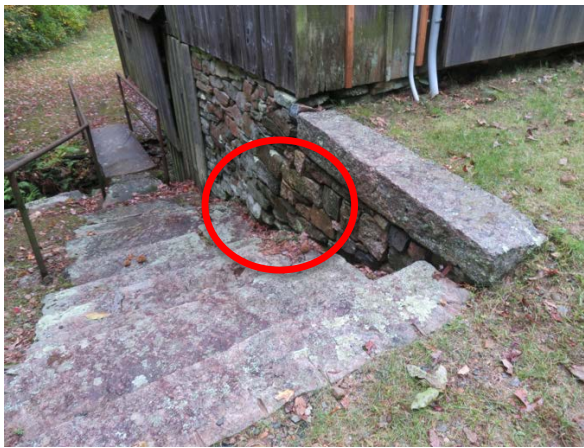
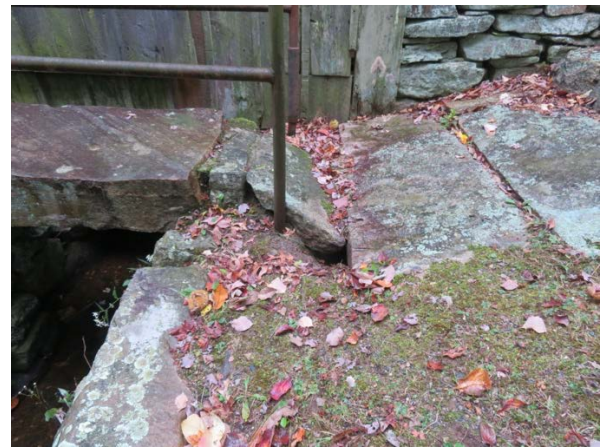
Description: The east exterior stone stairs provide access across the tailrace embankment. A small retaining wall extends north of the east mill wall to support the upper grade for the top 3 steps. Erosion has occurred below the bottom three steps allowing them to rotate out of place. The lowest step has settled into a significant hole. A substantial bulge and dampness are apparent in the masonry foundation wall of the mill at approximately the fourth step from the top. In 2021, the area just to the north of the stairs was regraded to create a small berm near the top of the stair and to direct site drainage to the southeast of the stairs.

Analysis: A geotechnical boring was performed slightly northwest of the area during this project, and the soil material found to have suitable properties for bearing without the propensity for foundation settlement. Long standing issues with site drainage and gutter discharge onto the east exterior stairs are apparent based on information from the town and mill volunteers. The issues noted in the stairs and foundation wall are consistent with erosion that might occur due to washout of soils from water flowing through and below the affected components. The bulge in the foundation wall is likely caused by movement of the individual dry-laid stones in response to pressure from discharging gutter drainage water.

Top: Overall view of damage; Bottom Left: Bulge in foundation wall; Bottom Right: Shifting and movement of bottom 3 steps due to erosion of soil below.

Recommendation: In addition to managing gutter discharge water (see section below), and maintenance of recent site grading that now directs water to the southeast of the stairs, the authors recommend the resetting of the bottom 3 steps. In addition, some additional probing into the foundation wall is recommended to determine if the full thickness of it has bulged or just the outer stones below the gutter. Local rebuilding of the bulged stone might be considered, the extent to which can be determined by the further probing.

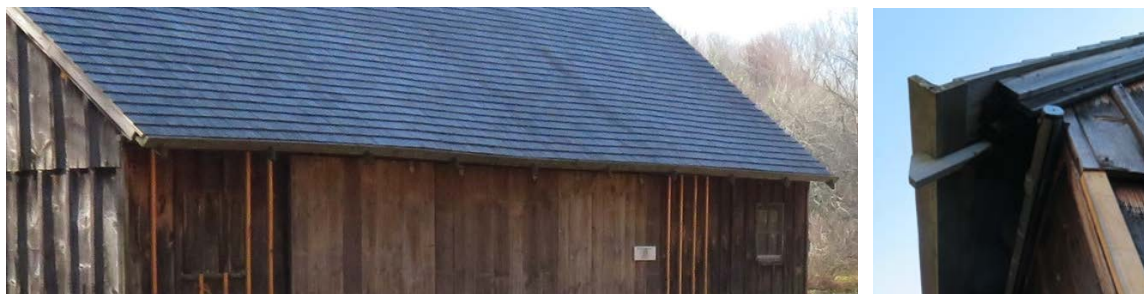
Analysis: The wood V-gutter on the north side appears to be in good condition. Biological growth and general weathering appear on the south box gutter. The gutter pitches east, but dips down perhaps due to a missing bracket about 10' from east end. The gutters do not appear to be lined, which leaves them vulnerable to deterioration and a relatively short life-span. It is not known how the joints in the gutters are treated.

North gutter overall and profile of V-shape and bracket.

Recommendation: At the north gutter, the authors recommend adding a leader and below-grade drainage to the east end to manage flow of water away from the building on that side. A similar approach or at least a splash block should be considered on the west side. The south gutter is due for replacement relatively soon (within 5 years). In the meantime, the dip should be investigated and gutter re-supported as needed. A V-gutter shape should be considered when replacement occurs, along with linings and/or joint treatment. The leader should be tested to confirm that it is working.

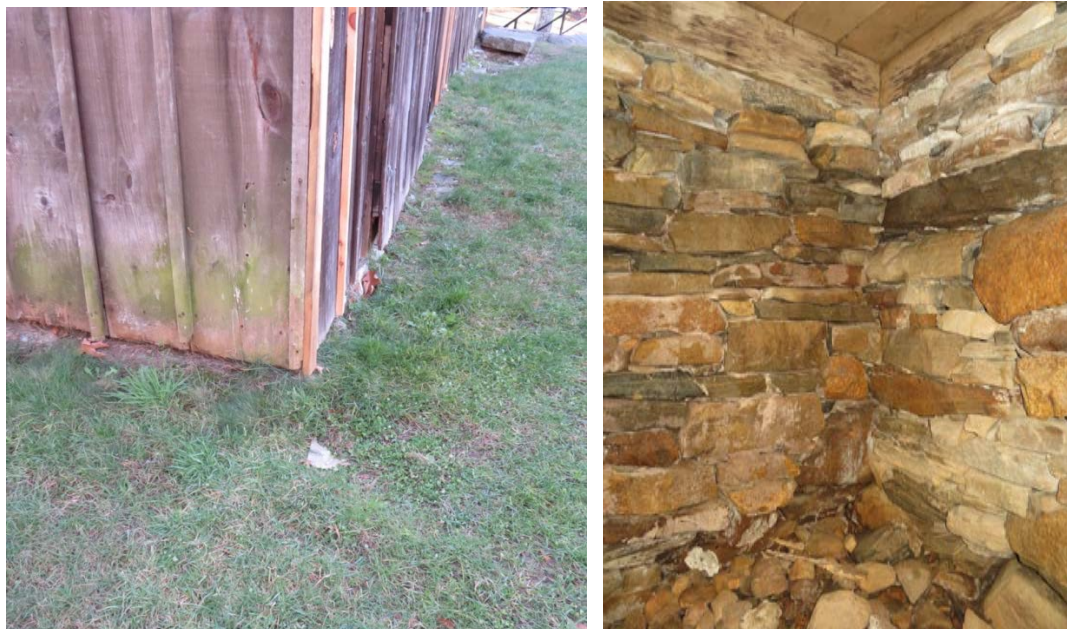
North gutter, west end; Left: grade where gutter is discharging; Right: inside face of foundation wall at northwest corner showing dampness and fungal growth on sill above.

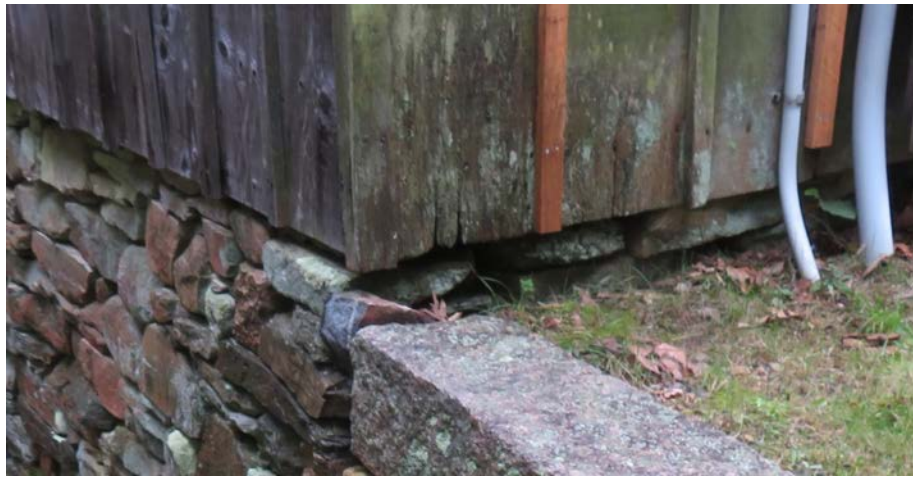
North gutter, east end, showing deteriorated board siding and erosion in masonry.

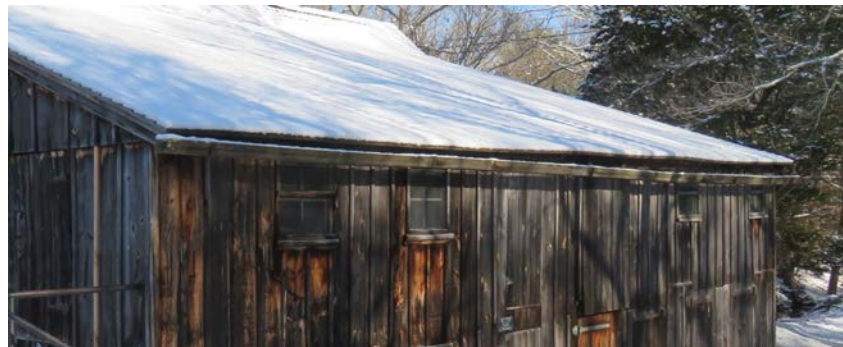
South gutter showing dip (likely missing bracket) toward east end.

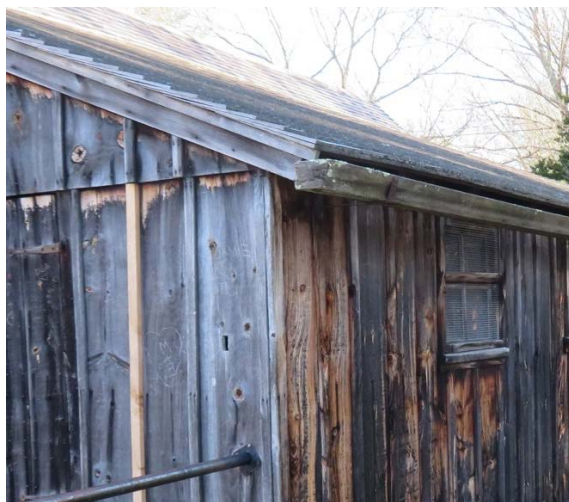
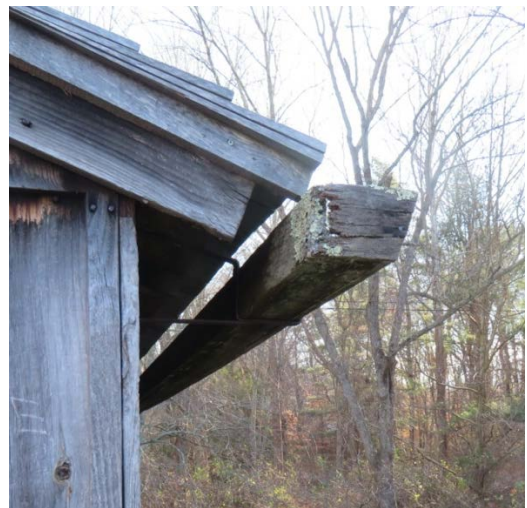
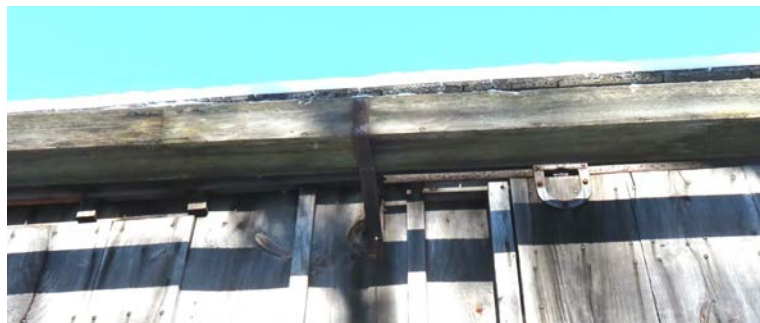
South gutter showing box gutter shape, weathering, biological growth and brackets.

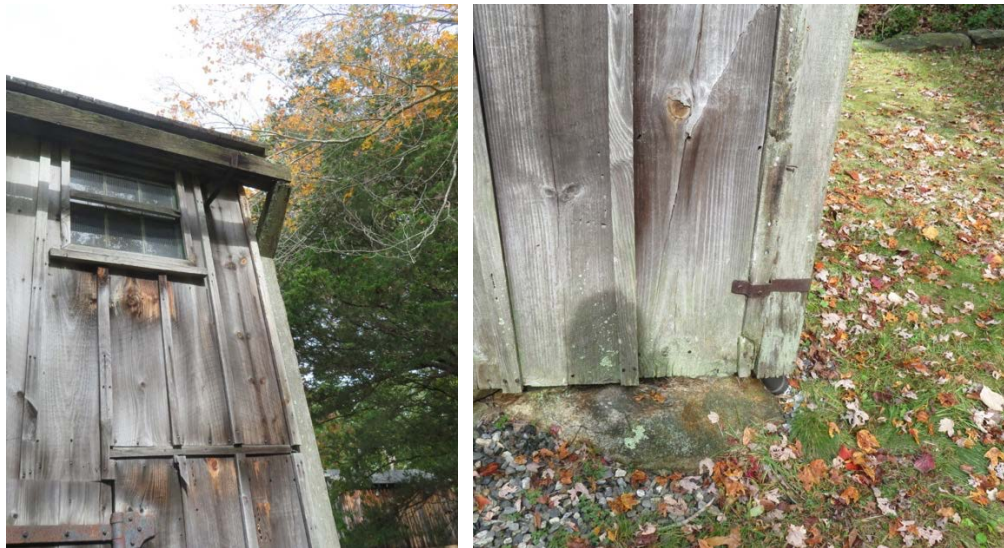
South gutter, east end, showing wood box trim around metal leader transitioning to sub-surface drainage.

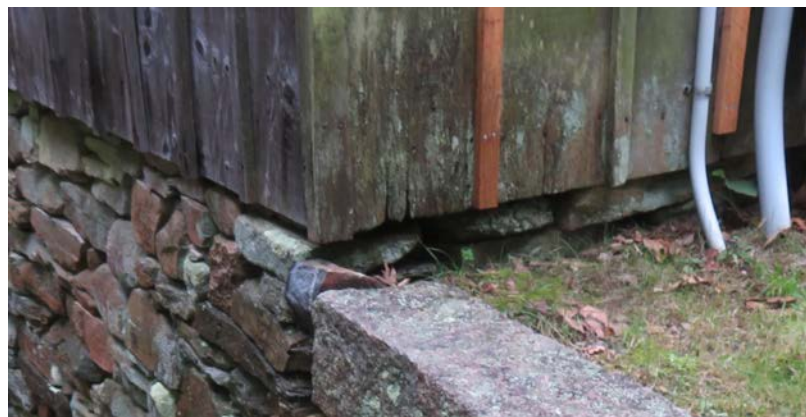
Description: The floor pitches roughly 3.5" to the east in the NE corner of the building. The upper-level floor is framed with 8x8 beams at 4' on center spanning in the north-south direction with 2" decking spanning east-west between beams. The distance between the north wall and first beam is roughly 4' from the corner. The east basement wall is constructed of masonry north of the tail race, then transitions to timber frame over the tail race to the south corner. The end post of the timber frame portion sits on the north raceway wall, and appears to have dropped slightly as indicated by the gap between the top of the post and sill/beam above.

Analysis: Movement in the foundation wall from the water issue noted in Item 1 is likely the main cause of the floor settlement; however, the irregular geometry of the stone walls made it difficult to directly correlate the two. It is also likely that the causes of the deflection are multifactorial and cumulative based on a number of issues observed including a shear crack at the east end of the northern-most beam. Based on the gutter discharge in the area and biological growth and deterioration of the siding, sill deterioration may also be a likely contributor, although not yet extensive. Some of the deflection may have also been caused by former beams and sills, which have now been replaced, but may not have been installed in flush / level condition. The deteriorated post base could also be contributing.

Exterior of northeast corner showing siding deterioration.

Recommendation: Once funds are raised to address the northeast corner, the authors recommend a holistic look at both further investigation and treatment, which might include local wall rebuilding, local sill replacement, post base repairs (dutchman) and beam hangers.

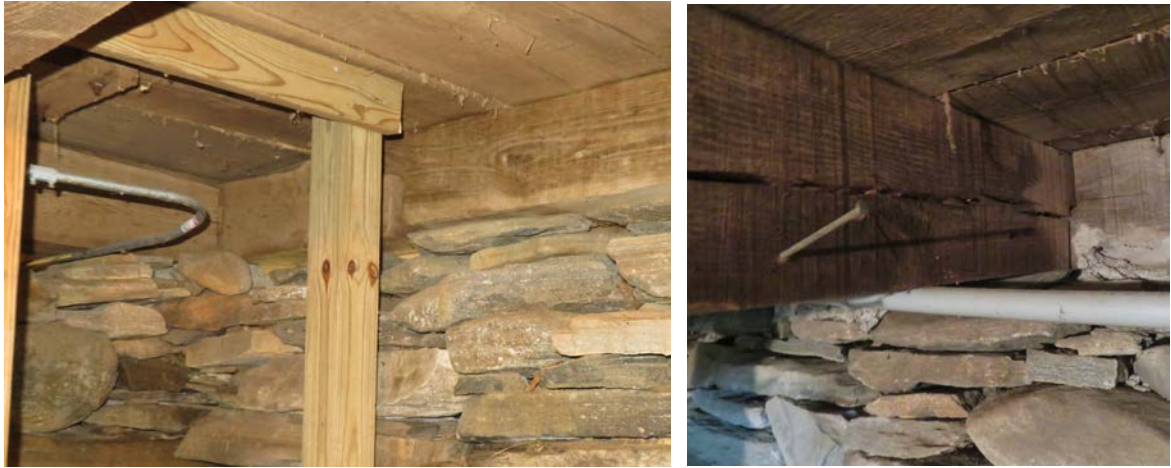
Left: Northeast corner from basement showing sill corner tenon (possibly bent); Right: East end of north beam show shear crack parallel with tenon (stress concentration).

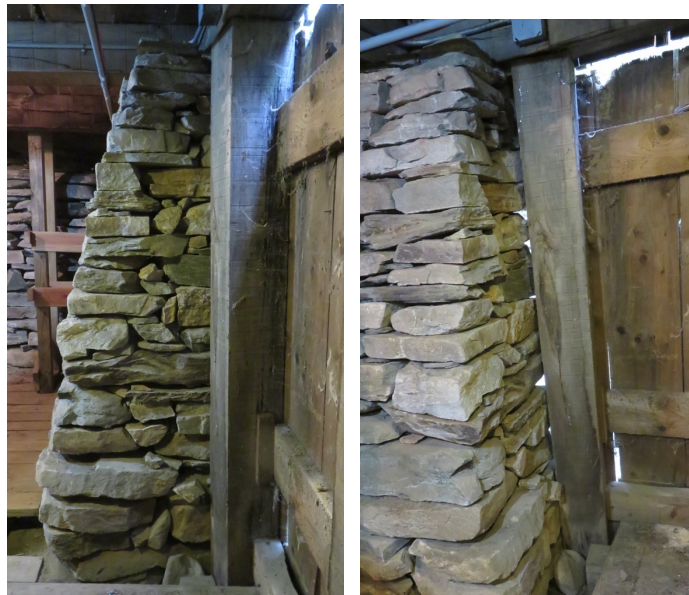
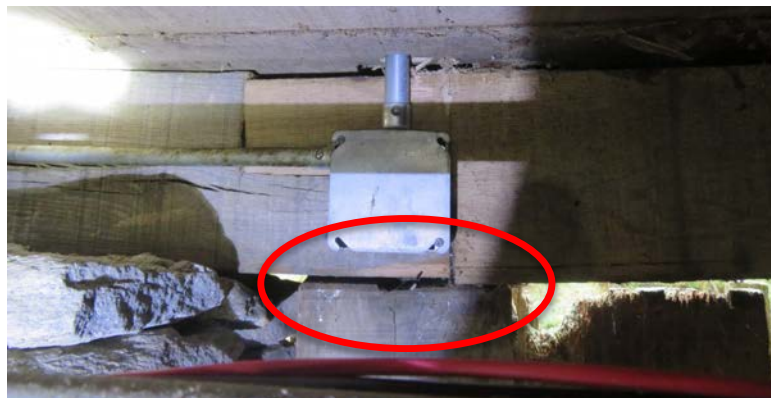
Top: East wall post from south and west respectively; Bottom: gap between top of post and beam/sill.

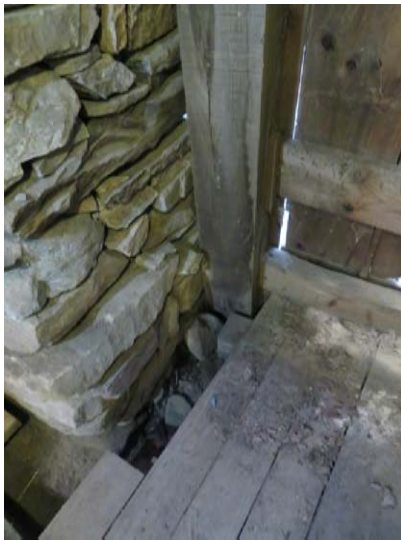
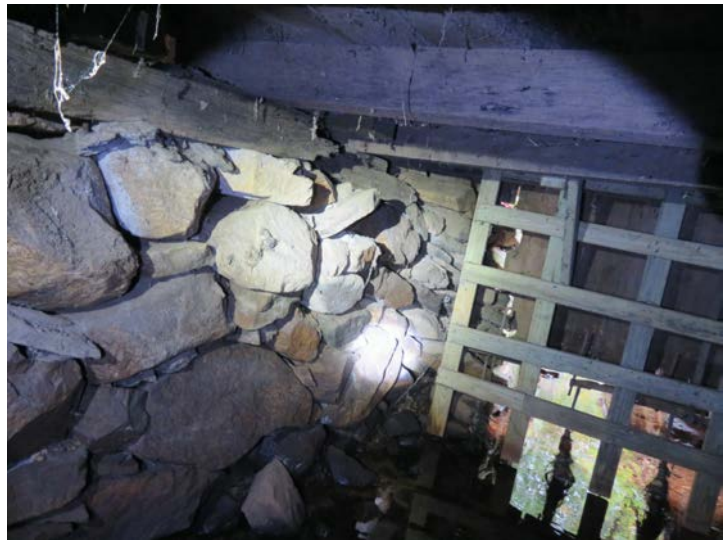
Left: Bottom of east wall post just above decking over raceway, post base is concealed below decking; Right: Deterioration of east end of decking sill over north wall of raceway looking east to gate to tail race, the post base is not apparent in this image but deterioration of deck sill is suggestive.

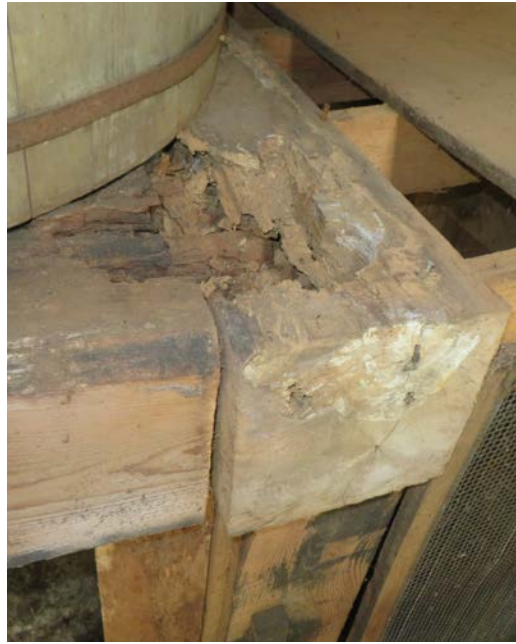
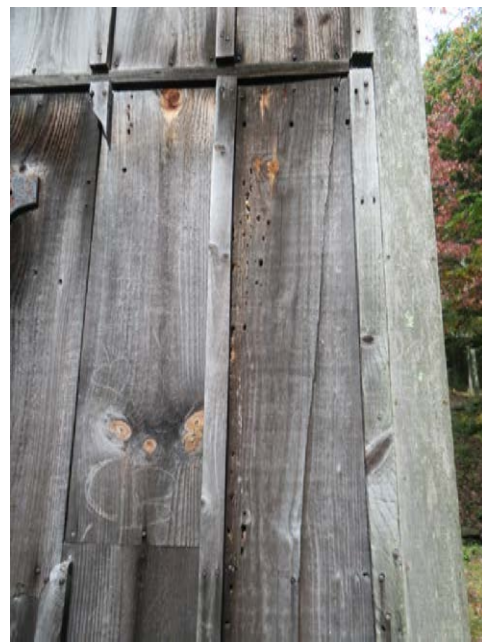
Analysis: On the exterior, the only visible sign of sill deterioration is at the central part of the south elevation (lean-to portion) below the double doors. As viewed from the basement, where visible, sills do not show any obvious deterioration; however, black staining is apparent on the surfaces in northwest and southeast corners suggesting that damp conditions due to proximity to grade and/or gutter discharge is allowing for fungal growth on wood. Sills were installed on a solid bed of mortar which may prevent bottom of sills from drying encouraging deterioration. The lower level framing on the south side is also in close proximity to grade leaving it vulnerable to deterioration. A former termite infestation occurred in the grist mill area but was caught and treated. Evidence of termite borings in the boards in the southeast corner suggest that the corner post may have been attacked.

Left: Termite damage at the grist mill frame; Right: tell-tale termite trails / holes at siding at the east end of the south elevation.

Recommendation: A deeper investigation is recommended to determine sill damage at areas of known exposure to water, primarily at the corners. If siding work is planned in the next 5 years, sill investigation and repairs / replacements could be performed as part of that work.

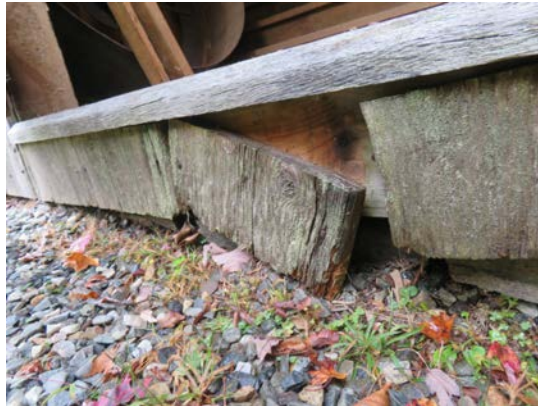
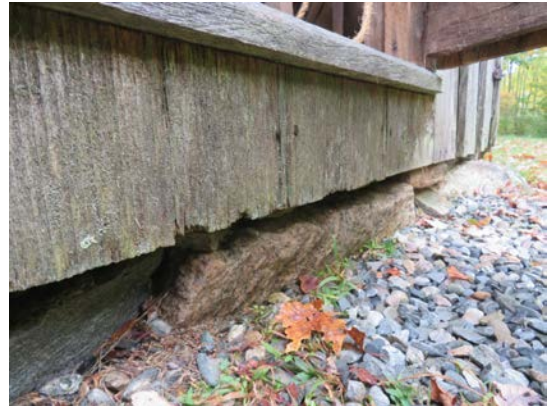
Siding and foundation below grist mill exterior doors. Siding nails have failed, but sill behind appears to be in good condition.

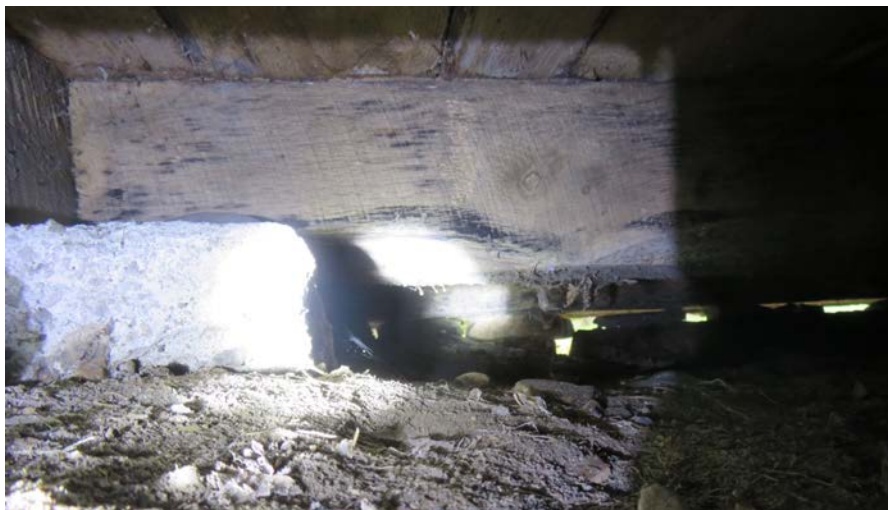
East end of joist in grist mill floor (crawlspace) showing black staining and close proximity to grade, but not visible deterioration.

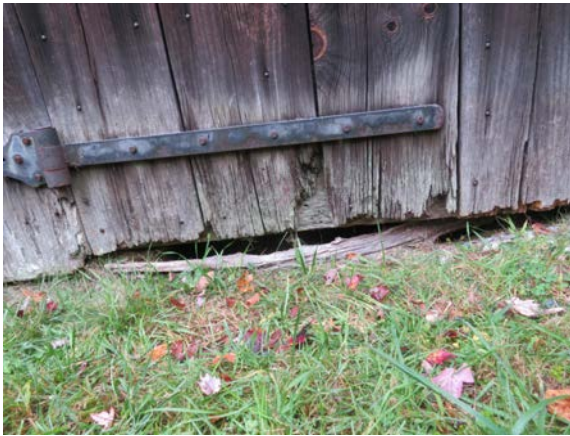
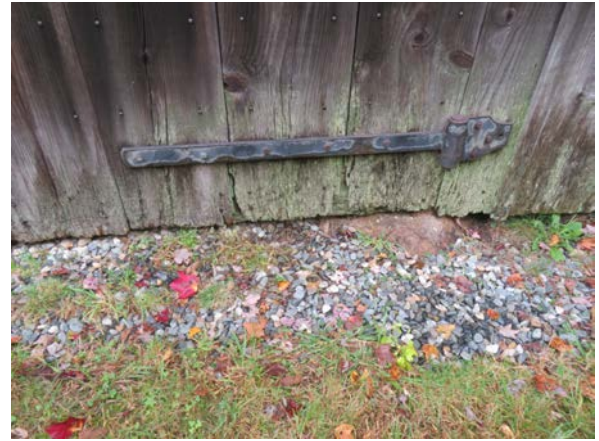
Central double doors at south elevation (lean-to) showing siding deterioration and sill / threshold deterioration behind.

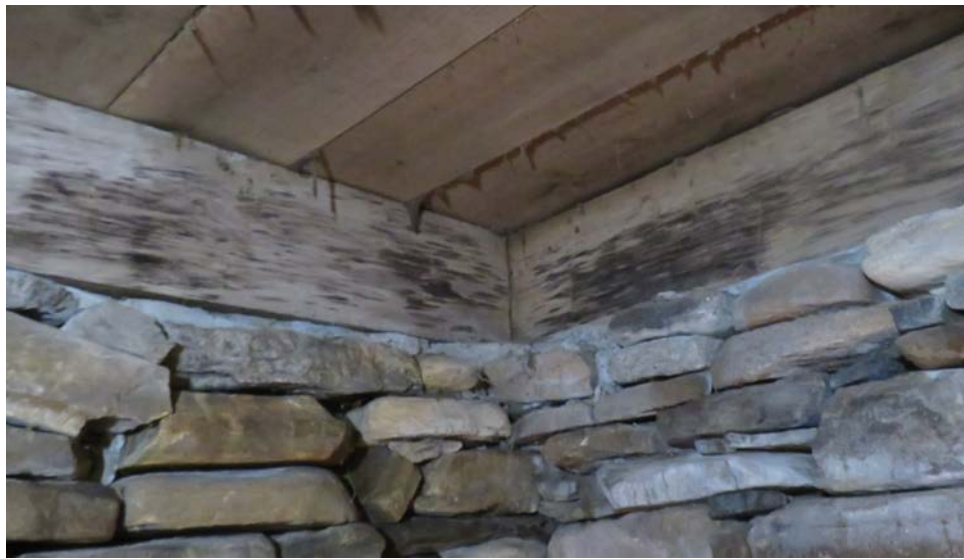
Northwest corner of sills from the basement showing black staining presumed to be fungal growth.

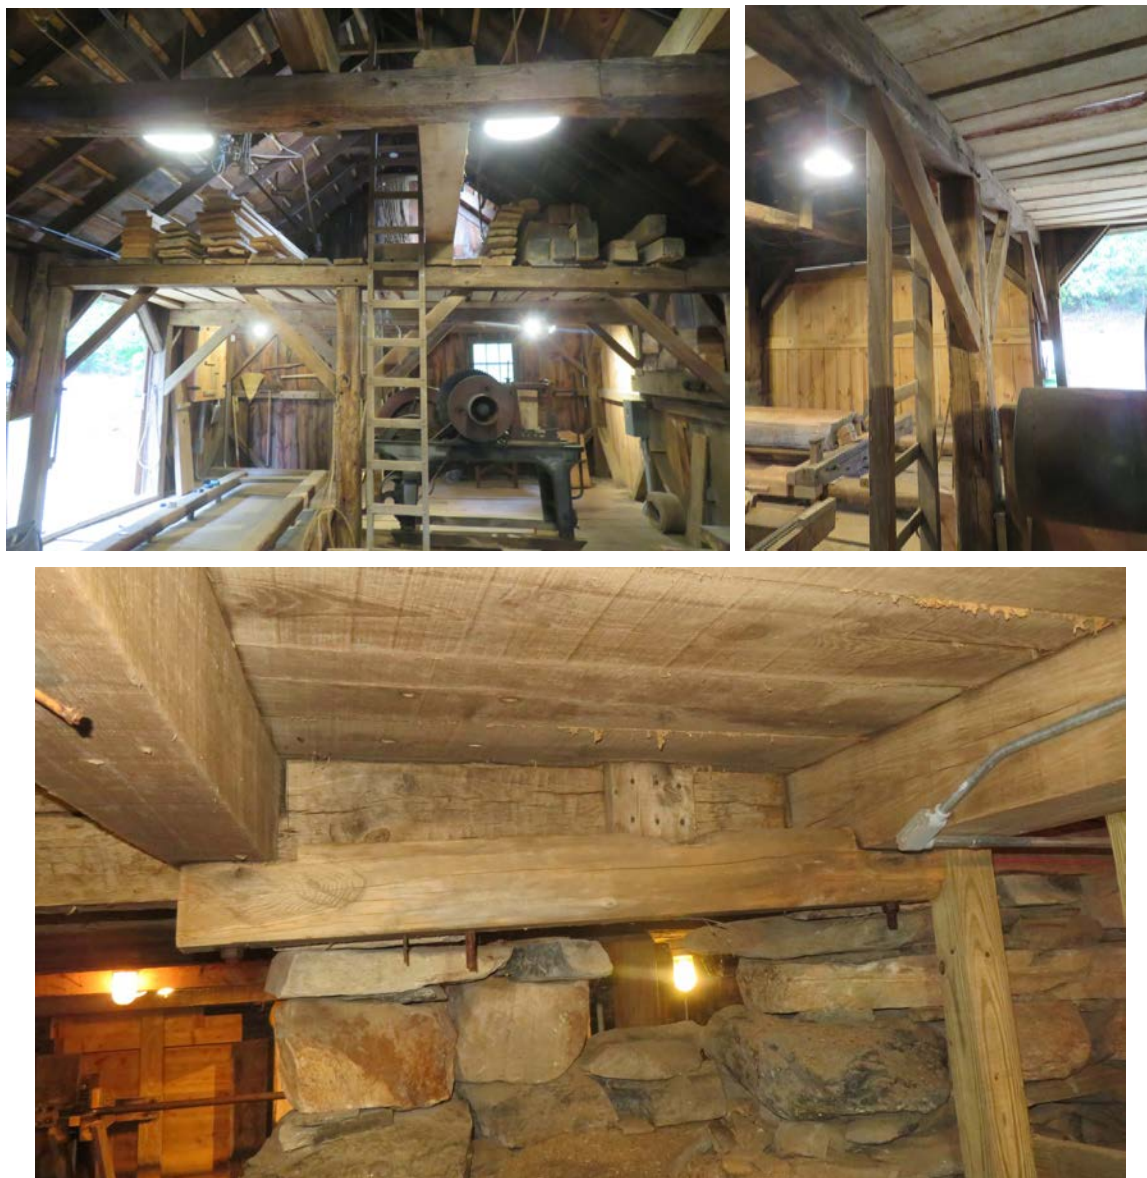
At loft-west, middle post, the north-south beam to support the post was hung from the adjacent east-west beams. While unconventional, the authors did not observe any obvious signs of distress at the beam or its connections.

Overall Loft and Loft-West support line. Left: Loft-West north bay showing replacement post; Right: Loft-West middle post with hung beam support below.

Recommendation: See Section E below for discussion of loft capacity. In addition, the authors recommend improving the connections noted above to meet industry standards in terms of strength and durability. To do this, we recommend that retrofit designs for each of the noted connections be developed by a preservation structural engineer (we'd be happy to provide this service) to ensure that load paths are safely transferred through the joint. Retrofits will likely include structural screws or bolts, galvanized or stainless steel hardware

(concealed to the extent possible) and wood blocking or bracing. The designs will be shown on sketches with material specifications that can be bid out for the work or completed by town personnel or volunteers.

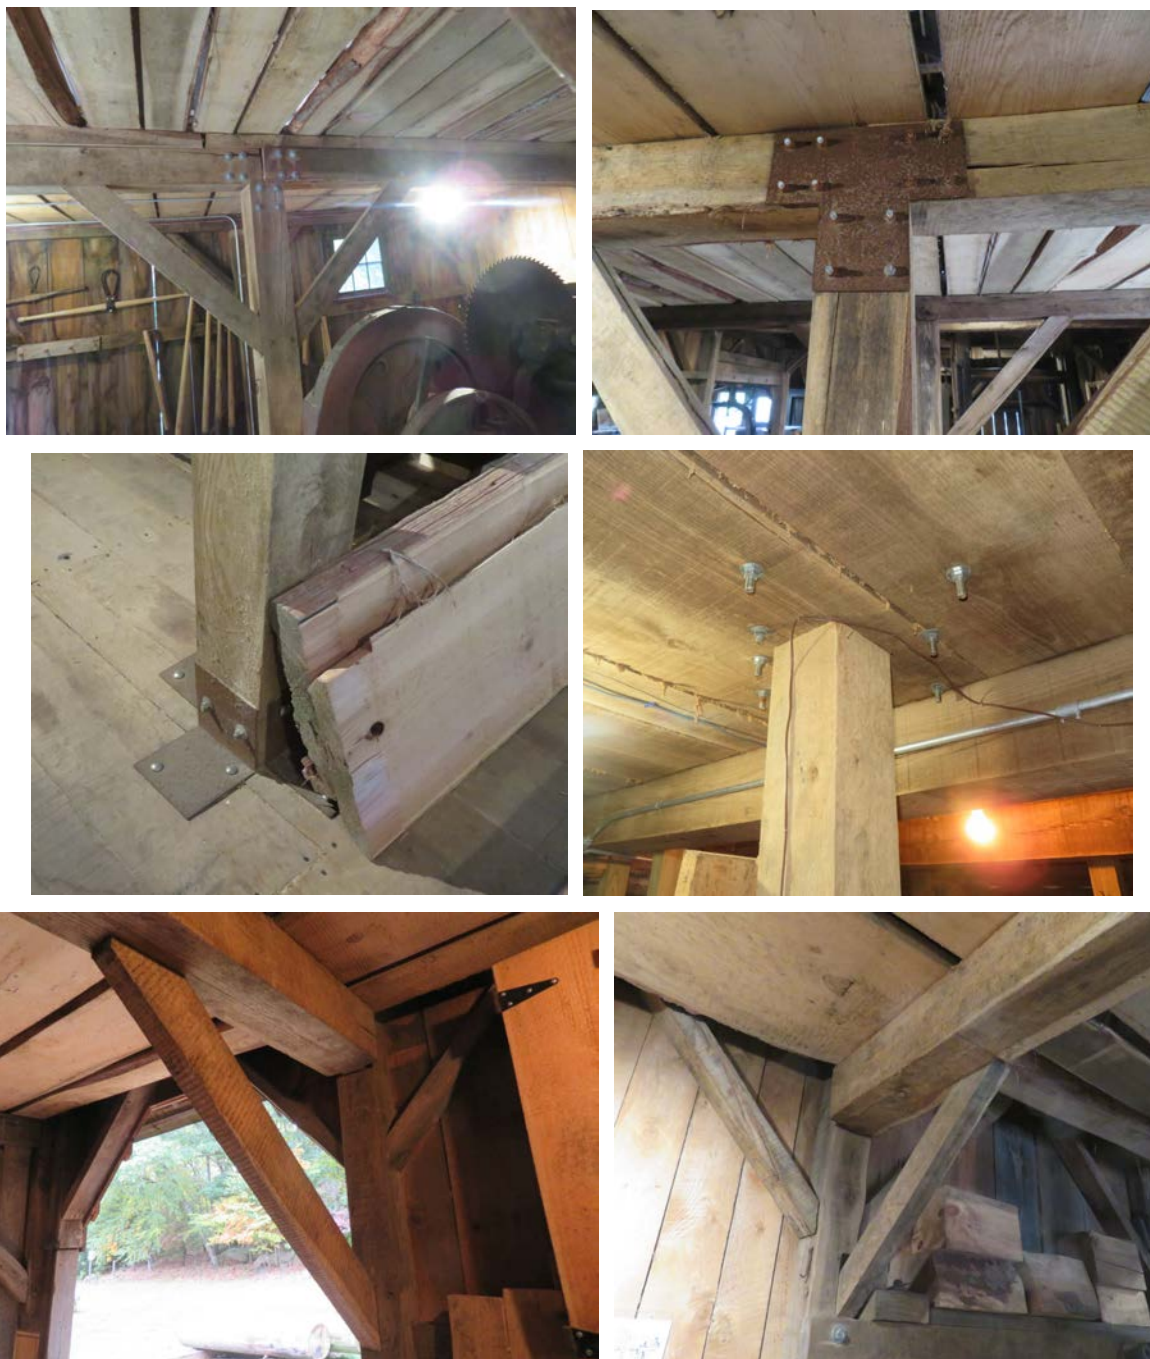
Analysis: The "new" loft-central tie-beam was installed in two pieces, with a new post supporting the middle at the joint between the pieces. Steel plates and bolts were used to make connections at the top and bottom of the post in lieu of traditional joinery causing it to stand out as visually new. The plates in both locations are plain steel and not protected from corrosion, thus showing signs of surface rust. A lower level post was also added at the

Loft-Central support line. Top: Middle post and beam connections at top; Middle: Middle post connection at bottom; Bottom: Beam connections into end post using historic joinery.

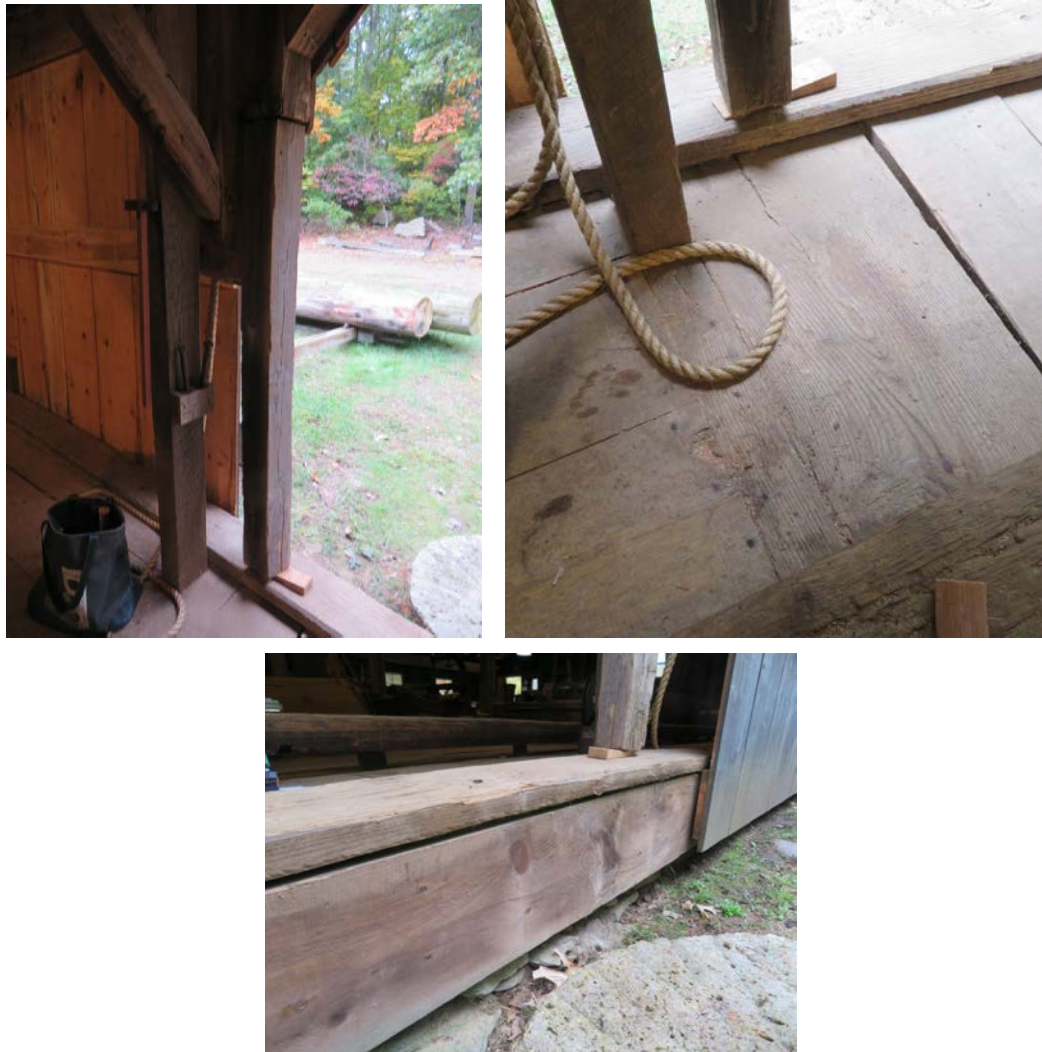
Loft-west, north post. Top: “new” offset post overall and zoomed in view at base supported by decking as well as deflection of deck board relative to adjacent one; Bottom: exterior view showing gap between door sill and skirt board suggesting lifting of door sill by decking.

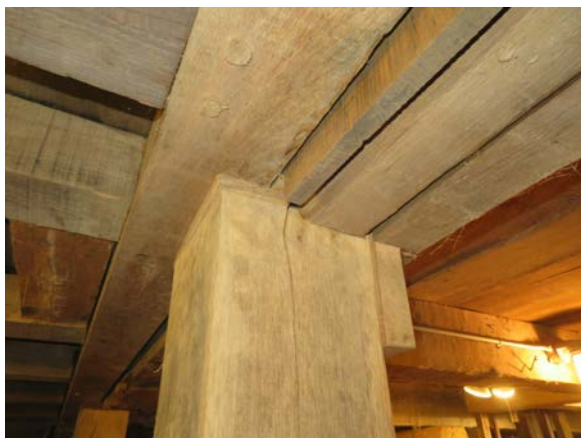
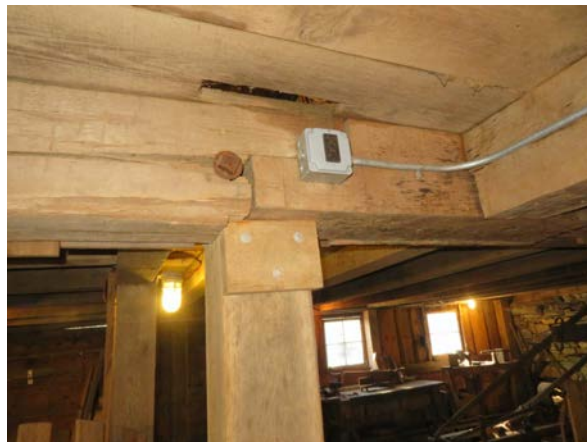
Analysis: The “crack” at the north beam appears to have started as a natural wood check or possibly a shear crack (if the post was not directly below prior to the addition of the lean-to), but was amplified by the drilling of the through-bolt and possibly expansion forces of corrosion of the through-bolt.

Left: from the southwest showing ledge, board siding and original building sill/beam with deep vertical check, as well as ledger on post to support inner edge of beam; Right: from north showing bolted lap splice over post, split, and ledger on post.

Recommendation: Similar to the previous item, we recommend that retrofit designs for both of the noted connections be developed by a preservation structural engineer to ensure that load paths are safely transferred through the joint. Retrofit designs will likely include vertical screws or bolts across the cracks, steel seat angles or hangers, and possibly epoxy injection.

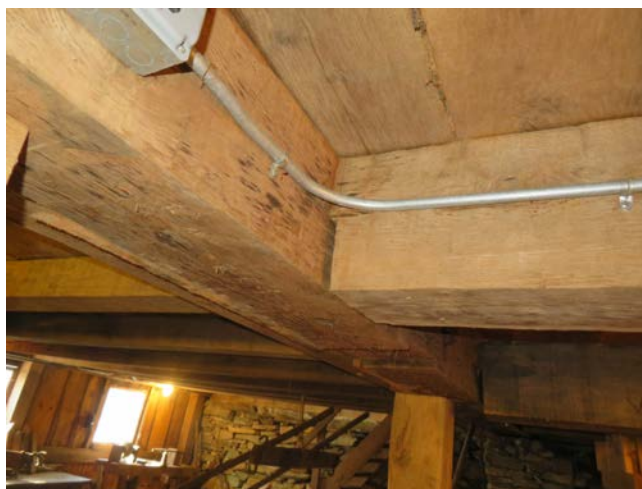
The “crack” at the end of the main building joist is a classic presentation of “shear crack” which occurs due to a shear stress concentration at the mortise joint.

Shear crack in original mill joist framing into the sill / beam (behind the conduit).

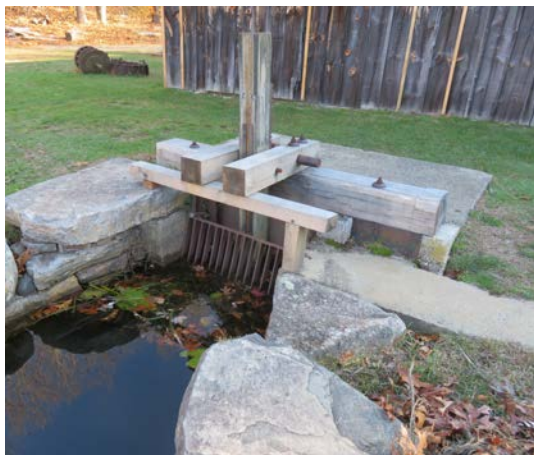
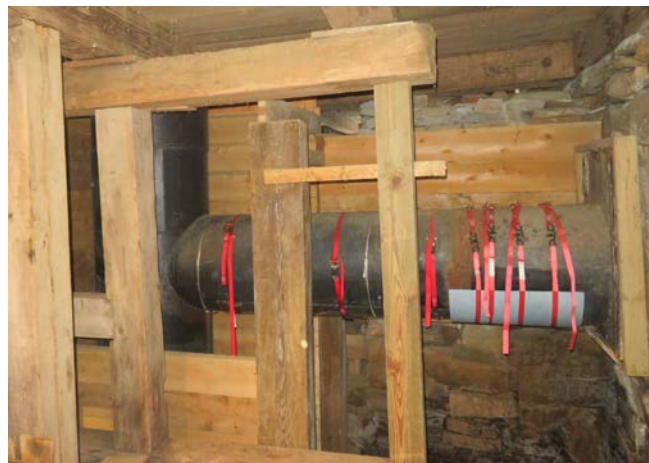
Description: The existing steel penstock and water tank installed circa 1982 connects to a reinforced concrete culvert that travels below grade to the gate at the mill pond. The steel penstock is corroding and has been reinforced with strapping to hold it together. The town would like to replace it, but in a form more historically authentic.

Left: Gate at mill pond; Right: circa 1980s vertical tube and penstock with nylon tension straps reinforcing it.

Recommendation: Per historic examples, the design concept that the group coalesced around is of a rectangular flume (penstock) constructed of 2" or 3" pressure-treated plank with groove edges connected with $\frac{3}{4}$ " or 1" spline slightly oversized and lined with rubber to make it watertight. The planks would be braced by 4x4 (or bigger) frames every few feet with possible mortise and tenon joints. The frames could be wedged against the planks with shingles to pre-tension / pressurize against water pressure. The bottom of the interior of the flume / penstock would epoxy coated to extend its longevity. The downpipe connecting the flume to the turbine would also be square and of similar construction. We have provided a conceptual sketch of a cross-section through the flume of this assembly below. A full design is outside the scope of this project and would require exact head dimensions and detailed measurements of the area. Tom Kelleher suggests that making the supply 50% bigger than gate offers a less rigorous engineering analysis of the final design.

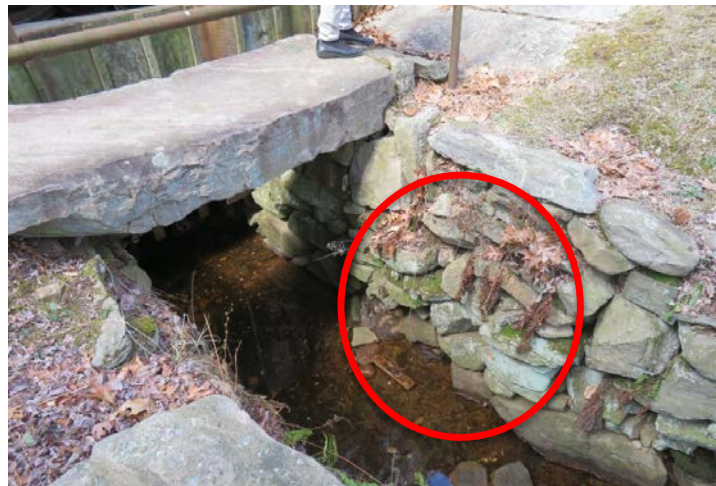
Analysis: The bulge is located at the most downstream end of the water flow and damage described in Item 1 and is likely caused by the same drainage path from the water pressure that builds up behind the wall.

North tailrace wall showing bulge in dry laid masonry

Recommendation: The condition could lead to instability and should be addressed. The most effective solution is to locally rebuild the wall in a plumb condition. This would also allow the opportunity to excavate behind the wall and improve drainage by adding a curtain drain wrapped with filter fabric. Weep holes through the wall could also be added to ensure overflow drainage in case the curtain drain becomes clogged in the future. Installing struts across the tailrace could provide temporary stabilization and/or a lower cost but less effective alternative to rebuilding.

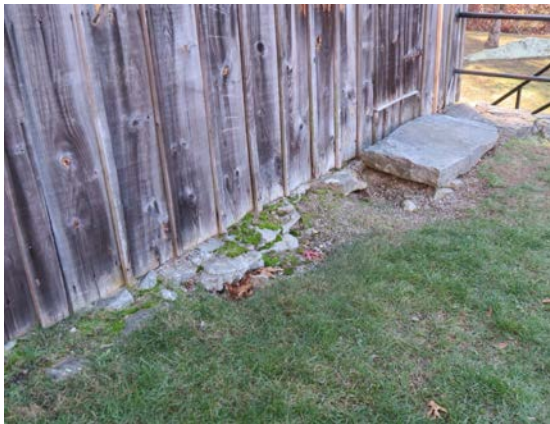
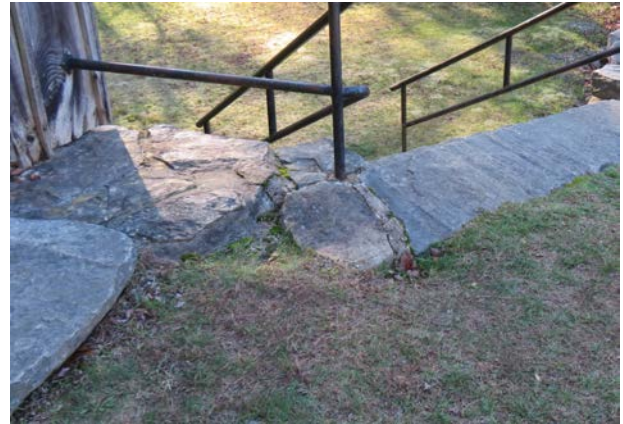
Description: Similar to the east side drainage and erosion issues noted in Items 1 and 9, the west side exhibits similar but milder conditions. Erosion was observed along the foundation wall and above the stair along with displacement of the dry-laid stone retaining wall and stone steps.

Analysis: Unlike the west side, the pitch of the grade on this side of the building is less severe. Floods from the adjacent pond on several occasions in the last decade have been noted when water breached the pond and onto the strip of land between pond and mill building. On these occasions, water flowed into the basement at the southwest corner of the building and caused damage. It is possible that the noted erosion is caused by both land drainage and prior flooding.

Erosion at west side of building, to north and south of door threshold

Recommendation: Excavating below this area to improve drainage by adding a curtain drain wrapped with filter fabric would prevent continued damage due to erosion, particularly if the accessibility / ramp project is undertaken. The drain would need to be routed to drain away from the building, which could prove to be a significant project. Weep holes through the wall could also be added to ensure overflow drainage in case the curtain drain becomes clogged in the future.

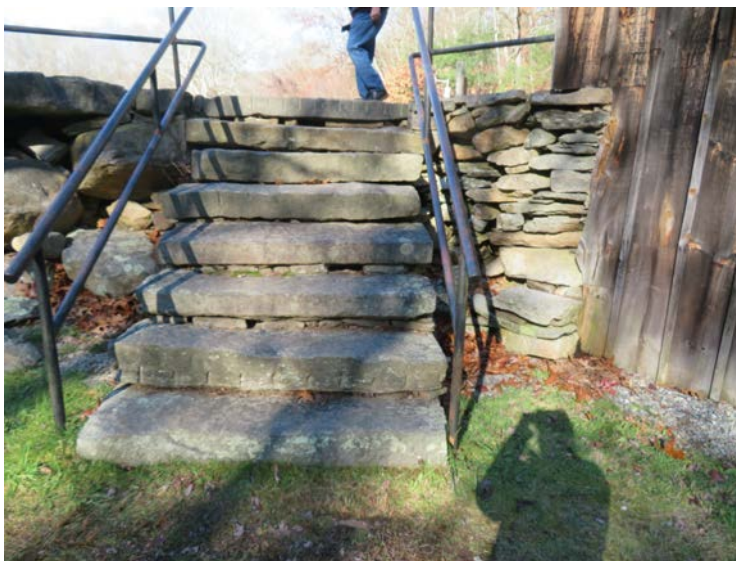
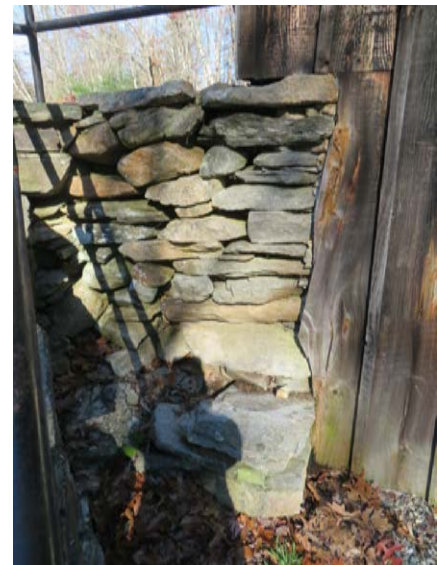
Displacement of steps and dry laid retaining wall at lower level below eroded areas above

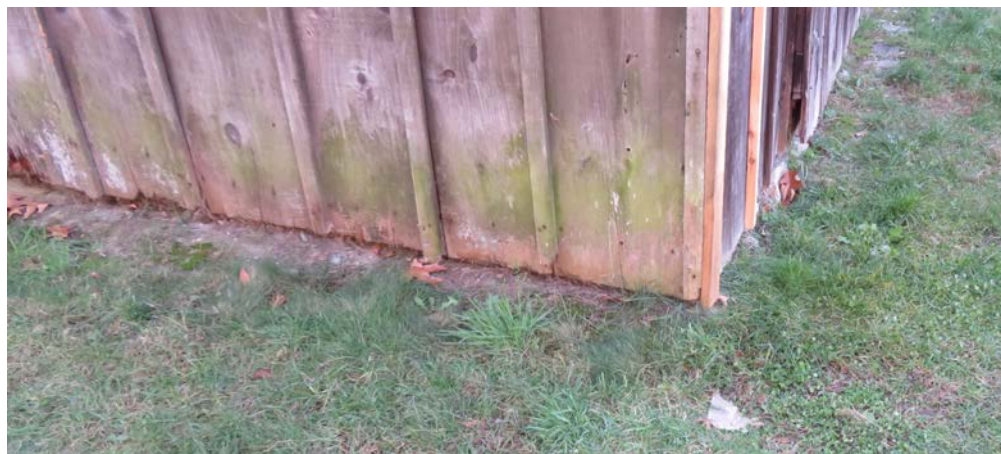
Some battens have been replaced. The base of the boards are warped in areas and exhibit checks or rot in spots. Some cracks/checks are located at areas of nails or where metal tube railings (at the west side south corner) are fastened into the siding. The boards are also generally weathered and discolored.

Biological growth, weathering, deterioration and replacement battens (shown at northwest corner).

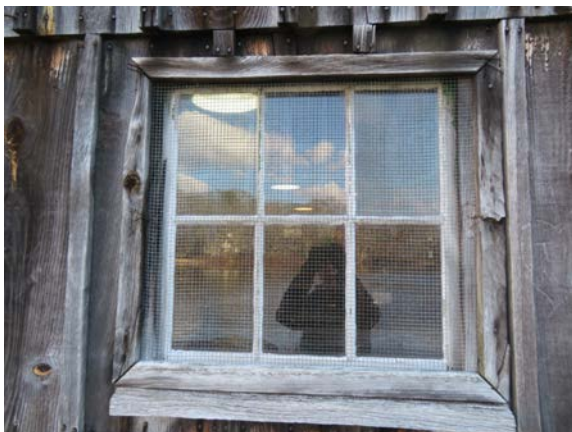
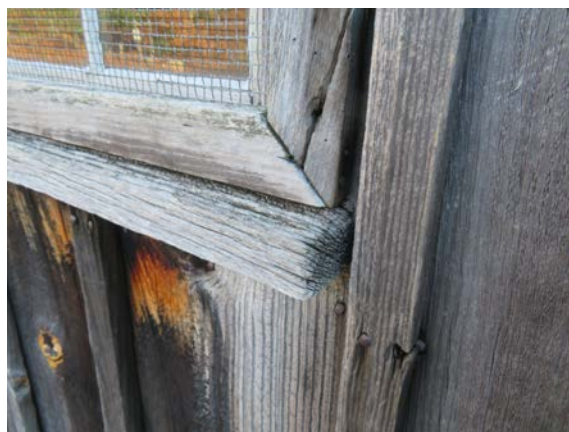
Exterior original mill window with wood mounted screen. Sill is weathered with dry end grain.
