LEDYARD UP-DOWN SAWMILL

HISTORIC PROPERTY STRUCTURAL AND CONDITION ASSESSMENT

Ledyard Up-Down Sawmill
172 Iron Street
Ledyard, Connecticut

March 2, 2023, *Revisions April 14, 2023 (noted in blue text)*

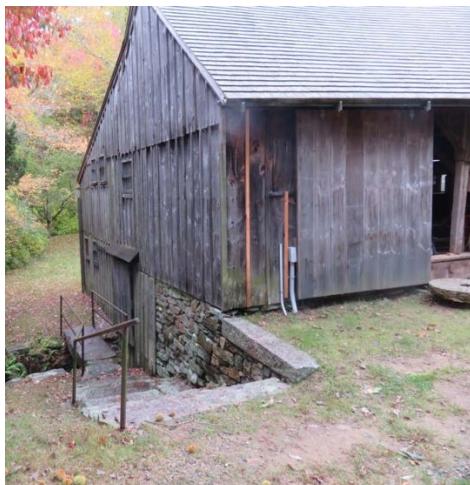
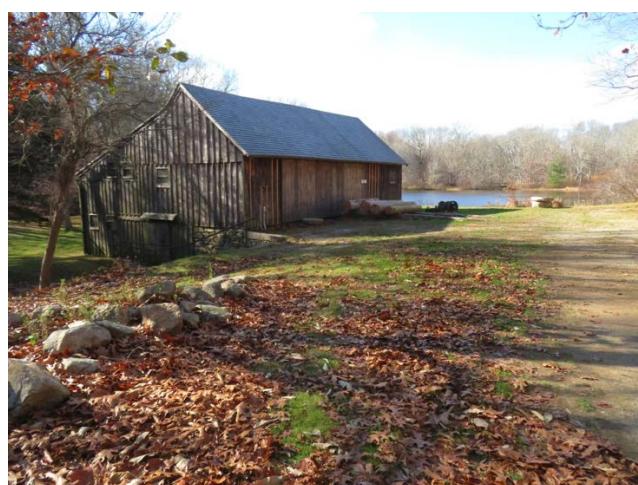
Description: The east exterior stone stairs provide access across the tailrace embankment. A small retaining wall extends north of the east mill wall to support the upper grade for the top 3 steps. Erosion has occurred below the bottom three steps allowing them to rotate out of place. The lowest step has settled into a significant hole. A substantial bulge and dampness are apparent in the masonry foundation wall of the mill at approximately the fourth step from the top. In 2021, the area just to the north of the stairs was regraded to create a small berm near the top of the stair and to direct site drainage to the southeast of the stairs.

Analysis: A geotechnical boring was performed slightly northwest of the area during this project, and the soil material found to have suitable properties for bearing without the propensity for foundation settlement. Long standing issues with site drainage and gutter discharge onto the east exterior stairs are apparent based on information from the town and mill volunteers. The issues noted in the stairs and foundation wall are consistent with erosion that might occur due to washout of soils from water flowing through and below the affected components. The bulge in the foundation wall is likely caused by movement of the individual dry-laid stones in response to pressure from discharging gutter drainage water.

Images from the northeast show the uphill site grading at the stairs and overall.

Recommendation: In addition to managing gutter discharge water (see section below), and maintenance of recent site grading that now directs water to the southeast of the stairs, the authors recommend the resetting of the bottom 3 steps. In addition, some additional probing into the foundation wall is recommended to determine if the full thickness of it has bulged or just the outer stones below the gutter. Local rebuilding of the bulged stone might be considered, the extent to which can be determined by the further probing.

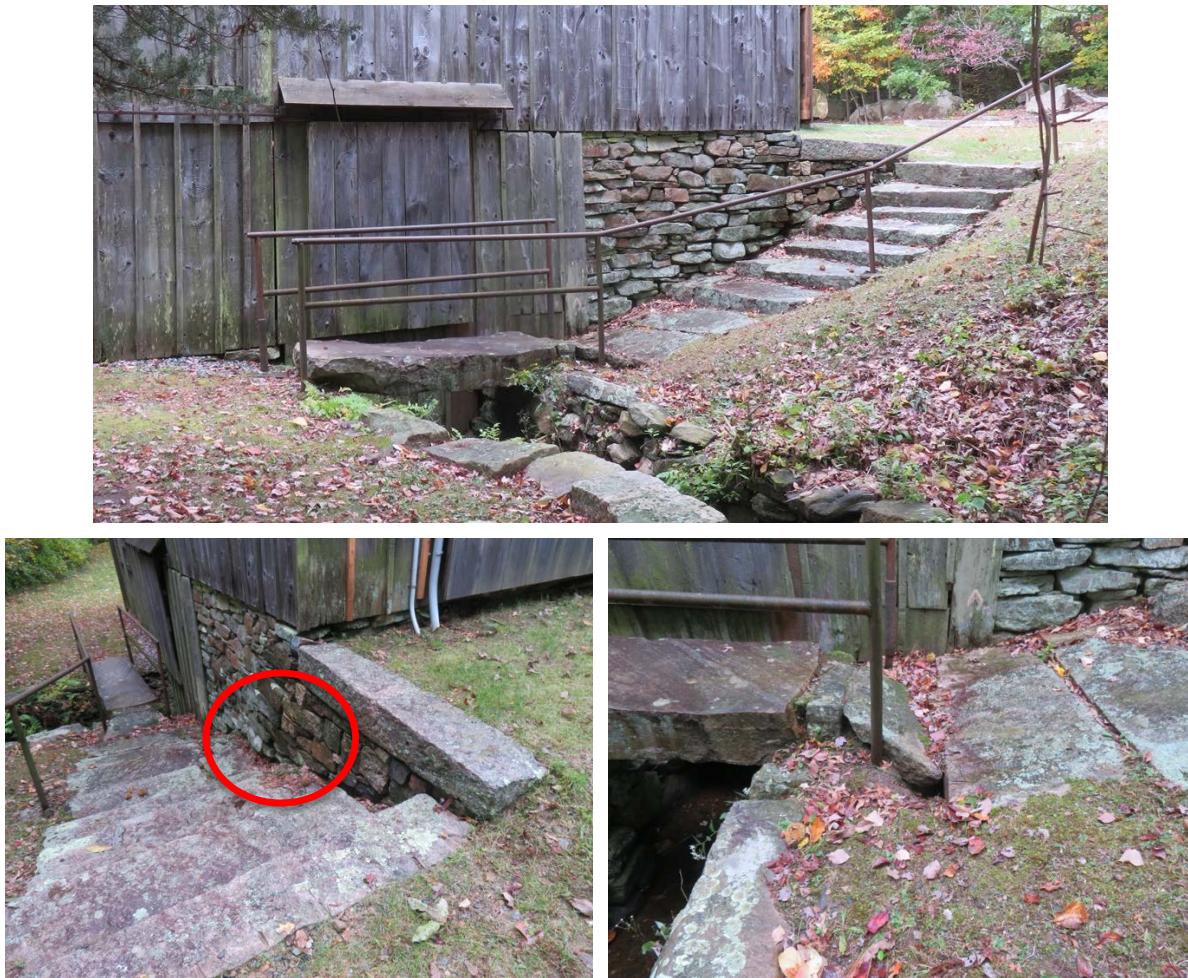
Top: Overall view of damage; Bottom Left: Bulge in foundation wall; Bottom Right: Shifting and movement of bottom 3 steps due to erosion of soil below.

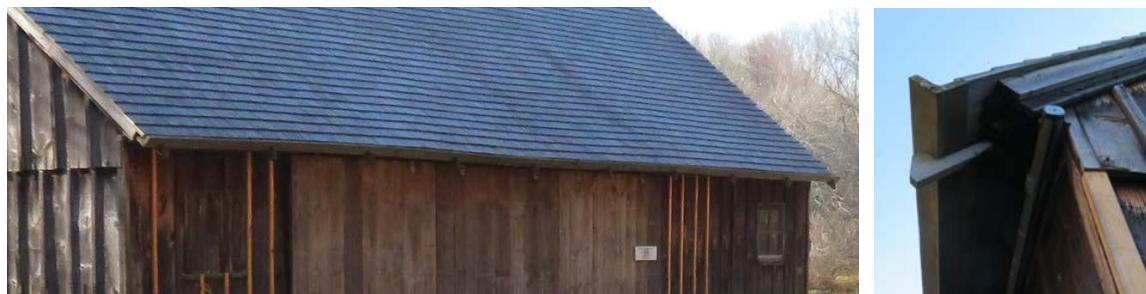
Analysis: The wood V-gutter on the north side appears to be in good condition. Biological growth and general weathering appear on the south box gutter. The gutter pitches east, but dips down perhaps due to a missing bracket about 10' from east end. The gutters do not appear to be lined, which leaves them vulnerable to deterioration and a relatively short life-span. It is not known how the joints in the gutters are treated.

North gutter overall and profile of V-shape and bracket.

Recommendation: At the north gutter, the authors recommend adding a leader and below-grade drainage to the east end to manage flow of water away from the building on that side. A similar approach or at least a splash block should be considered on the west side. The south gutter is due for replacement relatively soon (within 5 years). In the meantime, the dip should be investigated and gutter re-supported as needed. A V-gutter shape should be considered when replacement occurs, along with linings and/or joint treatment. The leader should be tested to confirm that it is working.

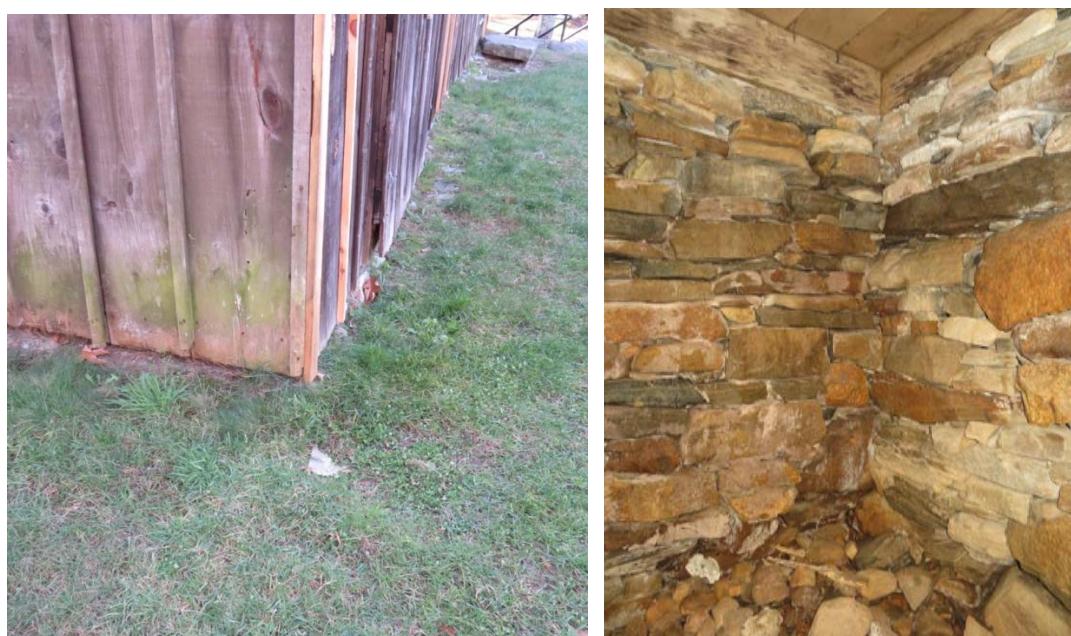
North gutter, west end; Left: grade where gutter is discharging; Right: inside face of foundation wall at northwest corner showing dampness and fungal growth on sill above.

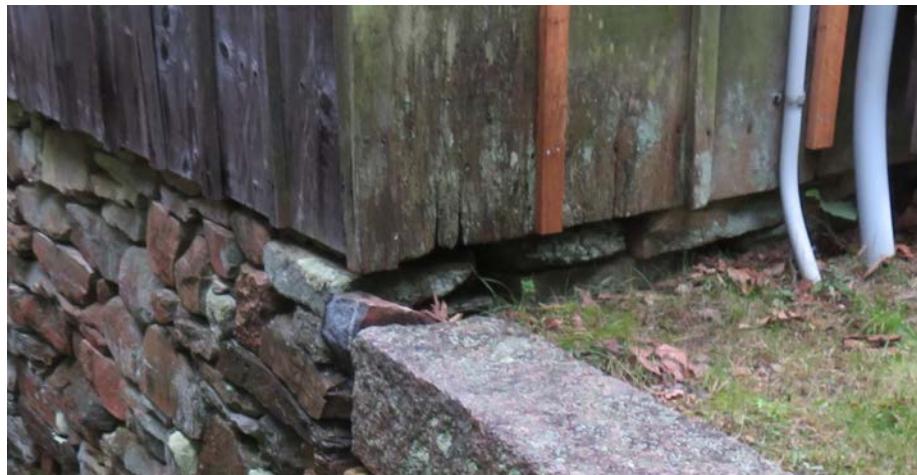
North gutter, east end, showing deteriorated board siding and erosion in masonry.

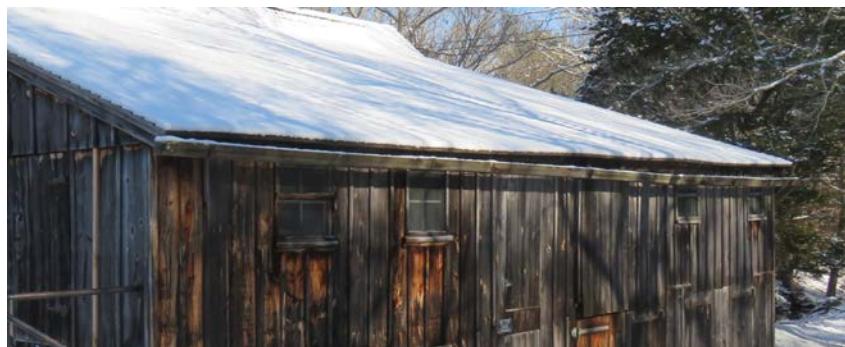
South gutter showing dip (likely missing bracket) toward east end.

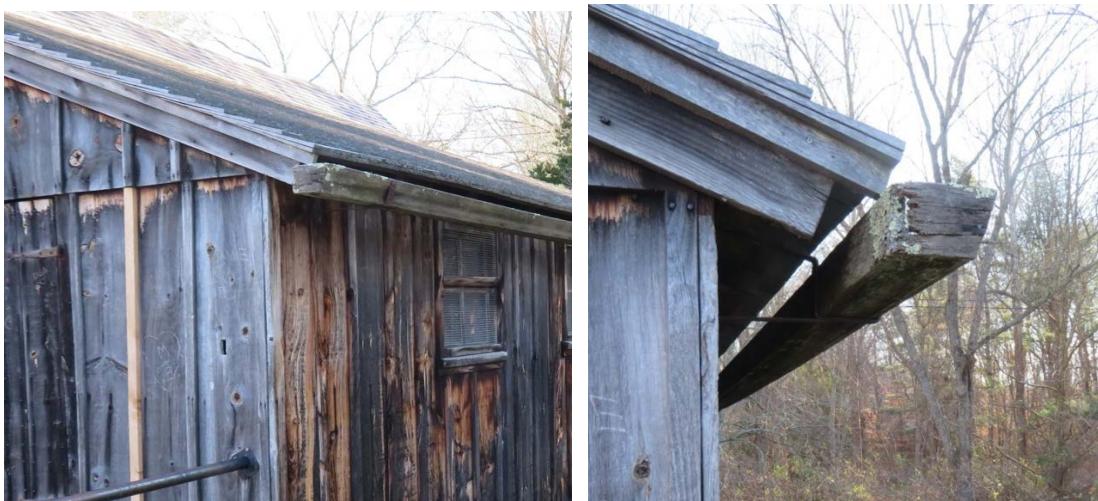
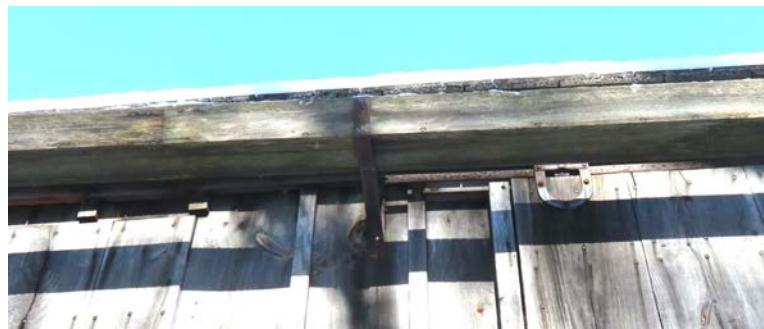
South gutter showing box gutter shape, weathering, biological growth and brackets.

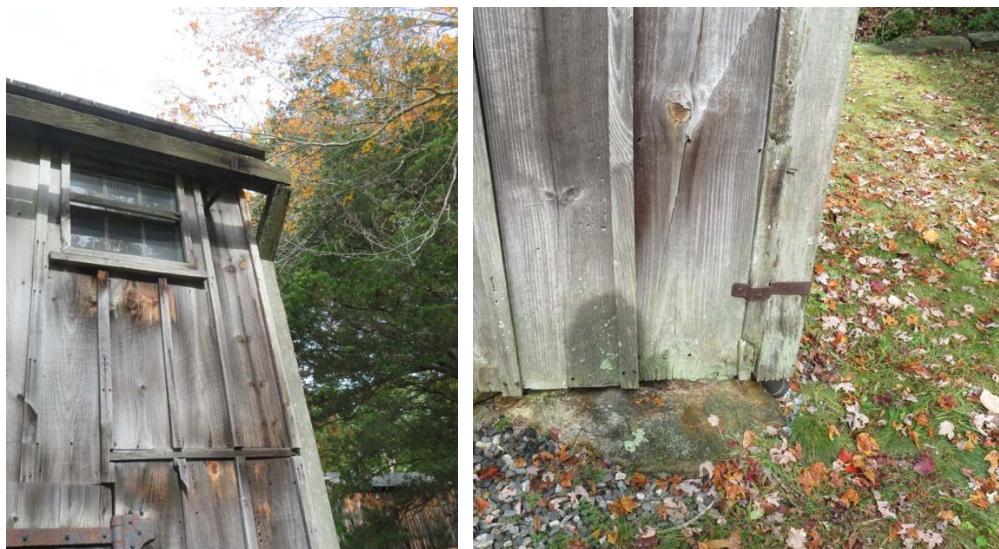
South gutter, east end, showing wood box trim around metal leader transitioning to sub-surface drainage.

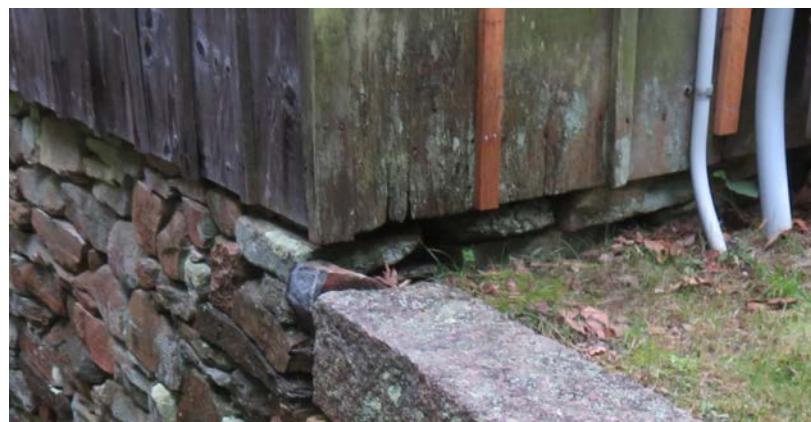
Analysis: Movement in the foundation wall from the water issue noted in Item 1 is likely the main cause of the floor settlement; however, the irregular geometry of the stone walls made it difficult to directly correlate the two. It is also likely that the causes of the deflection are multifactorial and cumulative based on a number of issues observed including a shear crack at the east end of the northern-most beam. Based on the gutter discharge in the area and biological growth and deterioration of the siding, sill deterioration may also be a likely contributor, although not yet extensive. Some of the deflection may have also been caused by former beams and sills, which have now been replaced, but may not have been installed in flush / level condition. The deteriorated post base could also be contributing.

Exterior of northeast corner showing siding deterioration.

Recommendation: Once funds are raised to address the northeast corner, the authors recommend a holistic look at both further investigation and treatment, which might include local wall rebuilding, local sill replacement, post base repairs (dutchman) and beam hangers.

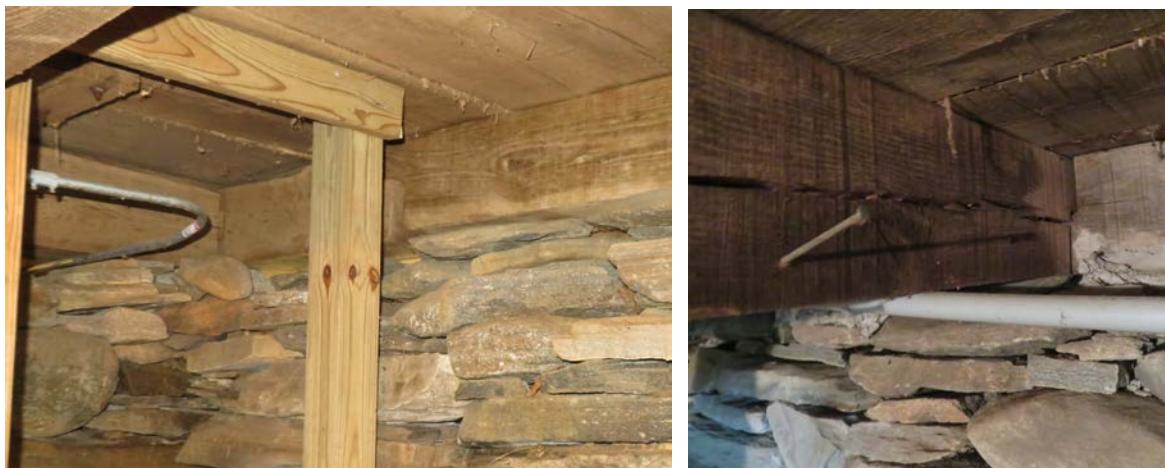
Left: Northeast corner from basement showing sill corner tenon (possibly bent); Right: East end of north beam show shear crack parallel with tenon (stress concentration).

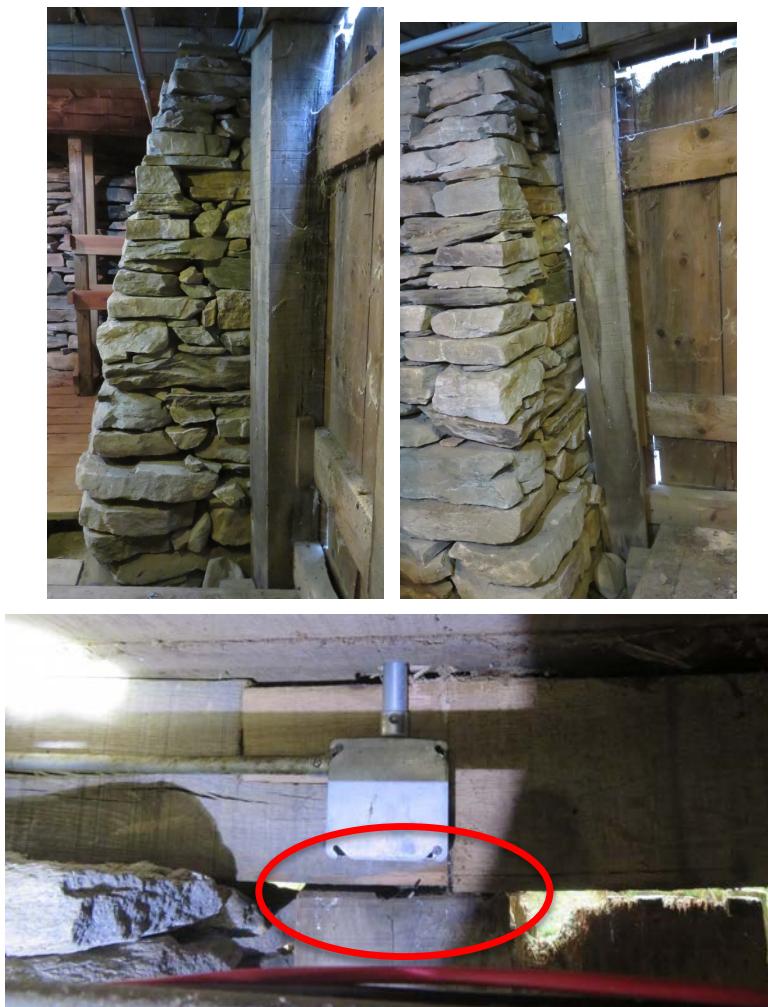
Top: East wall post from south and west respectively; Bottom: gap between top of post and beam/sill.

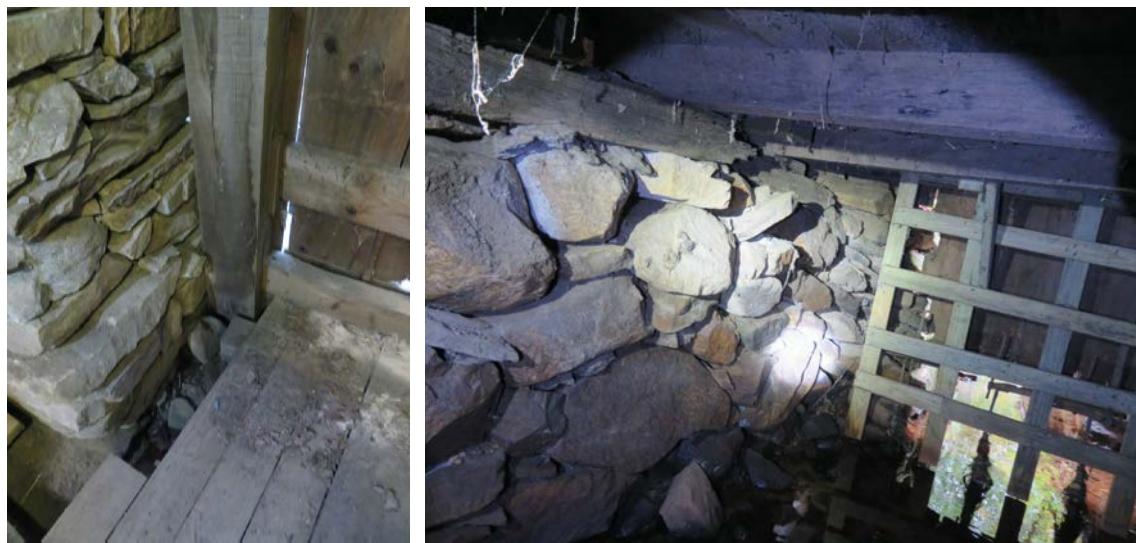
Left: Bottom of east wall post just above decking over raceway, post base is concealed below decking; Right: Deterioration of east end of decking sill over north wall of raceway looking east to gate to tail race, the post base is not apparent in this image but deterioration of deck sill is suggestive.

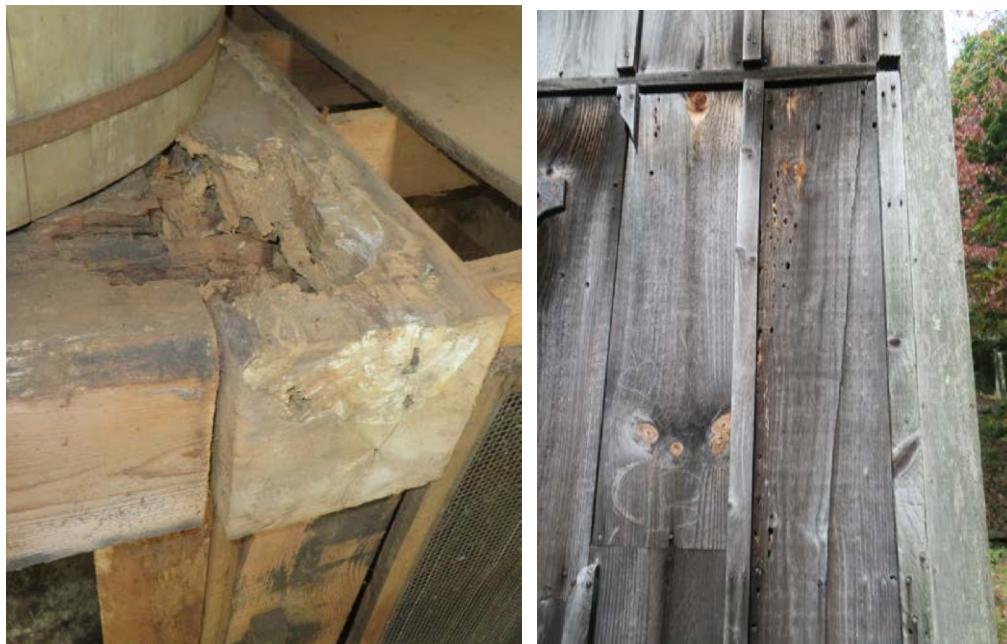
Analysis: On the exterior, the only visible sign of sill deterioration is at the central part of the south elevation (lean-to portion) below the double doors. As viewed from the basement, where visible, sills do not show any obvious deterioration; however, black staining is apparent on the surfaces in northwest and southeast corners suggesting that damp conditions due to proximity to grade and/or gutter discharge is allowing for fungal growth on wood. Sills were installed on a solid bed of mortar which may prevent bottom of sills from drying encouraging deterioration. The lower level framing on the south side is also in close proximity to grade leaving it vulnerable to deterioration. A former termite infestation occurred in the grist mill area but was caught and treated. Evidence of termite borings in the boards in the southeast corner suggest that the corner post may have been attacked.

Left: Termite damage at the grist mill frame; Right: tell-tale termite trails / holes at siding at the east end of the south elevation.

Recommendation: A deeper investigation is recommended to determine sill damage at areas of known exposure to water, primarily at the corners. If siding work is planned in the next 5 years, sill investigation and repairs / replacements could be performed as part of that work.

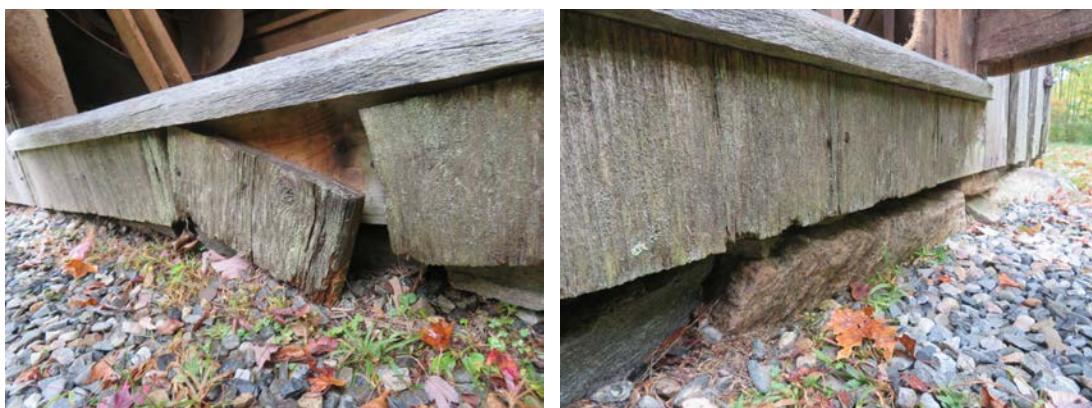
Siding and foundation below grist mill exterior doors. Siding nails have failed, but sill behind appears to be in good condition.

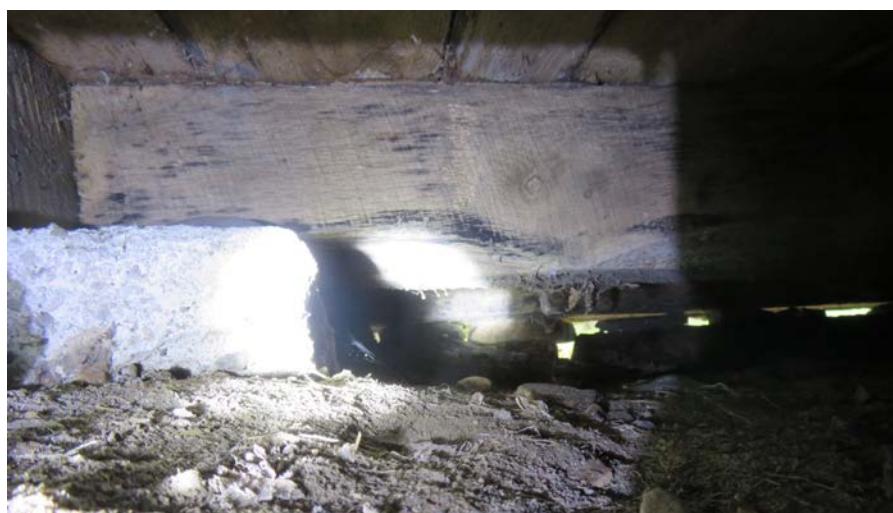
East end of joist in grist mill floor (crawlspace) showing black staining and close proximity to grade, but not visible deterioration.

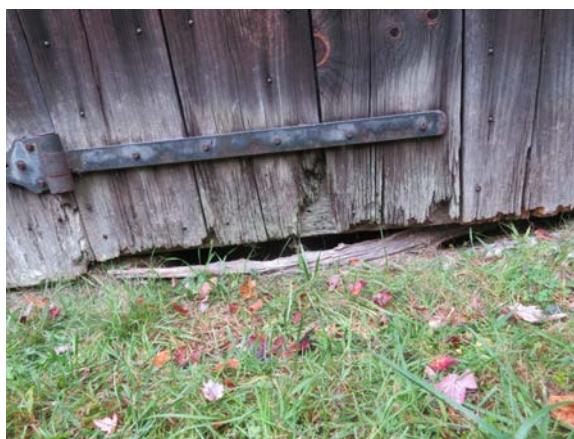
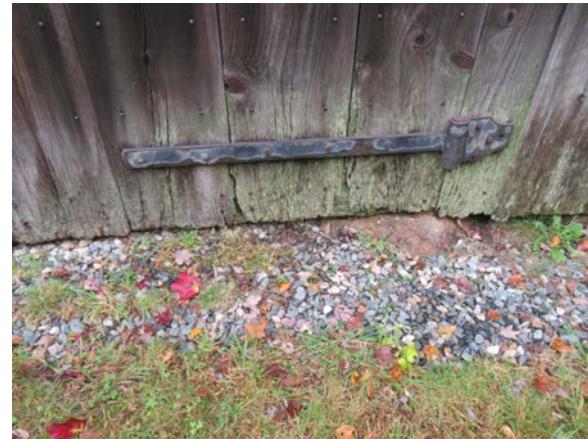
Central double doors at south elevation (lean-to) showing siding deterioration and sill / threshold deterioration behind.

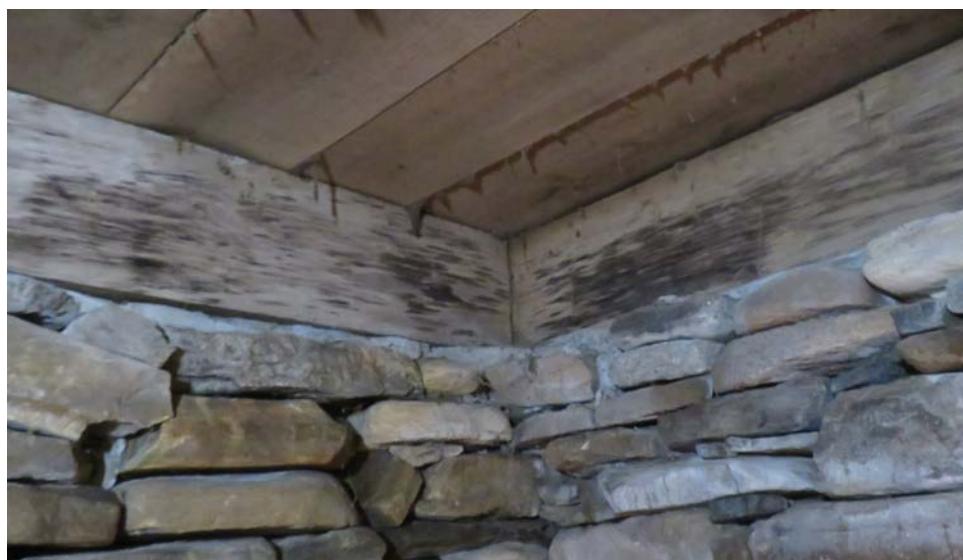
Northwest corner of sills from the basement showing black staining presumed to be fungal growth.

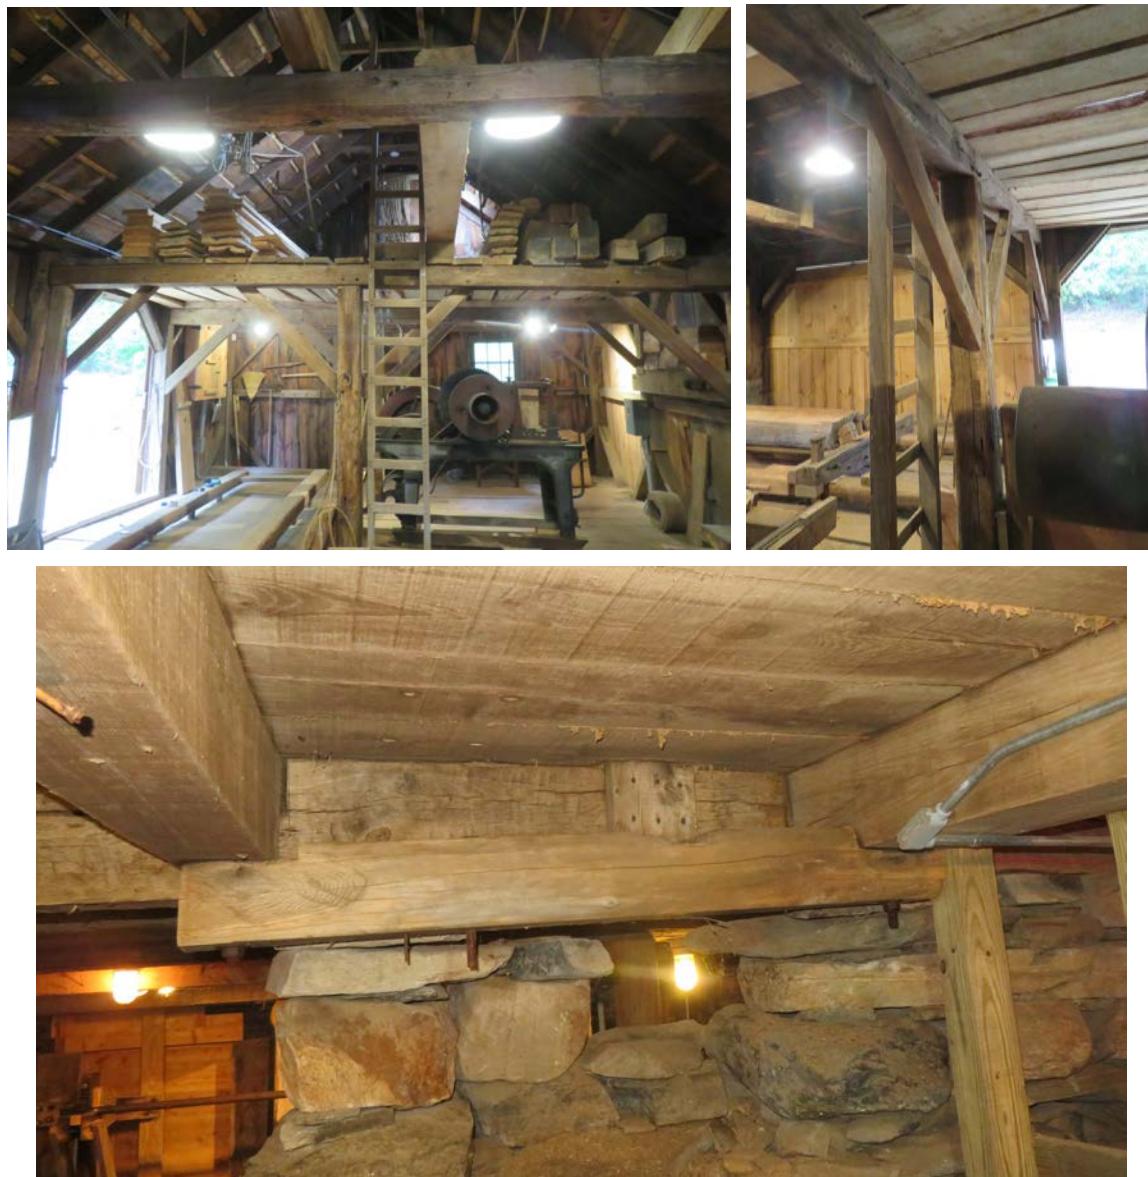
At loft-west, middle post, the north-south beam to support the post was hung from the adjacent east-west beams. While unconventional, the authors did not observe any obvious signs of distress at the beam or its connections.

Overall Loft and Loft-West support line. Left: Loft-West north bay showing replacement post; Right: Loft-West middle post with hung beam support below.

Recommendation: See Section E below for discussion of loft capacity. In addition, the authors recommend improving the connections noted above to meet industry standards in terms of strength and durability. To do this, we recommend that retrofit designs for each of the noted connections be developed by a preservation structural engineer (we'd be happy to provide this service) to ensure that load paths are safely transferred through the joint. Retrofits will likely include structural screws or bolts, galvanized or stainless steel hardware

(concealed to the extent possible) and wood blocking or bracing. The designs will be shown on sketches with material specifications that can be bid out for the work or completed by town personnel or volunteers.

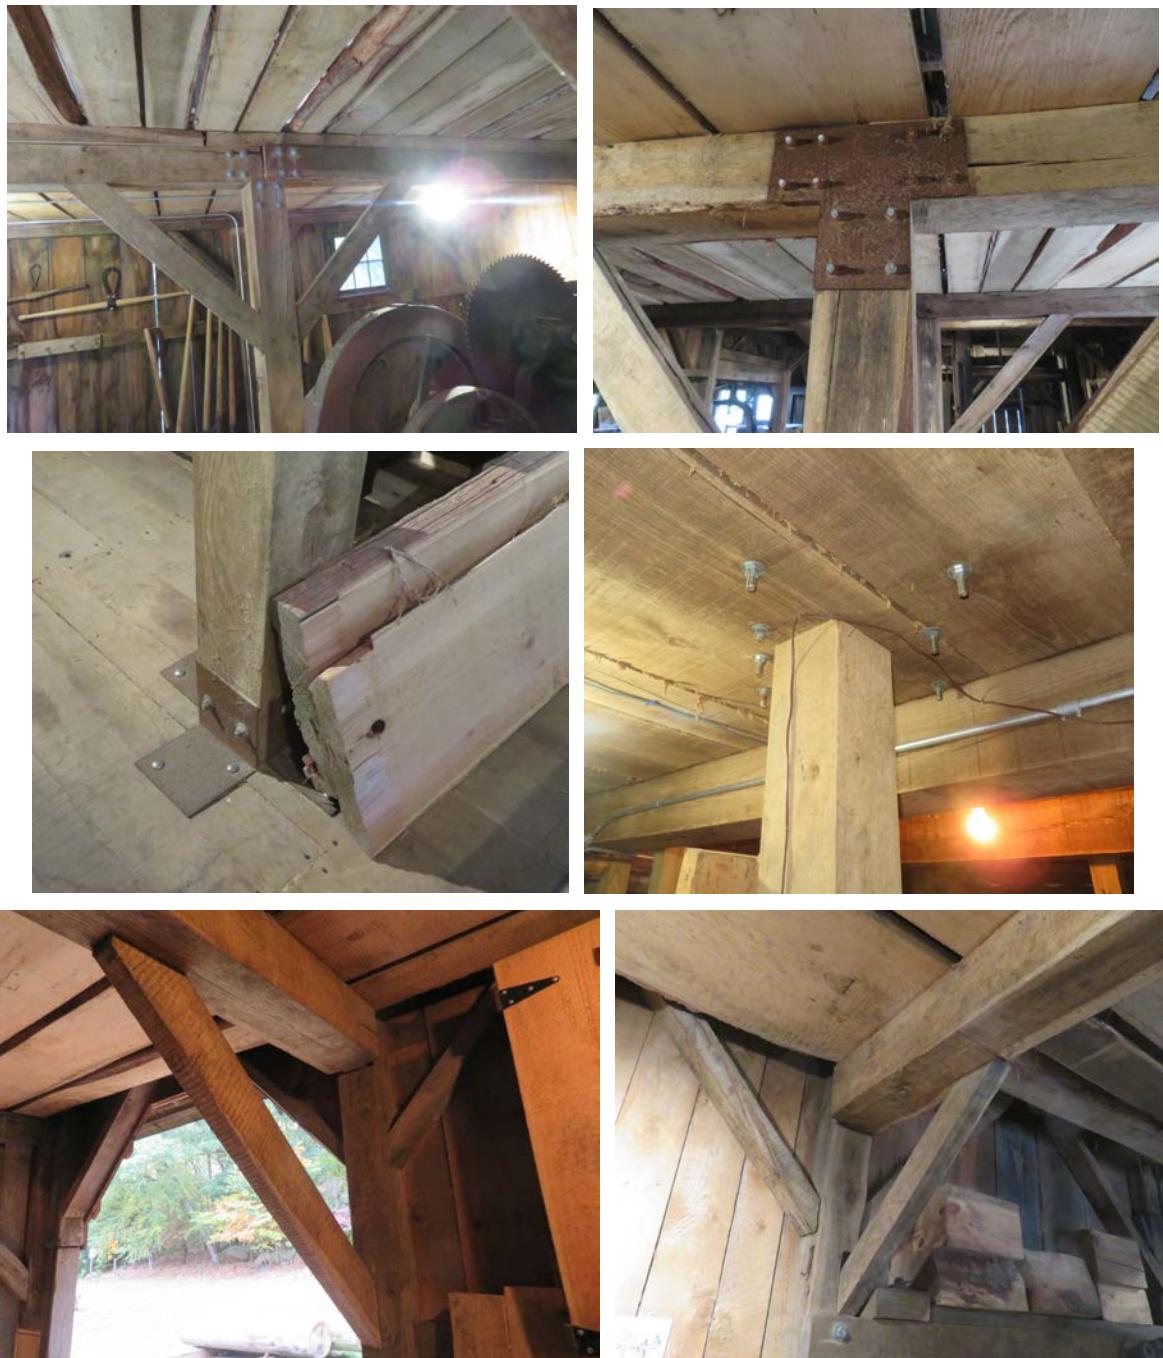
Analysis: The “new” loft-central tie-beam was installed in two pieces, with a new post supporting the middle at the joint between the pieces. Steel plates and bolts were used to make connections at the top and bottom of the post in lieu of traditional joinery causing it to stand out as visually new. The plates in both locations are plain steel and not protected from corrosion, thus showing signs of surface rust. A lower level post was also added at the

Loft-Central support line. Top: Middle post and beam connections at top; Middle: Middle post connection at bottom; Bottom: Beam connections into end post using historic joinery.

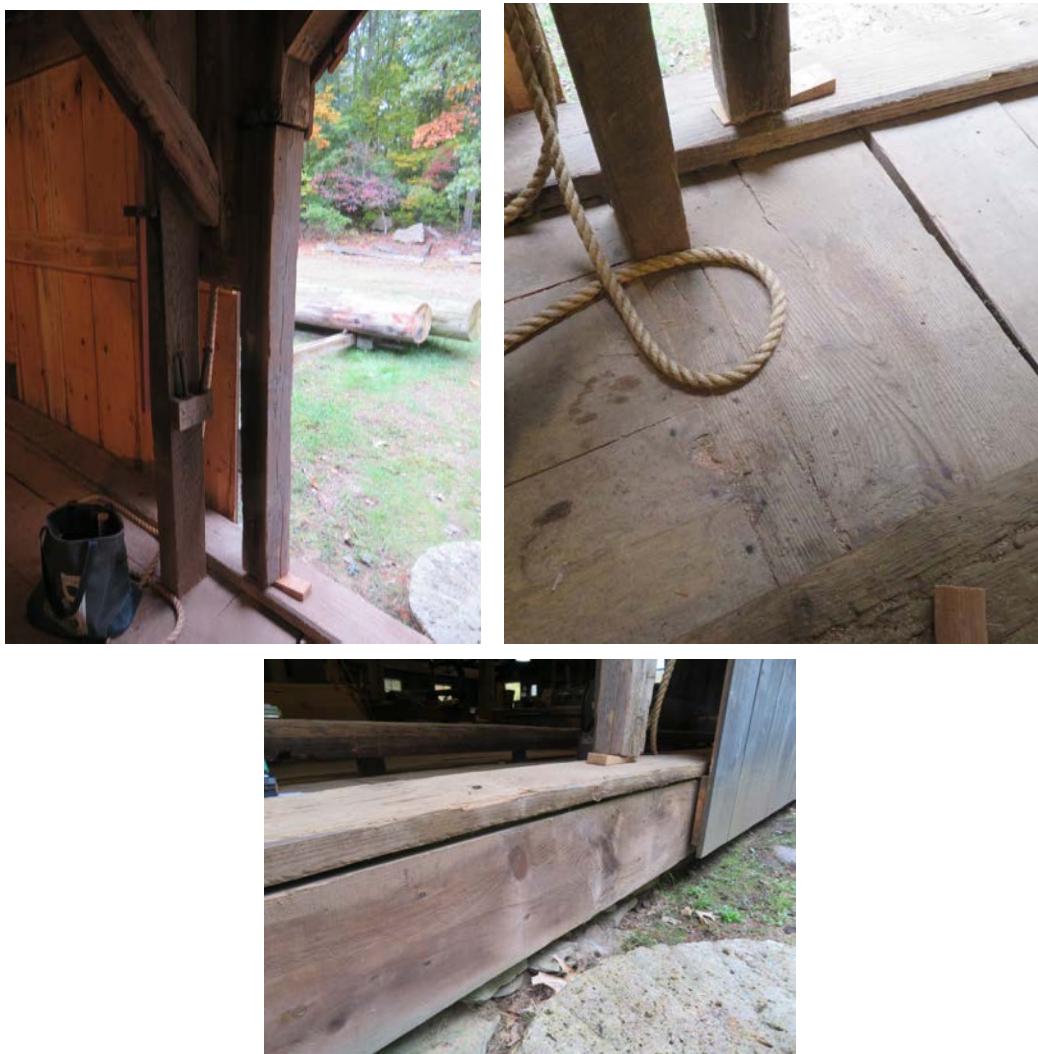
Loft-west, north post. Top: “new” offset post overall and zoomed in view at base supported by decking as well as deflection of deck board relative to adjacent one; Bottom: exterior view showing gap between door sill and skirt board suggesting lifting of door sill by decking.

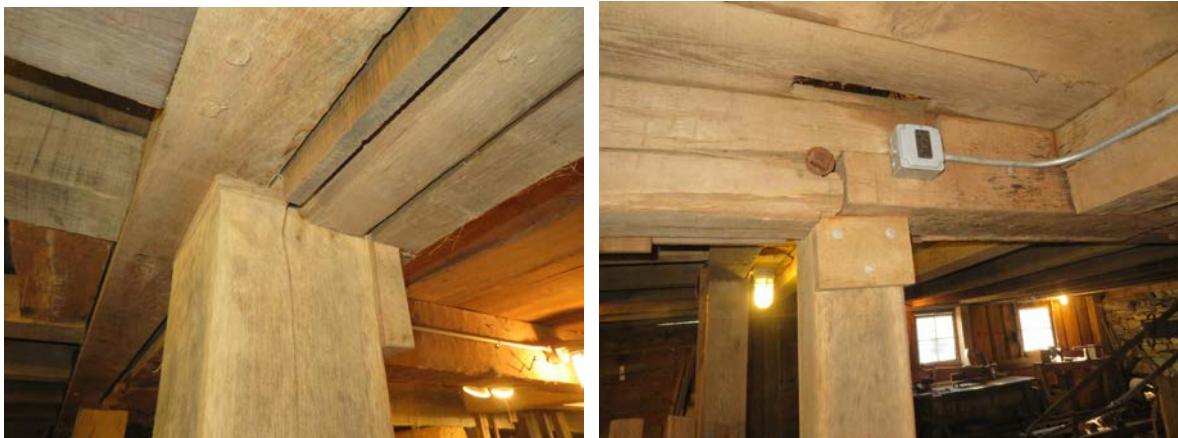
Analysis: The “crack” at the north beam appears to have started as a natural wood check or possibly a shear crack (if the post was not directly below prior to the addition of the lean-to), but was amplified by the drilling of the through-bolt and possibly expansion forces of corrosion of the through-bolt.

Left: from the southwest showing ledge, board siding and original building sill/beam with deep vertical check, as well as ledger on post to support inner edge of beam; Right: from north showing bolted lap splice over post, split, and ledger on post.

Recommendation: Similar to the previous item, we recommend that retrofit designs for both of the noted connections be developed by a preservation structural engineer to ensure that load paths are safely transferred through the joint. Retrofit designs will likely include vertical screws or bolts across the cracks, steel seat angles or hangers, and possibly epoxy injection.

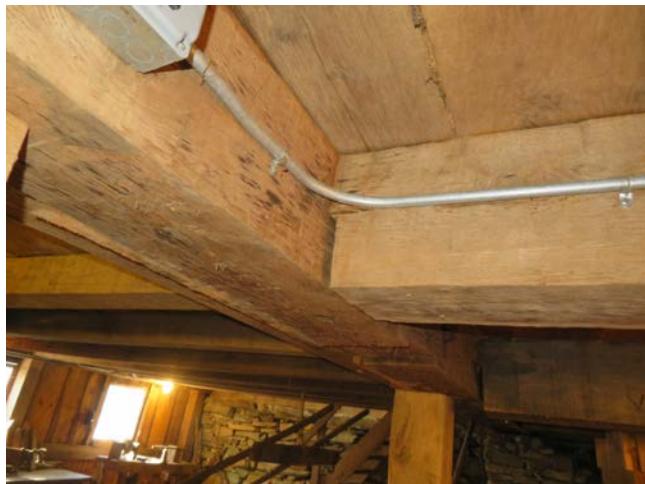
The “crack” at the end of the main building joist is a classic presentation of “shear crack” which occurs due to a shear stress concentration at the mortise joint.

Shear crack in original mill joist framing into the sill / beam (behind the conduit).

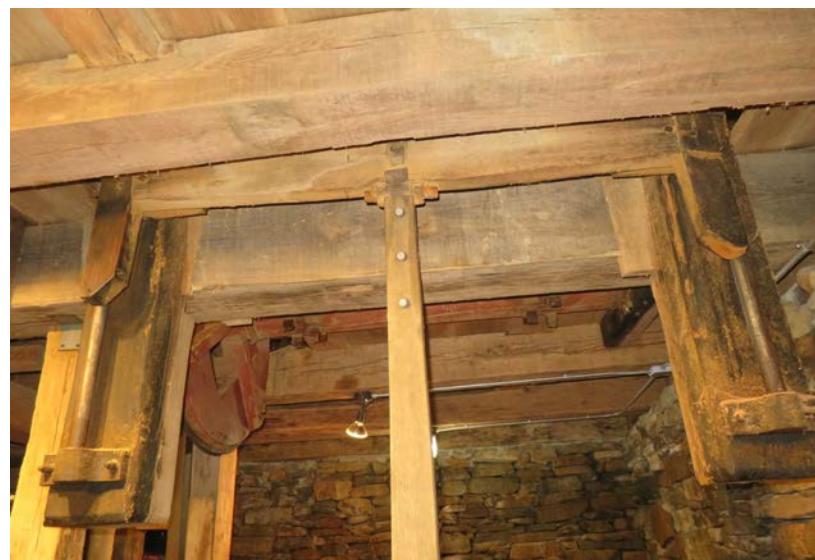
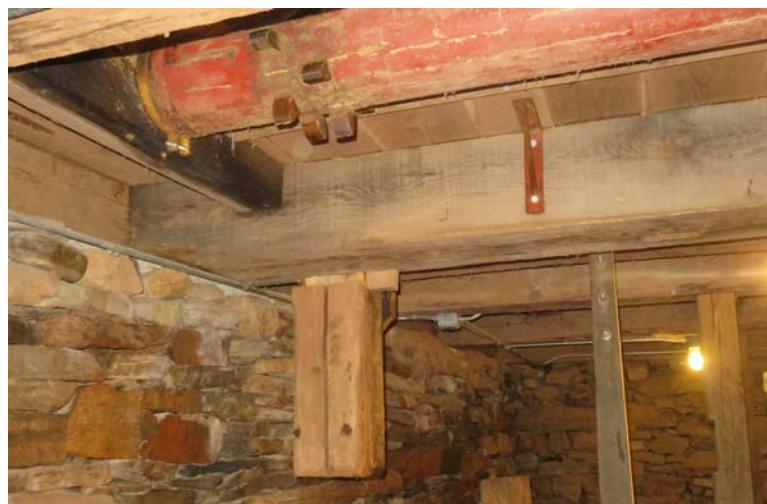
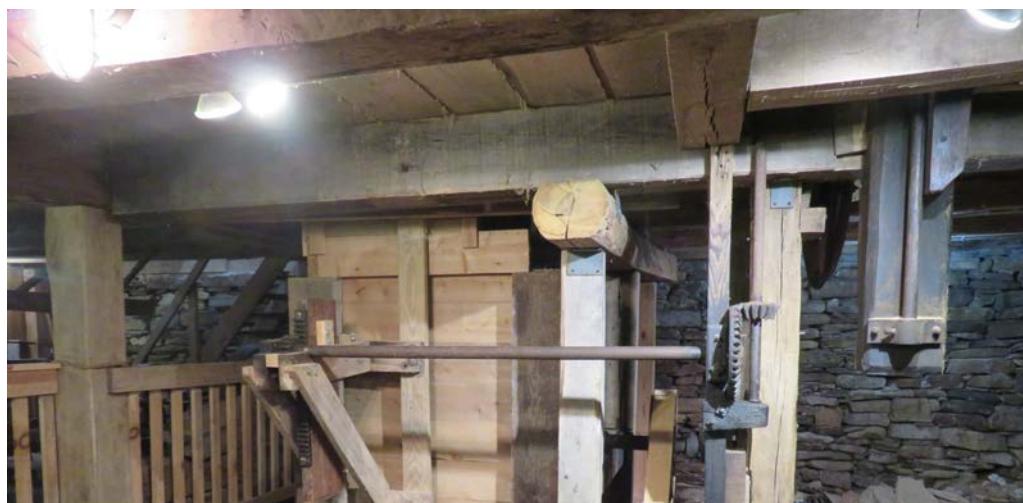
*Top: overall view of fender beam from the east showing two saw guides extending below;
Middle: north end of fender beam; Bottom: south end of fender beam including newer
intermediate post supported on north raceway wall below.*

Recommendation: The authors would be happy to undertake a more rigorous analysis should it be desired.

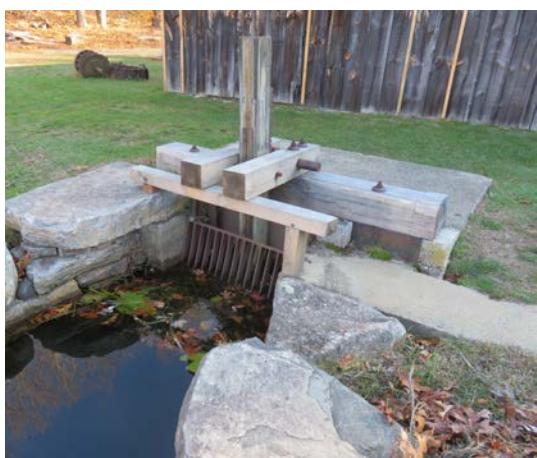
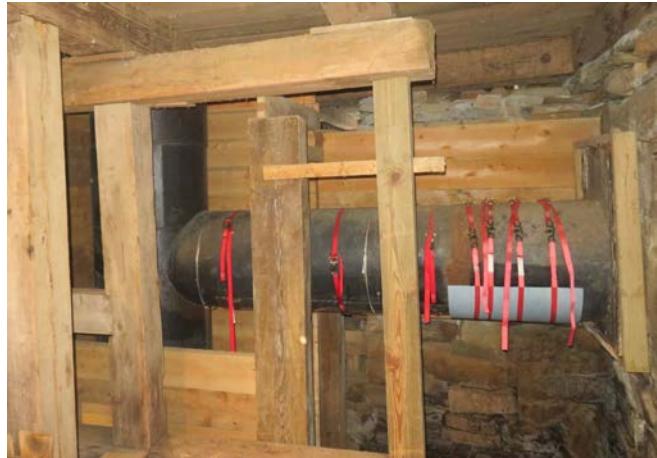
Description: The existing steel penstock and water tank installed circa 1982 connects to a reinforced concrete culvert that travels below grade to the gate at the mill pond. The steel penstock is corroding and has been reinforced with strapping to hold it together. The town would like to replace it, but in a form more historically authentic.

Left: Gate at mill pond; Right: circa 1980s vertical tube and penstock with nylon tension straps reinforcing it.

Recommendation: Per historic examples, the design concept that the group coalesced around is of a rectangular flume (penstock) constructed of 2" or 3" pressure-treated plank with groove edges connected with 3/4" or 1" spline slightly oversized and lined with rubber to make it watertight. The planks would be braced by 4x4 (or bigger) frames every few feet with possible mortise and tenon joints. The frames could be wedged against the planks with shingles to pre-tension / pressurize against water pressure. The bottom of the interior of the flume / penstock would epoxy coated to extend its longevity. The downpipe connecting the flume to the turbine would also be square and of similar construction. We have provided a conceptual sketch of a cross-section through the flume of this assembly below. A full design is outside the scope of this project and would require exact head dimensions and detailed measurements of the area. Tom Kelleher suggests that making the supply 50% bigger than gate offers a less rigorous engineering analysis of the final design.

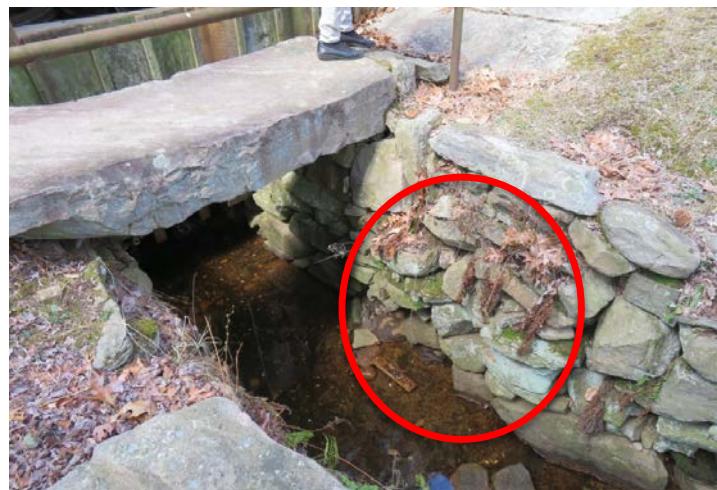
Analysis: The bulge is located at the most downstream end of the water flow and damage described in Item 1 and is likely caused by the same drainage path from the water pressure that builds up behind the wall.

North tailrace wall showing bulge in dry laid masonry

Recommendation: The condition could lead to instability and should be addressed. The most effective solution is to locally rebuild the wall in a plumb condition. This would also allow the opportunity to excavate behind the wall and improve drainage by adding a curtain drain wrapped with filter fabric. Weep holes through the wall could also be added to ensure overflow drainage in case the curtain drain becomes clogged in the future. Installing struts across the tailrace could provide temporary stabilization and/or a lower cost but less effective alternative to rebuilding.

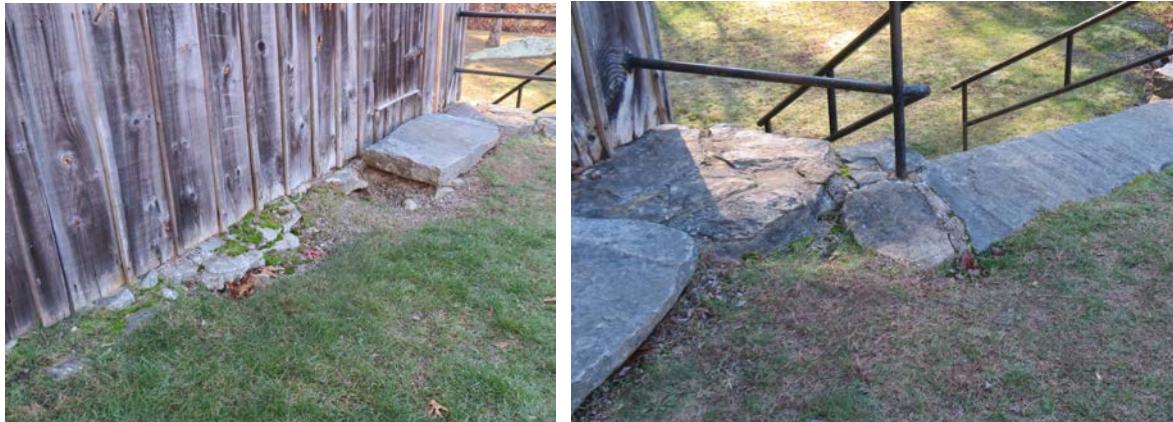
Description: Similar to the east side drainage and erosion issues noted in Items 1 and 9, the west side exhibits similar but milder conditions. Erosion was observed along the foundation wall and above the stair along with displacement of the dry-laid stone retaining wall and stone steps.

Analysis: Unlike the west side, the pitch of the grade on this side of the building is less severe. Floods from the adjacent pond on several occasions in the last decade have been noted when water breached the pond and onto the strip of land between pond and mill building. On these occasions, water flowed into the basement at the southwest corner of the building and caused damage. It is possible that the noted erosion is caused by both land drainage and prior flooding.

Erosion at west side of building, to north and south of door threshold

Recommendation: Excavating below this area to improve drainage by adding a curtain drain wrapped with filter fabric would prevent continued damage due to erosion, particularly if the accessibility / ramp project is undertaken. The drain would need to be routed to drain away from the building, which could prove to be a significant project. Weep holes through the wall could also be added to ensure overflow drainage in case the curtain drain becomes clogged in the future.

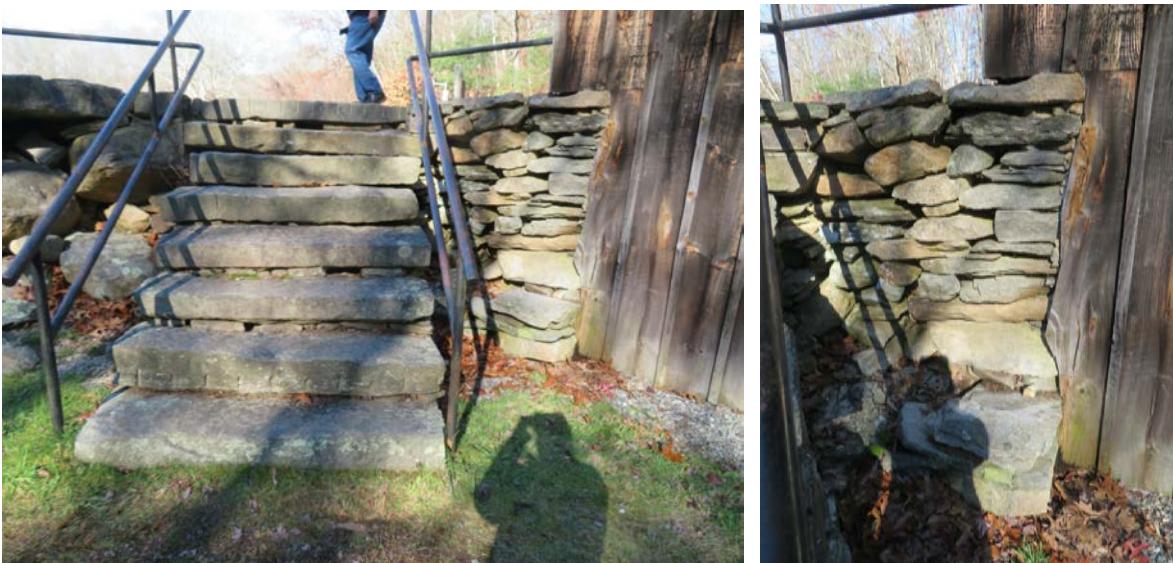
Displacement of steps and dry laid retaining wall at lower level below eroded areas above
