LEDYARD UP-DOWN SAWMILL

HISTORIC PROPERTY STRUCTURAL AND CONDITION ASSESSMENT

Ledyard Up-Down Sawmill
172 Iron Street
Ledyard, Connecticut

March 2, 2023, *Revisions April 14, 2023 (noted in blue text)*

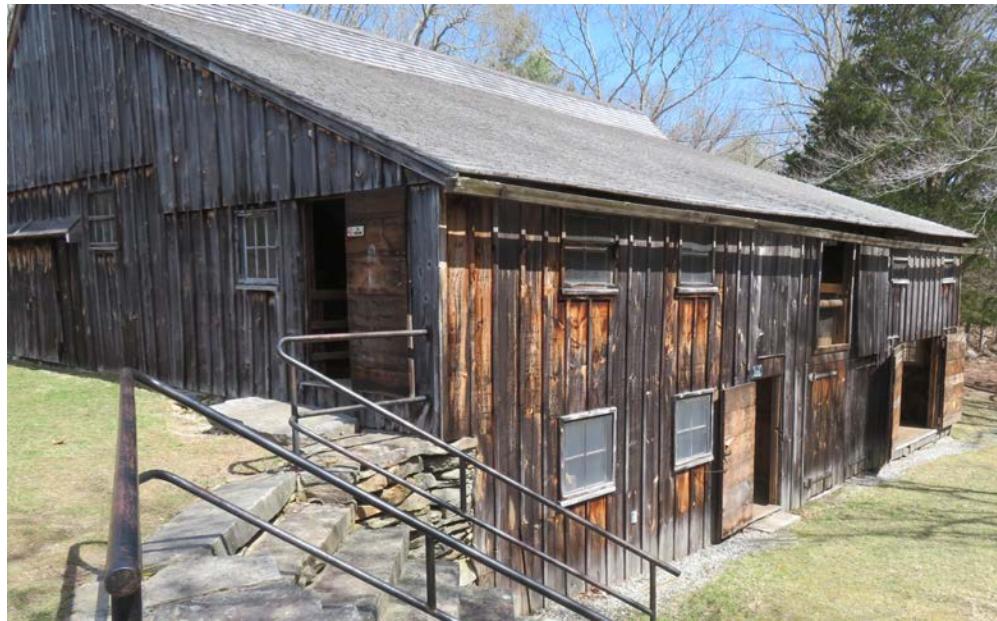
Some battens have been replaced. The base of the boards are warped in areas and exhibit checks or rot in spots. Some cracks/checks are located at areas of nails or where metal tube railings (at the west side south corner) are fastened into the siding. The boards are also generally weathered and discolored.

West and south elevations.

Recommendation: Short term treatment would involve the removal and replacement of any deteriorated sections of siding, and treatment of end grains via sanding and application of preservative treatment. It would also include removal and replacement of the horizontal batten, and if possible the addition of a Z-flashing along the upper surface of the horizontal batten to allow for any moisture that gets behind the siding above to drain out.

For a long term repair, it is recommended that the existing siding be removed and replaced with new wood batten siding, using at least either a pressure treated pine or cedar, and following industry recommended batten siding installation practices. This includes components such as the addition of a water table at the base and Z-flashing along the top. If stacking wood batten siding vertically, it is recommended that a Z-flashing be installed at the upper termination and a space of $\frac{1}{4}$ " left before another piece of siding installed above.

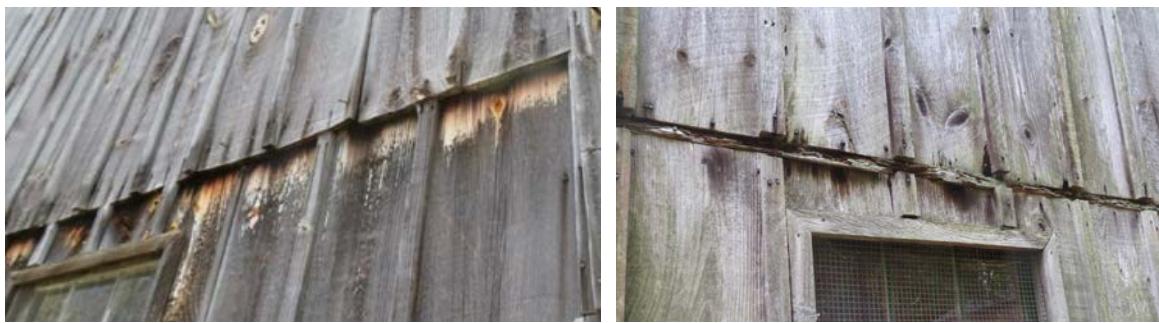
There are several construction details that may have led to premature deterioration of the siding. One of the most significant is the extension of the siding all the way to the ground, resulting in the exposure end grains of the wood making it susceptible to moisture absorption, warping and deterioration. Other details such as the vertical stacking of the boards without intermediary flashing and space for movement is similarly resulting in absorption of moisture via the end grains and deterioration at these locations. The horizontal "batten" at the butt joint details is essentially acting as a shelf for rain water, which is then absorbed by the siding above and below.

Left: Overlapped detail at board joints on west elevation; Right: Butt joint detail at board joints on grist mill portion of east elevation.

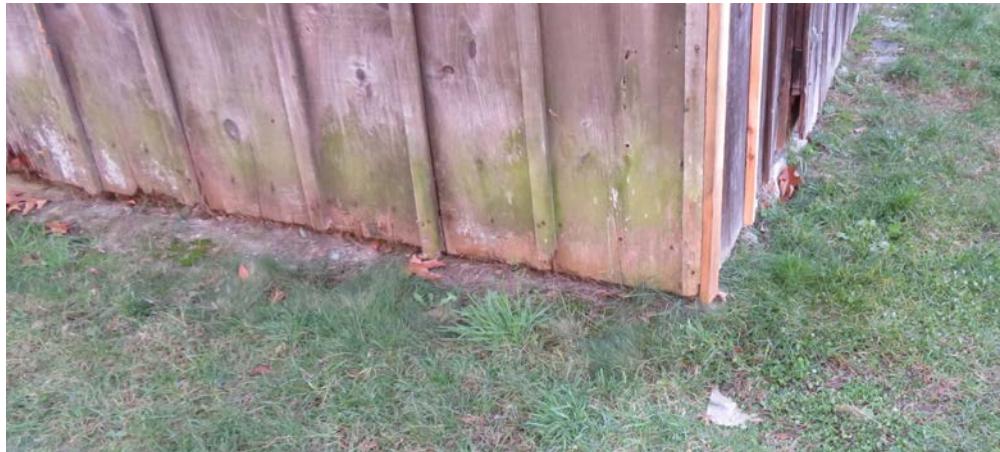
Biological growth, weathering, deterioration and replacement battens (shown at northwest corner).

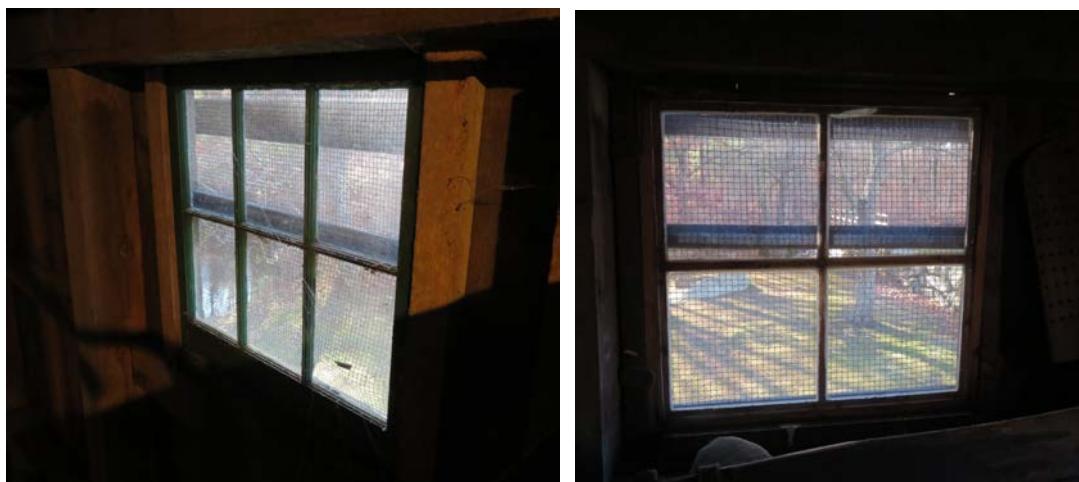
Analysis: Peeling paint and areas of failed glazing putty are visible, but overall the sashes appear to be in fair condition. Some of the exterior mounted wood frames have cracks/checks and the wood is dried out in areas. Similarly, the wood sills show deep weathering, especially at the limits where the end grains are exposed, and sky-facing surfaces exhibit heavy cracking in many areas suggesting that wood fibers are separating due to deterioration from exposure to the elements.

Interior view; Left: painted salvaged window in grist mill addition; Right: south lean-to window with plexiglass replacement

As part of the window work it is recommended that the existing interior plexiglass enclosures and exterior wood mounted screens be reviewed to assess need for these elements, and whether they should be reinstalled, replaced or omitted in the future.

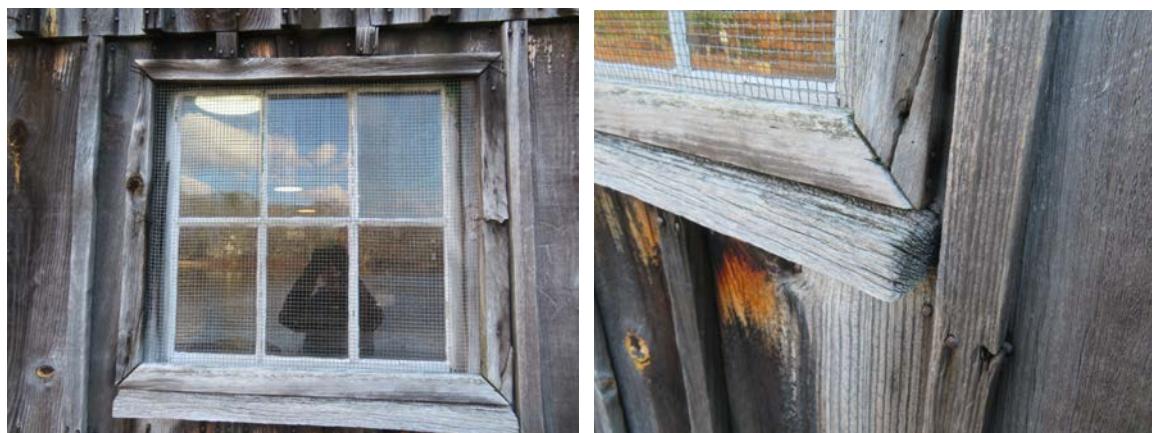
Exterior original mill window with wood mounted screen. Sill is weathered with dry end grain.

Recommendation: Based on the observed conditions of the windows and sashes, it is recommended that the exterior window frames and associated components most susceptible
