**Southeast Connecticut Road-Stream Crossing
Assessment for Community and Wildlife Resilience:
Findings Report and Restoration Opportunities**

**Prepared by:
Jon C. Vander Werff
Save the Sound
Fisheries Biologist
127 Church St, New Haven, CT 06510**

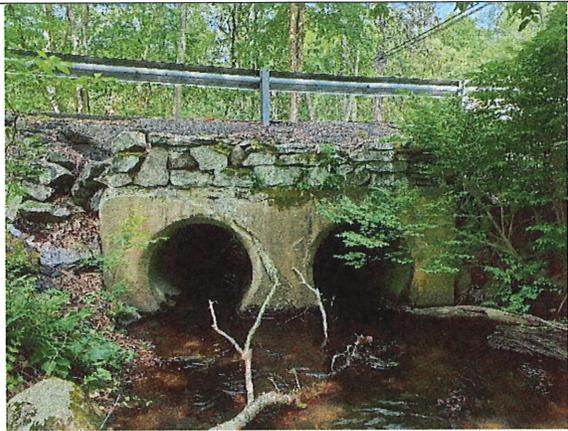
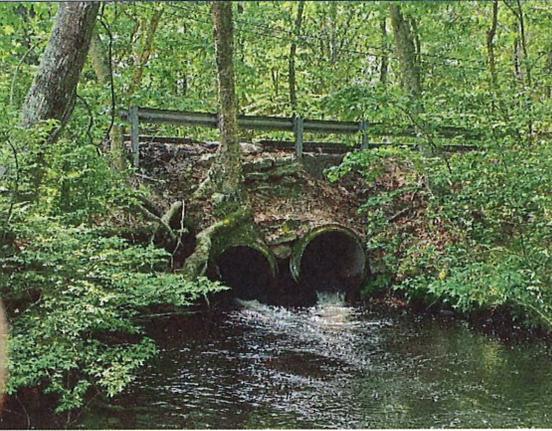
#1 Flat Brook, Pinelock Dr, Ledyard

- Located under a dead-end road, Pinelock Drive
- Two undersized perched, round culverts creating very large scour pool
- Evidence of erosion along Long Cove Road
- Damage to downstream headwall has occurred, large trees growing out of damaged area
- Susceptible to wash out during storm event

- **Crossing type:** 2 round concrete culverts with 4 ft diameter
- **Crossing condition:** Poor
- **Constriction severity:** Severe
- **AOP Coarse Screen / NAACC AOP Score:** Reduced AOP / 0.51

- Close proximity to tidally influenced Thames River
- Downstream side of culvert perched, limiting fish passage
- Spawning habitat potential upstream

- Replace with Stream Simulation Design culvert or bridge: widen and restore stream channel (i) to increase hydraulic capacity and reduce over-topping risk, (ii) restore aquatic organism passage, and (iii) reduce debris accumulation and maintenance.
- Long Cove Road in need of bank stabilization for erosion control and storm resilience

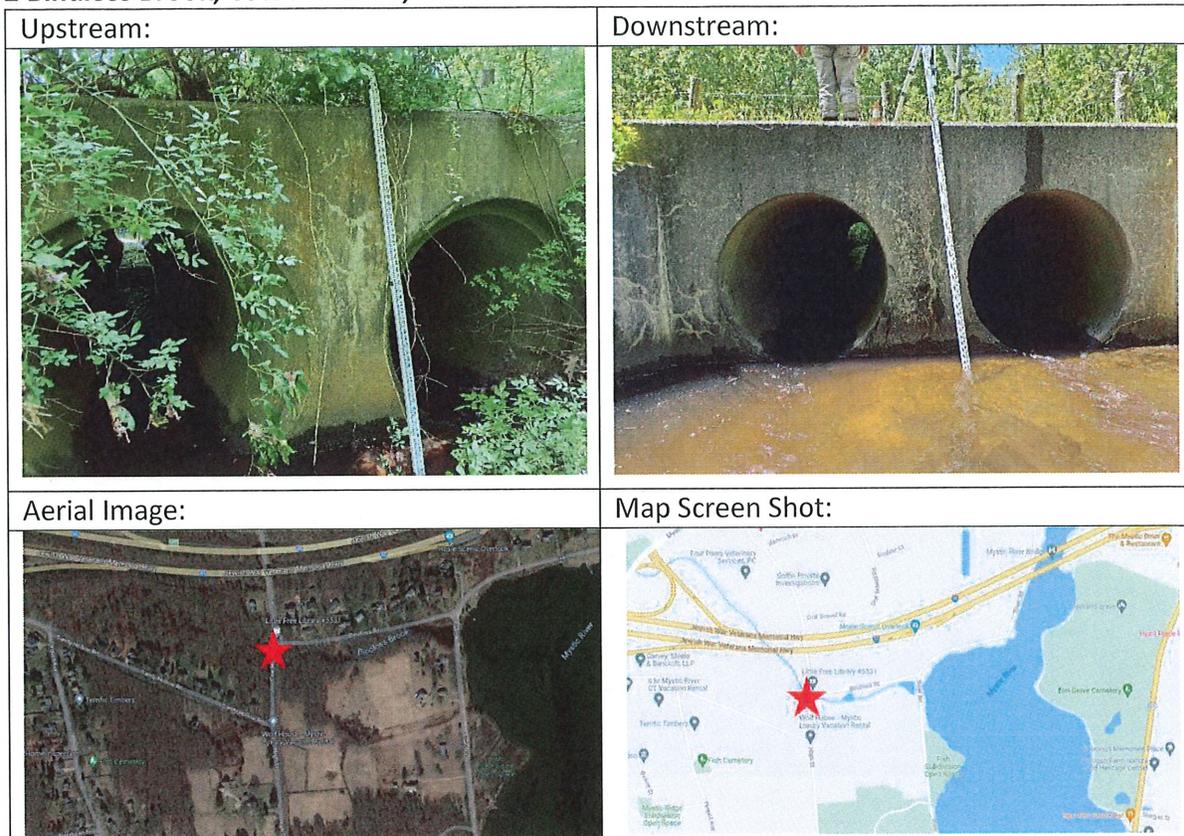
#2 Bindloss Brook, Cow Hill Road, Groton

- Near Cow Hill Road and Bindloss Road intersection
- Two Round Culverts undersized creating large scour pool downstream
- Sediment accretion evident upstream and erosion present downstream
- Limited depth of water in structure will likely limit fish movement and migration

- **Crossing type:** 2 round concrete culverts with 4 ft diameters
- **Crossing condition:** OK
- **Constriction severity:** Severe
- **AOP Coarse Screen / NAACC AOP Score:** Reduced AOP / 0.48

- Strong potential for spawning habitat upstream with restoration efforts
- Breached dam downstream is present at Bindloss Preserves, Avalonia Land Conservancy
- Structure is influencing substrate particle size, modifying habitat

- Replace with Stream Simulation Design culvert or bridge: widen and restore stream channel (i) to increase hydraulic capacity and reduce over-topping risk, (ii) restore aquatic organism passage, and (iii) reduce debris accumulation and maintenance.
- Stabilize outlet with riparian plantings and stone to reduce erosion

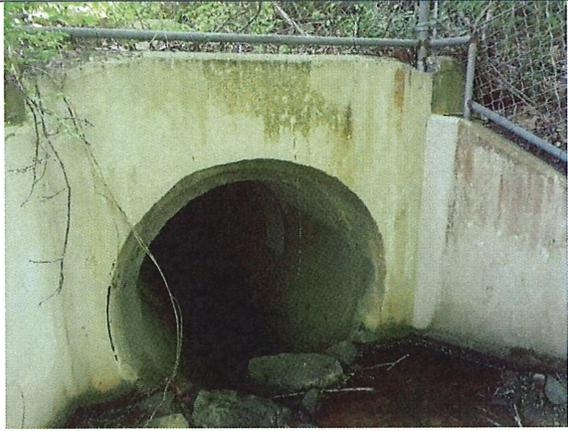
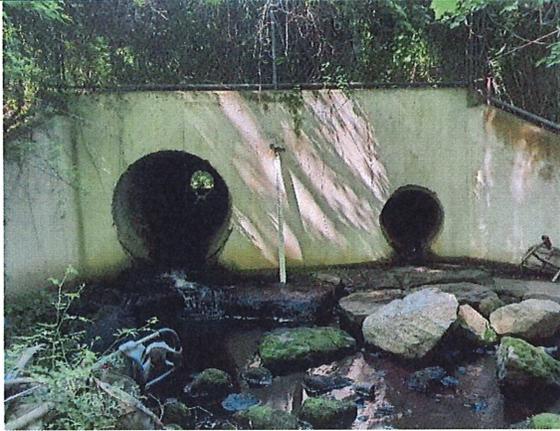
#3 Bindloss Brook, Indigo Street, Groton

- Between 243 and 219 Indigo Street
- Single culvert with shallow water depth likely to limit aquatic organism passage
- Perched downstream side of structure reduces aquatic organism passage
- Secondary storm drain outlet present on downstream side of structure

- **Crossing type:** Single primary concrete culvert with 4.5 ft diameter.
- Crossing condition: OK
- **Constriction severity:** Moderate
- **AOP Coarse Screen / NAACC AOP Score:** Reduced AOP / 0.06

- Replace with Stream Simulation Design culvert or bridge: widen and restore stream channel (i) to increase hydraulic capacity and reduce over-topping risk, (ii) restore aquatic organism passage, and (iii) reduce debris accumulation and maintenance.

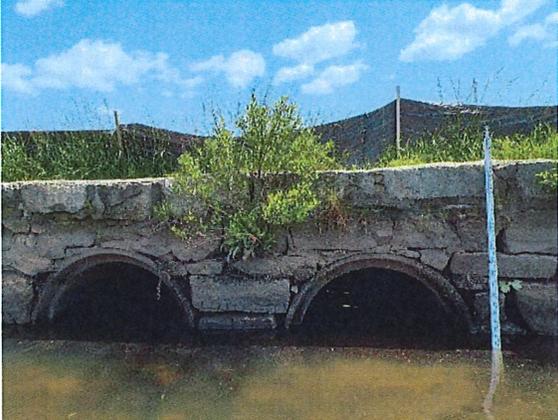
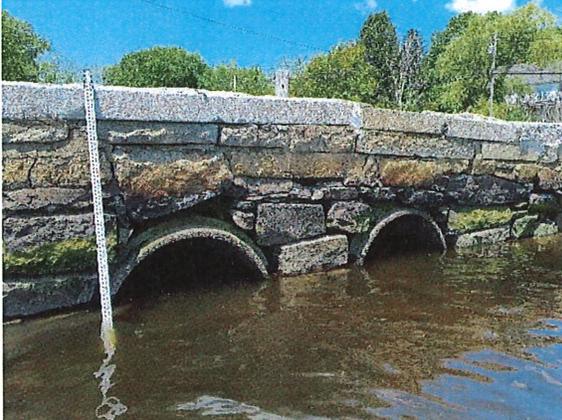
#4 Bindloss Brook, River Road, Groton

- Two round culverts 4 ft in diameter, restrict fluvial and tidal flows
- High tide mark is close to road elevation
- Possible road over topping in storm event
- Restriction in flow path may lead to debris accumulation

- **Crossing type:** 2 round concrete culverts with 4 ft diameters
- **Crossing condition:** OK
- **Constriction severity:** Severe
- **AOP Coarse Screen / NAACC AOP Score:** Full AOP / 0.77

- Replace with wider culvert or bridge (i) to increase hydraulic capacity and tidal fluctuation, (ii) reduce debris accumulation and maintenance

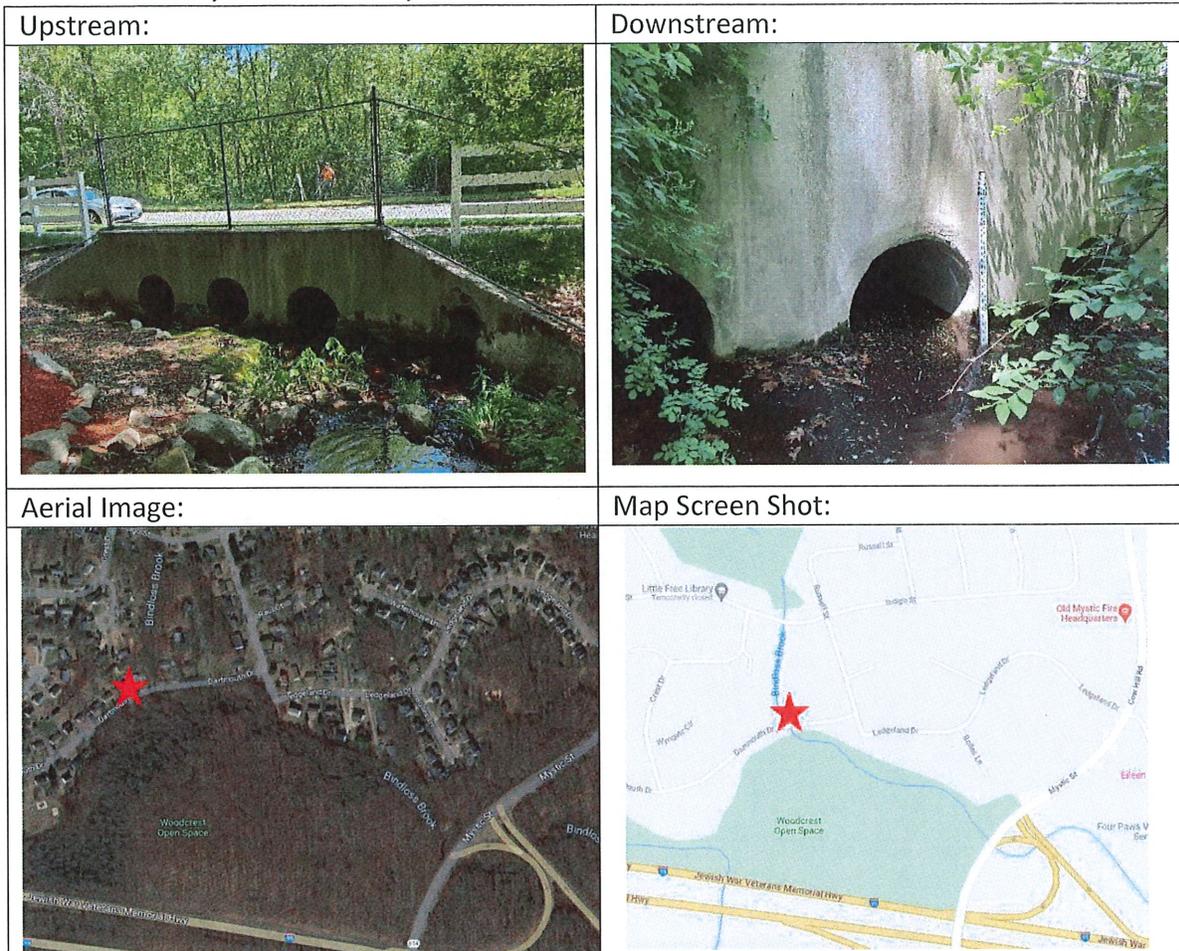
#5 Bindloss Brook, Dartmouth Rd, Groton

- Upstream of Interstate I-95
- Three round culverts with minimal water depth moving through each
- Sharp skew of stream at entrance of structure increases maintenance needs

- **Crossing type:** 3 round concrete culverts with 3 ft diameter
- **Crossing condition:** OK
- **Constriction severity:** Moderate
- **AOP Coarse Screen / NAACC AOP Score:** Reduced AOP / 0.70

- Unknown downstream crossing conditions on I-95 due to limited access
- Shallow water depth in structure likely to limit aquatic organism passage
- Structure/stream design susceptible to sediment (cobbles and boulders) and debris accumulation

- Replace with Stream Simulation Design culvert or bridge: widen and restore stream channel (i) to increase hydraulic capacity and reduce over-topping risk, (ii) restore aquatic organism passage, and (iii) reduce debris accumulation and maintenance.
- Restore stream channel to be in line with crossing structure

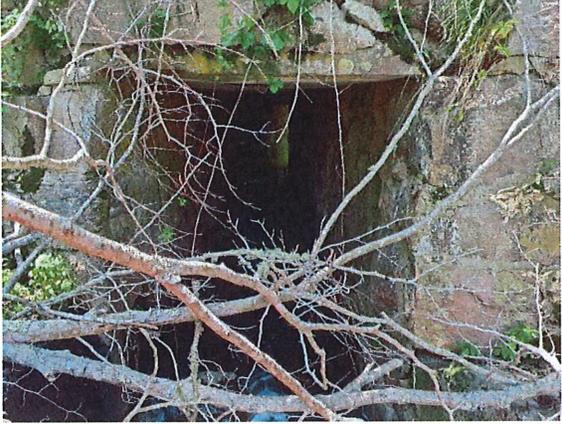
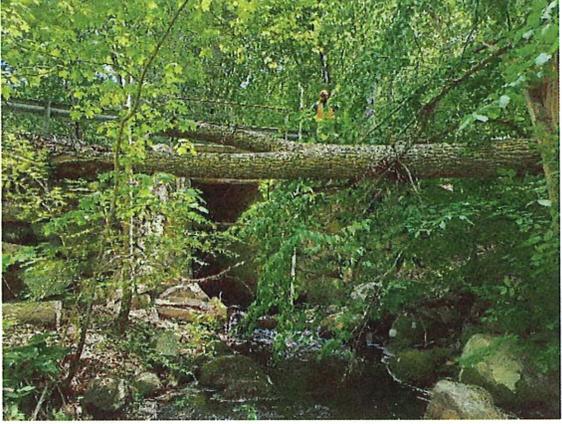
#6 Billings Avery Brook, Stoneybrook Rd, Ledyard

- Fieldstone structure under Stoneybrook Road
- A small spillway immediately upstream of culvert inlet and Stoneybrook Road form the dam of Glenwoods Pond
- CTDEEP Dam Safety database identifies this as Long Pond Dam, #7220, Low Hazard
- Structure curves under the road

- **Crossing type:** single rock / stone box bridge with abutments 6 ft wide 10 feet tall
- **Crossing condition:** OK
- **Constriction severity:** Moderate
- **AOP Coarse Screen / NAACC AOP Score:** Reduced AOP / 0.70

- Pond habitat present for river herring spawning if access is provided
- Close proximity to tidally influenced Thames River
- Vegetation was thick and fallen trees were present
- Erosion present downstream
- Likely to be susceptible to storm debris jams because of design intricacies

- Consider feasibility of installing technical fishway through crossing to provide diadromous fish access to Glenwoods Pond.
- Consider feasibility for removing the small spillway upstream of crossing, which would likely eliminate Glenwoods Pond, and replace with Stream Simulation Design culvert or bridge: widen and

restore stream channel (i) to increase hydraulic capacity and reduce over-topping risk, (ii) restore aquatic organism passage, and (iii) reduce debris accumulation and maintenance.

- Failing masonry in structure should be repaired in any future work.

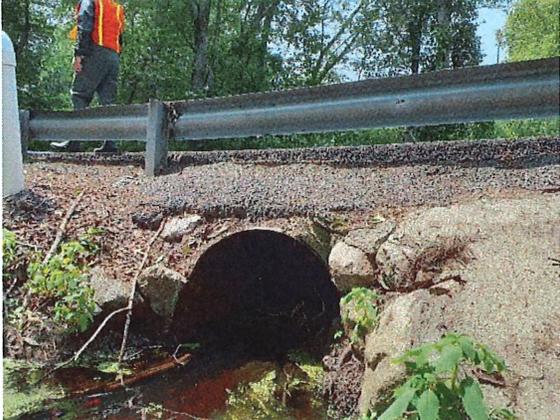
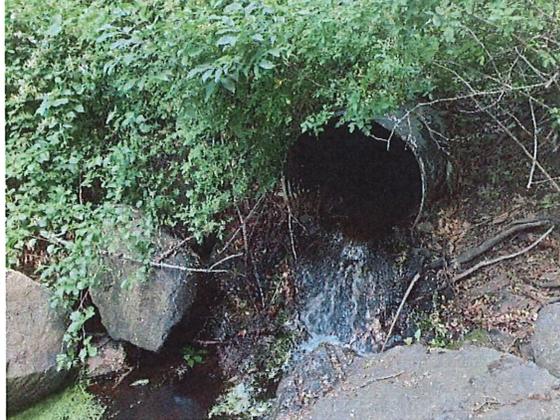
#7 Pine Swamp Brook, Structure 1 on Harvard Terrace, Ledyard

- Road crossing comprises dam of Pine Swamp Pond (aka Avalonia Land Trust Pond).
- CTDEEP Dam Safety database identifies this as Pine Swamp Pond Dam, #7212, Low Hazard
- Perched round culvert with a rusted out dilapidated bottom
- Fall hazard around guard rail and repaired curbing pavement and apron

- **Crossing type:** 1 metal culvert with a 3 ft diameter
- **Crossing condition:** Poor
- **Constriction severity:** Severe
- **AOP Coarse Screen/ NAACC AOP Score:** No AOP / 0.03

- Downstream barrier to fish migration due to natural waterfall located south of Smith Pond Way
- Resident fish habitat upstream in pond and downstream in river channel
- Perched structure reduces movement of fish migration

- Consider feasibility of installing technical fishway through crossing to provide fish passage to Pine Swamp Pond
- Failing masonry in structure should be repaired in any future work.
- Reduce fall risk for children in neighborhood.

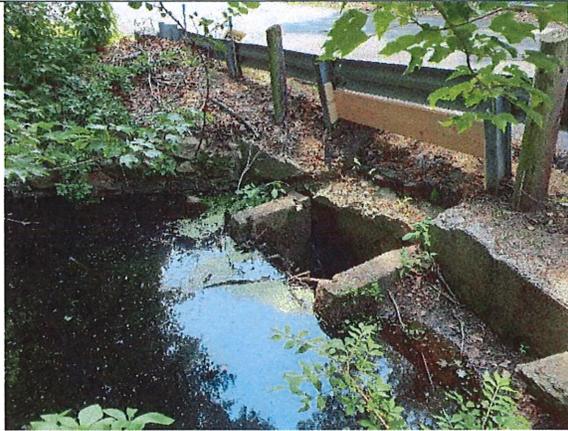
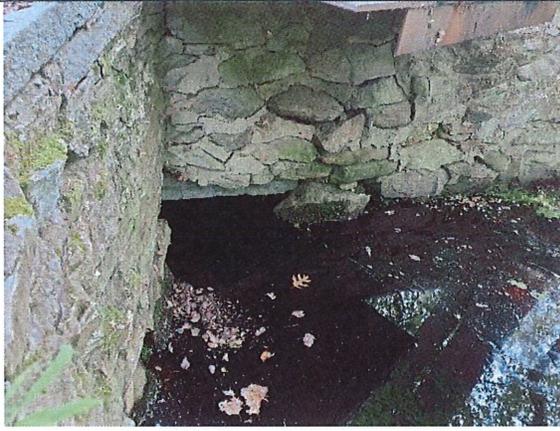
#8 Pine Swamp Brook, Structure 2 on Harvard Terrace, Ledyard

- Under Harvard Terrace Road downstream of Avalonia Land Trust Pond
- CTDEEP Dam Safety database identifies this as Pine Swamp Pond Dam, #7212, Low Hazard
- Inlet drop culvert to square stone outlet
- Fall hazard around guard rail and repaired curbing pavement and apron
- Large metal conveyance structure present to move water away from road creating another safety hazard

- **Crossing type:** Inlet drop to square outlet
- **Crossing condition:** Poor
- **Constriction severity:** Severe
- **AOP Coarse Screen/ NAACC AOP Score:** No AOP / No score

- Downstream barrier to fish migration due to natural waterfall located south of Smith Pond Way
- Resident fish habitat upstream in pond and downstream in river channel

- Perched structure reduces movement of fish migration

- Refurbish dated and worn areas of structure
- Reduce fall risk for children in neighborhood
