| Field Report No.: | | | | | | | | | | | | | | 17 | | |
| SP&A Project No: 22.33 | | | 22.331 | 22.331 | | | | Report Date: 1.03.2025 | | | | | | Time: | 9:30AM | |
| | ( | Project:<br>Name & Location) | Gales Fe<br>1854 CT-<br>Gales Fe<br>General ( | 12<br>rry, ( | CT 063 | 335 | | | | | | | | | | |

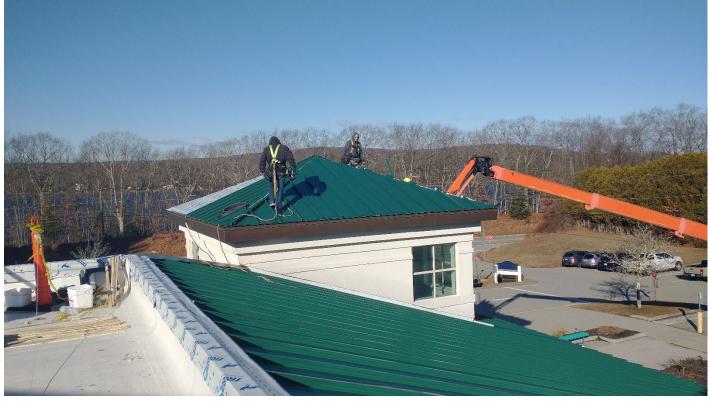
| Field Report No.: | | | | | | | | | | | | | | 17 | | |
|---|--|---|---|---|---|---|---|---|---|---|---|---|---|---|---|--|
| <ul> <li>Approximate number of workers on site – 4</li> <li>Installing panels on the "tower" of roof A. See attached photo.</li> </ul> | | | | | | | | | | | | | | | | |

Work in progress on the "tower" of roof A

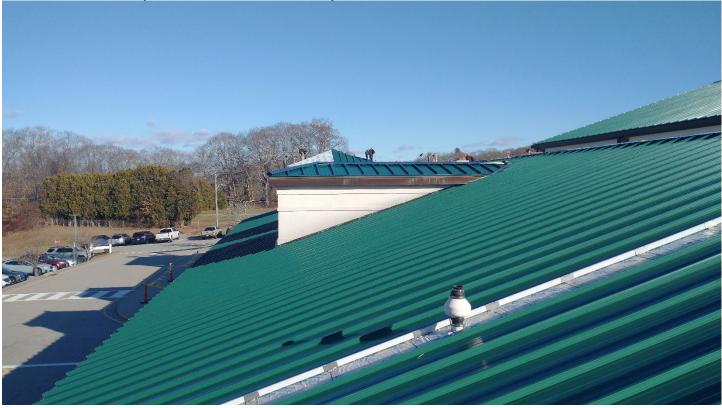
Roof A - Vent needs temp removal to install the new roof panels

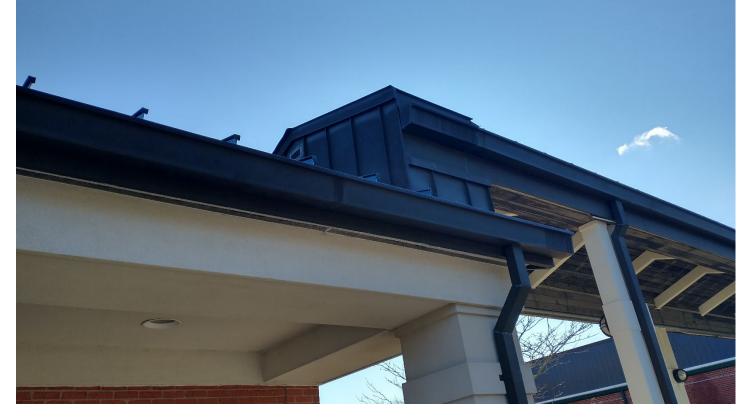
| Field Report No.: | | | | | | | | | | | | | | 17 | | |
|---|--|---|---|---|---|---|---|---|---|---|---|---|---|---|---|--|
| <ul> <li>Panels that were installed and have short screws that need to be replaced need to be observed for the correct screw length by Garland &amp; SPA in areas where the underside decking is not visible.</li> <li>Roof A – Gable end of walkway cover needs the lower 8" of the vertical panels (all three sides) removed for investigation of how to</li> </ul> | | | | | | | | | | | | | | | | |
| secure the new vertical panels to the existing structure and height requirements.<br>- At the gable end of the walkway roof, Garland needs to produce a drawing eliminating the current cricket for better flow of the rain water. | | | | | | | | | | | | | | | | |

Roof A - Discussed vertical panel installation on the gable end

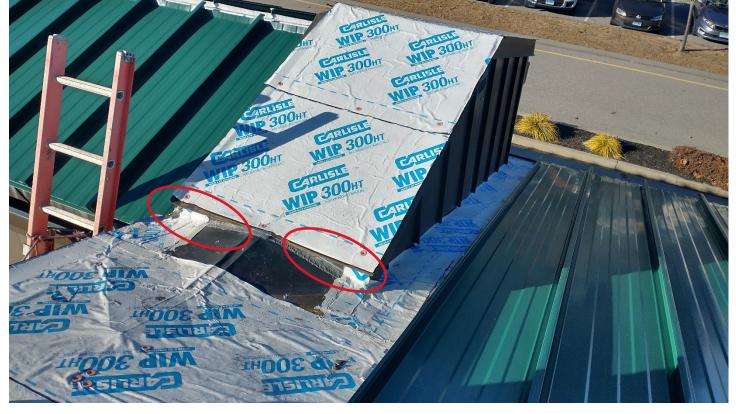
| Field Report No.: | | | | | | | | | | | | | | 17 | | |
|---|--|---|---|---|---|---|---|---|---|---|---|---|---|---|---|--|
| | Currently the water hits vertical end points at both sides of the cricket. See attached photo. | | | | | | | | | | | | | | | |

Roof A - In garland's hands to come up with a solution for the cricket due to vertical side walls on both sides of the cricket
