## Ledyard Up-Down Sawmill Dam Condition Assessment and proposed solutions

## Inspection and report (April/May 2025)

## Conceptual Alternative No. 1 Rehabilitation - Overtopping Protection (from GZA)

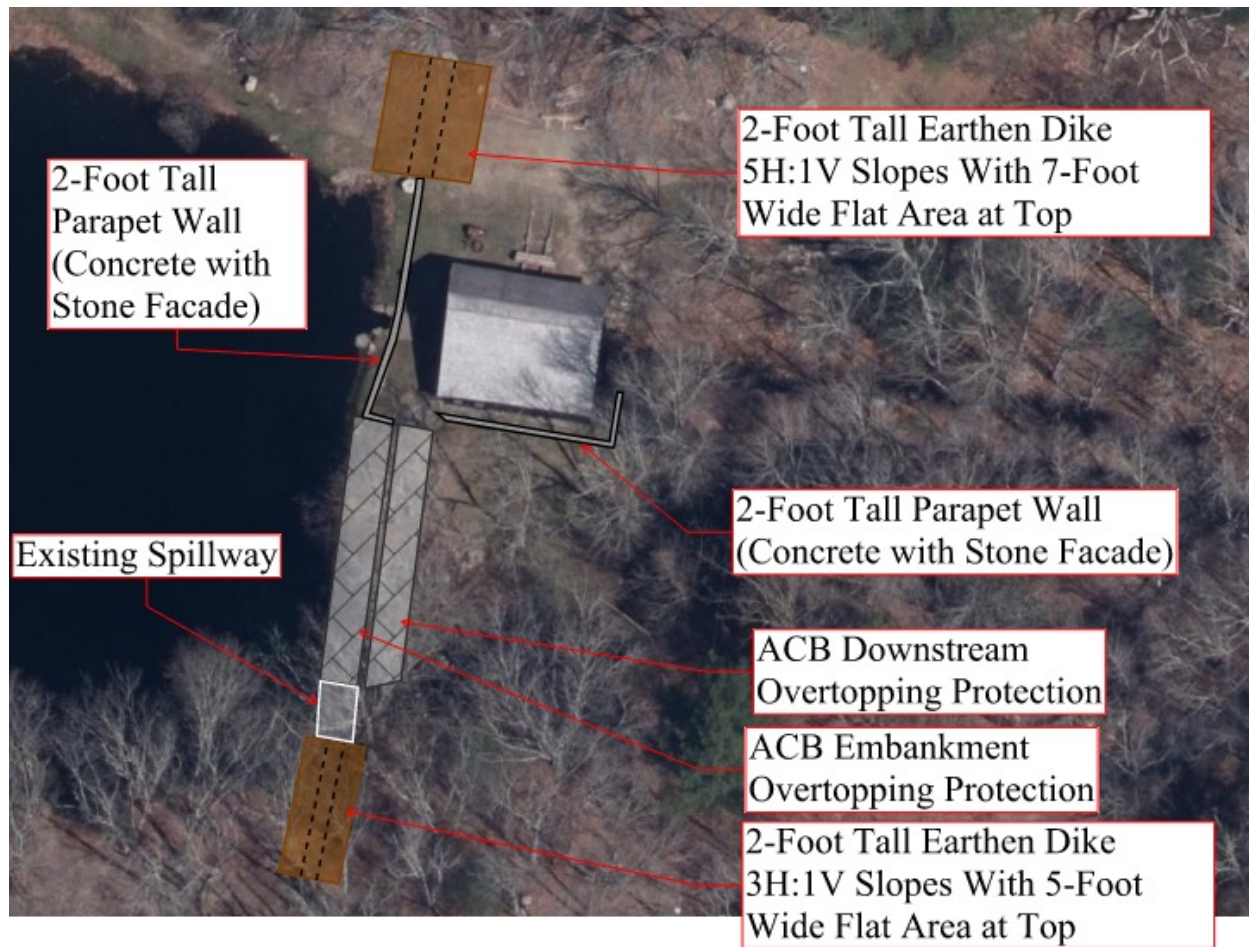
**Figure 1- Conceptual Alternative No. 1 Rehabilitation- Overtopping Protection**

- Overall the dam is in good condition (although at risk from floods that lead to overtopping).
- The crest of embankment is uneven with settlement apparent along downstream stone wall (included misplaced stones). Spillway is in good condition.
- Dam is at risk from overtopping which is the most common cause of failure for similar dams.
  - “deficiencies included an uneven crest, erosion at the masonry wall downstream toe, misaligned stones in the wall, and voids in portions of the downstream wall at the sawmill building.” (GZA report page 5)
  - “Overtopping of an earthen and stone masonry dam is a serious dam safety concern that, left unaddressed, is likely to lead to dam failure.” (GZA report page 3)
  - “With a 1 foot of water over the dam, I think the potential for failure is high, at least partial failure.” (J. Davis 6/24/2025 email)

- New 2-foot earthen dike near NE corner of pond
- New 2 foot parapet wall on top of dam (south end at existing spillway)
- New 2 foot parapet wall below dam on south and east sides of mill building
- New ACB (articulated concrete block) on dam embankment.
  - See example photos of ACB usage on last page
- New ACB on downstream side of dam
- New 2-foot tall earthen dike south of existing spillway
