DAM SAFETY PROGRAM DAM INSPECTION REPORT FORM – FOR REGULATORY INSPECTION

| Dam Name: | Pine Swamp Brook Pond Dam | Inspection Date(s): | December 18, 2024 |
| Alternate Dam Name(s): | none | CT Dam ID #: | 7212 |
| Location (Municipality): | Ledyard | Temperature / Weather: | ±32°, Clear, calm |

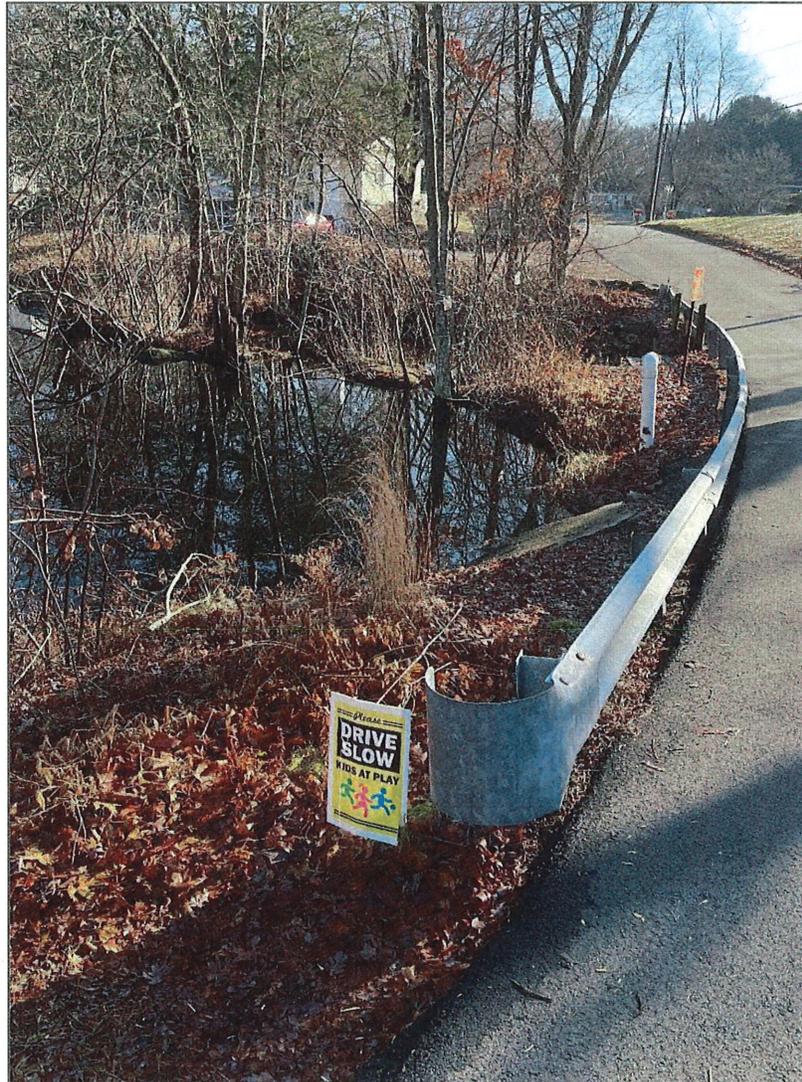
Vegetative Cover: Heavy growth of trees and brush on dam embankment

Photo 1: Upstream face of embankment

1. Clear vegetation from dam and ± 25 beyond. Grubbing of trees requires Dam Safety permit.
2. Replace or repair failing auxiliary spillway pipe.
3. Monitor principal spillway grouted stone walls, and repoint grout as needed.
4. Monitor principal spillway inlet for blockage

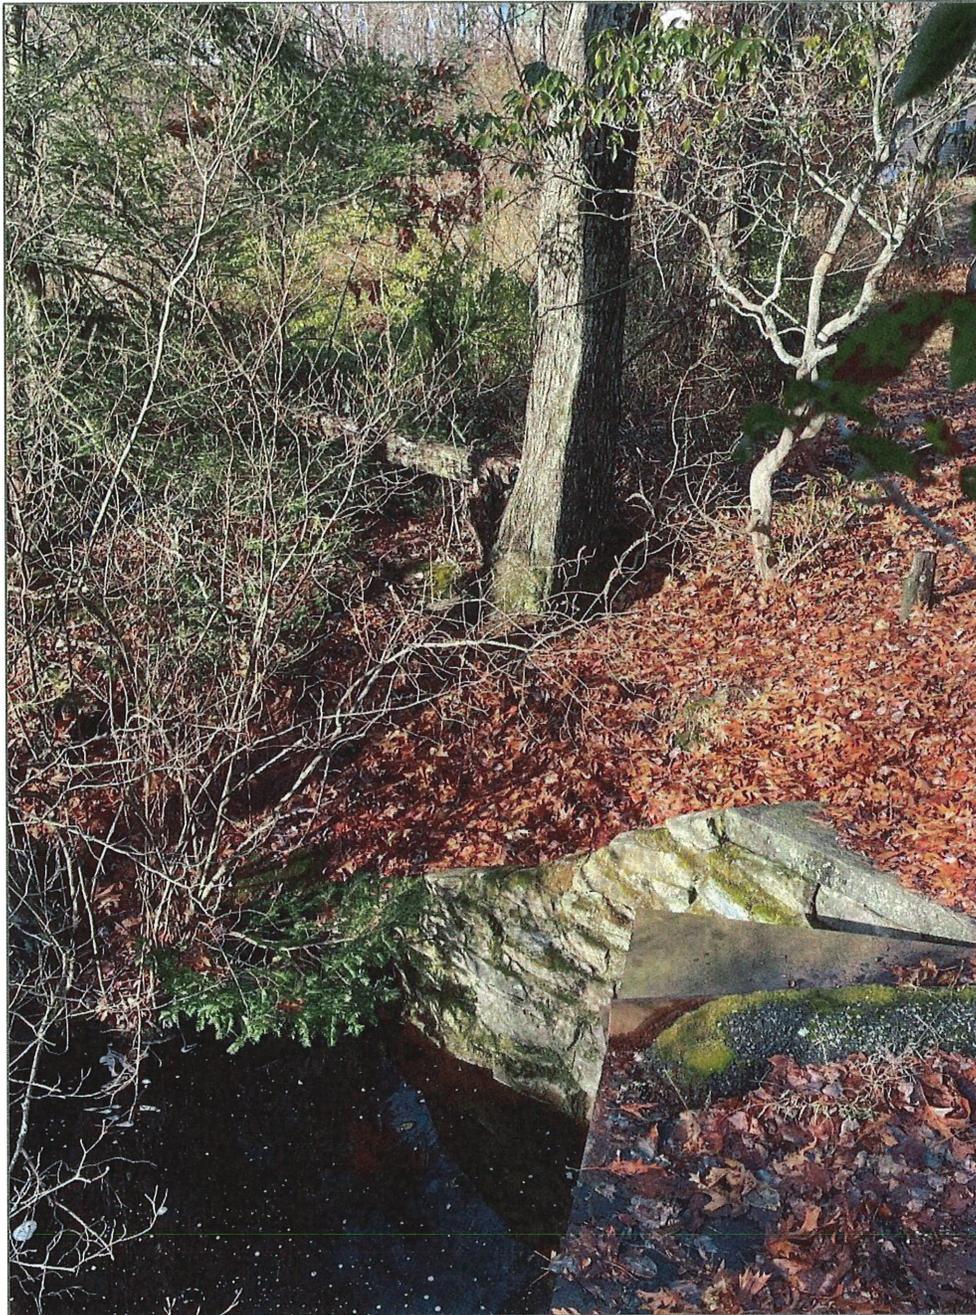
Photo 2: Downstream face of embankment

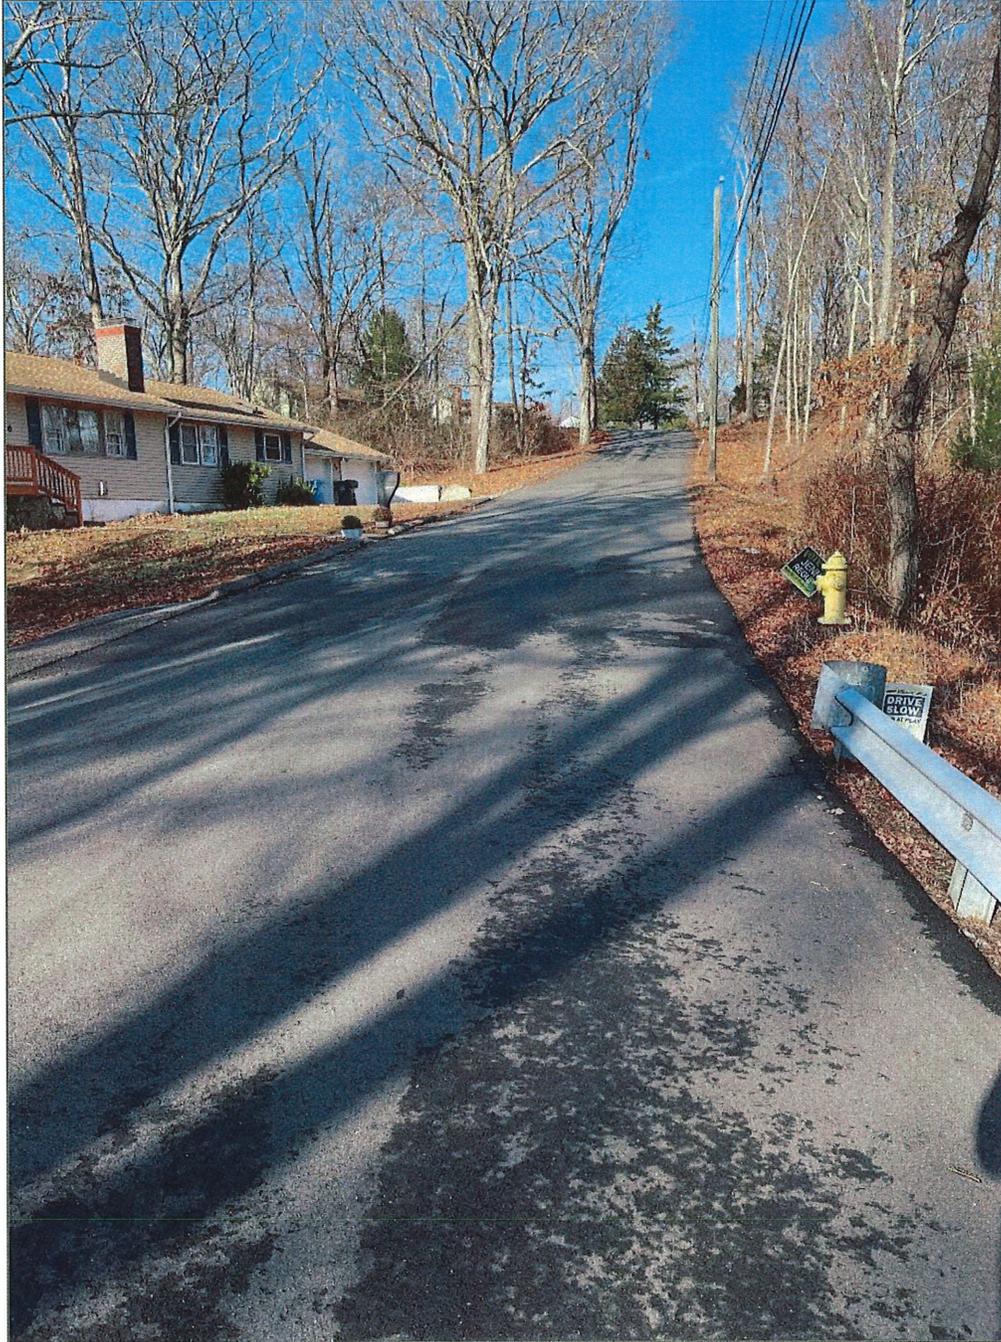
Photo 3: Roadway approach to right abutment and hydrant position

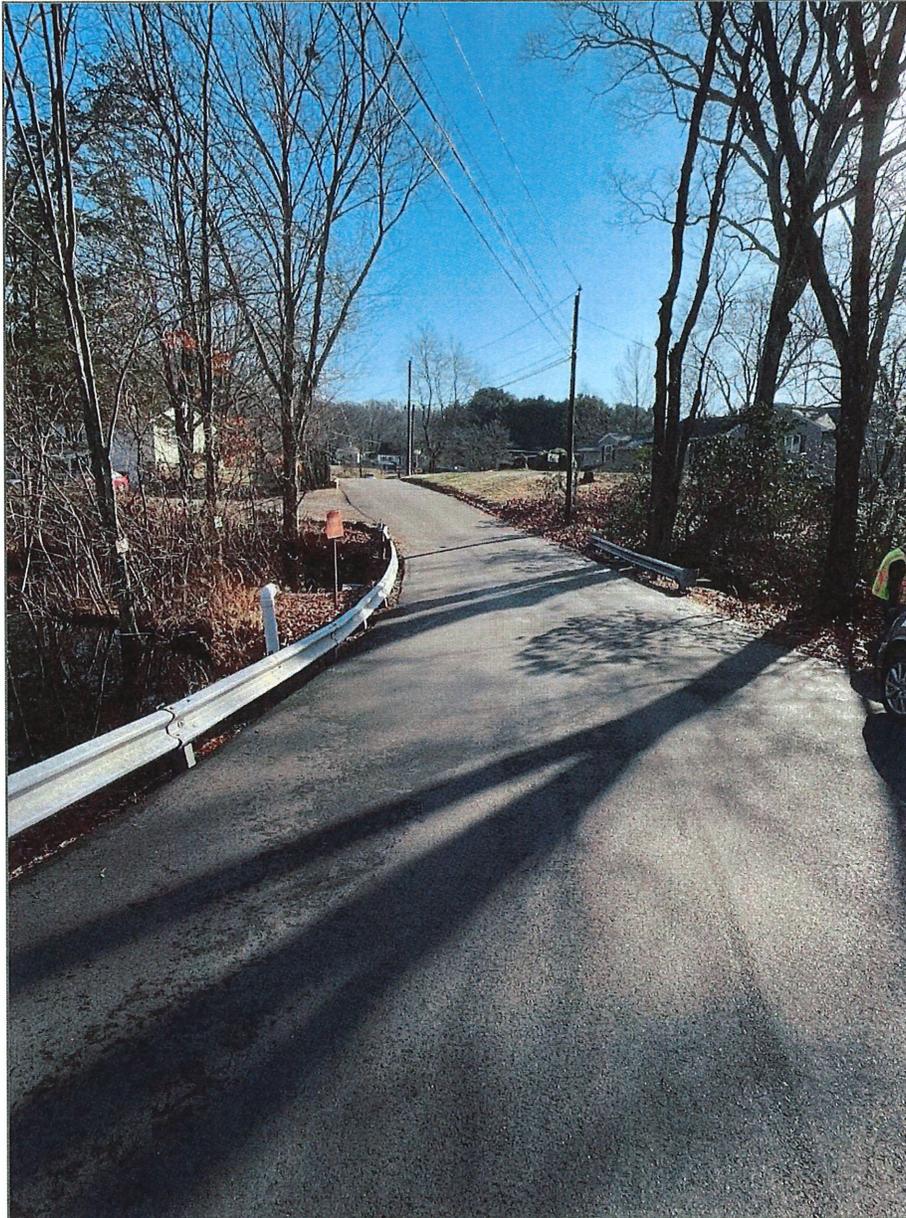
Photo 4: Roadway across dam embankment and beyond left abutment

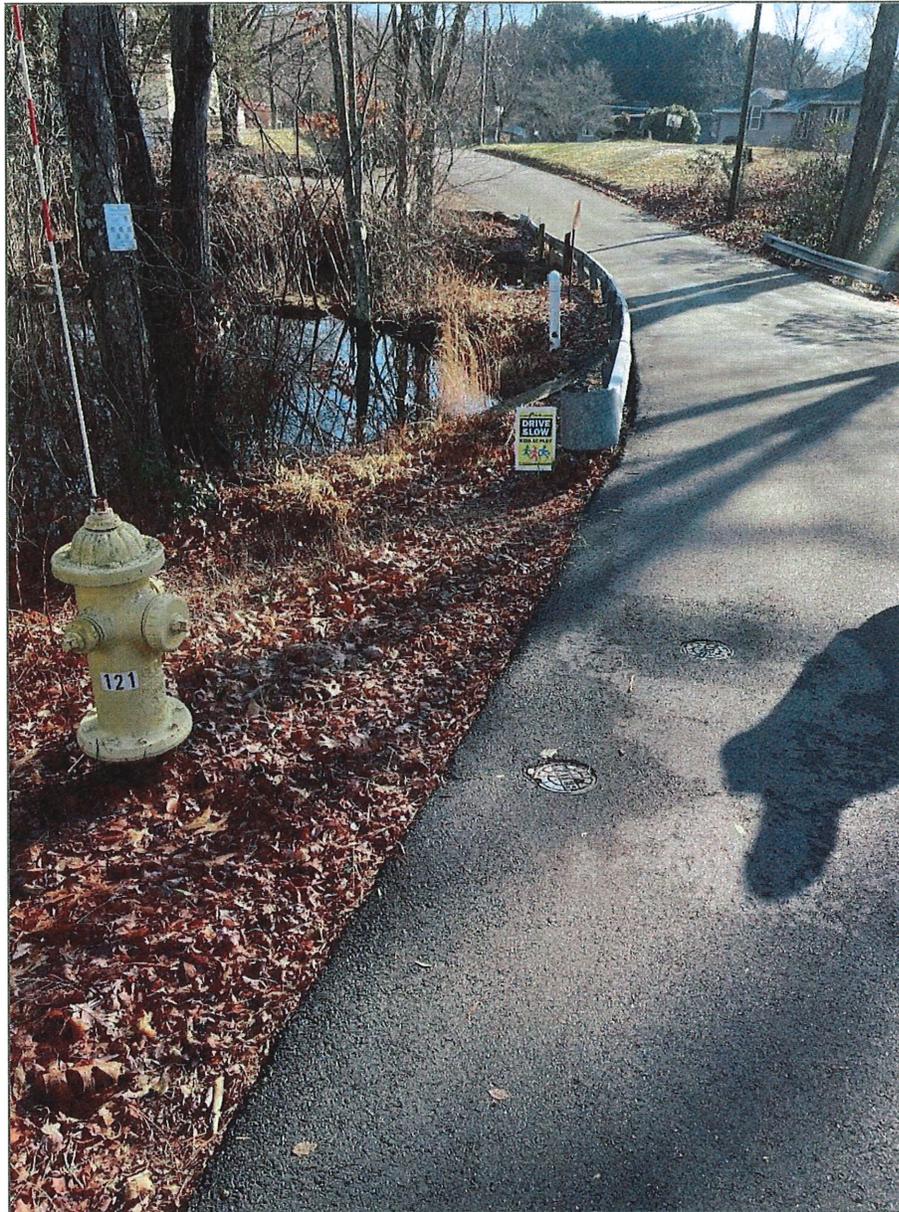
Photo 5: Water shut-off for hydrant and pipe crossing dam. Similar arrangement at left abutment

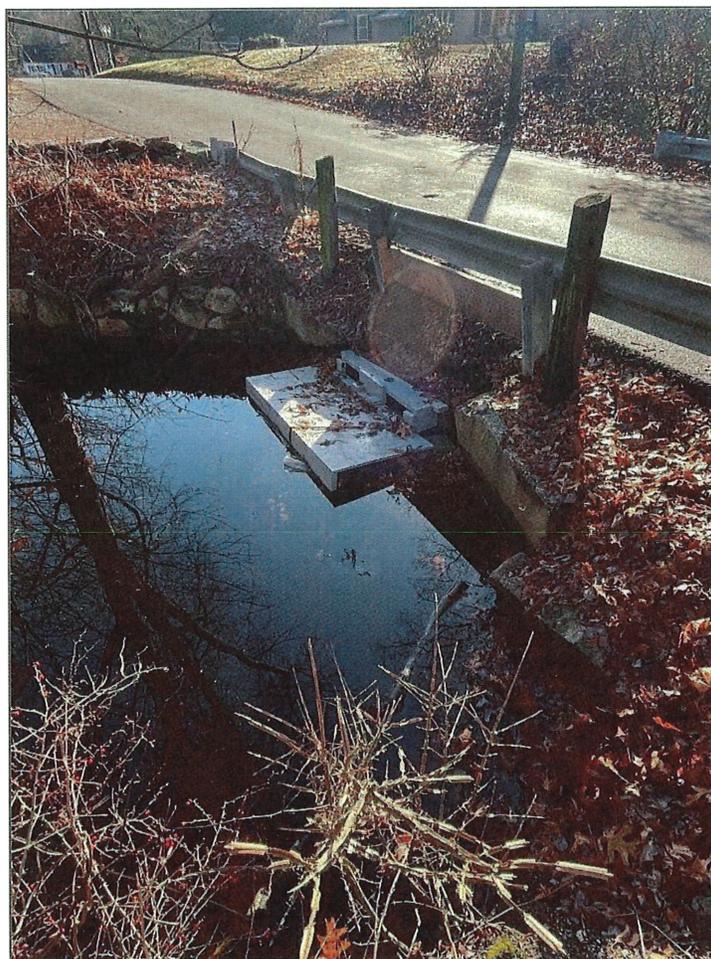
General Description: Drop inlet located near left abutment, connecting to stone masonry culvert through embankment. Inlet has a removable wood cover, to prevent vegetation and other obstructions from entering the inlet.

Photo 6: Principal spillway inlet with cover

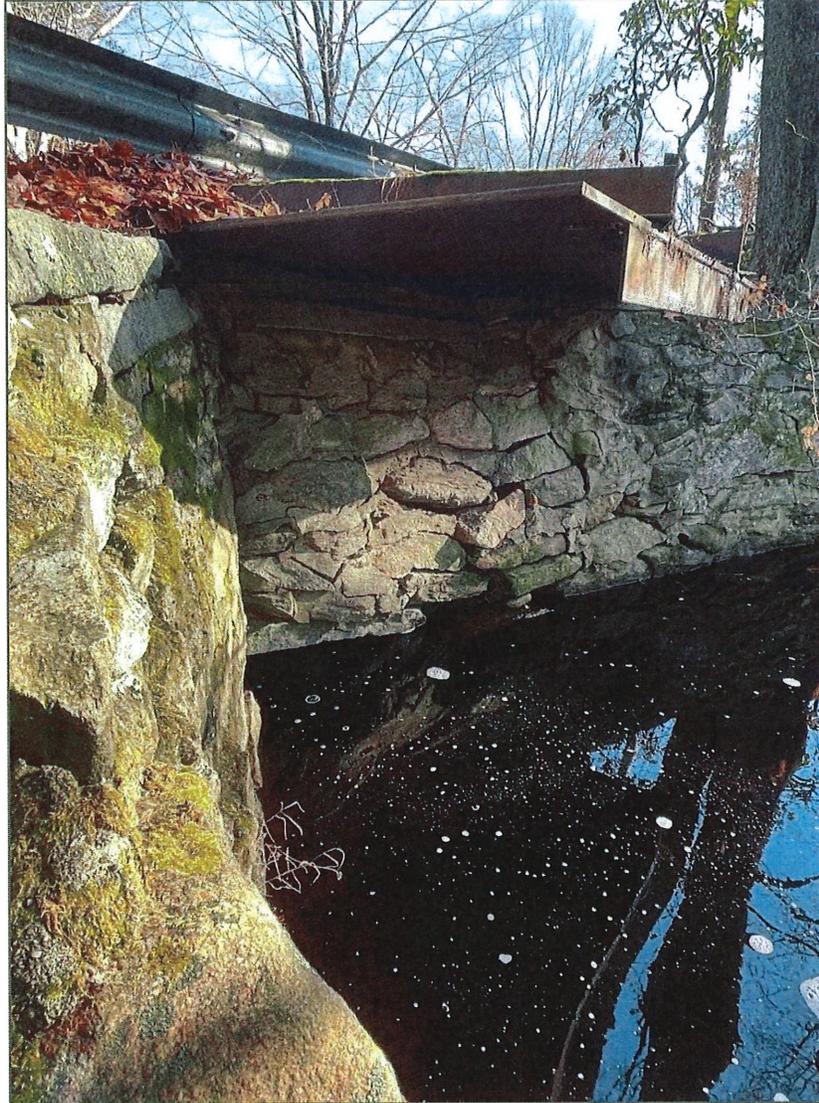
Stone Masonry: Some grout missing near outlet end of culvert

Other: Culvert has flared exit walls and cantilevered concrete slab over outlet

Photo 7: Principal spillway outlet

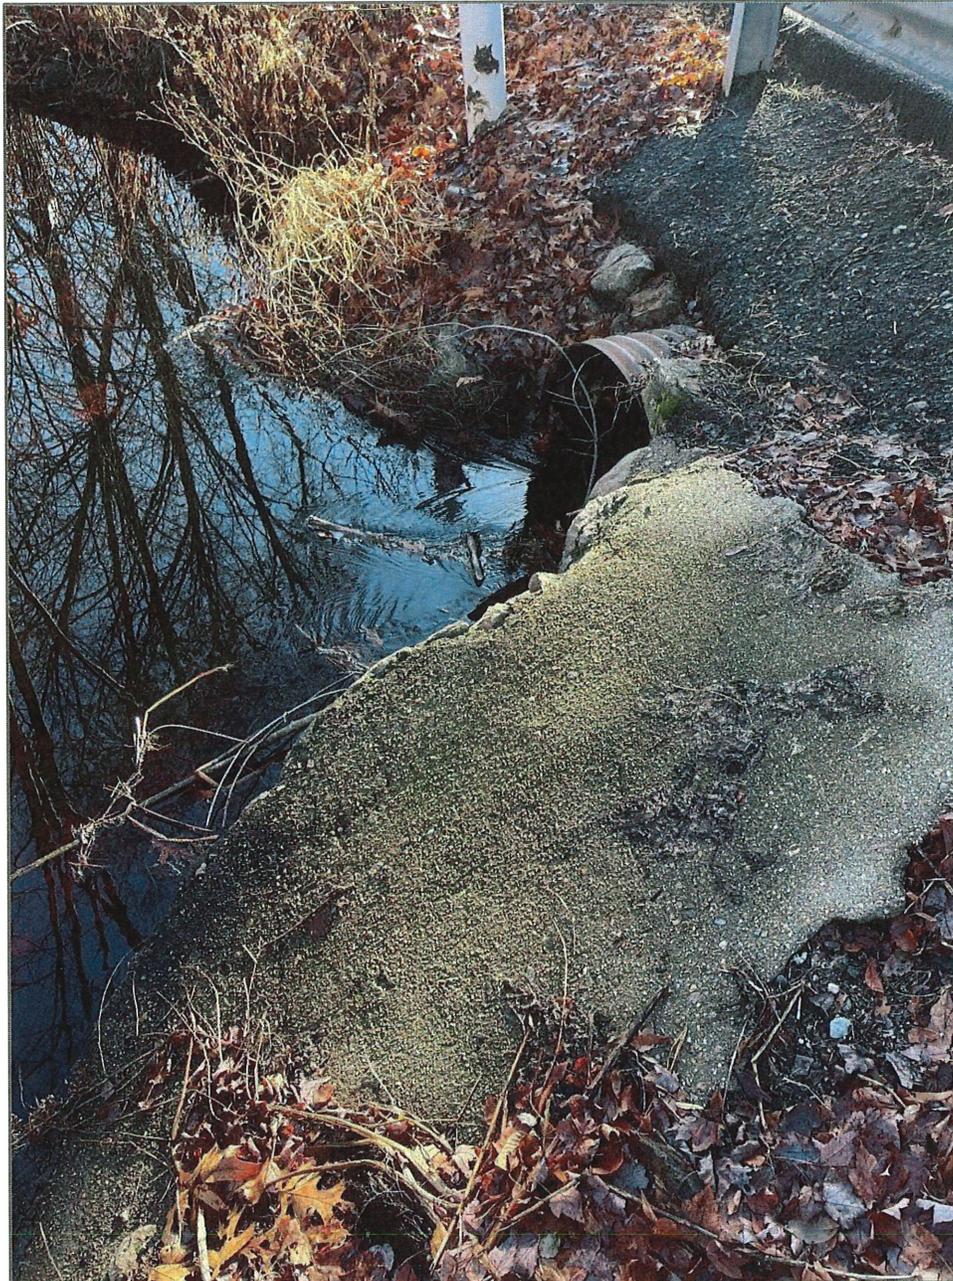
General Description: 2-foot diameter corrugated metal pipe. Inlet and outlet end project beyond the dam embankment

Photo 8: Auxiliary spillway inlet

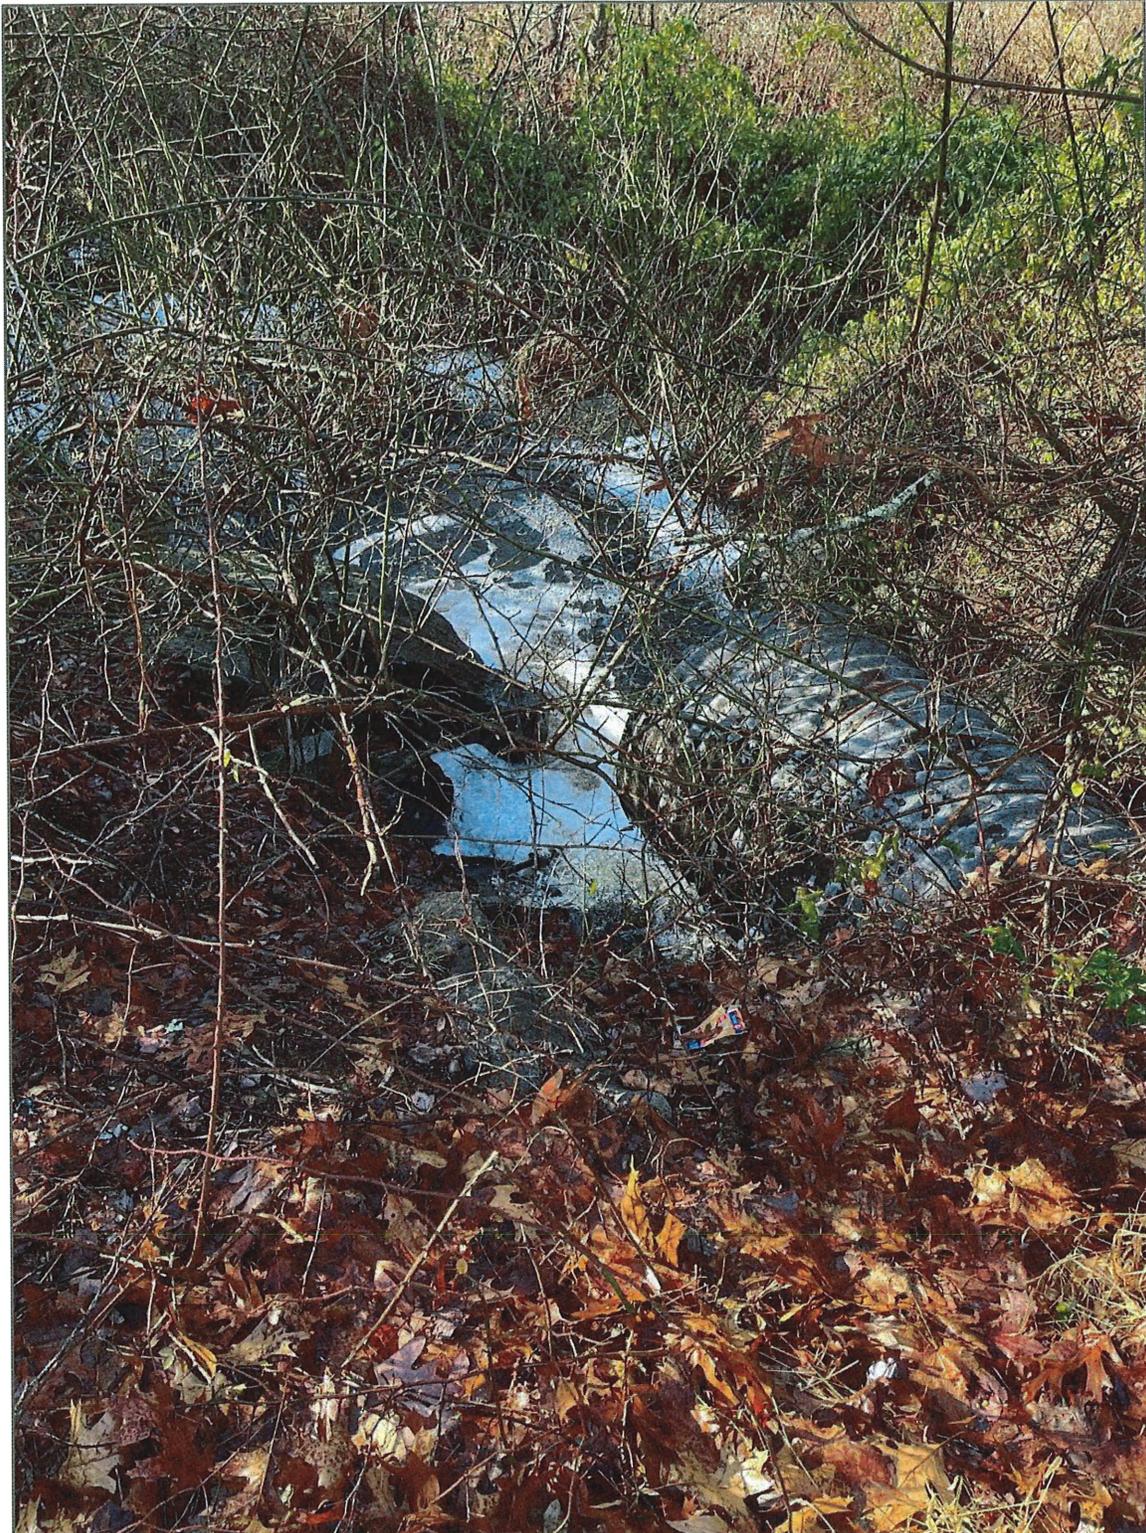
Scouring/Undermining: Scouring on downstream embankment

Other: Downstream invert of CMP has rotted through and flow spills out onto dam embankment before it exits at the outlet. Also, there is no scour protection at outlet.

Photo 9: Auxiliary spillway outlet

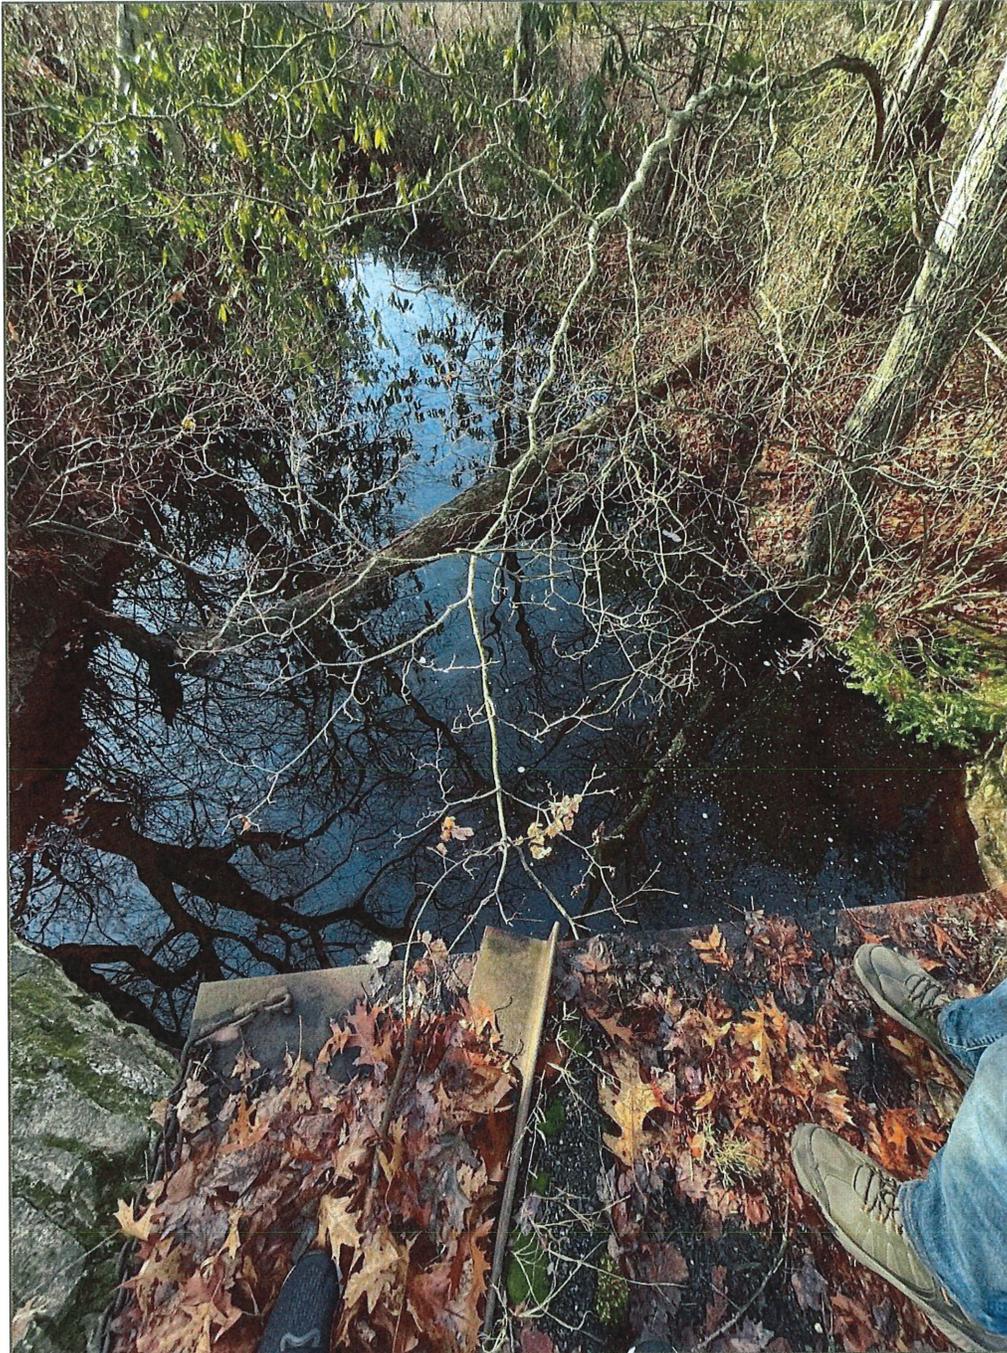
General Description: Natural stream channel with dense vegetation on banks, sand-cobble bottom

Other: Short reach just downstream is two channels for the two spillways of dam before merge

Photo 10: Downstream channel of Pine Swamp Brook

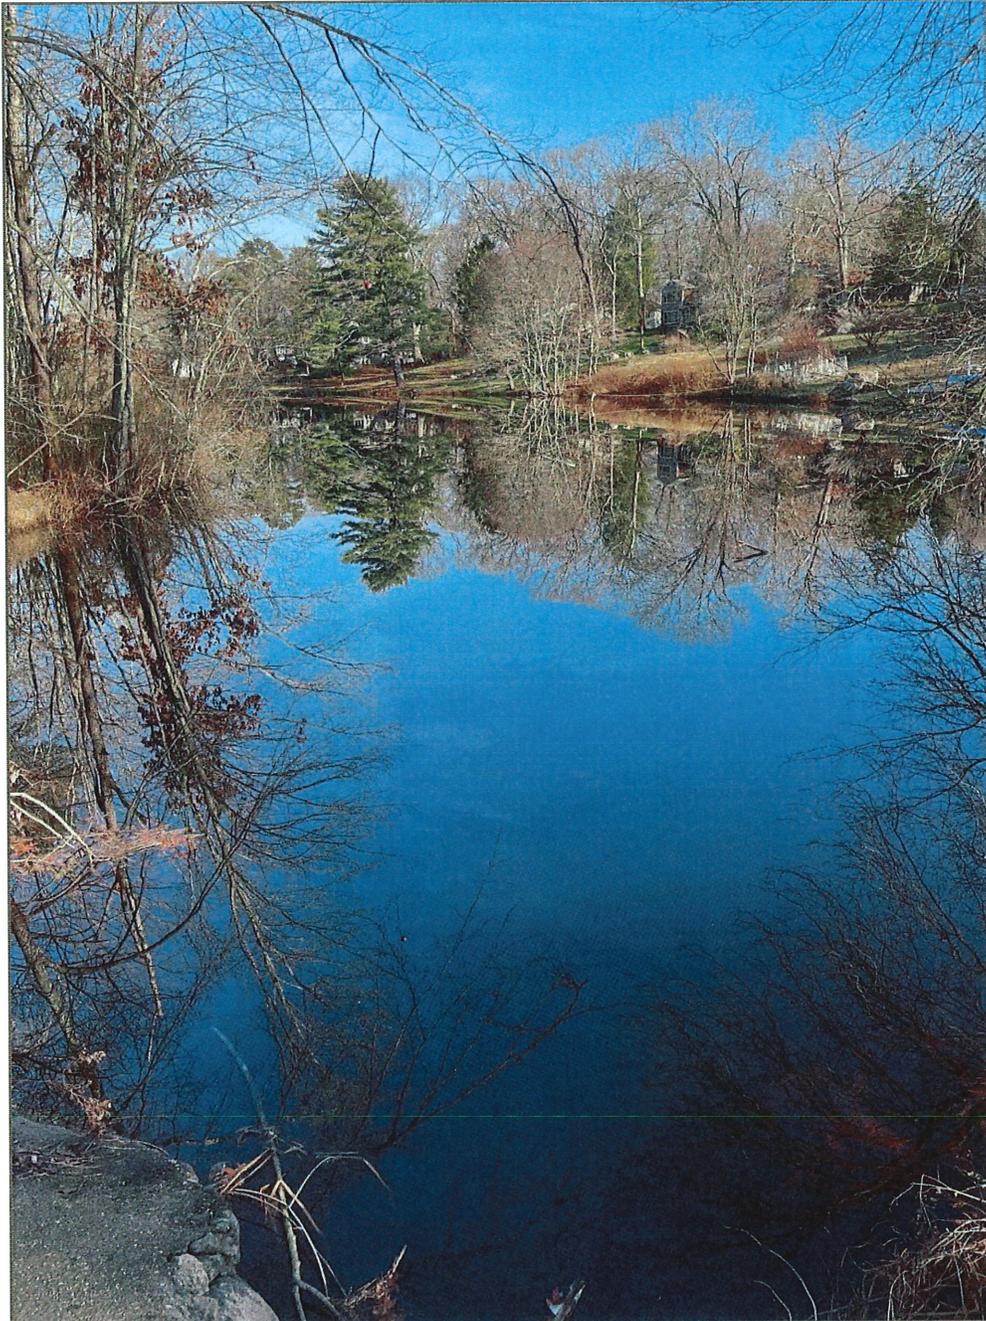
Photo 11: Pine Swamp Brook Pond

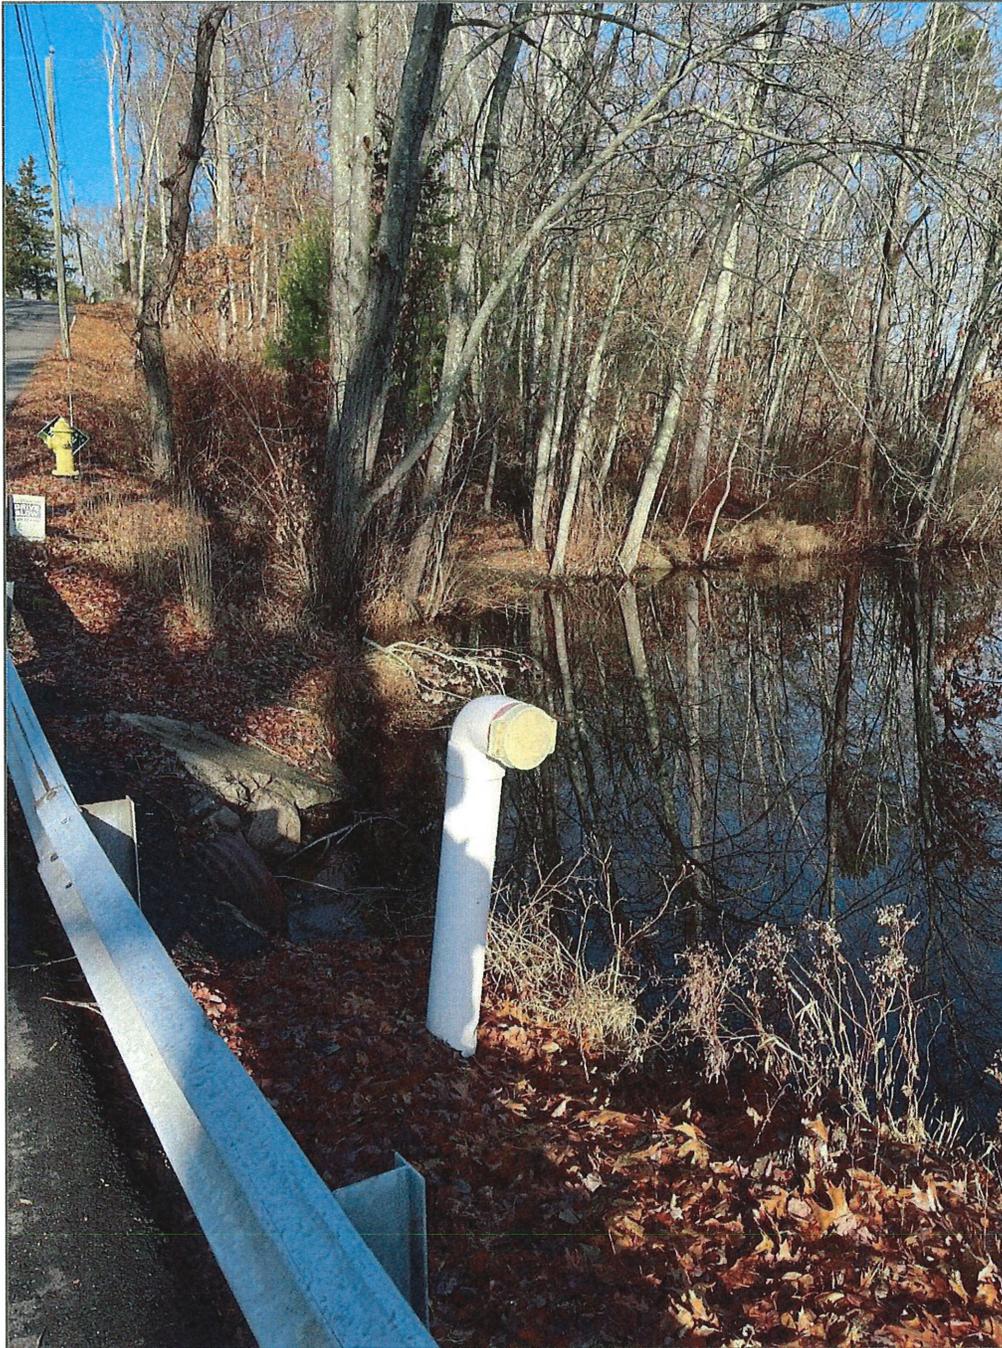
Photo 12: Dry hydrant and potable water hydrants

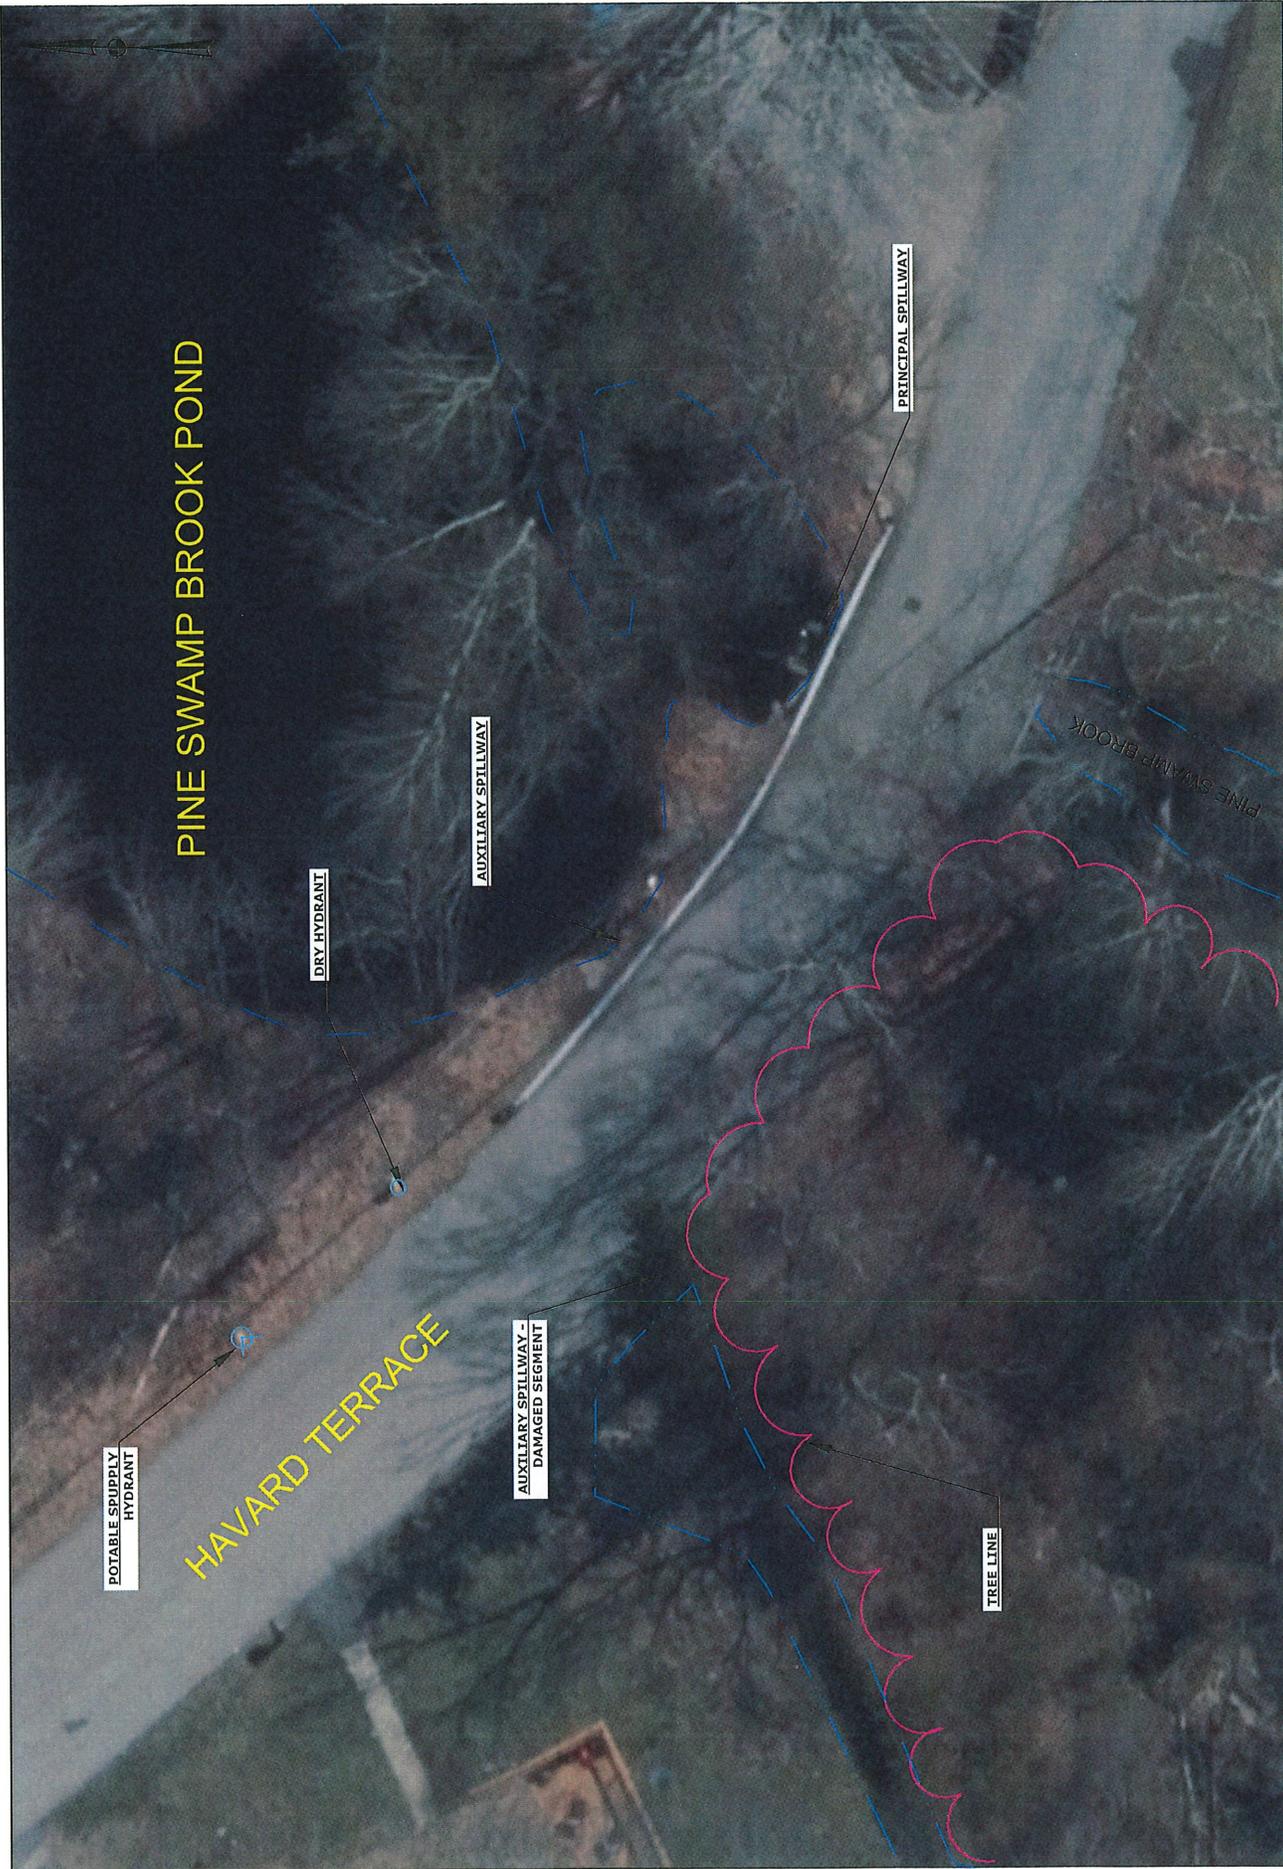
| SUPV. | S.R.M. | PINE SWAMP BROOK POND DAM - #7212 SKETCH MAP SCALE - 1:50 | SHEET 1 OF 1 |

AUXILIARY SPILLWAY -
DAMAGED SEGMENT
