Progress Report

LEDYARD SD
4 BLONDER PARK RD
LEDYARD, CONNECTICUT 06339

FACILITY: Gales Ferry School	ROOF SECTION: ALL	DATE: 11/18/2024
------------------------------	-------------------	------------------

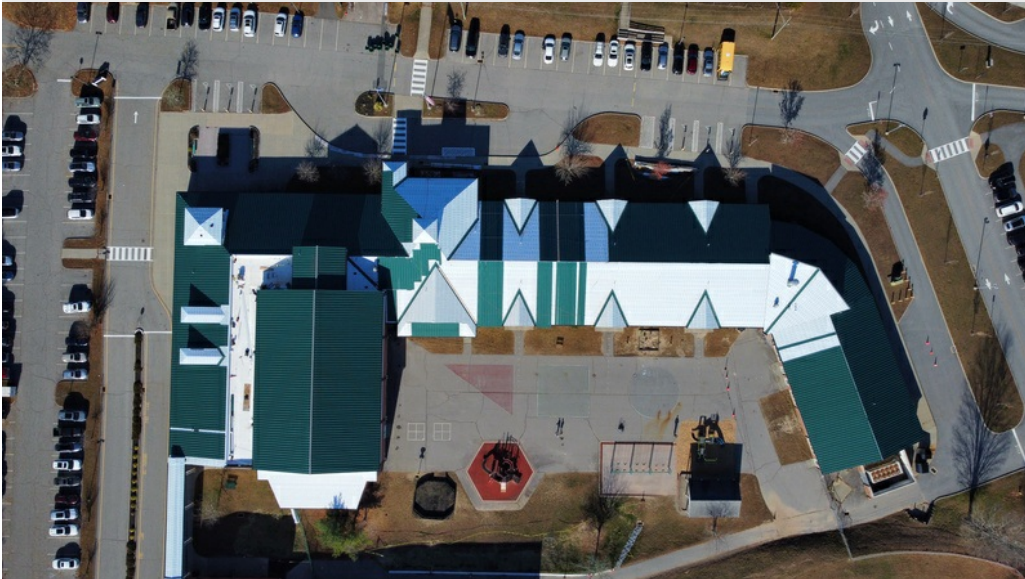
2

Overview- 11/14/24

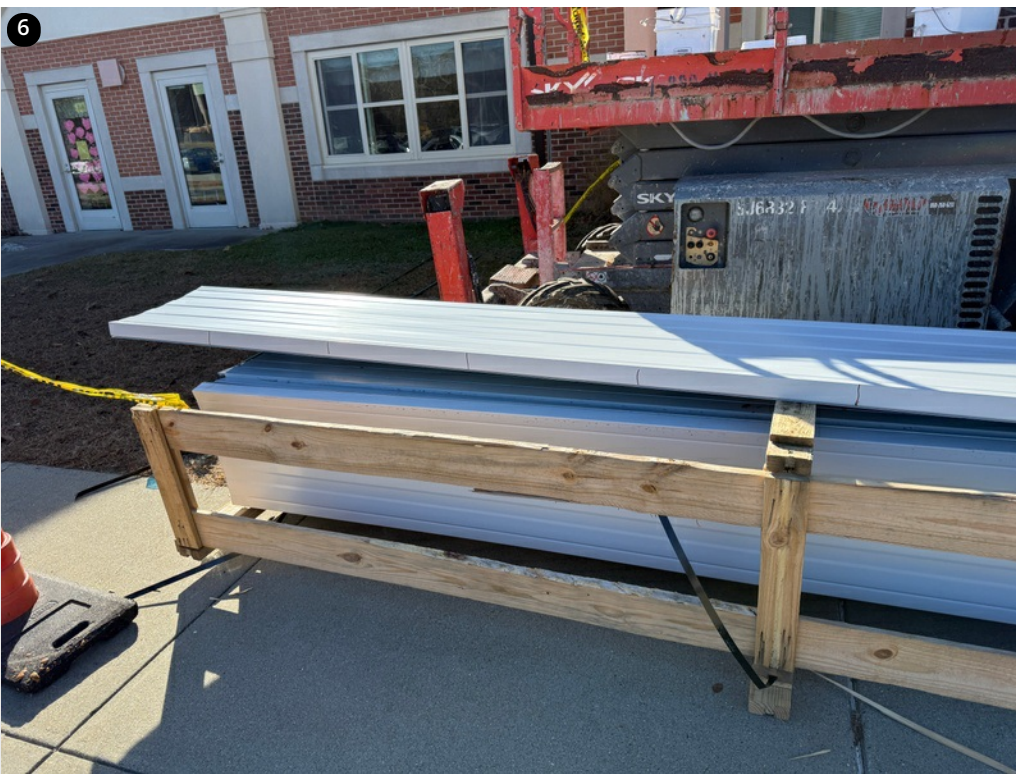
Clip spacing marked out on panels prior to install

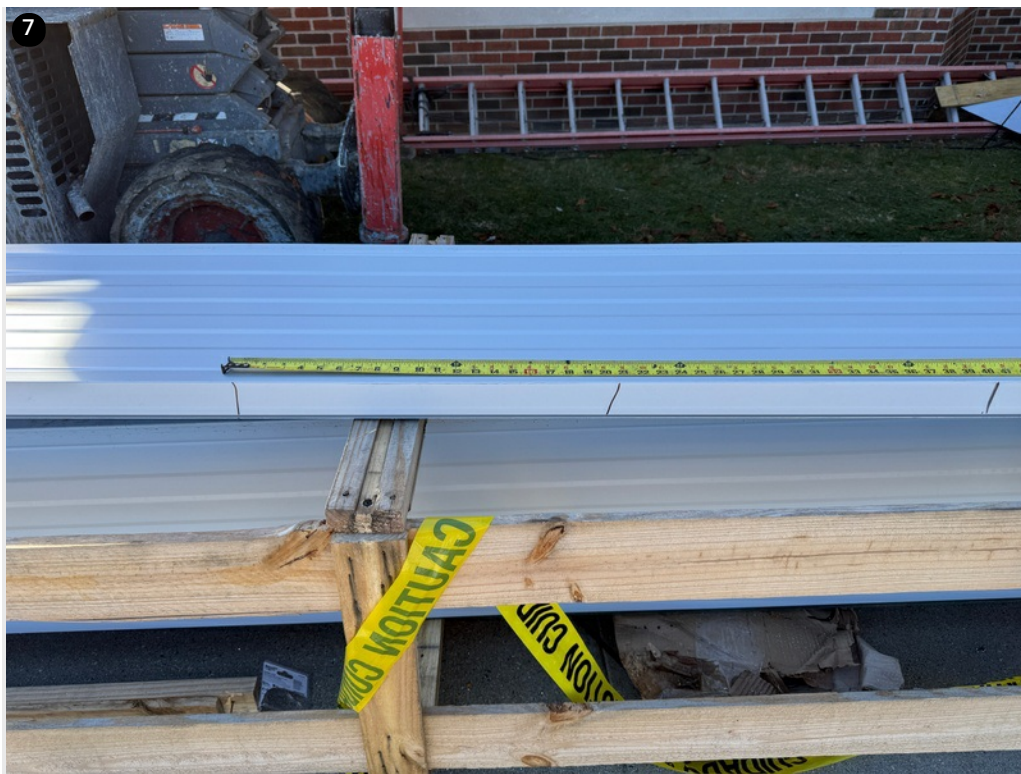
7
Clip spacing marked on panels according to zone

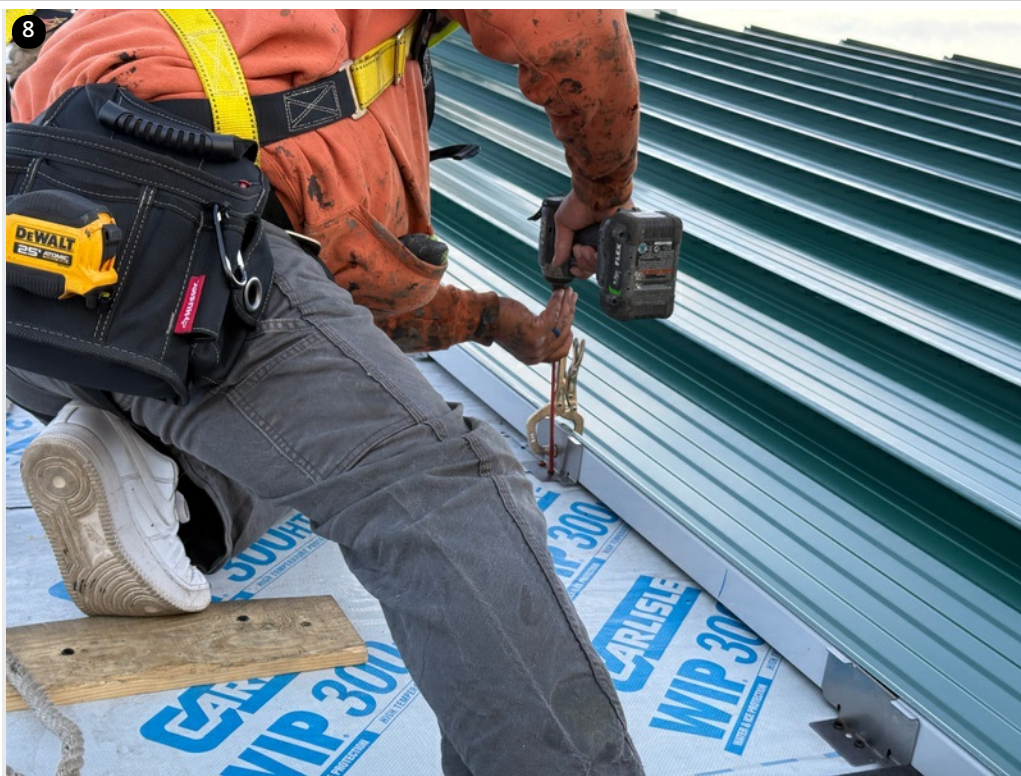
8
Crew fastening clips spaced at 1'8" using 8" red fasteners- 11/14/24

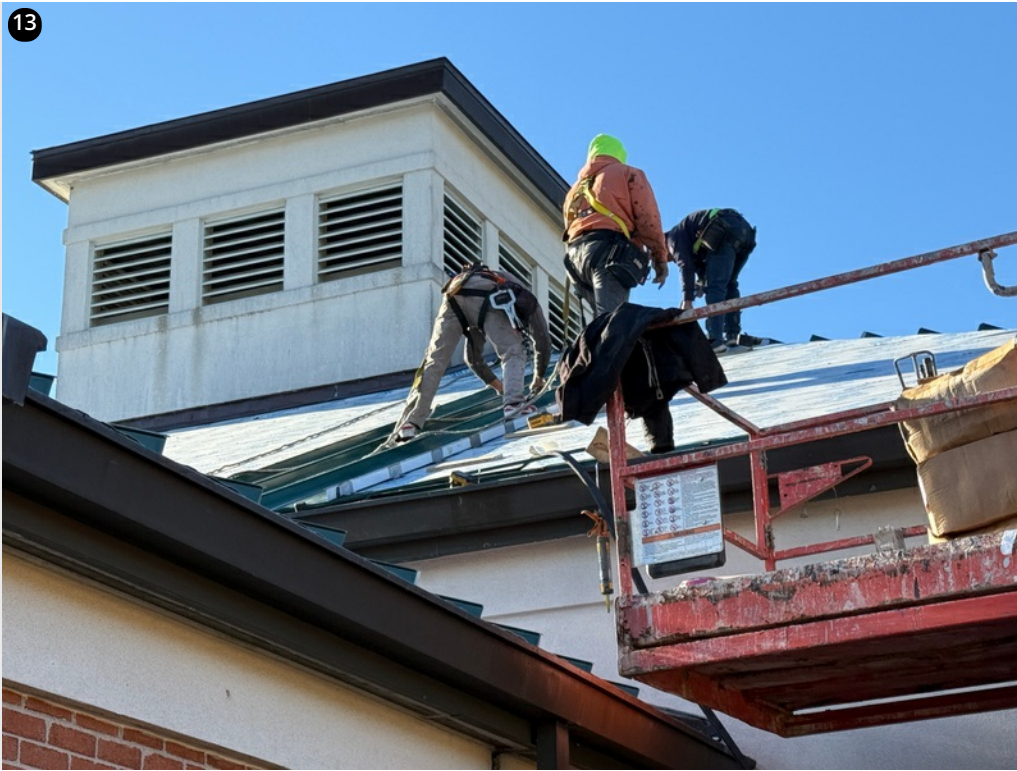
Crew fastening clips using 8" red fasteners- 11/15/24

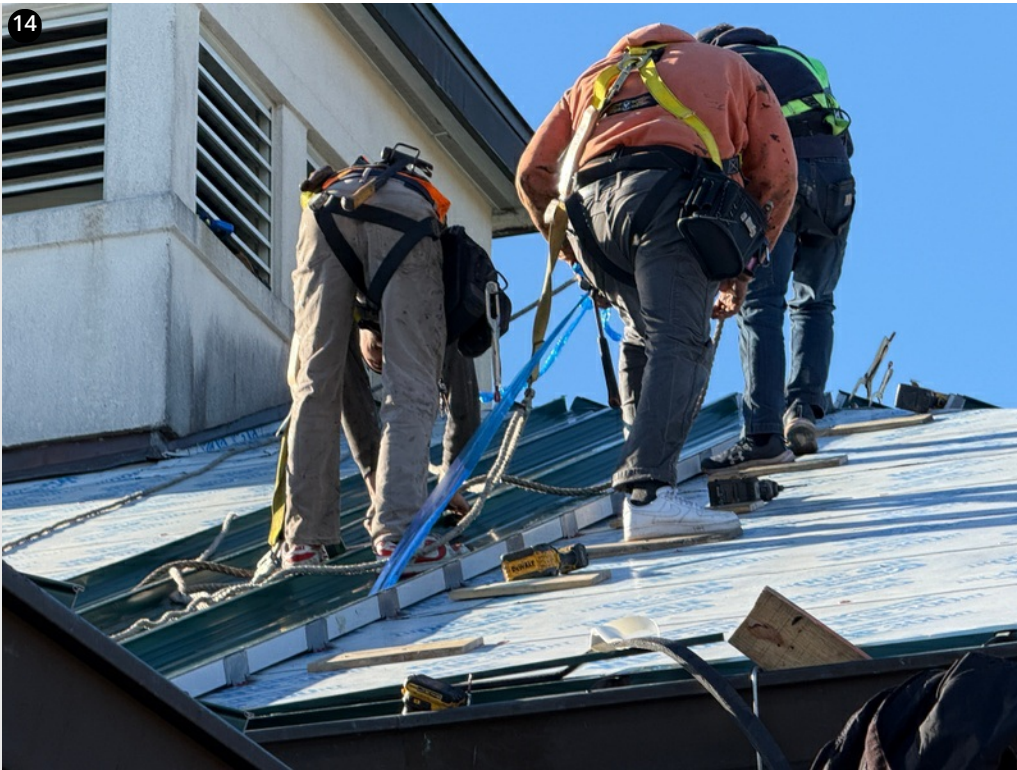
View of clip spacing- 11/15/24

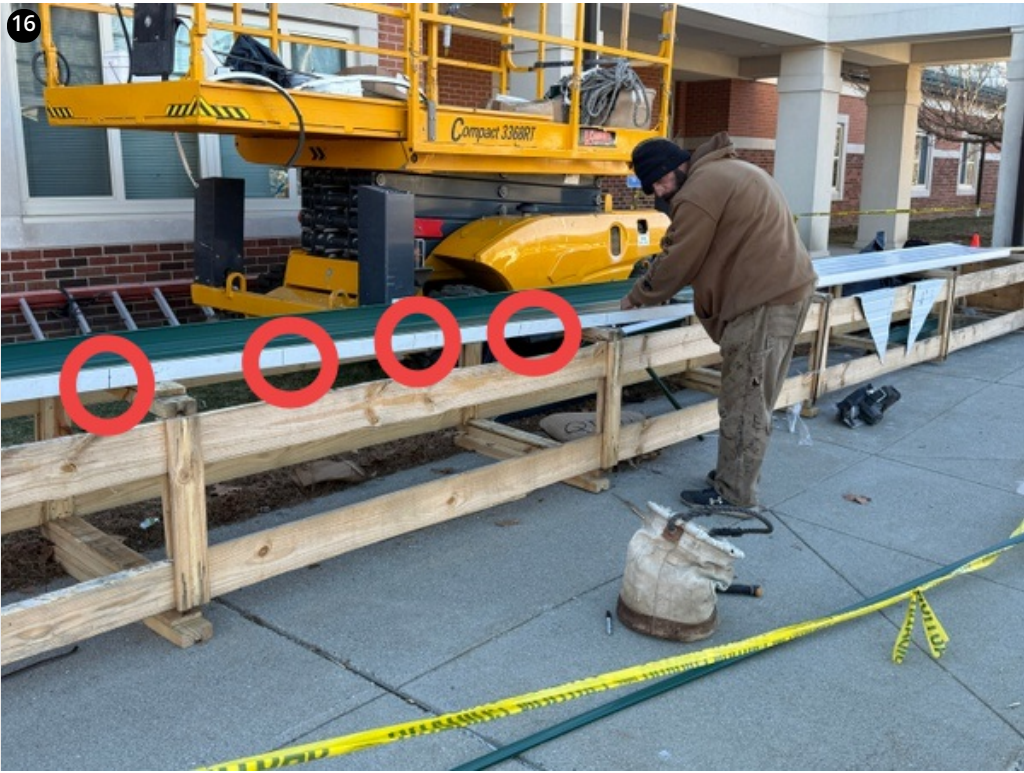
Crew marking out clip spacing per zone on panels prior to install- 11/15/24

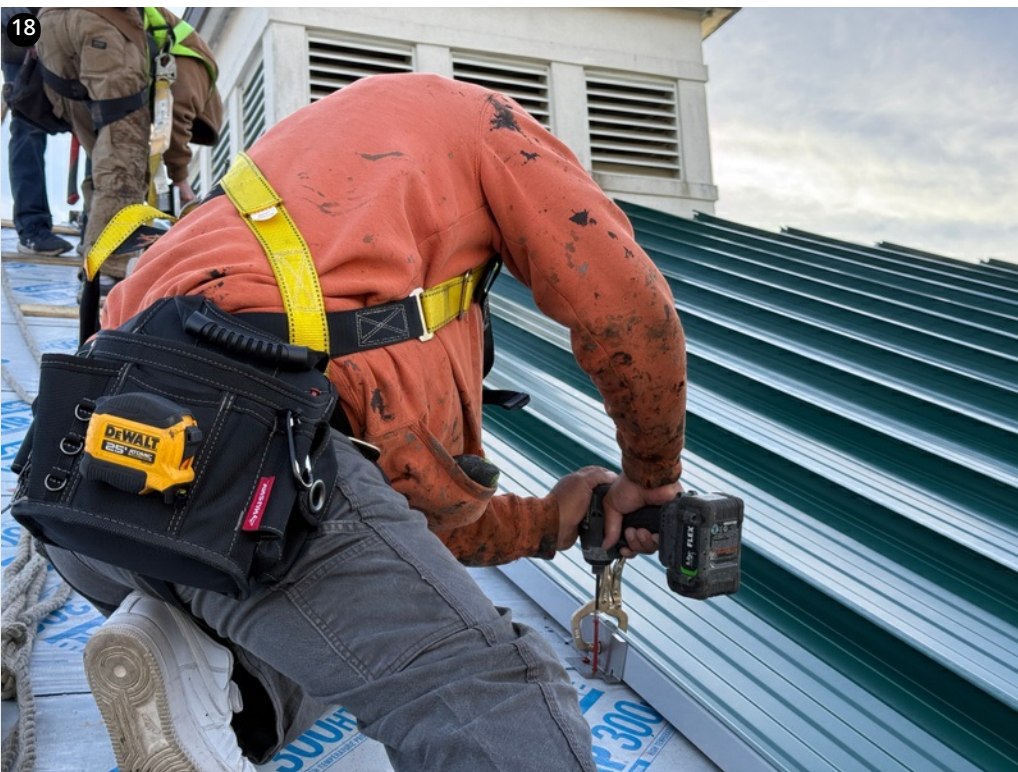
Crew fastening clips using red 8" fasteners

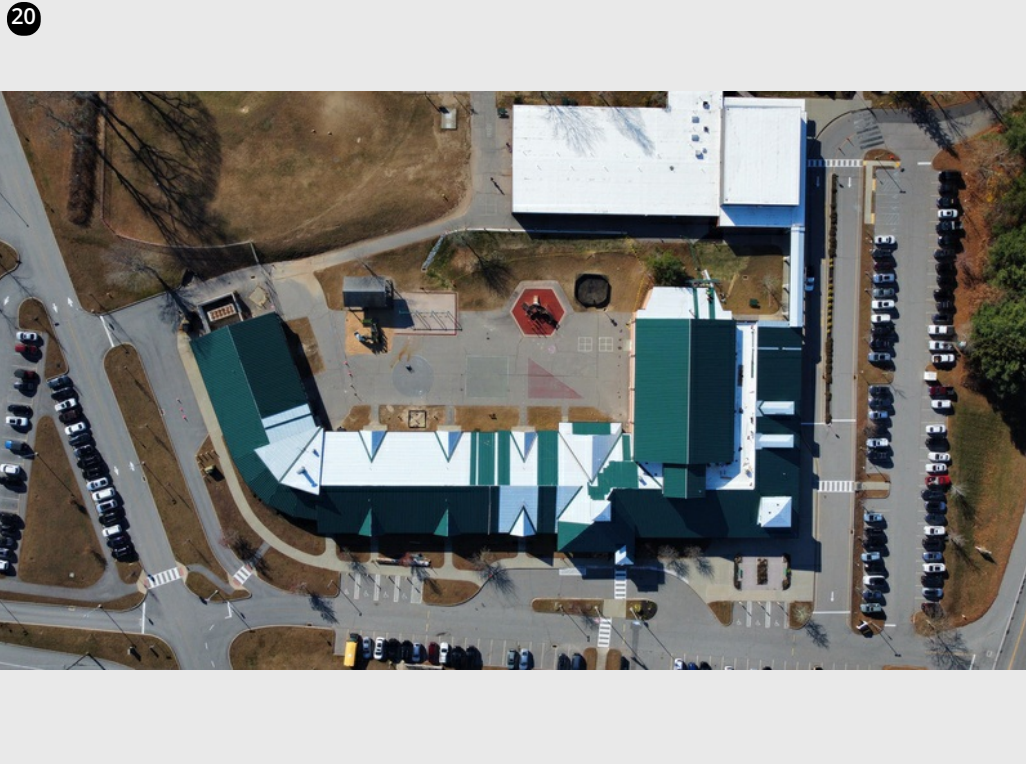
Overview- 11/18/24

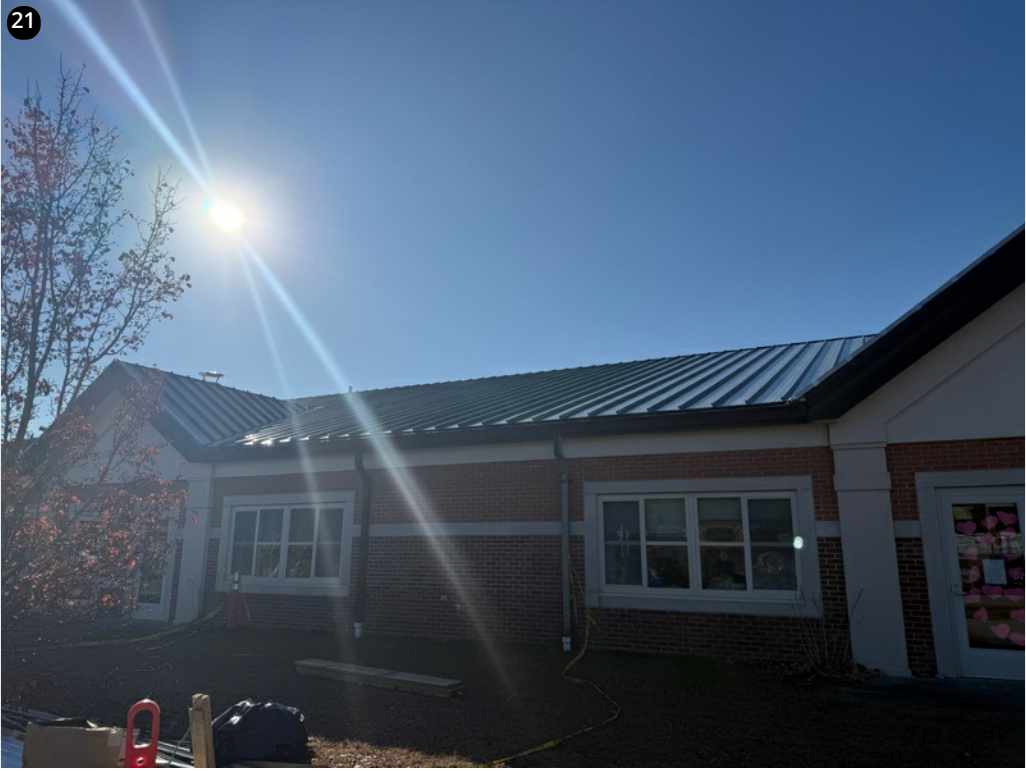
Panels installed 11/16/24

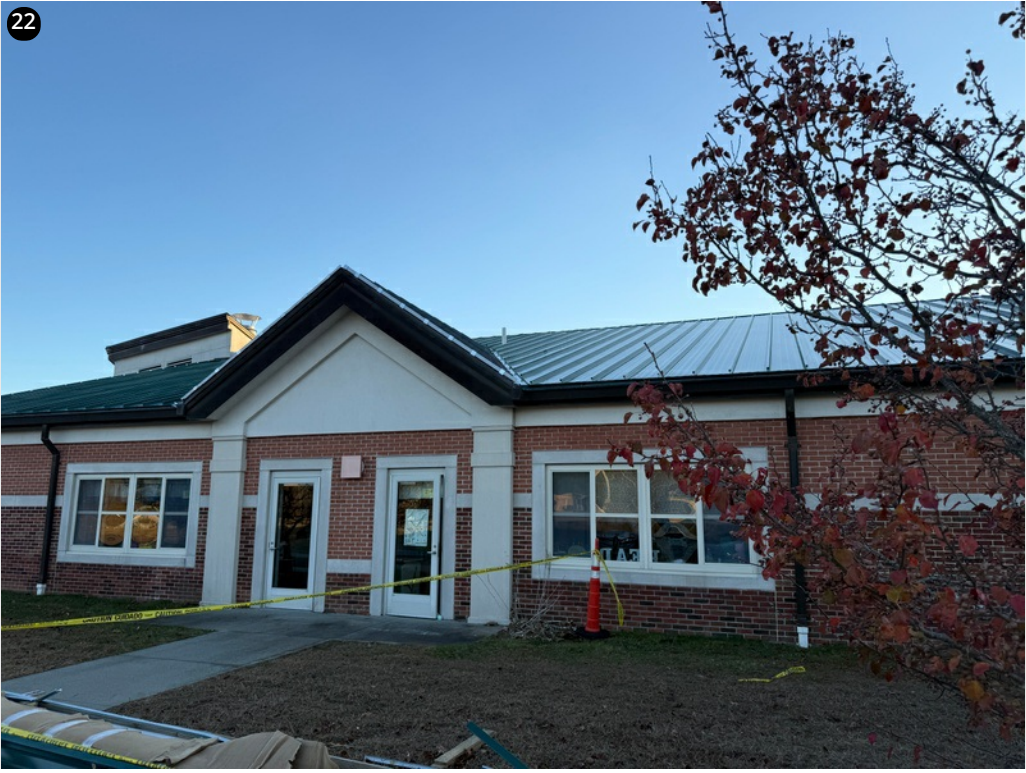
Panels installed 11/16/24

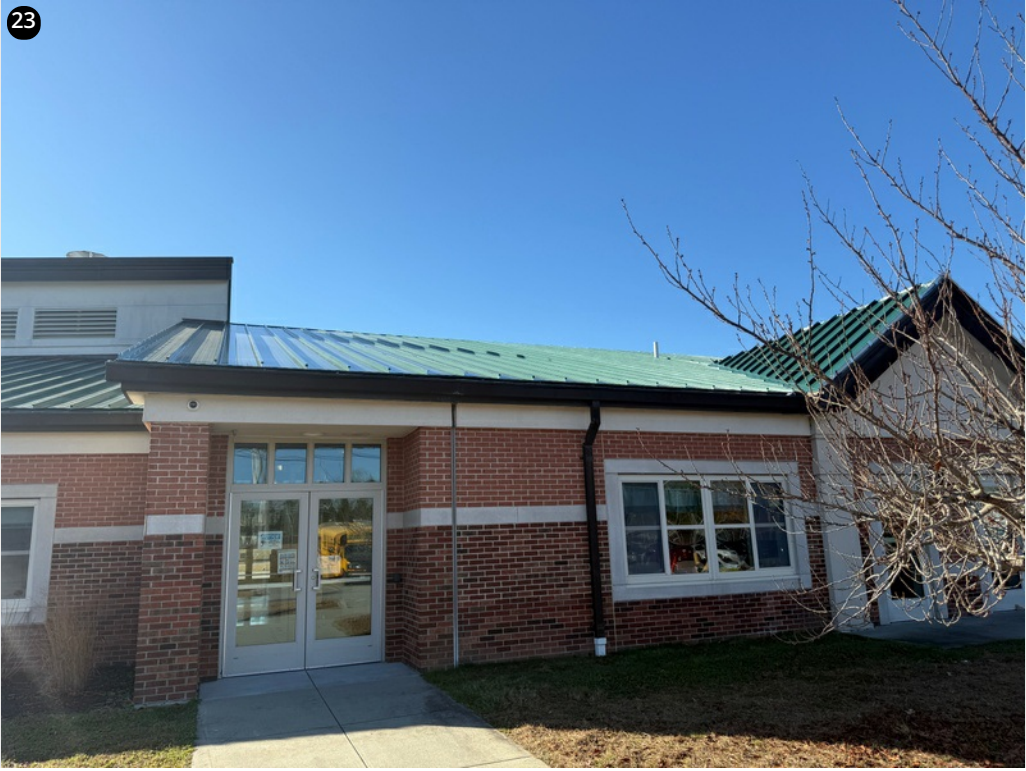
Panels installed 11/16/24

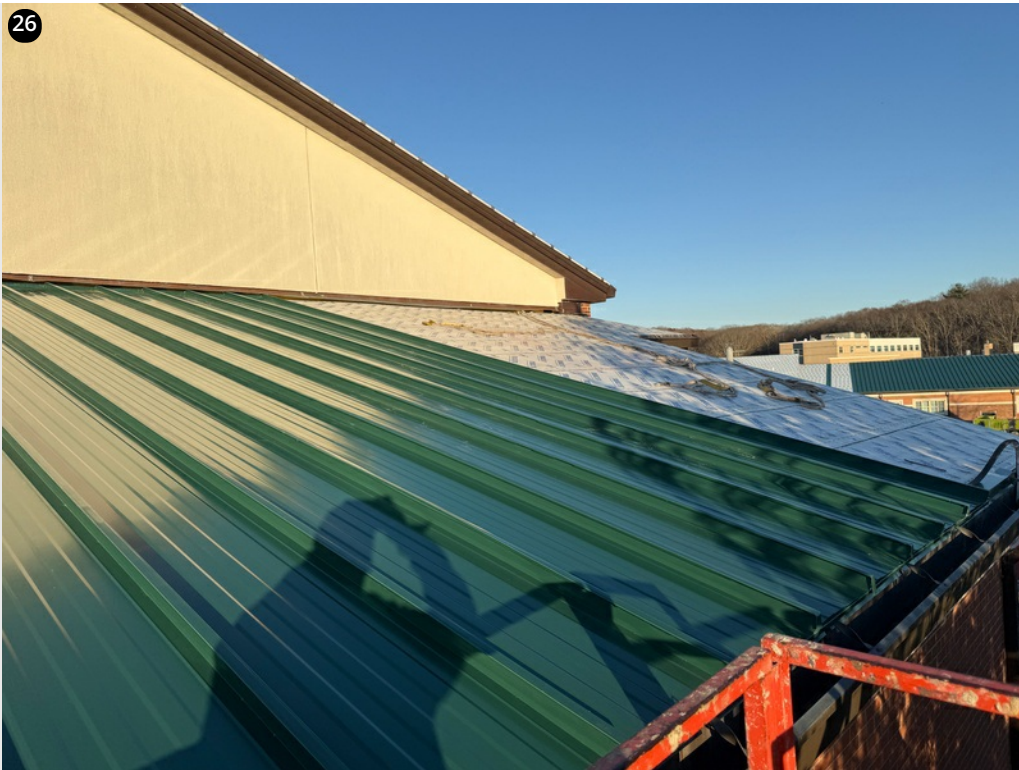
Panels installed 11/18/24

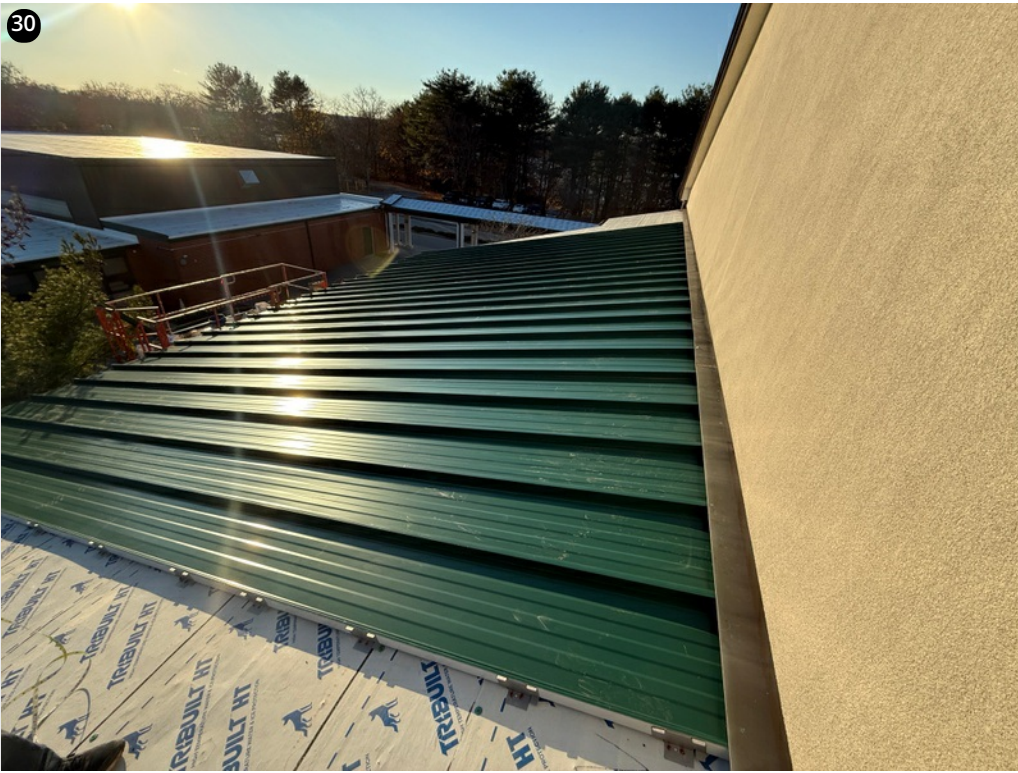
Panels installed 11/18/24

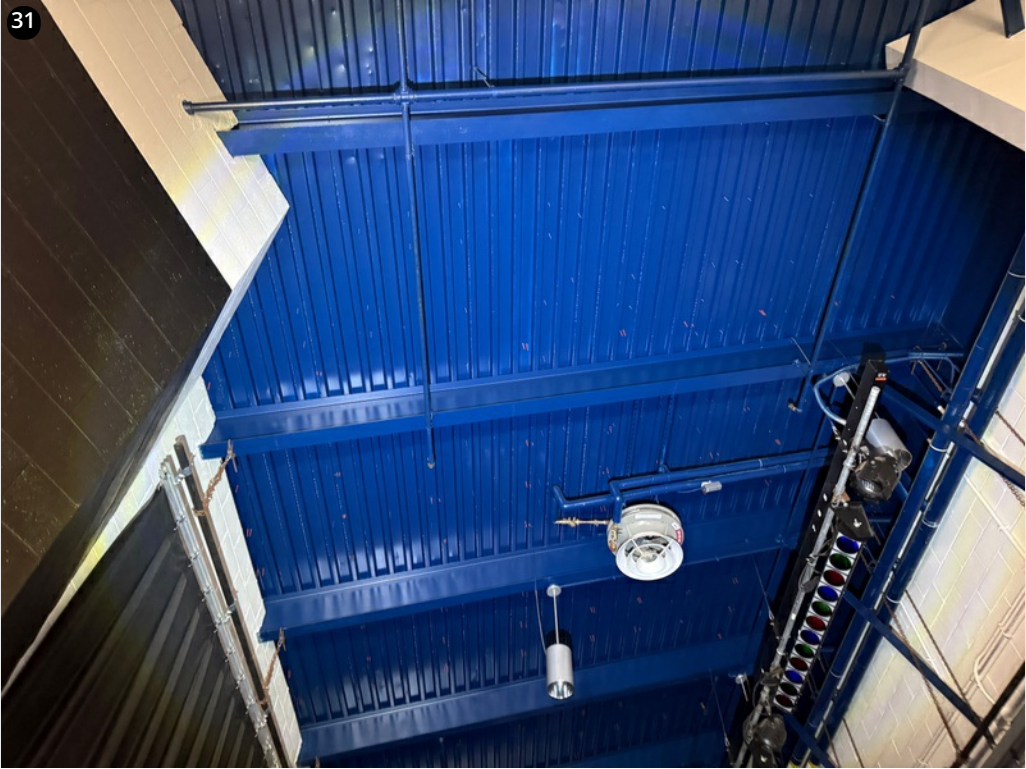
11/18/24- Fasteners visible properly penetrating deck

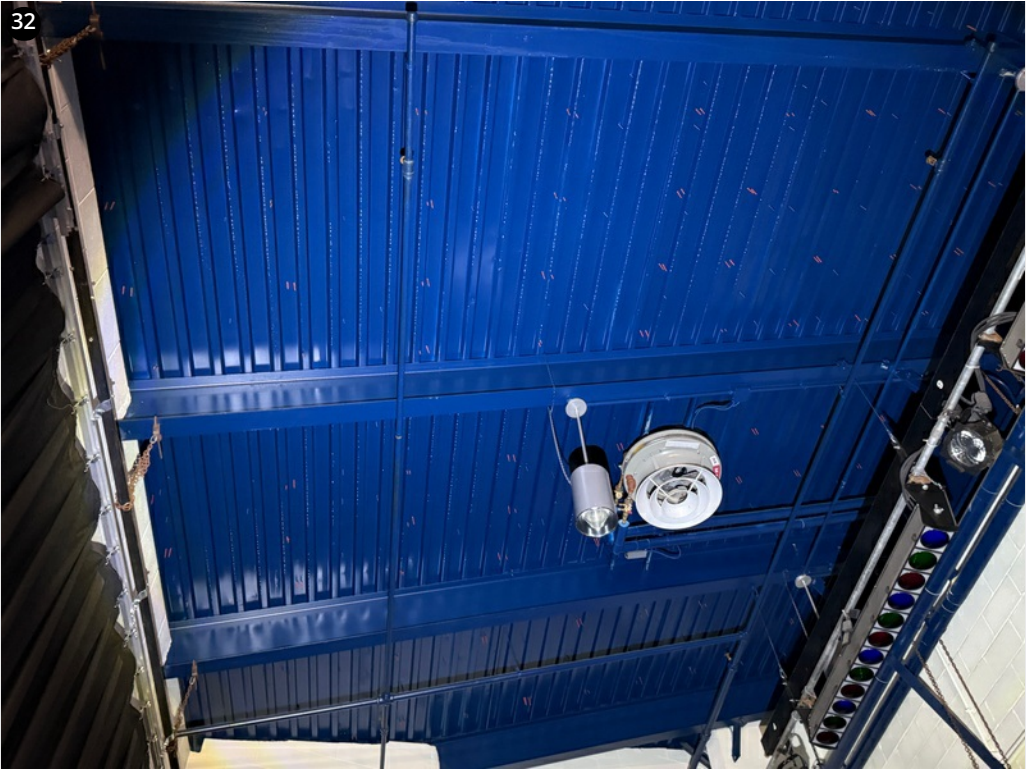
11/18/24- Fasteners observed properly penetrating deck
