Field Report No.: 21											
SP&A Project No: 22.331					Report Date: 1.28.2025		Time: 9:30AM				
Project: Gales Ferry School (Name & Location) 1854 CT-12 Gales Ferry, CT 06335											
General Contractor: The Imperial Company, Inc.											
Weather			Site Conditions			Day of Week					
<input type="checkbox"/> Temp. Range: 238°			<input checked="" type="checkbox"/> Clear			<input type="checkbox"/> Dusty		<input type="checkbox"/> Monday			
<input checked="" type="checkbox"/> Clear			<input type="checkbox"/> Muddy			<input type="checkbox"/> Windy		<input checked="" type="checkbox"/> Tuesday			
<input type="checkbox"/> Overcast			<input type="checkbox"/> Other					<input type="checkbox"/> Wednesday			
<input type="checkbox"/> Rain								<input type="checkbox"/> Thursday			
<input type="checkbox"/> Foggy								<input type="checkbox"/> Friday			
<input type="checkbox"/> Warm								<input type="checkbox"/> Saturday

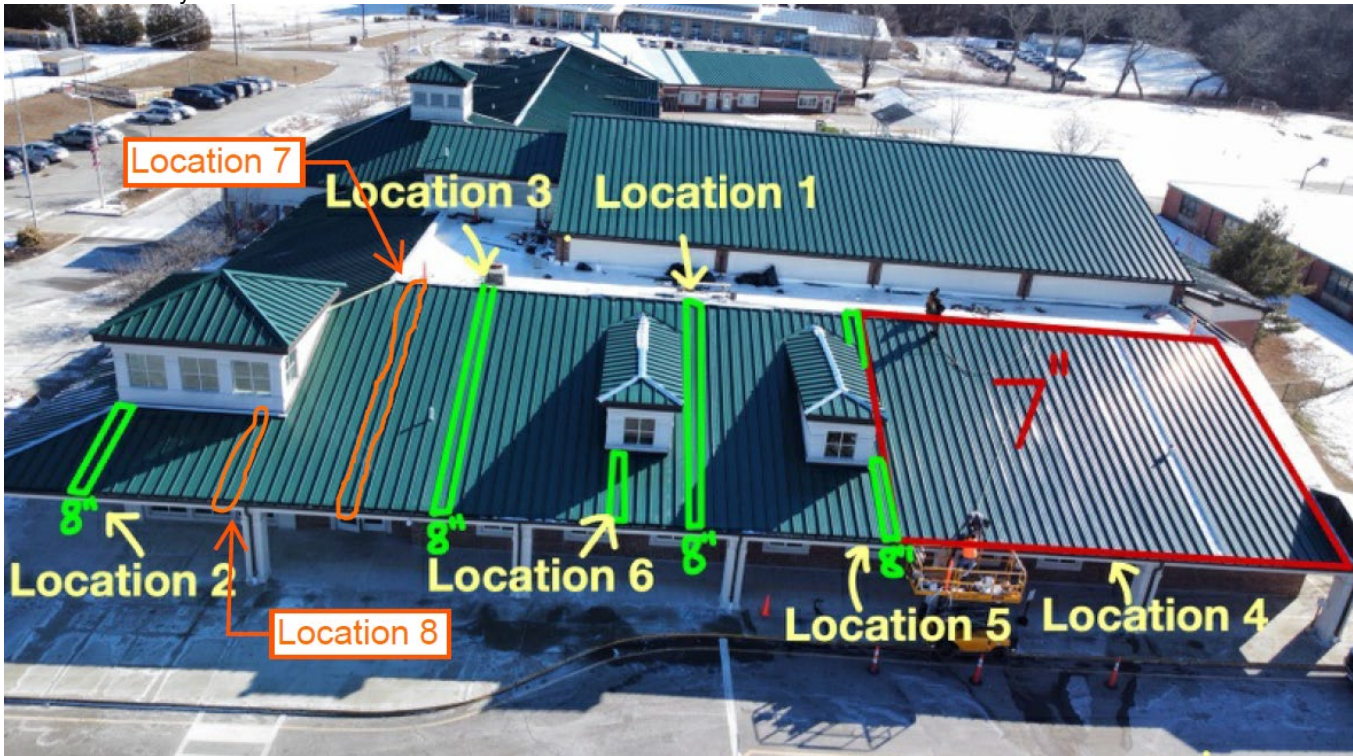
**Roof A - West Elevation –**

Locations marked as locations 7 & 8 were found to have 8" screws and were picked by random by SPA for verification. Other locations were reviewed by Garland -

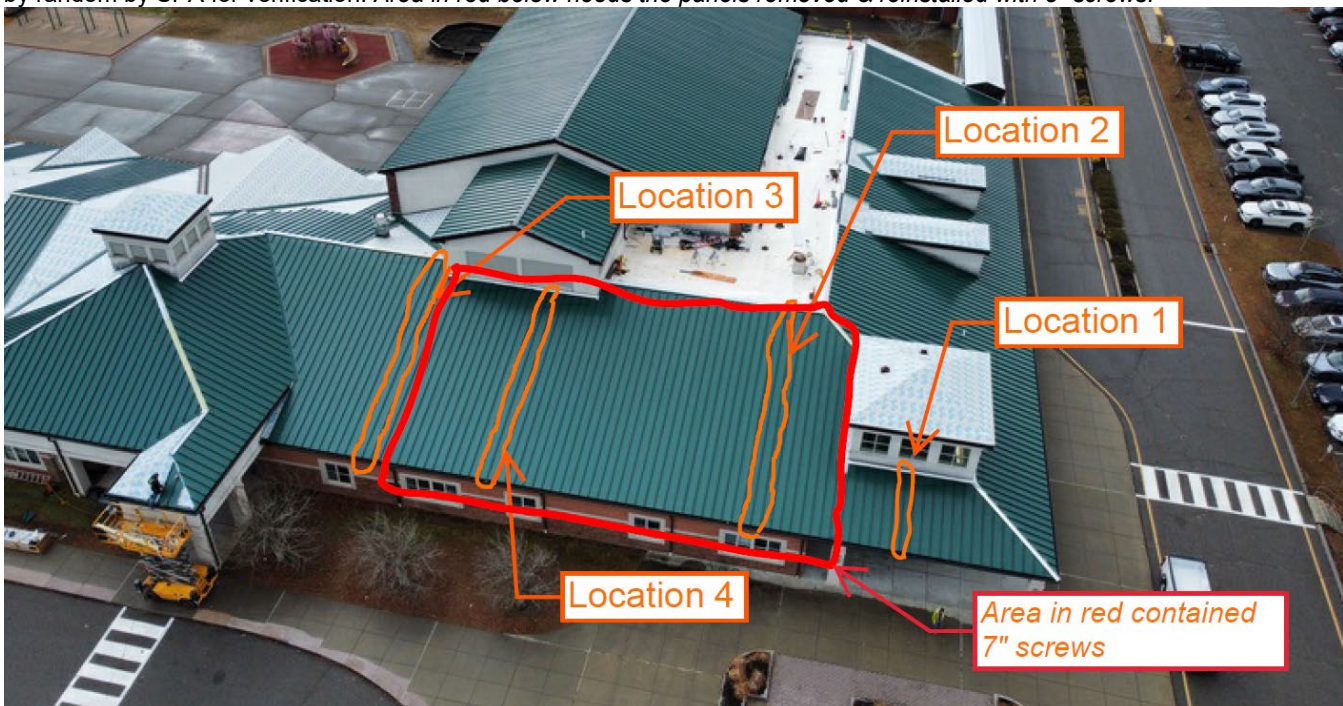
**Roof A - North Elevation –**

Locations marked as locations 1 & 3 were found to have 8" screws and locations 2 & 4 were found to have 7" screws and were picked by random by SPA for verification. Area in red below needs the panels removed & reinstalled with 8" screws.

- Past issues that need to be resolved - Panels that were installed and have short screws that need to be replaced need to be observed for the correct screw length by Garland & SPA in areas where the underside decking is not visible. See attached photo.

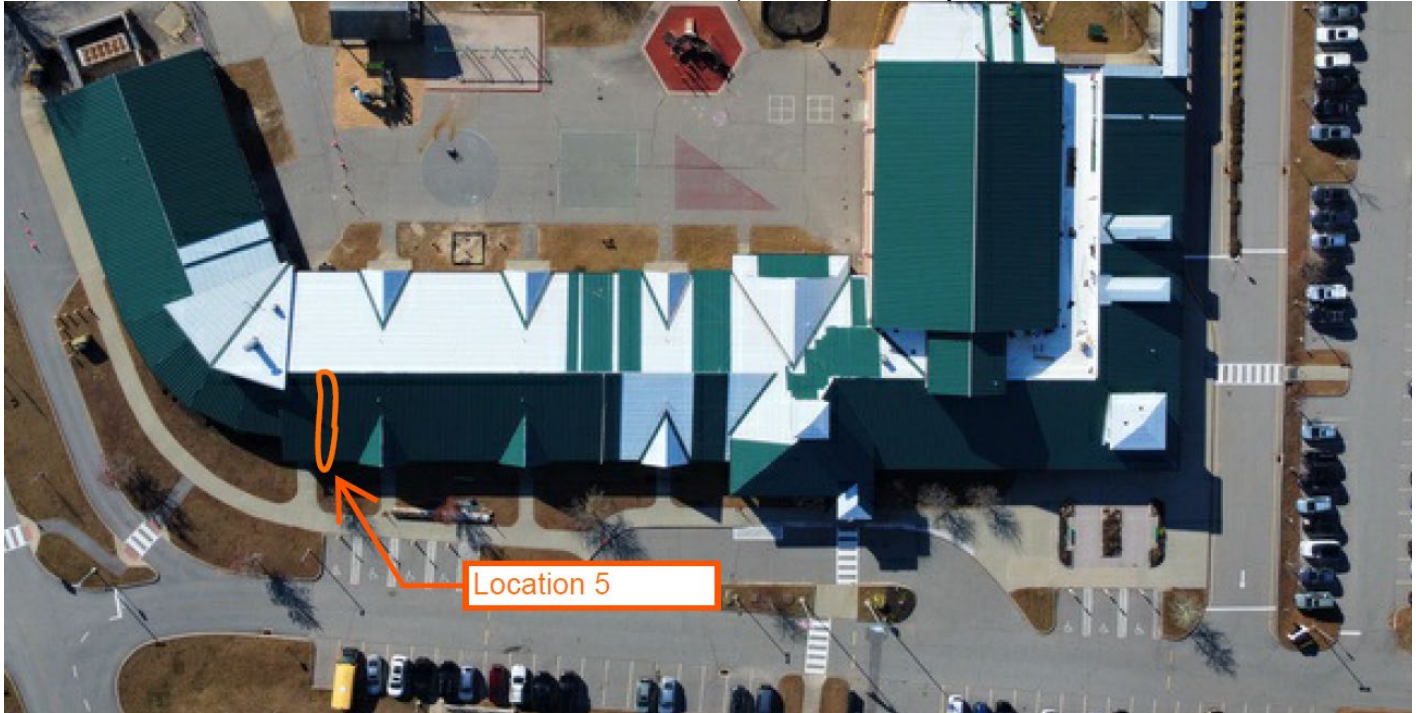
### Roof D - North Elevation –

Location marked as location 5 was found to have 8" screws and was picked by random by SPA for verification -
