## 23-1091 - Ledyard potential sites with maps

## **Draft Ledyard Proposed Projects List**

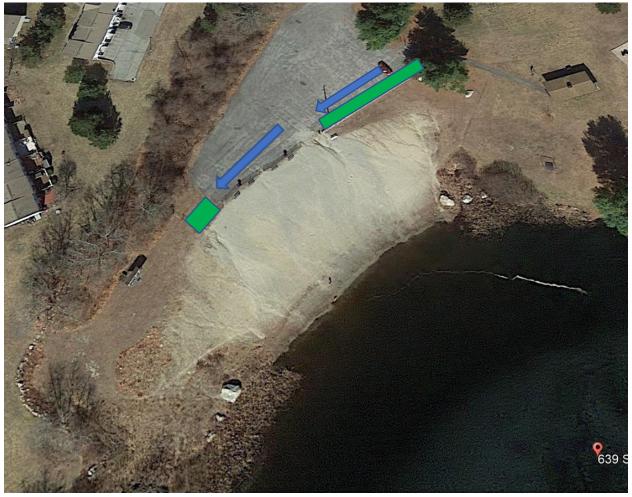
Highland Lake (goose poop issue)

Beach erosion is being caused by parking lot runoff. This site may benefit from 2 rain gardens. Blue arrows show the current direction of flow of stormwater runoff. Green areas demonstrate potential rain garden areas.

Garden 1 would be along the parking lot side of an existing stone wall, between the stone wall and the pavement to the opening to the beach access. An existing power pole may lead to buried utilities in the area. CBYD would need to be consulted prior to further planning this area. If this site selected, the stormwater overflow could be redirected to the eastern end of the stonewall to the grassy area. The swale can be extended to prevent any high-volume flow from being discharged onto any sandy surfaces. Curb stops may be needed to prevent cars from parking too close to the garden. (Curb stops would not be paid for by the grant.)

Garden 2 would be to the western end of an existing chain link fence to a grassy area. A grass pathway to the existing handicap picnic area would remain.

Barrier fencing is a very effective method for excluding walking geese from your yard. This method consists of placing a physical barrier that geese cannot pass through between the water and the area you want to protect. Barrier fences can be purchased or constructed from woven wire, plastic construction fence, chain link, netting, wood, or boulders. Retractable fencing is also available from Lake Restoration, Inc. An effective barrier fence for walking Canada geese uses durable material with openings no larger than 3 inches by 3 inches that is at least 24 inches high. Before you build any fence, check local ordinances and subdivision covenants. However, low fences may also be a temporary solution when geese have young or are molting. For example, 5 strands of 20-pound-test monofilament fishing line, strung at 4, 8, 12, 18, and 24 inches above the ground will exclude walking geese. Flag the lines to warn people, and expect pets and wildlife to knock them awry.

The downside of barrier fencing is that it would require staff to be on site to remove the fencing when the beach area is in use, and to close access to the beach when there is no human activity.

Signage regarding the hazards of feeding/attracting waterfowl may be available from CT Sea Grant.

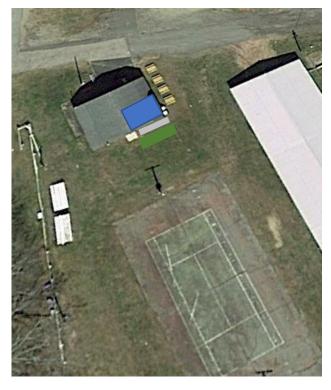
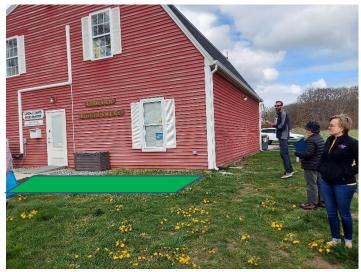
Ledyard food pantry, 740 Colonel Ledyard Hwy Food by the farmers market pavilion

There are existing downspout on all building corners

The garden would be highly visible area near farmer's market.

In rain garden (green polygon in the above image) will be small enough to not interfere with existing

uses of the area if designed to be square with the existing infrastructure.

In the above image, based on the roof area that drains to the downspout (blue polygon), the rain garden (green polygon) would be about  $60 \text{ ft}^2$ , or  $6 \times 10 \text{ feet}$ .

DPW planning to install a gravel strip around the building foundation. The existing outlet on the building corner would still be accessible.

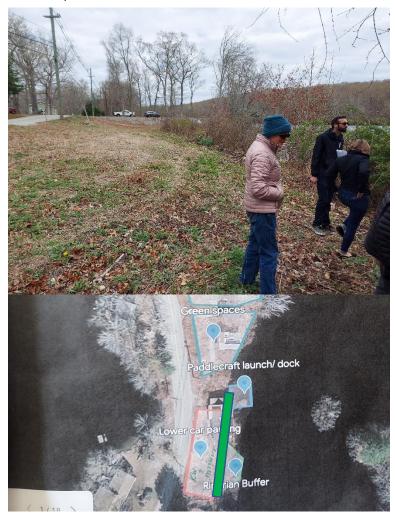
Lantern Hill Valley Park – Enhanced riparian buffer along the lower portion of the park where a new boat launch is planned.

An existing riparian buffer in the lower section of this new park is 5-10 feet wide. The proposal is for volunteers to remove invasive species prior to enhancing the existing buffer to a wide of approximately 15-20 feet

wide using native trees and shrubs. A gap will remain for car top boat access to Bush Pond.

Mugwort and Japanese knotweed are the dominant invasive plants in the lower area, with mugwort being established along the existing buffer and the Japanese knotweed more in the open area intended to be developed into a small parking area. Multiflora rose, garlic mustard and autumn olive were also noted in lesser amounts.

Measures to remove the mugwort would be recommended prior to planting native plants in the proposed enhanced riparian buffer area. Additional plantings could be established to prevent erosion in the upper section of this park.

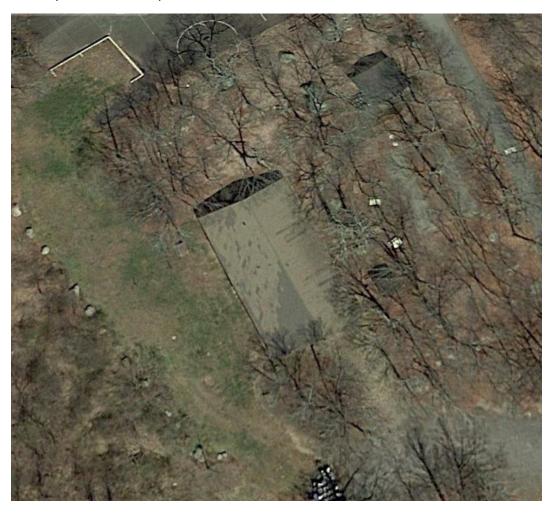
## Col Ledyard Park behind pavilion

The pavilion roof has gutters but no downspouts.

There soil appeared compacted and rocky. A sizable patch of invasive mugwort was near the proposed site.

There was no nearby water resource for maintaining the rain garden as it is becoming established.

This site may not be suitable for installation of a rain garden.

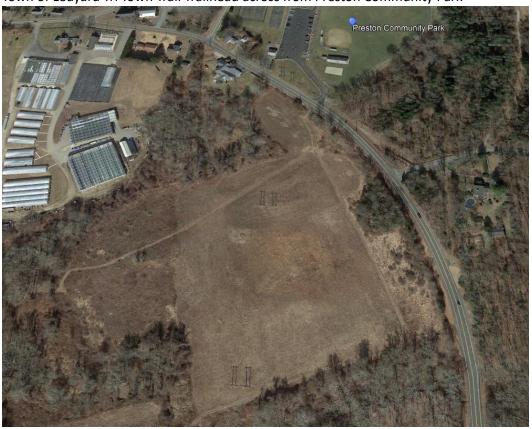
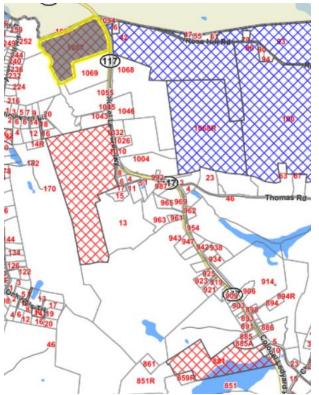
Town of Ledyard Tri Town Trail Trailhead across from Preston Community Park

Northeast Utilties will be improving the parking area at this location within the next two months. There may be possible to request them to excavate a rain garden during that parking lot construction.

The existing land cover is an old farm field dominated by a type of golden rod. The site, as is, is already pollinator friendly. Golden rod is an aggressive grower and will likely take over the rain garden without a lot of intervention.

There is no onsite water resource for watering the rain garden.

This site was not favorable for the installation of a rain garden.

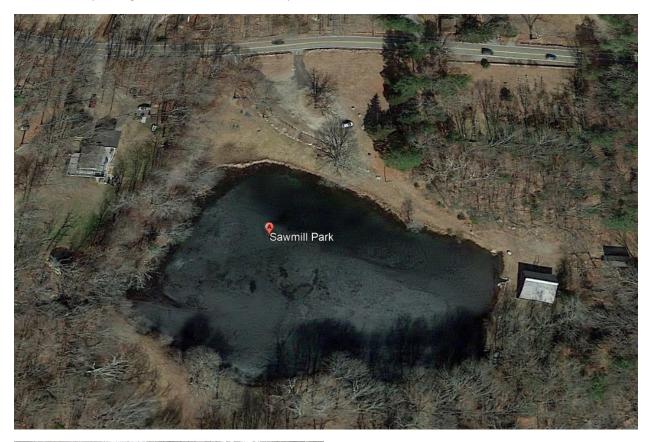
### Sawmill Park, Iron Street

Old mill site, parking lot runoff drained to the pond.

to the lower grassy areas where erosion is evident.

The parking lot is upslope of Sawmill Pond. The main drainage path from the parking area is paved. Additional foot traffic from the parking area to the grassy area next to the pond has created substantial erosion.

There is a natural low spot to the west, northwest of the paved leak off from the parking area. This area is in front of the stone retaining wall. If this area meets the perk test requirement, it would make a good location for a rain/pollinator garden.

The size of this garden will depend on the area of the upslope drainage.

Recommendation 1: install a rain garden planted with pollinator species in the area to the left of the paved parking lot leak off.

Recommendation 2: (not covered by the grant) discourage foot traffic on the fragile slope or install an appropriate reinforced walkway or stairs
