TOWN OF LEDYARD
CONNECTICUT
PUBLIC WORKS DEPARTMENT

Pine Swamp Brook Pond Drainage Remediation (IWWC#26-3SITE)

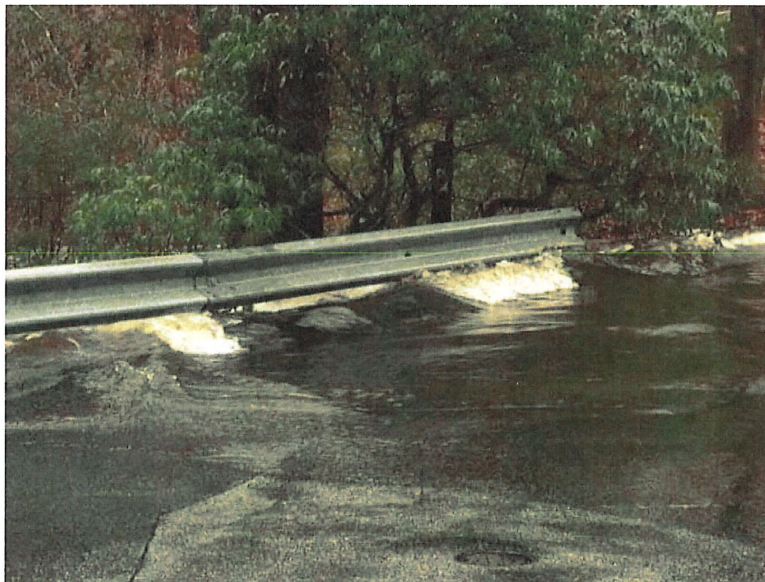
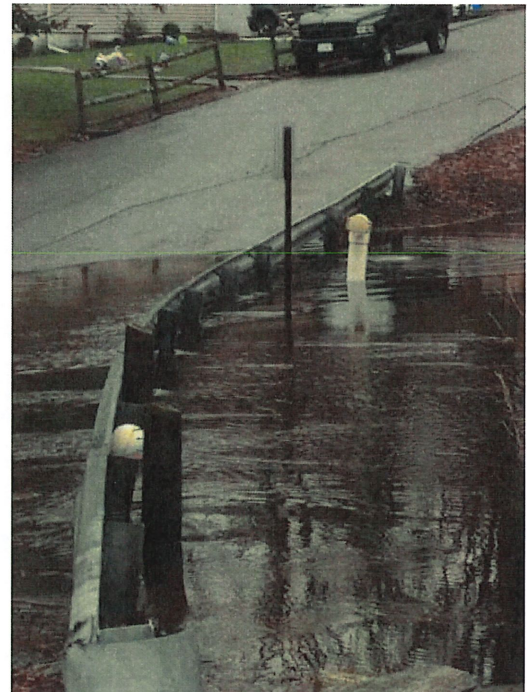
This application addresses this and other needs to provide further flooding protection at the Pine Swamp Brook Pond dam at Harvard Terrace. One of the outlets of the pond has been at least partially obstructed by an earthen berm, which was further reinforced by unauthorized activity last summer. This has only exacerbated a condition of inadequate capacity of discharge flow, leaving the dam further vulnerable to overtopping. This is not a hypothetical concern; flooding has occurred in at least two instances, one in May 1989 and the most recent (photos below) in March 2010.

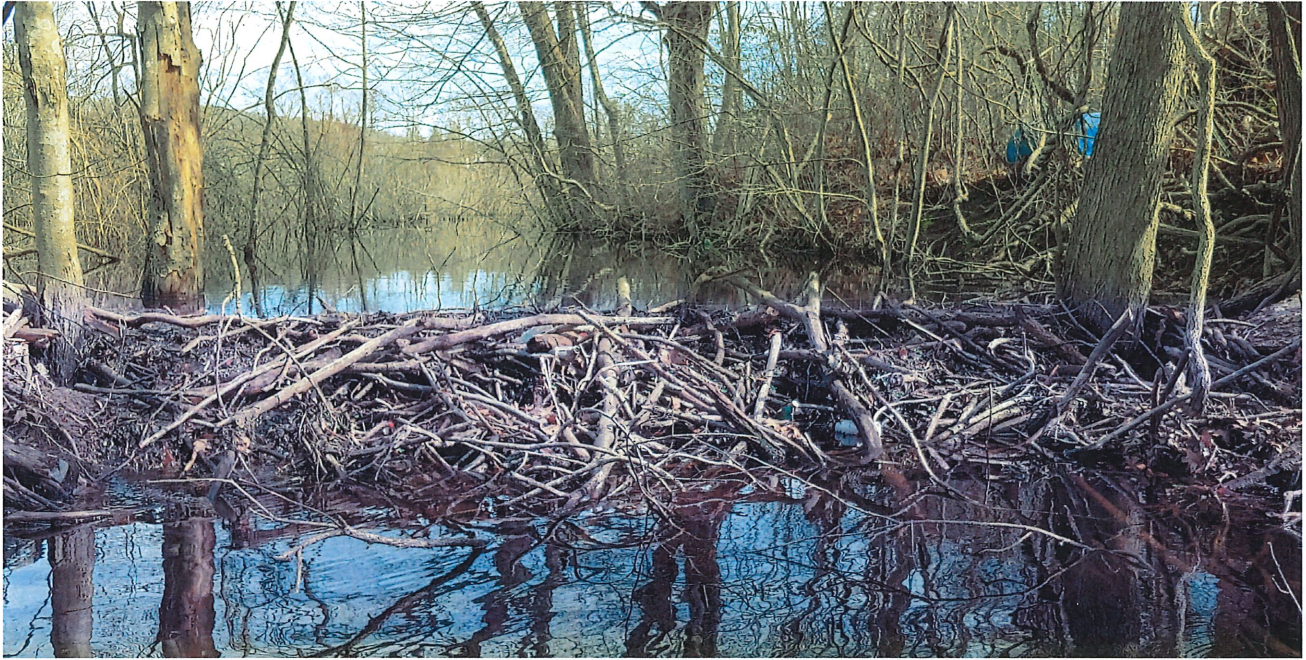
Most recently, even apart from extreme flooding situations, beaver activity (see below photo) had compromised the flow capacity in the vicinity of the pond to the point that water was backing up all the way beyond the brook crossing at Route 12 to properties north of Christy Hill Road. This was a primary basis for immediate rectification.

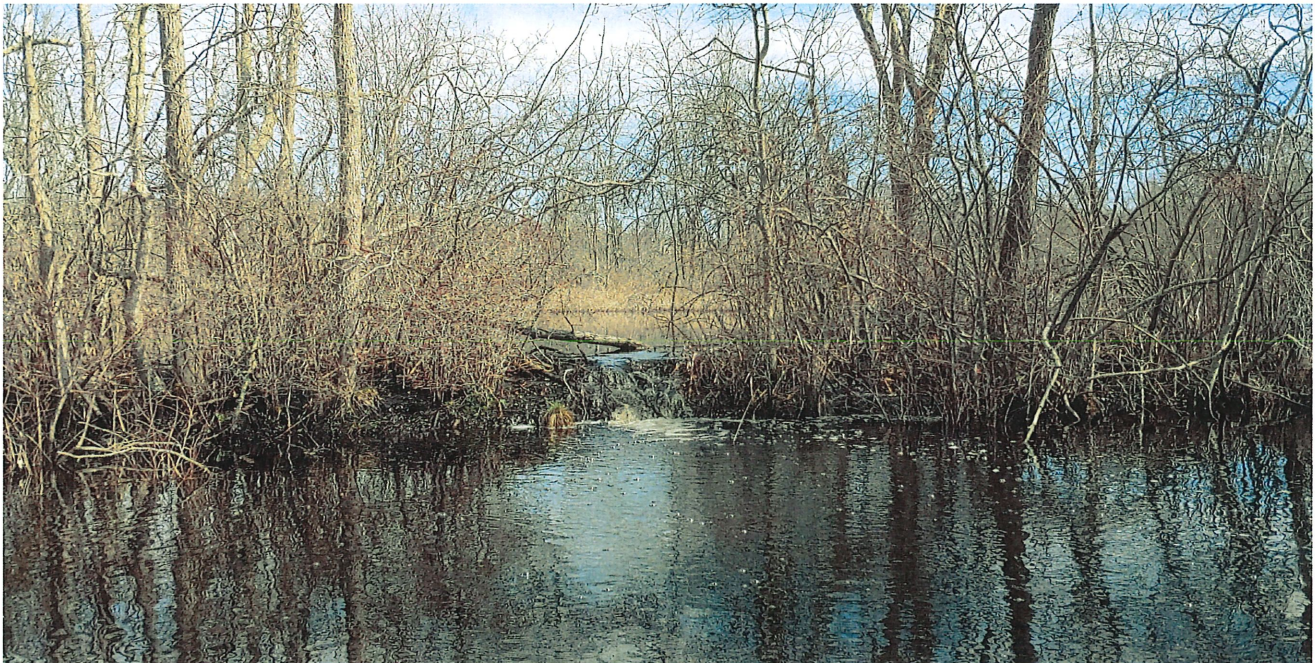
After the beavers were removed, because the beaver dam itself was inaccessible, Public Works Personnel were dispatched to relieve the flooding by cutting two trenches through a berm that separated the pond proper from the wetlands area in the watershed above it that was flooded by the beaver activity. The trenches were cut in two locations of additional activity (see photo below for one of these).

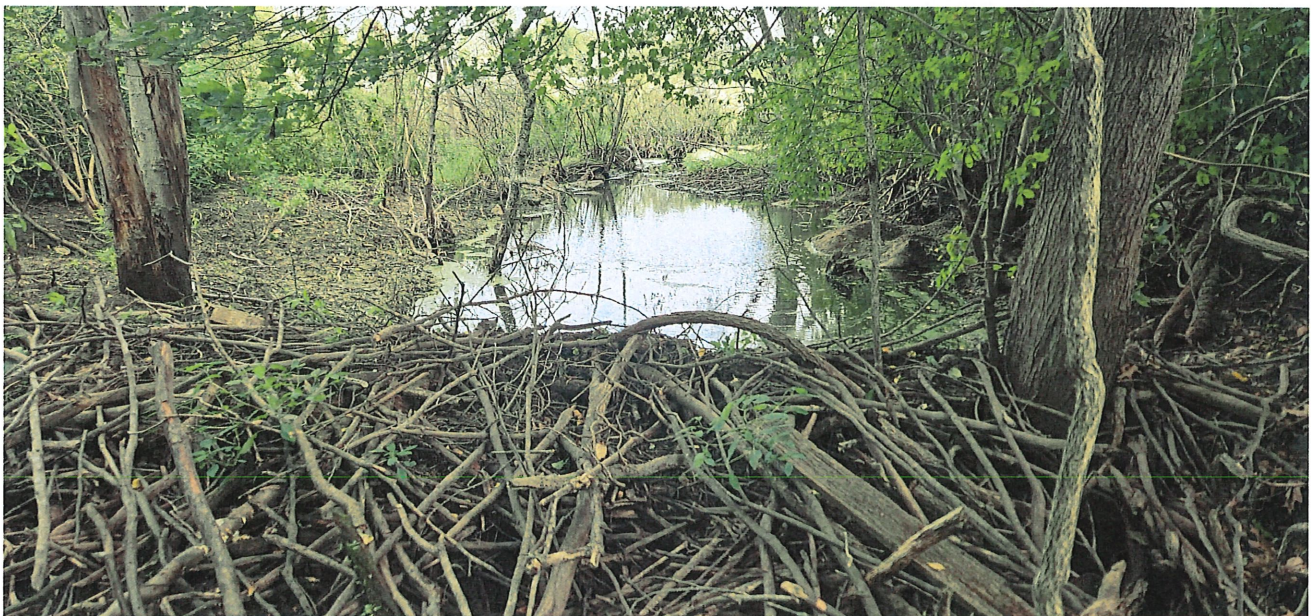
There are two remaining issues of primary present concern, one at the inlet and one at the outlet of the pond. At the inlet, the beaver dam remains as an obstruction in Pine Swamp Brook (see below).

Inlet: In order to remove the beaver dam, suitable equipment will be needed. Access is presently expected to be through 39 Military Highway and across the berm from west to east. This will require a small track excavator that would be able to navigate the narrow berm. The Town would also have to conduct brush and tree (several already dead) removal to clear an adequate path.

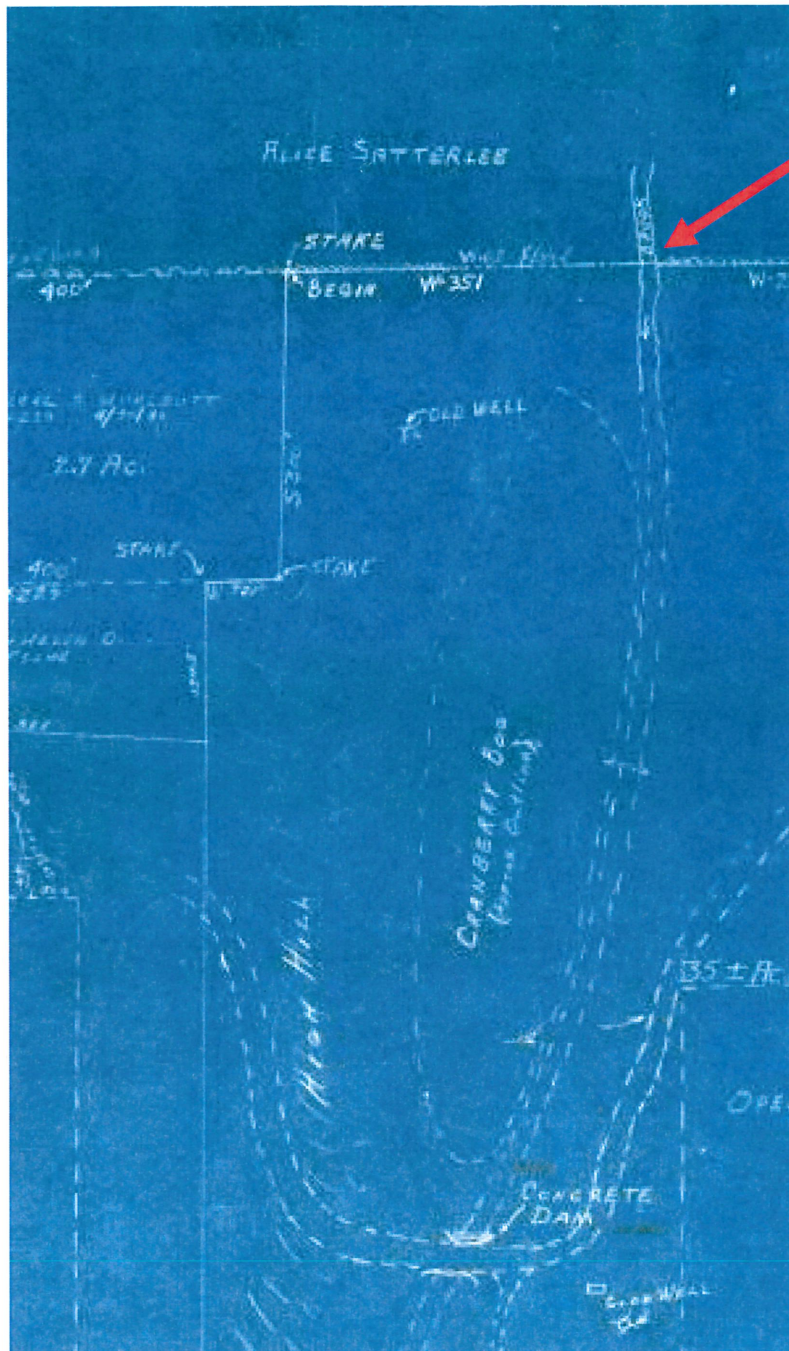
We do not know how long the beaver dam had been in place and altered the flow path over the berm, but the historic flow path to the pond has been through the brook at the east edge of the pond. This is confirmed by map #27A filed in the Town’s records that shows conditions as recorded in June 1948. (Excerpt below)

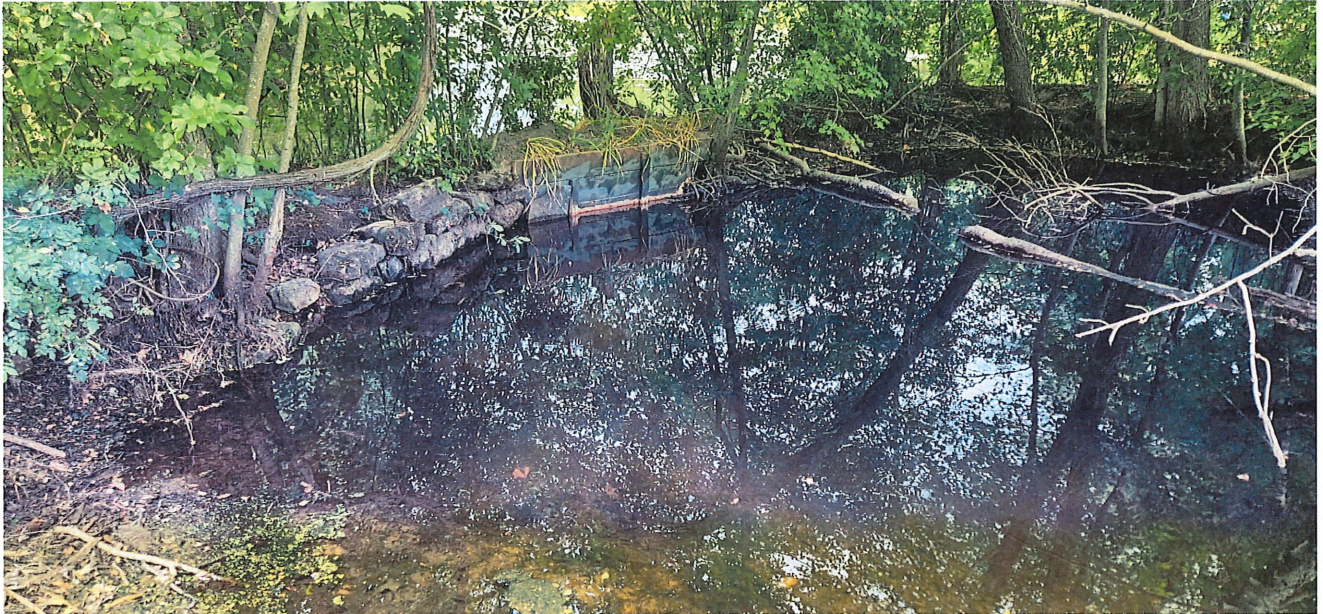
residents without due authority or permission filled this gap. The photo below shows the berm in its present condition with this “plug.”

As detailed in attachment 2, this berm compromises the discharge capacity at the dam, which in its unhindered state is already inadequate.

Outlet: The Town will remove the illicit “plug” and an additional section of the berm to open the drop inlet to normal pond flows. The total length of removal (including and in immediate proximity to the “plug”) will be about fifteen to twenty feet. The Town will conduct repair work at each of the two outlet structures to ensure maximum function.

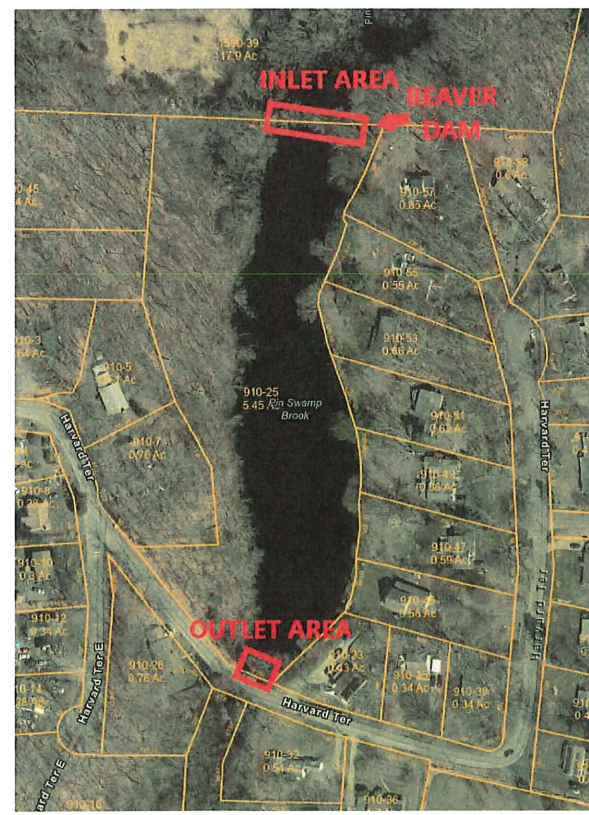
The Town proposes targeted actions at the two locations cited above, as depicted below:
