AVIZINIS
ENVIRONMENTAL
SERVICES INC

WETLAND REPORT

SITE LOCATION:
8, 9, and 11 Colby Drive
Ledyard, Connecticut

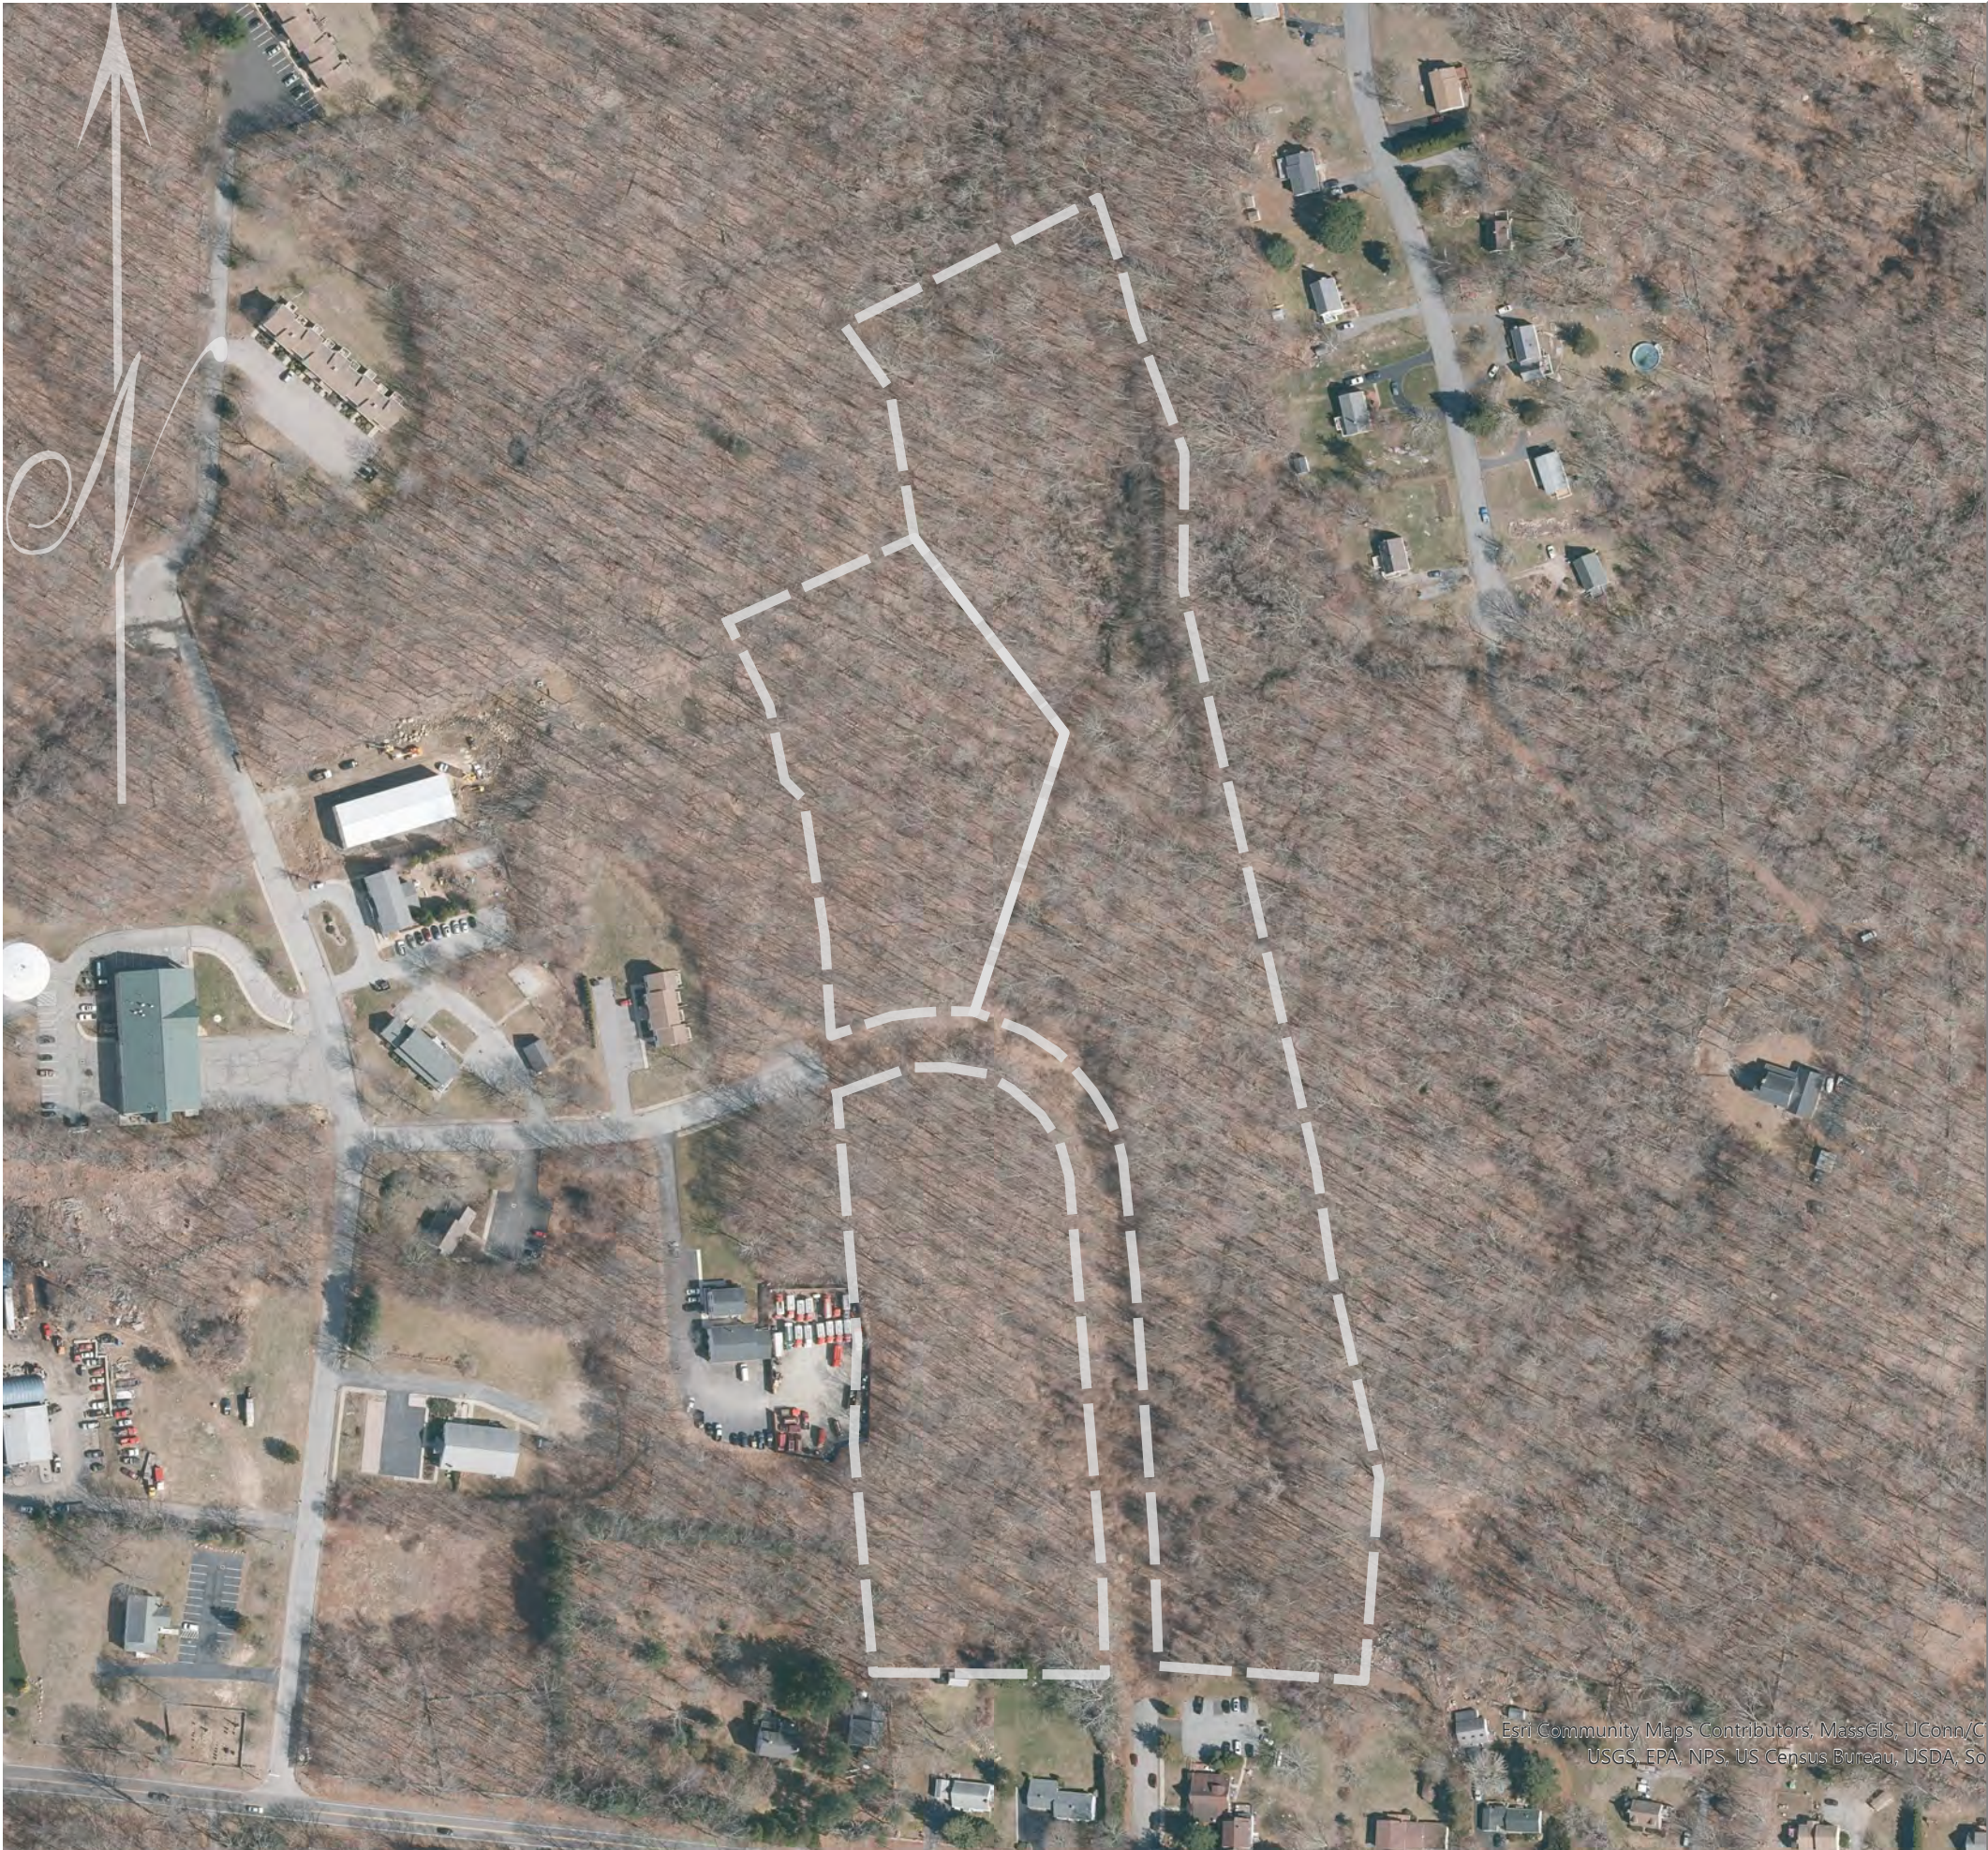
2020 AERIAL MAP
8, 9, 11 Colby Drive
Ledyard, Connecticut

The property is located extending north and east from Colby Drive in Ledyard, Connecticut. The lots are undeveloped and primarily forested. The property has inland wetlands in the northern portion of the site. The closest limits of the wetlands were delineated by AES.

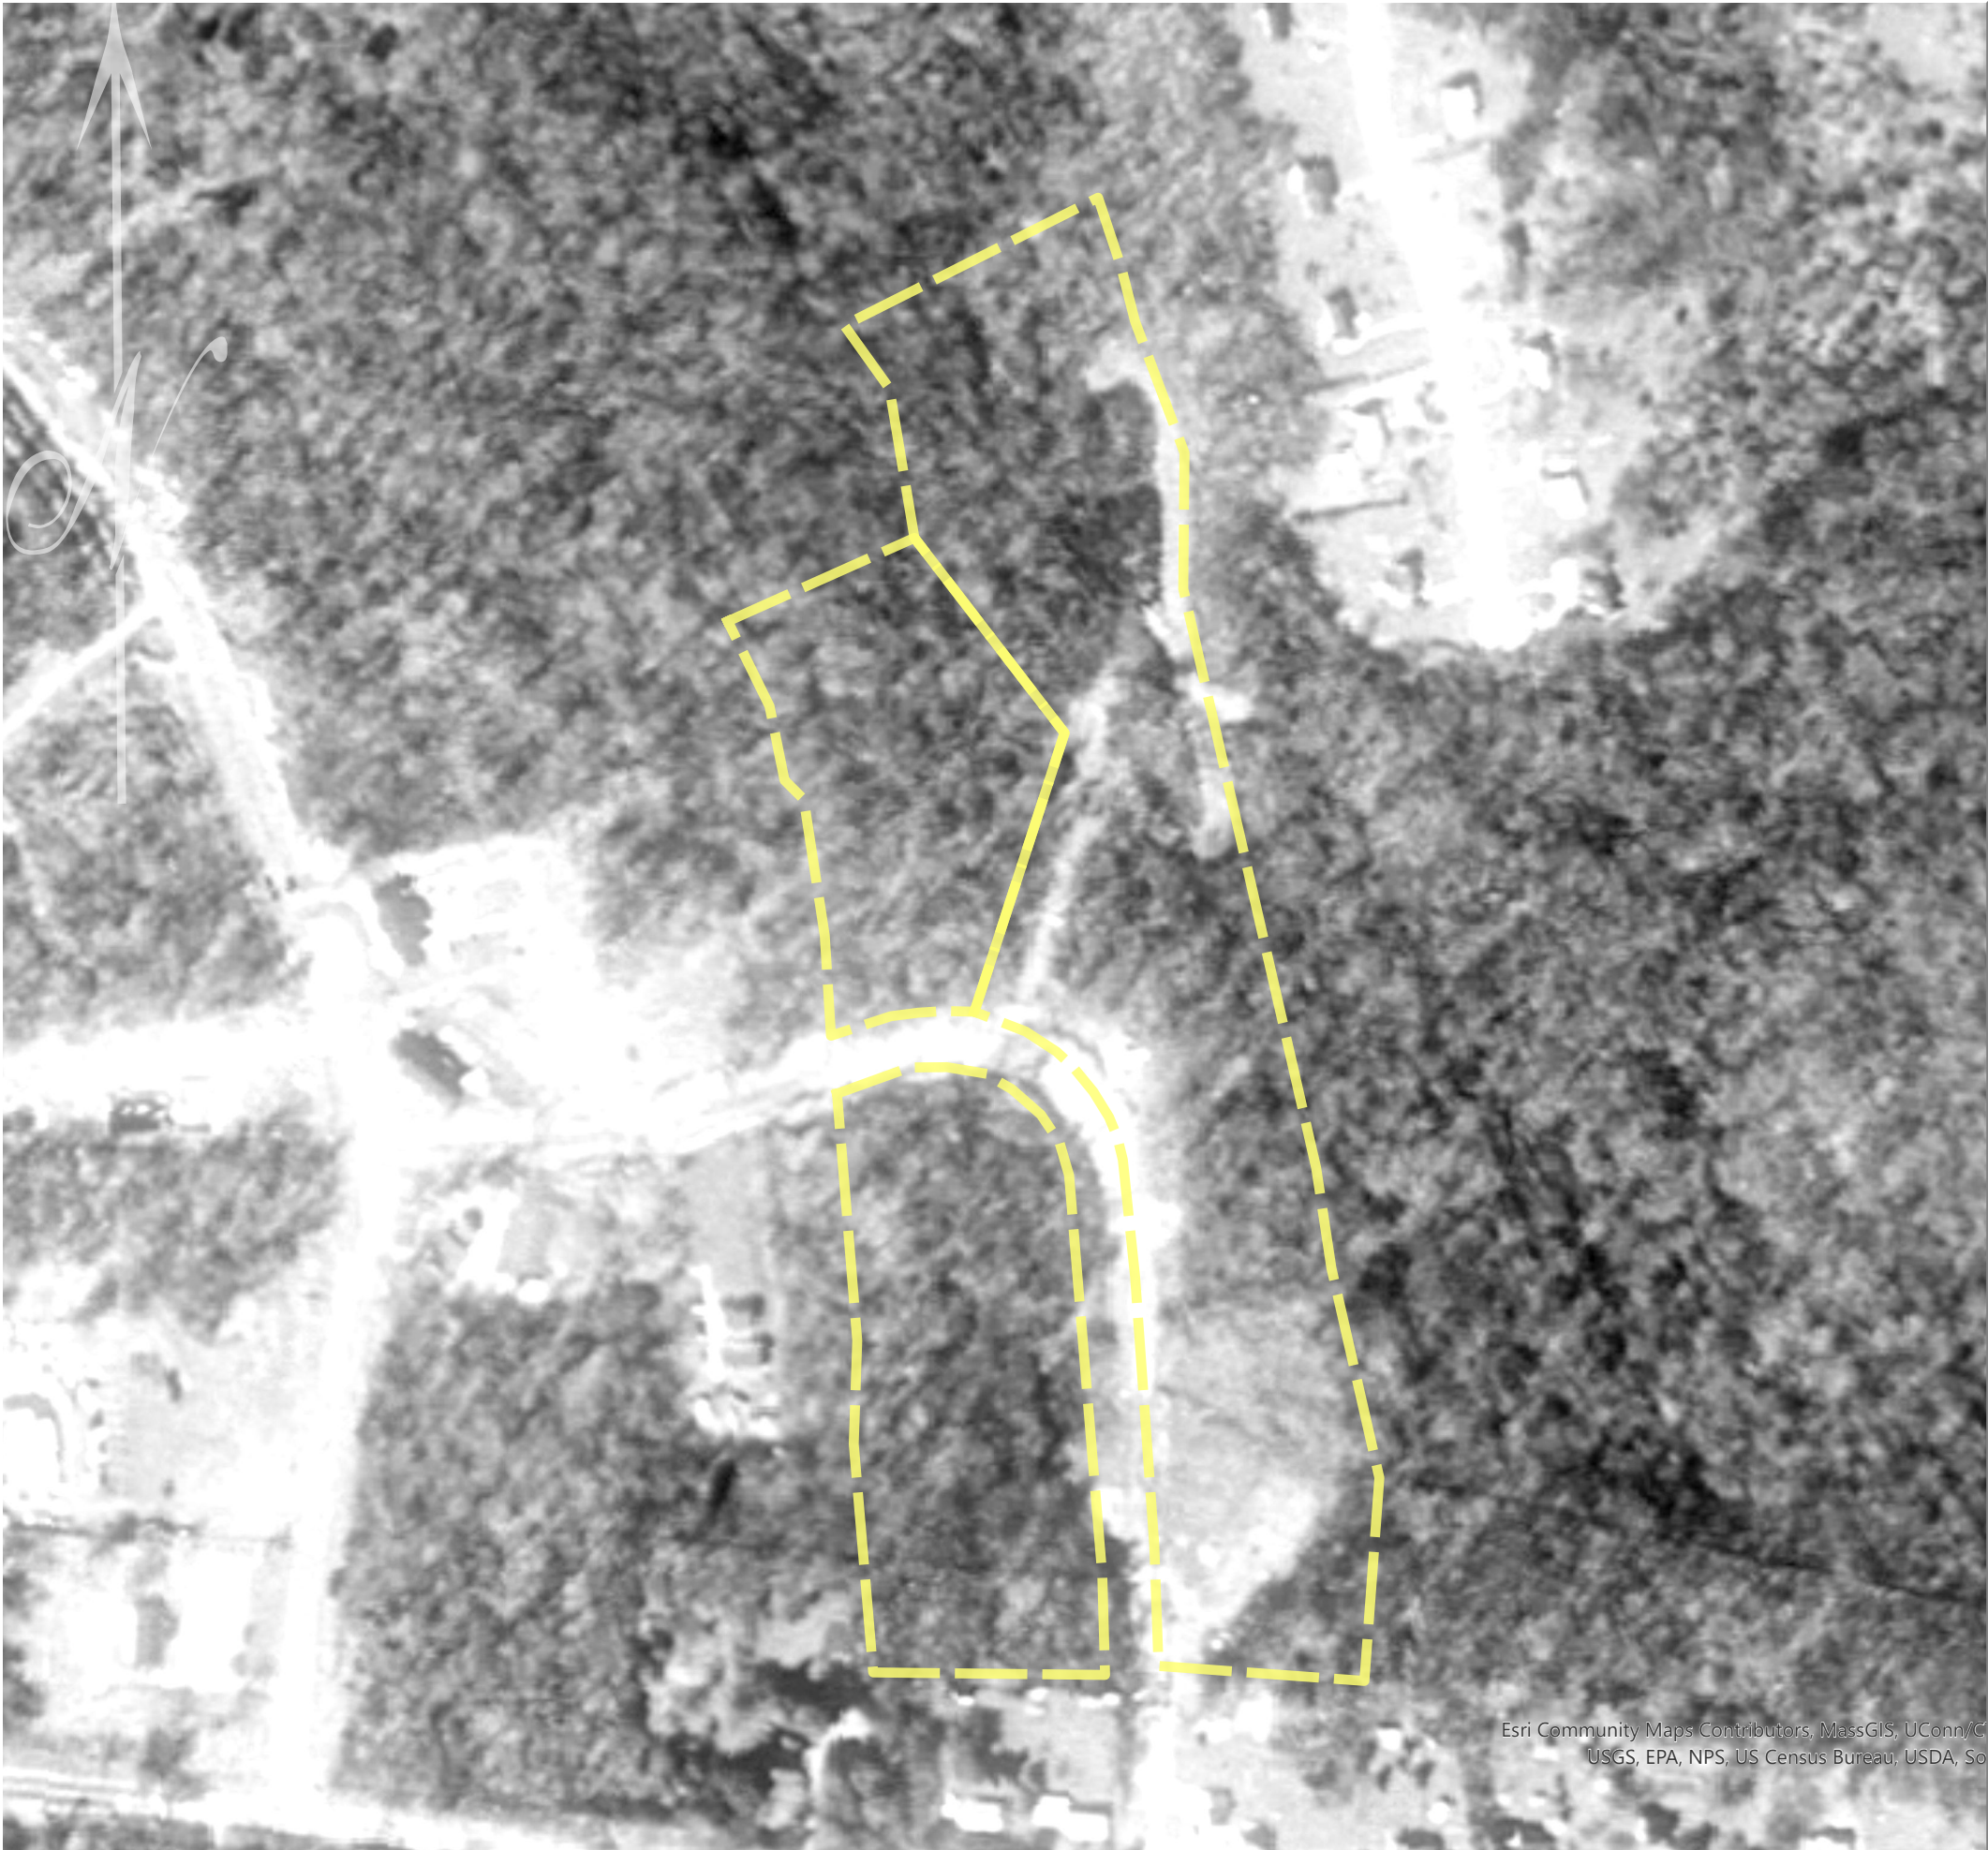
1990 AERIAL MAP
8, 9, 11 Colby Drive
Ledyard, Connecticut

A historic aerial photographic review shows little change to the property until the earliest available photographs taken in 1934, in which a portion of the northern lot had been cleared as part of an agricultural complex. As of the next available imagery from 1957, this section had been left to revegetate naturally.

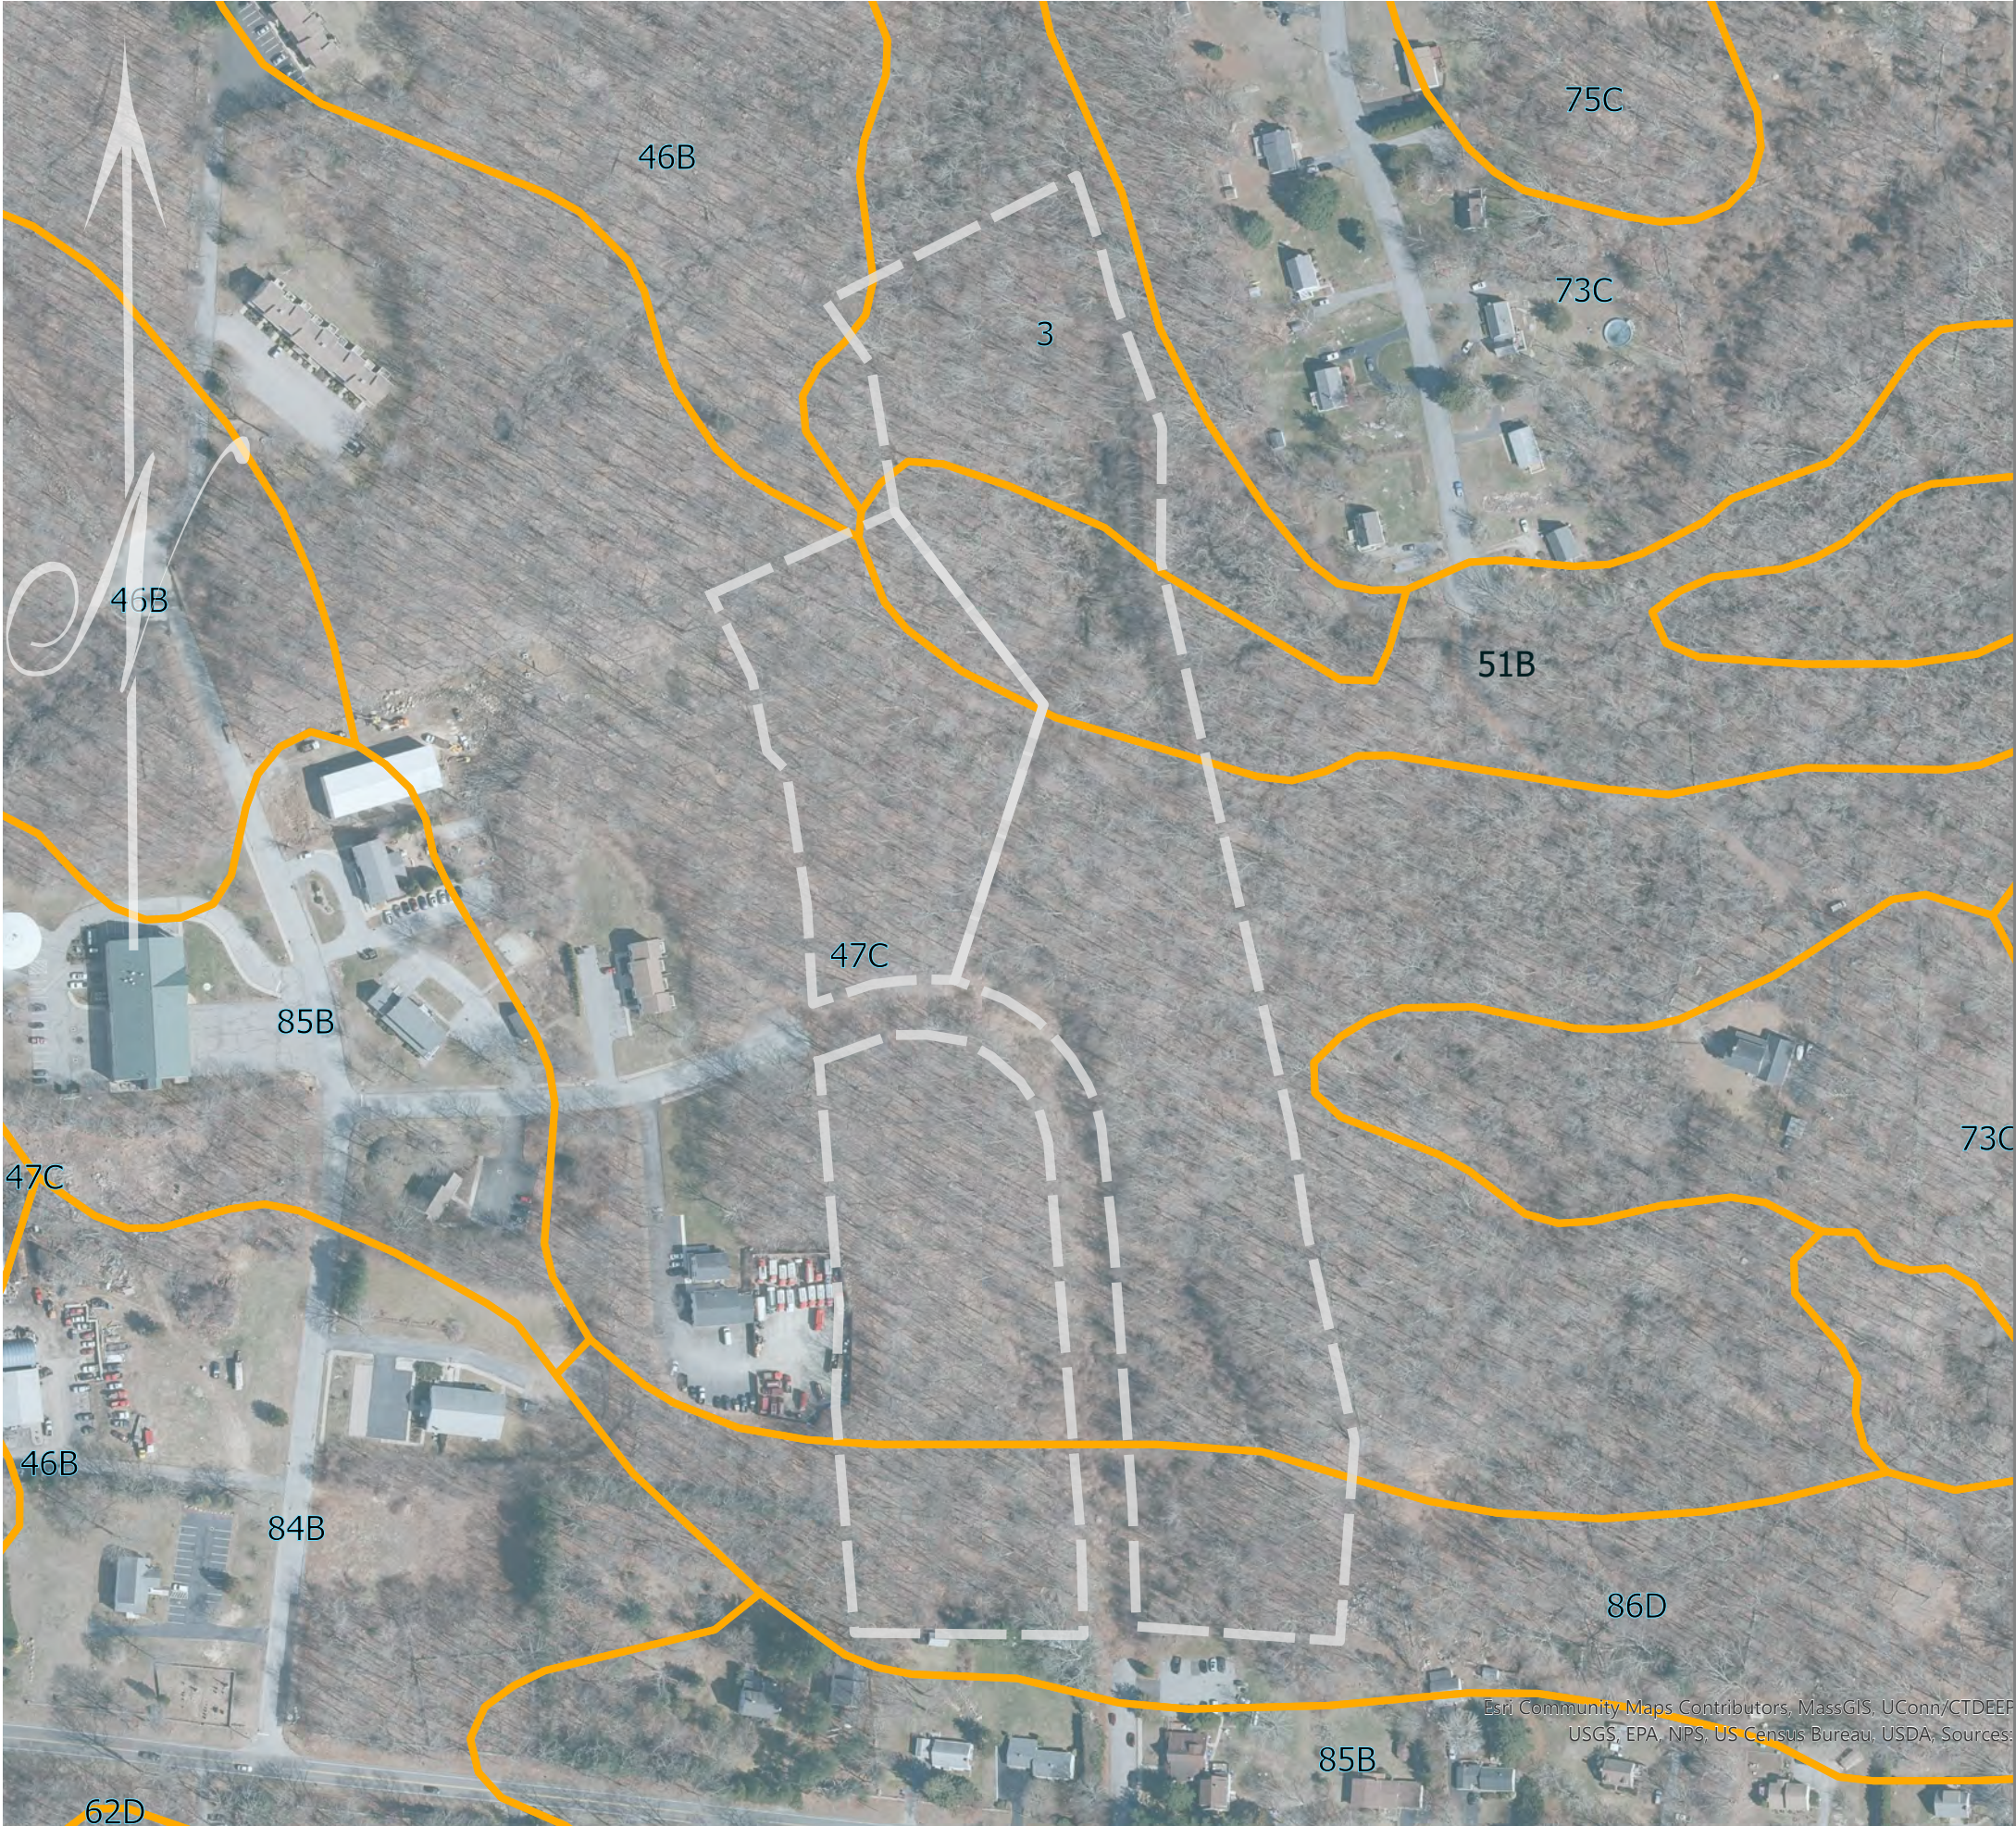
USDA - NRCS SOIL SURVEY MAP
8, 9, 11 Colby Drive
Ledyard, Connecticut

- 3 - Ridgebury, Leicester, and Whitman soils, 0 to 8 percent slopes, extremely stony
- 46B - Woodbridge fine sandy loam, 0 to 8 percent slopes, very stony
- 47C - Woodbridge fine sandy loam, 3 to 15 percent slopes, extremely stony
- 51B - Sutton fine sandy loam, 0 to 8 percent slopes, very stony
- 73C - Charlton-Chatfield complex, 0 to 15 percent slopes, very rocky
- 86D - Paxton and Montauk fine sandy loams, 15 to 35 percent slopes, extremely stony

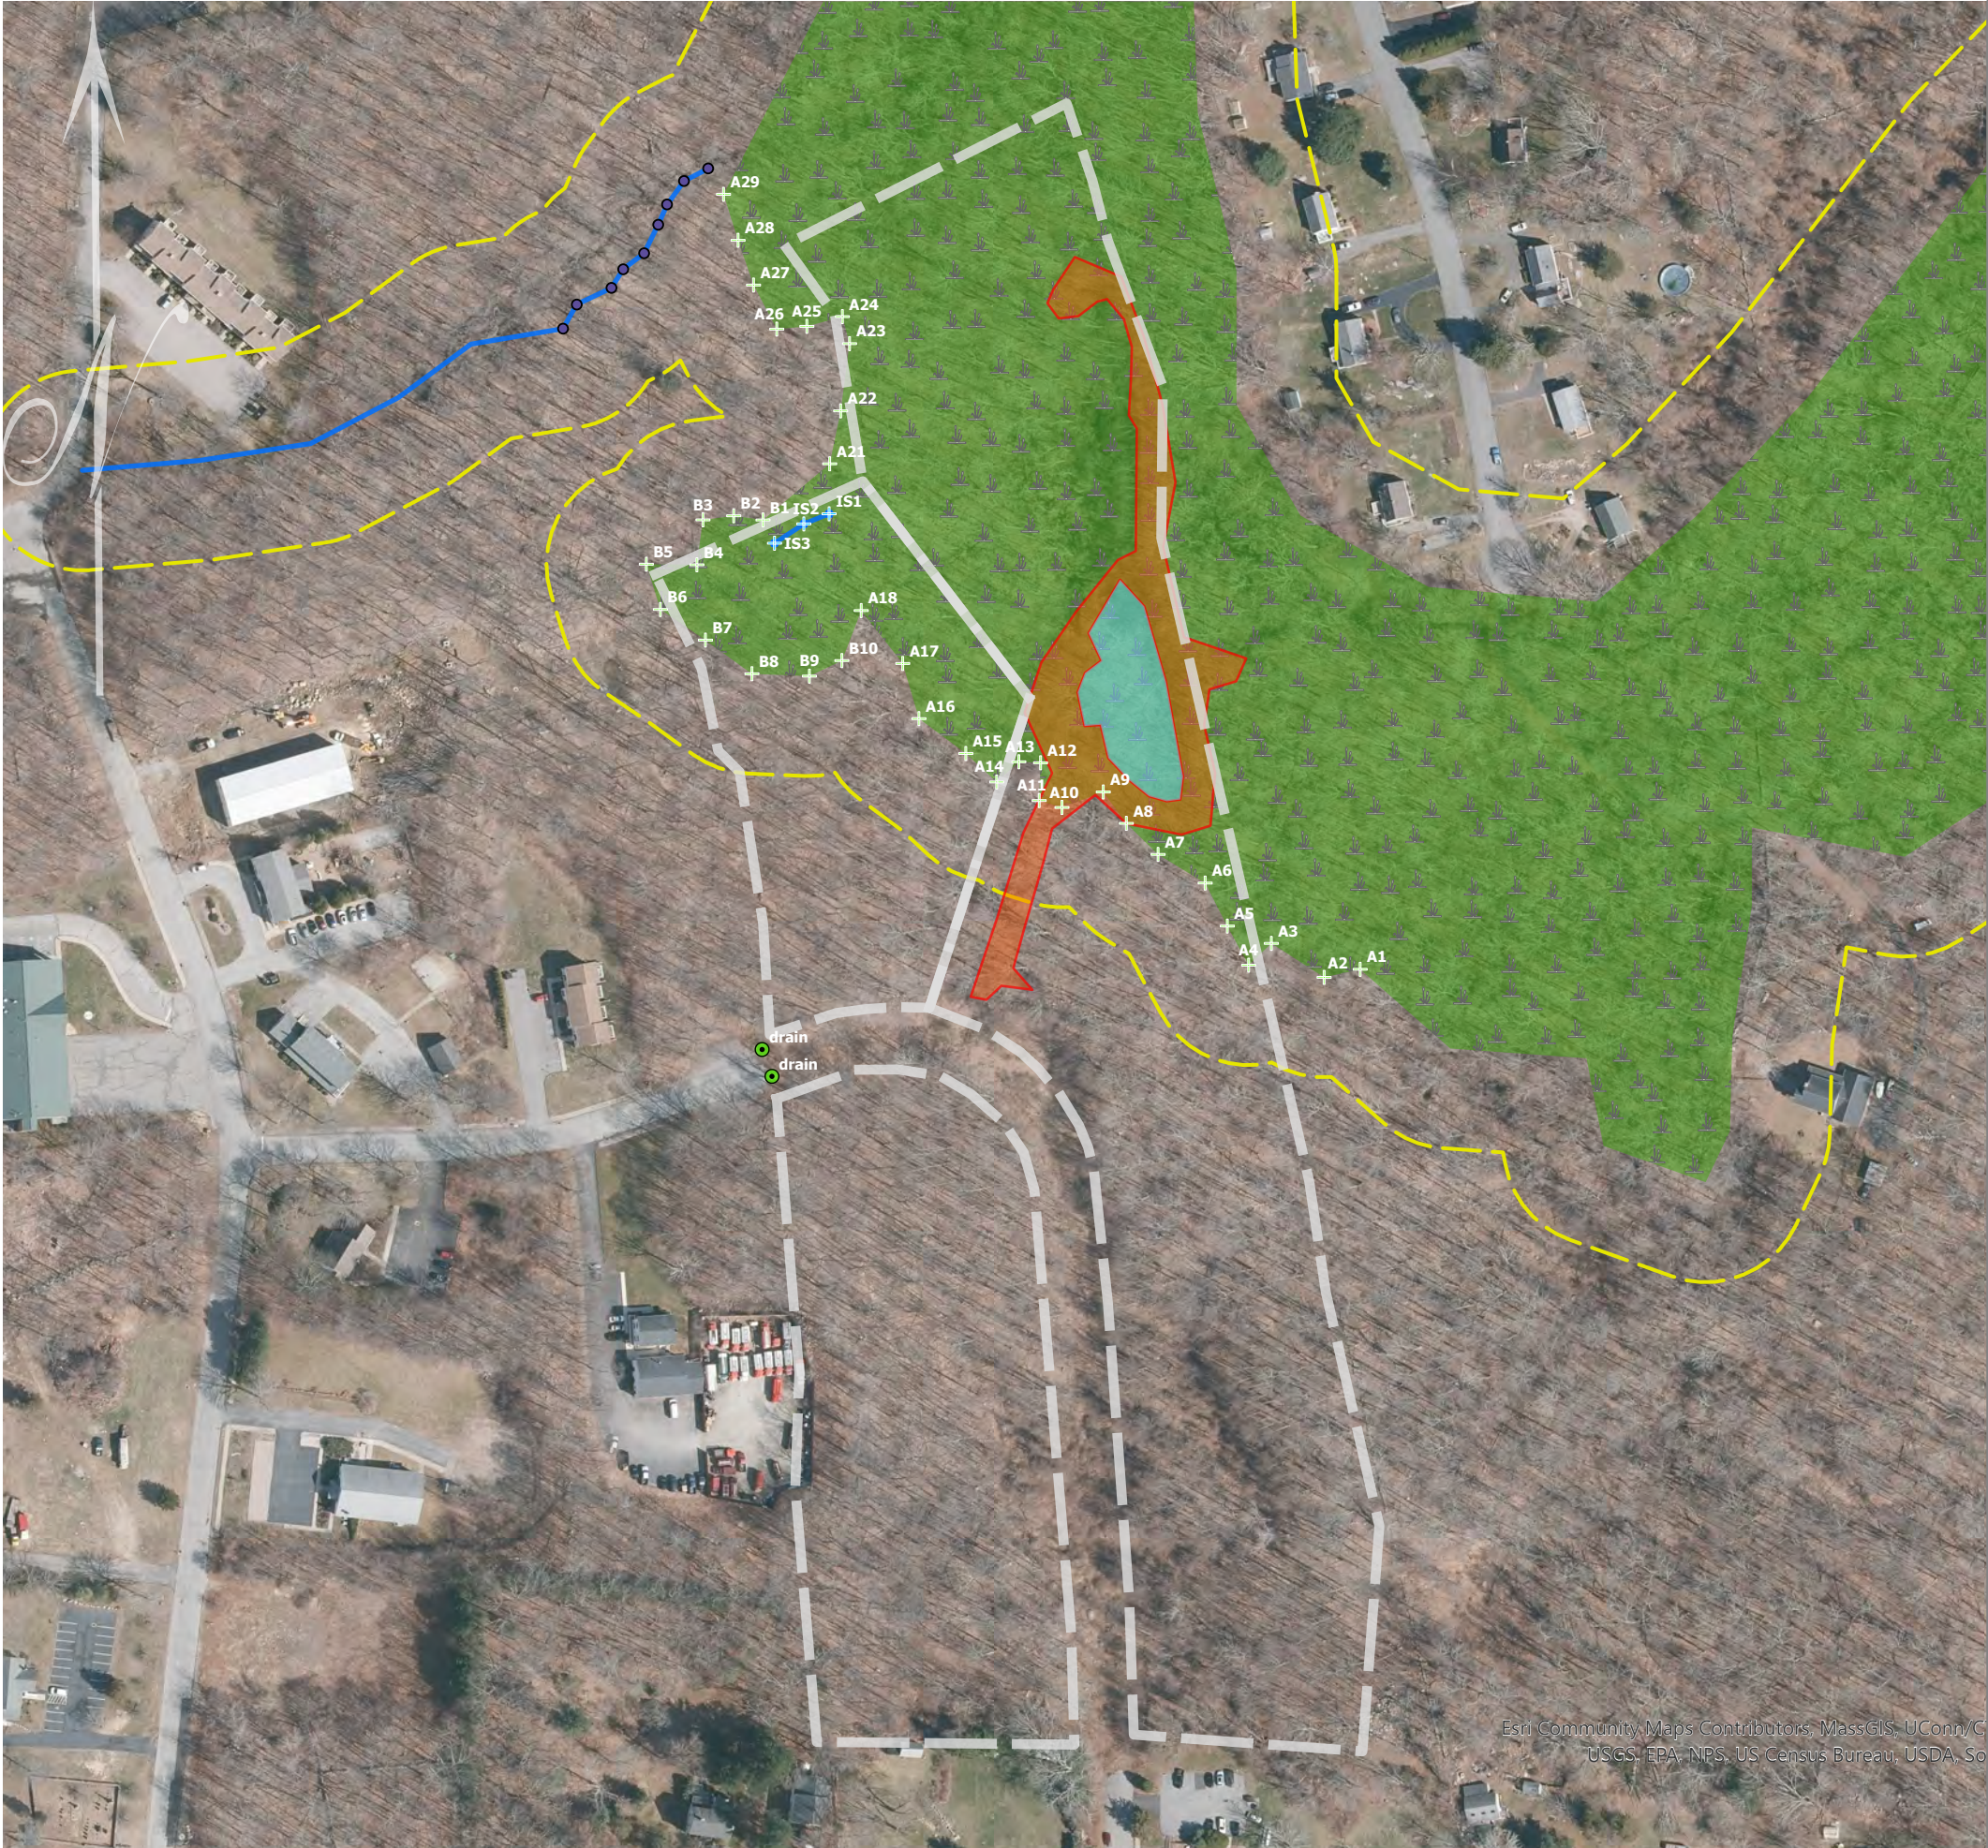
2022 WETLAND DELINEATION MAP
8, 9, 11 Colby Drive
Ledyard, Connecticut

AES staff have delineated three regulated wetland features in relation to this property. Flagging labeled **A1 – A29** and **B1 – B10** delineate the limits of a freshwater wetland that covers the northern portion of the site and extends well offsite to the north and east. Flagging labeled **IS1 – IS3** delineates the course of an intermittent stream that lies between the A and B-series. Just northwest of the property, another intermittent stream was GPs located that intersects the same wetland complex just north of flag A29. These wetland features will require the application of 100-foot upland review areas. Activities within 100 feet of the outer limits of these wetland features will require review from the Inland Wetland Agency (IWA).
