TOWN OF LEDYARD
CONNECTICUT
PUBLIC WORKS DEPARTMENT

Pine Swamp Brook Pond Drainage Remediation (IWWC#26-3SITE)

Background

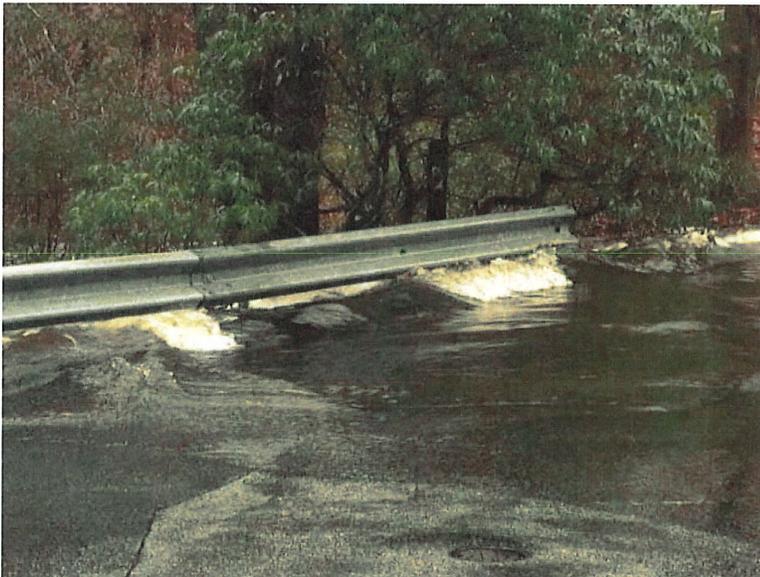
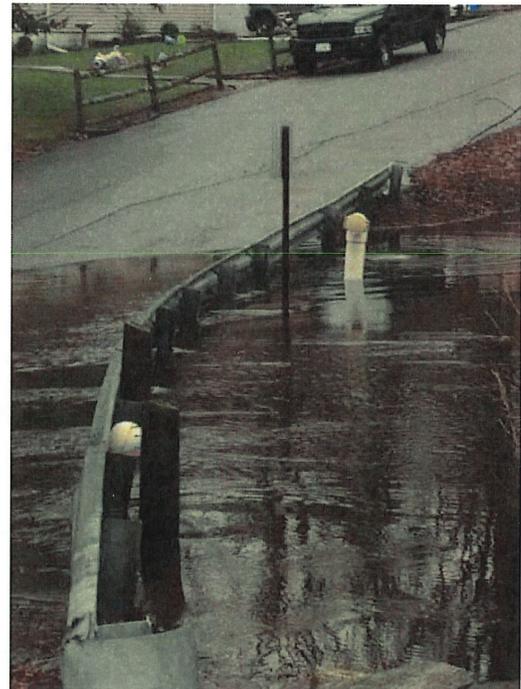
This application addresses this and other needs to provide further flooding protection at the Pine Swamp Brook Pond dam at Harvard Terrace. One of the outlets of the pond has been at least partially obstructed by an earthen berm, which was further reinforced by unauthorized activity last summer. This has only exacerbated a condition of inadequate capacity of discharge flow, leaving the dam further vulnerable to overtopping. This is not a hypothetical concern; flooding has occurred in at least two instances, one in May 1989 and the most recent (photos below) in March 2010.

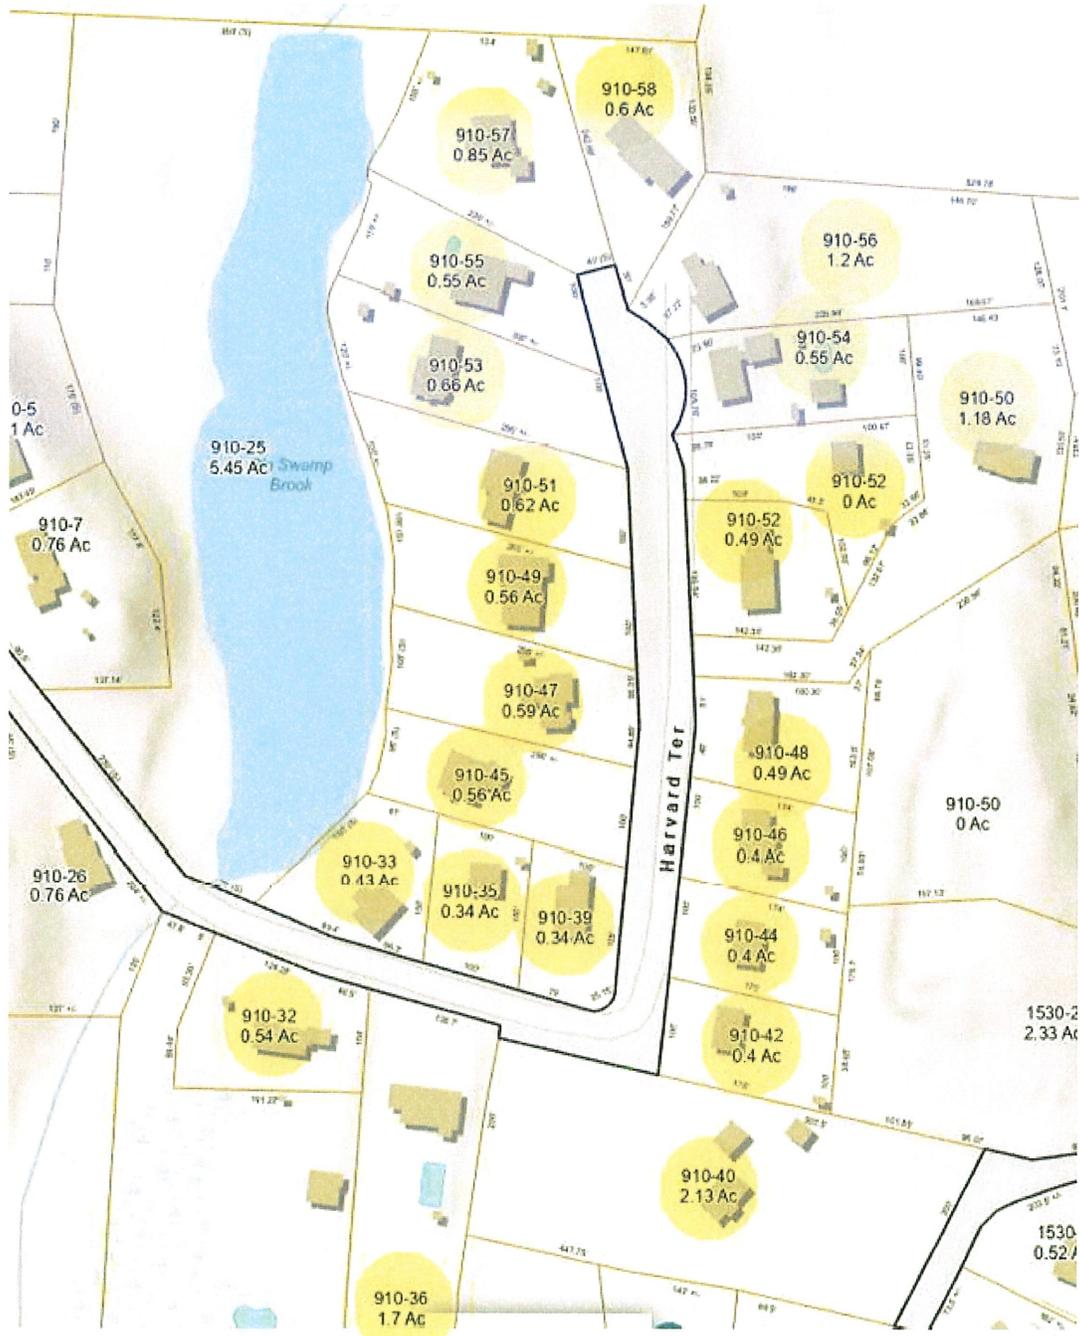
The overtopping of Harvard Terrace at the Pine Brook Swamp Pond dam poses particular threat to several properties on Harvard Terrace that would be effectively isolated by a dam failure leading to road washout (see below). Additionally, a dam failure could sever public water supply provided to these (and other homes) on Harvard Terrace.

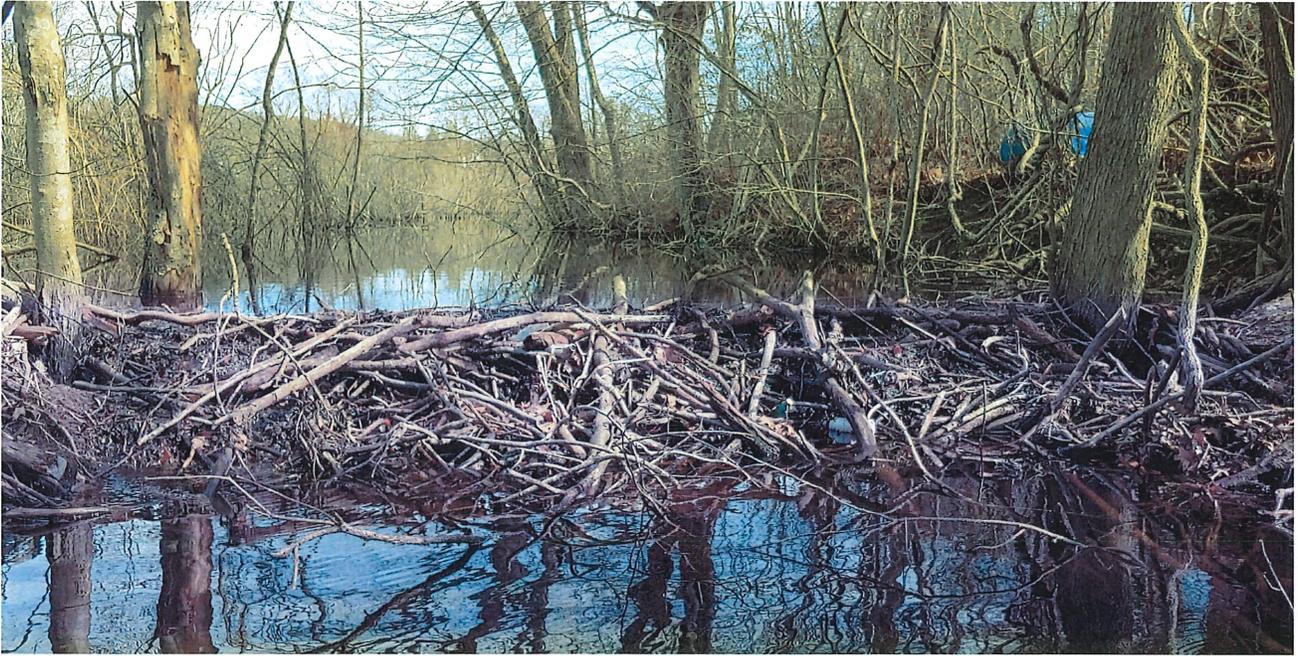
Most recently, even apart from extreme flooding situations, beaver activity (see below photo) had compromised the flow capacity in the vicinity of the pond to the point that water was backing up all the way beyond the brook crossing at Route 12 to properties north of Christy Hill Road. This was a primary basis for immediate rectification.

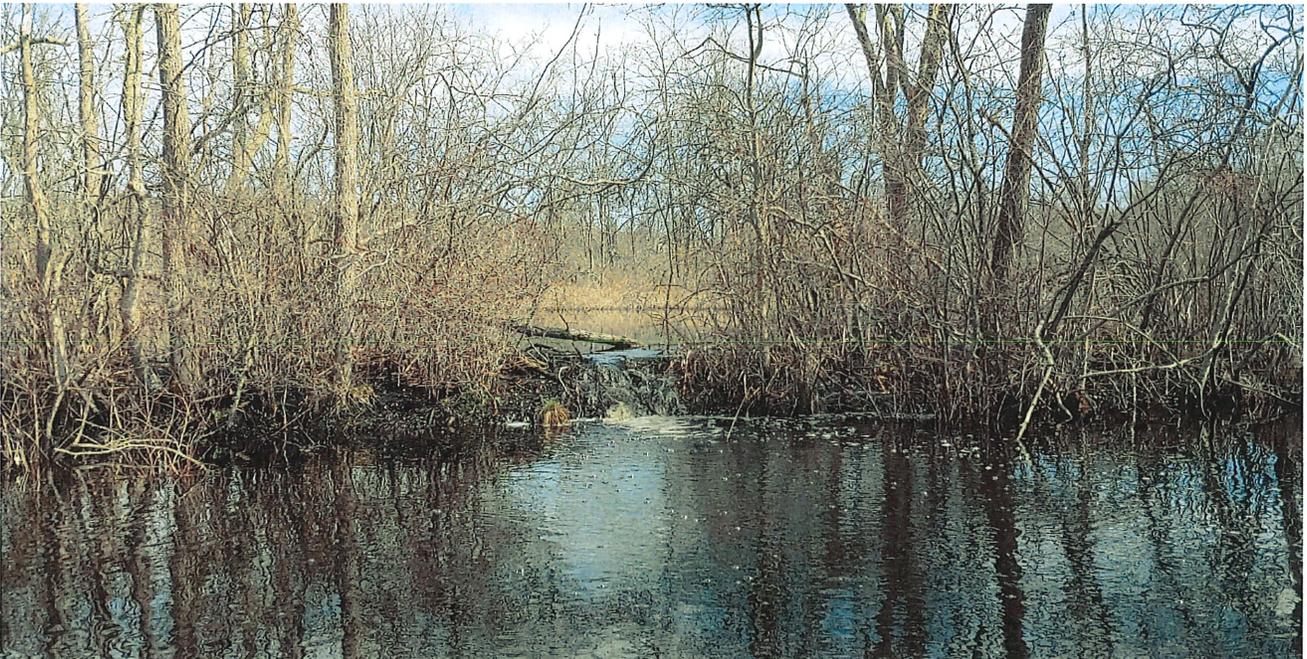
After the beavers were removed, because the beaver dam itself was inaccessible, Public Works Personnel were dispatched to relieve the flooding by cutting two trenches through a berm that separated the pond proper from the wetlands area in the watershed above it that was flooded by the beaver activity. The trenches were cut in two locations of additional activity (see photo below for one of these).

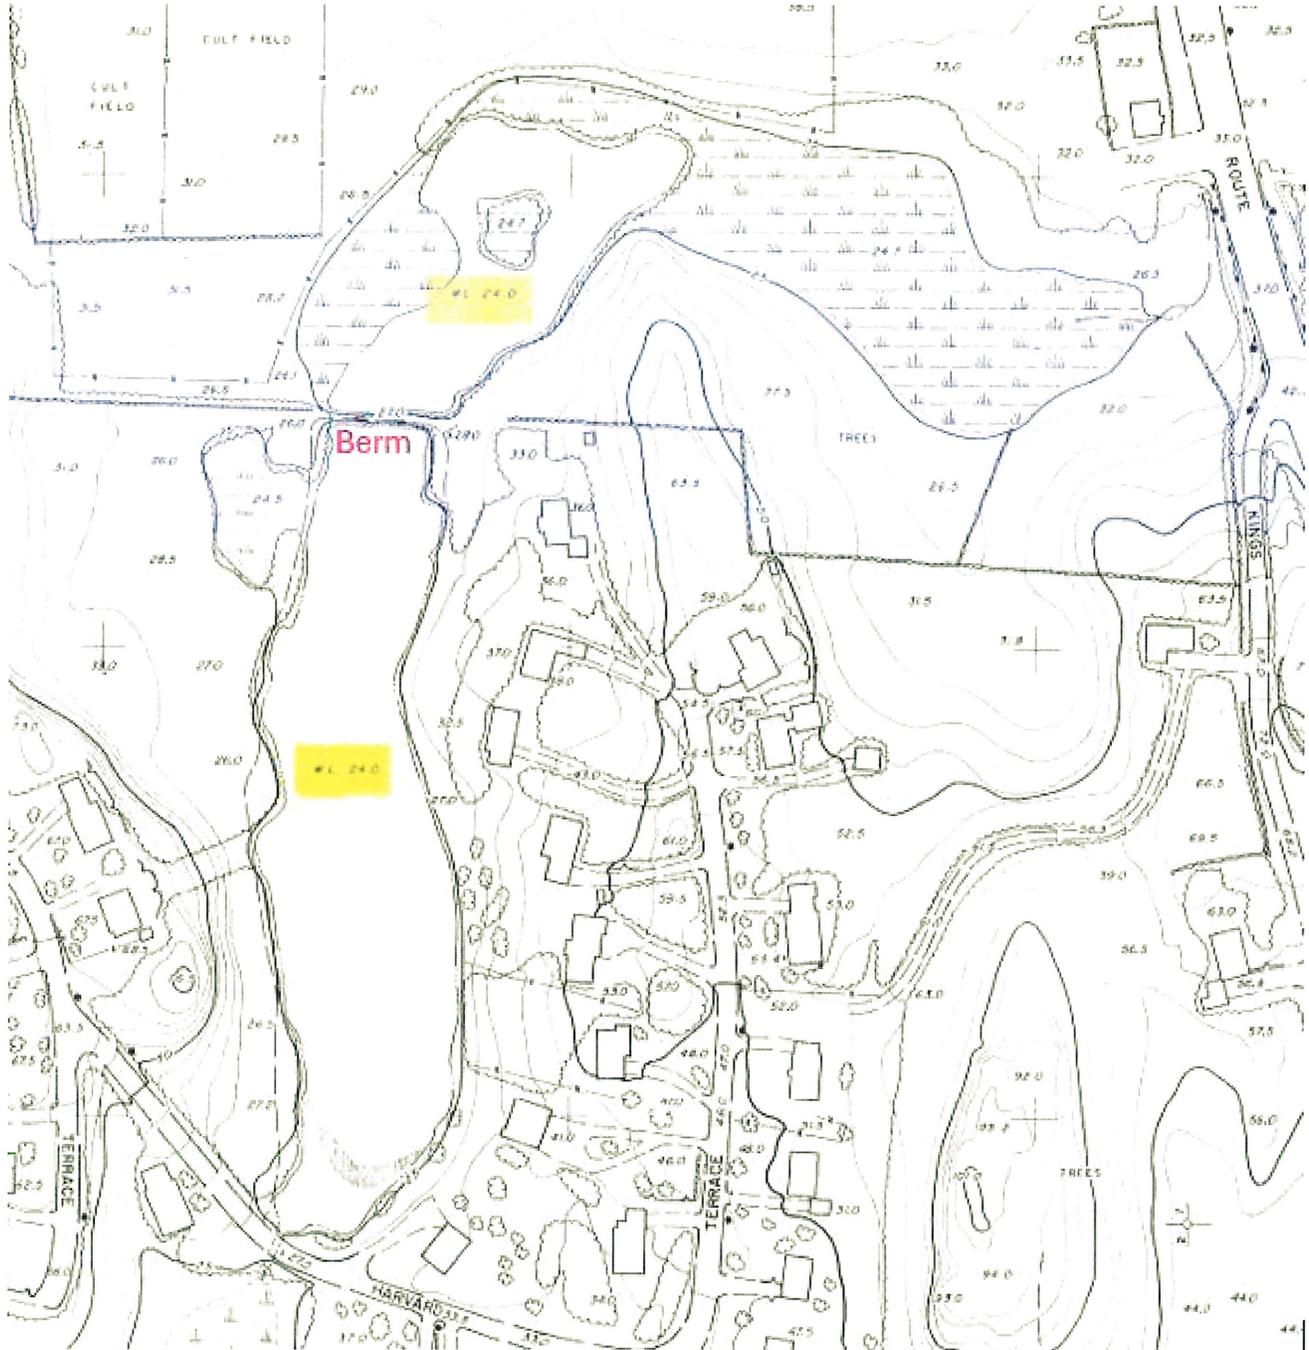
This restored the historical equalized water level in the area, as depicted below from the Town Assessor's Topographic Map 91 (circa 1971).

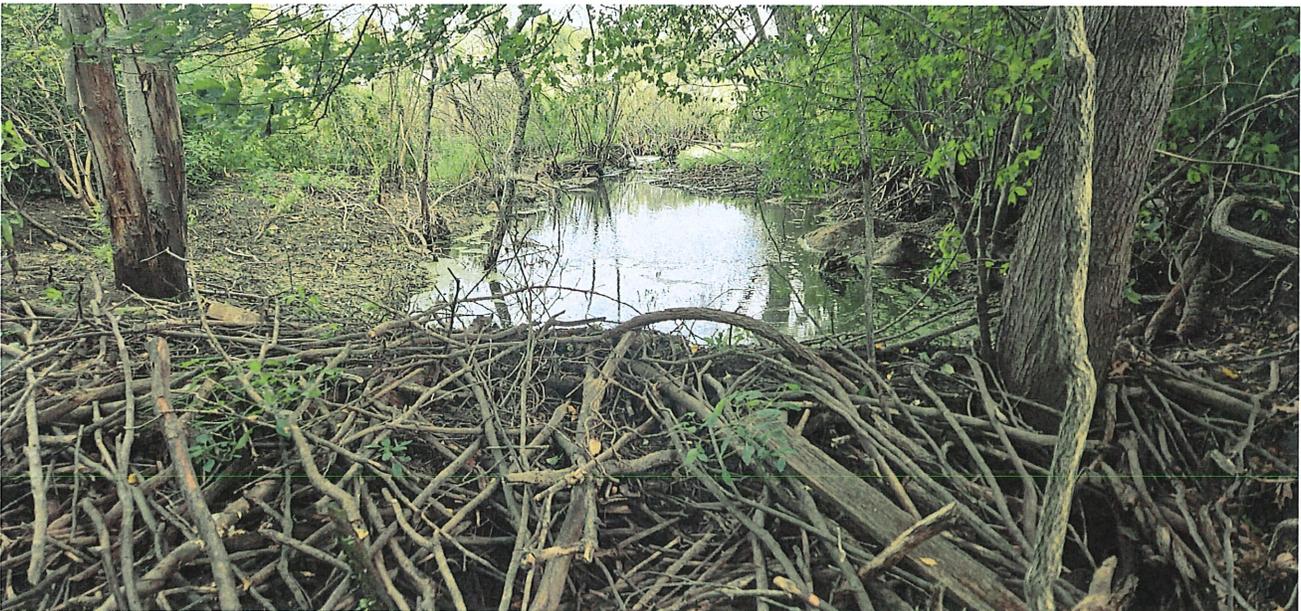
There are two remaining issues of primary present concern, one at the inlet and one at the outlet of the pond. At the inlet, the beaver dam remains as an obstruction in Pine Swamp Brook (see below).

Inlet: In order to remove the beaver dam, suitable equipment will be needed. Access is presently expected to be through 39 Military Highway and across the berm from west to east. This will require a small track excavator that would be able to navigate the narrow berm. The Town would also have to conduct brush and tree (several already dead) removal to clear an adequate path.

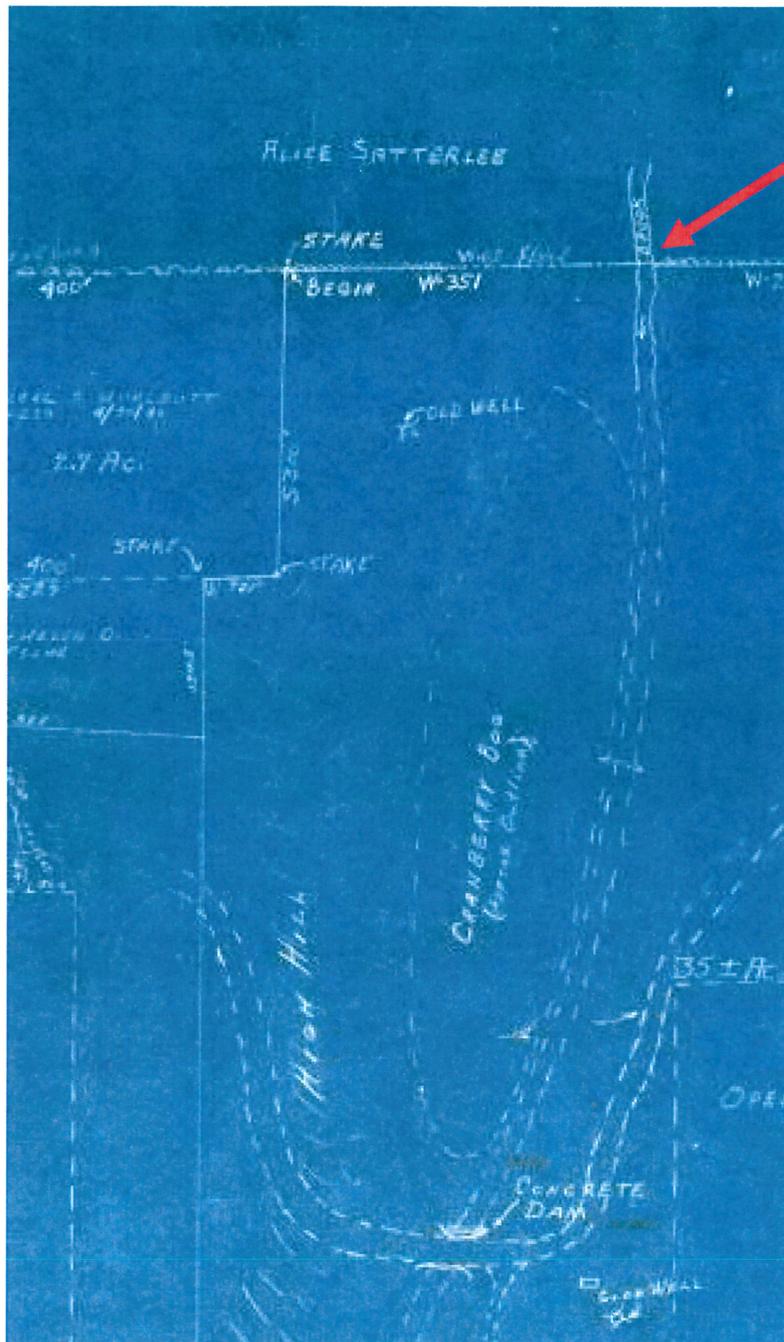
We do not know how long the beaver dam had been in place and altered the flow path over the berm, but the historic flow path to the pond has been through the brook at the east edge of the pond. This is confirmed by map #27A filed in the Town’s records that shows conditions as recorded in June 1948. (Excerpt below)

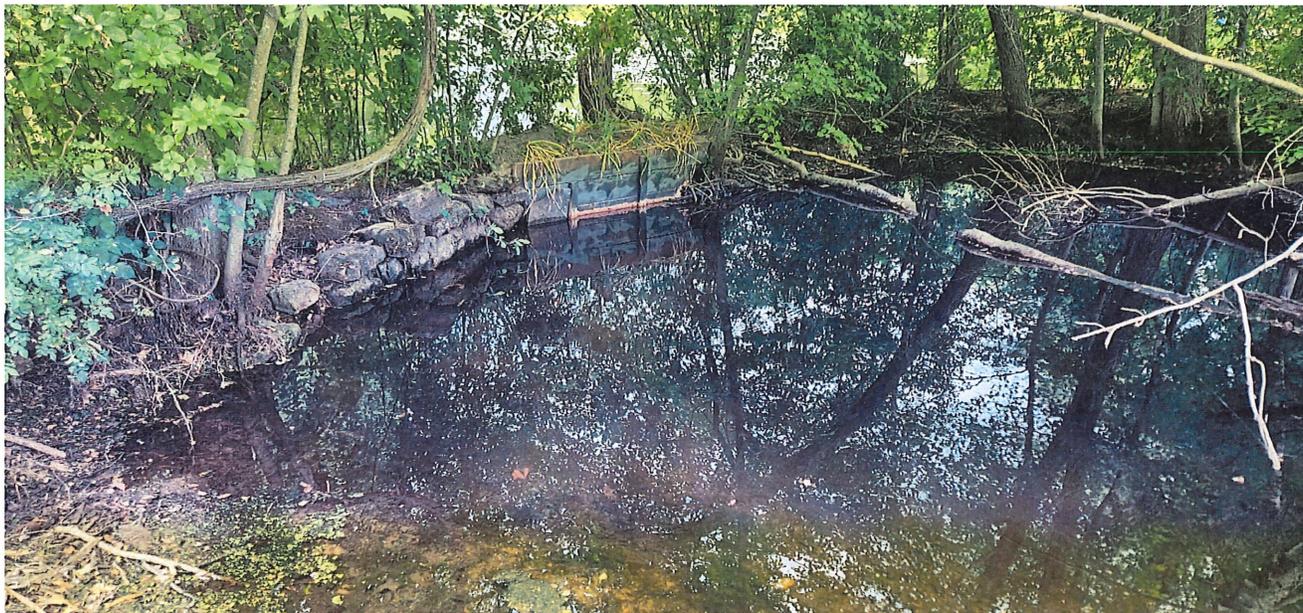
residents without due authority or permission filled this gap. The photo below shows the berm in its present condition with this “plug.”

As detailed in attachment 2, this berm compromises the discharge capacity at the dam, which in its unhindered state is already inadequate.

Outlet: The Town will remove the illicit “plug” and an additional section of the berm to open the drop inlet to normal pond flows. The total length of removal (including and in immediate proximity to the “plug”) will be about fifteen to twenty feet. The Town will conduct repair work at each of the two outlet structures to ensure maximum function.

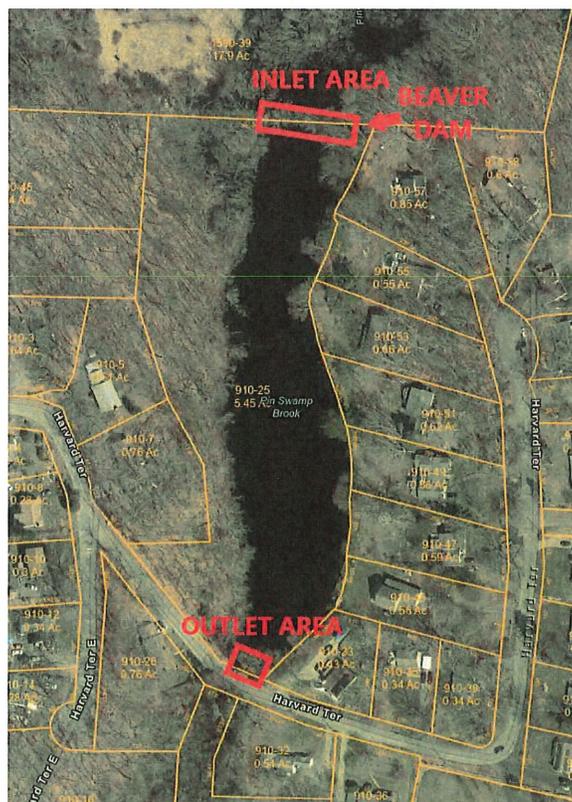
The Town proposes targeted actions at the two locations cited above, as depicted below:
