# Field Report

| <b>Field Report No.:</b> 15 | | | | | | | | | | | |
| <b>SP&amp;A Project No:</b> 22.331 | | | | | <b>Report Date:</b> 12-06-2024 | | <b>Time:</b> 9:30AM | | | | |
| <b>Project:</b> Gales Ferry School<br>(Name & Location) 1854 CT-12<br>Gales Ferry, CT 06335 | | | | | | | | | | | |

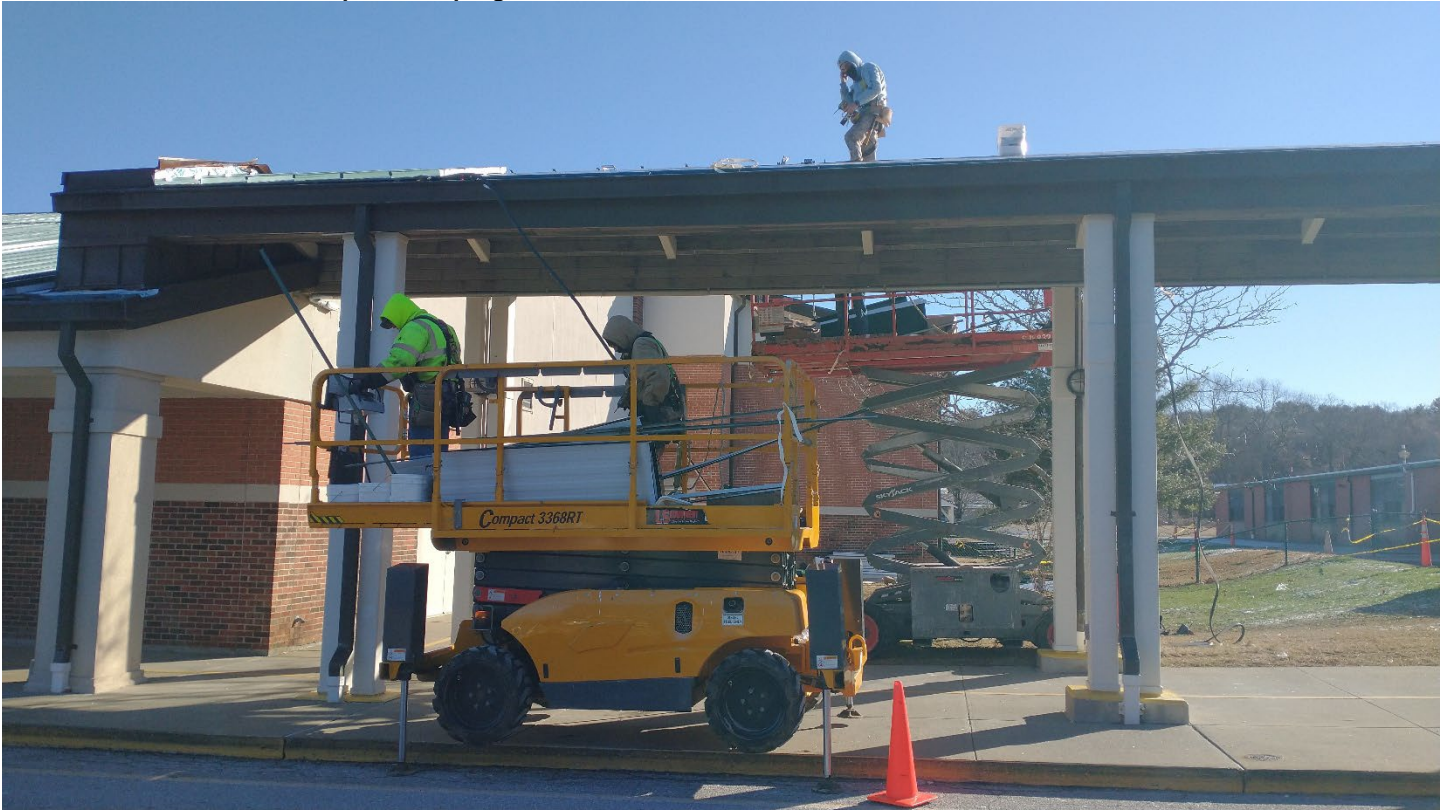
**Roof – Installation of the roof panels in progress**

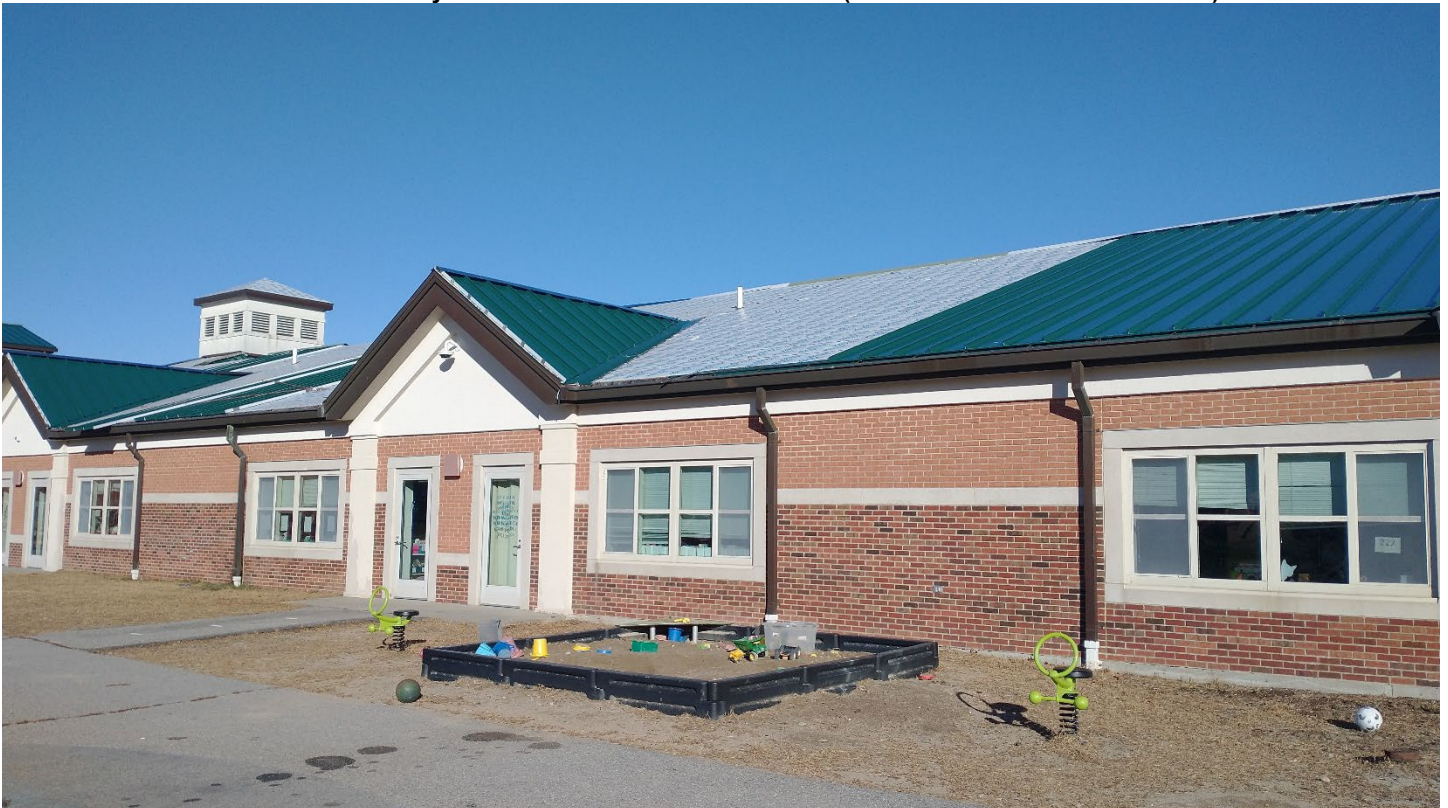
**Roof D – Roof D installation tentatively scheduled to continue work 12/21 (see attached tentative schedule)**

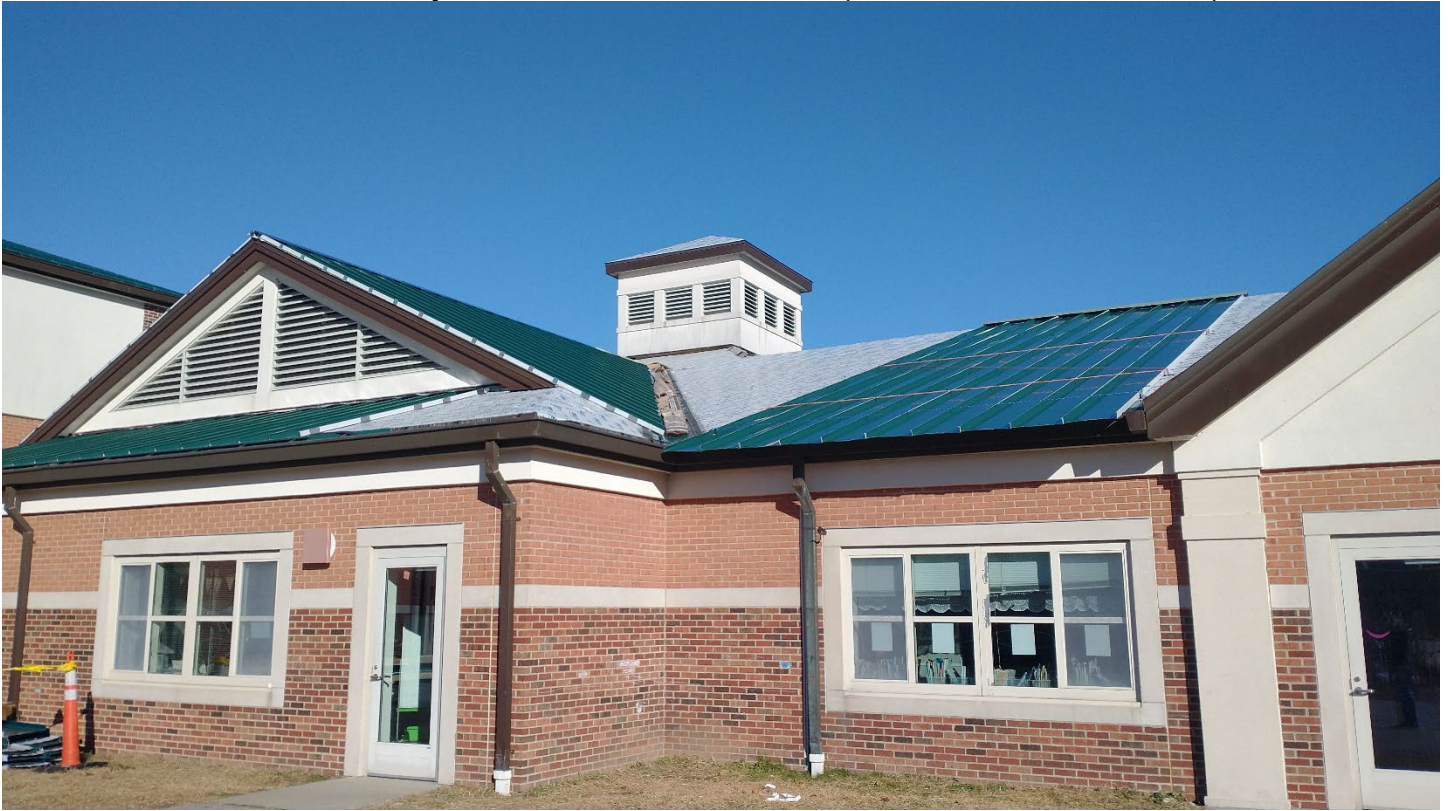
**Roof D – Roof D installation tentatively scheduled to continue work 12/21 (see attached tentative schedule)**

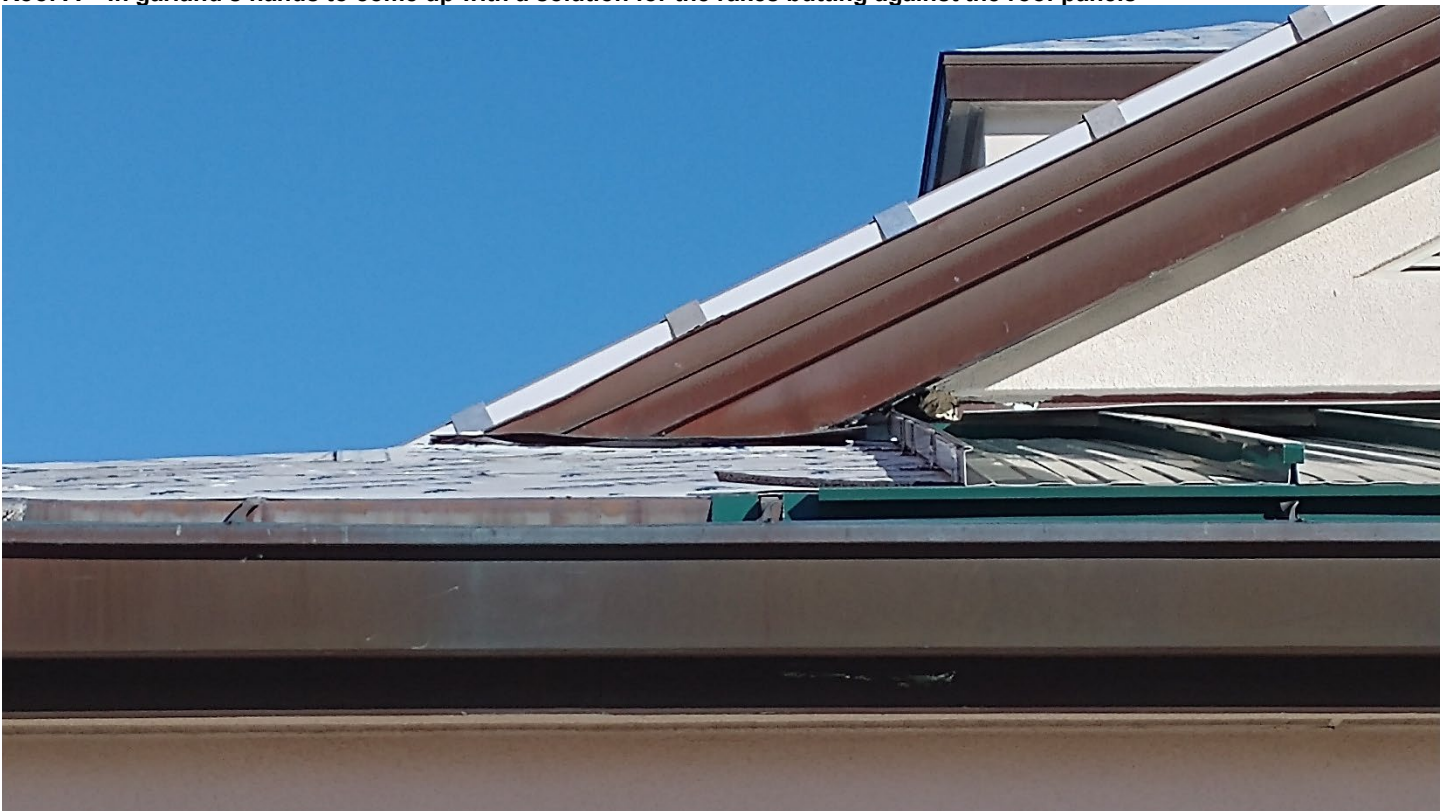
**Roof A – In Garland's hands to come up with a solution for the rakes butting against the roof panels**

| - Garland is to come up with a solution for where the bottom metal of the dormer rakes butt against the new roof panels. See attached photo. | | | | | | | | | | | |

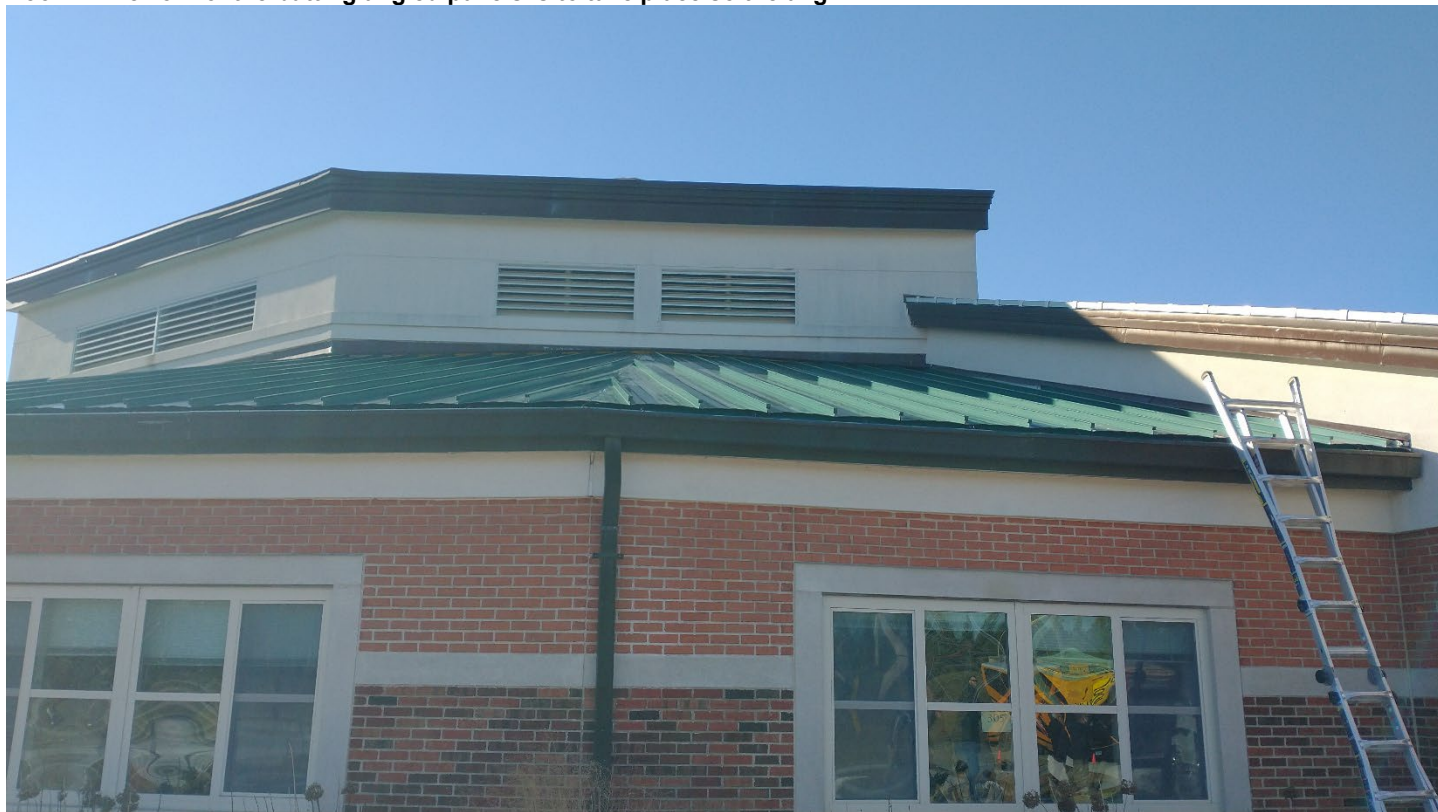
**Roof E – Rework of the butting angled panels is to take place so the align**

| - Rework of the angled panels on roof E where the different angles butt against each other is to take place so that the rib align with each other when the panels are reworked with proper screws. See attached photo. | | | | | | | | | | | |
| - Roof E angles/direction of the panels will be reviewed for better flow of the rainwater by Garland. | | | | | | | | | | | |

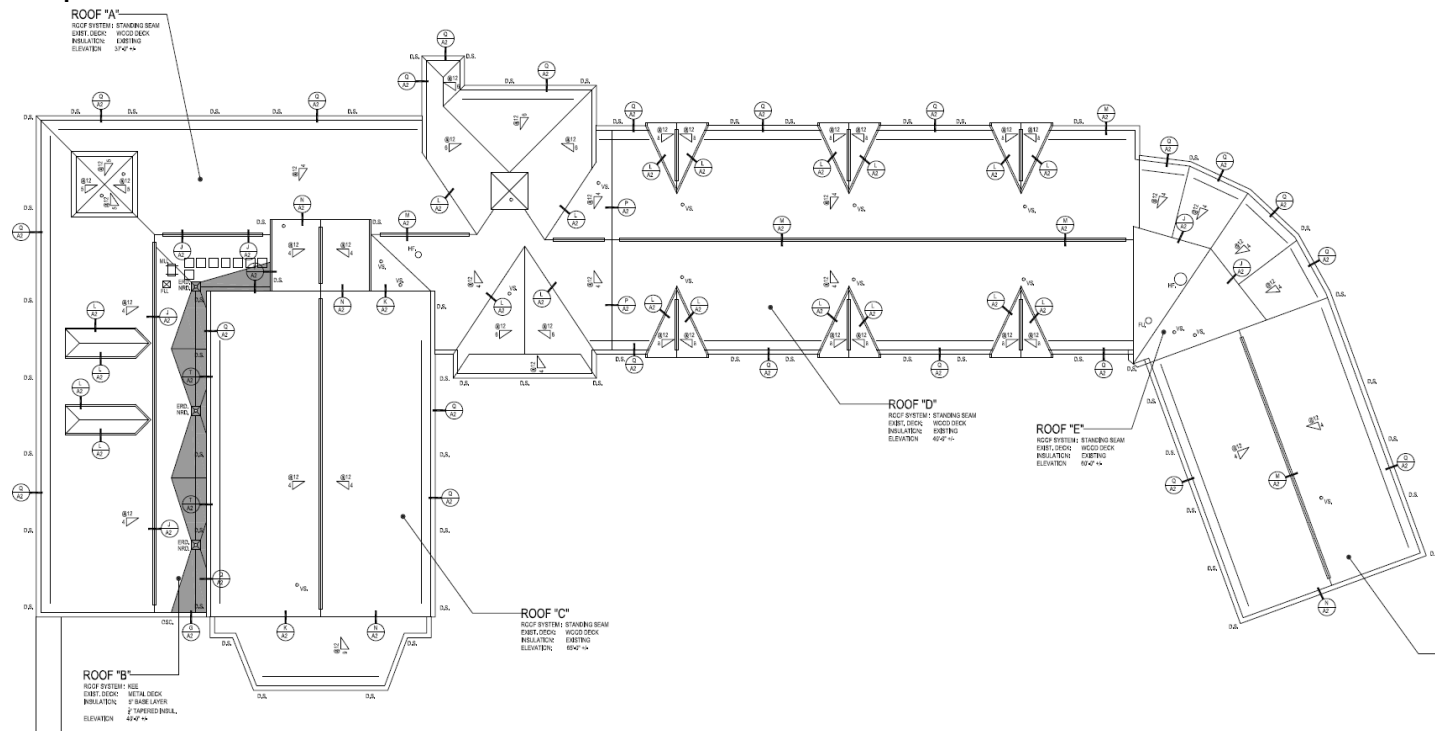
**ROOF "A"\_\_\_\_\_**  
**ROOF SYSTEM:** STANDING BEAM  
**EXIST. DECK:** WOOD DECK  
**INSULATION:** EXISTING  
**CLIMATE:** 35-20-6
