# Progress Report

LEDYARD SD  
4 BLONDER PARK RD  
LEDYARD, CONNECTICUT 06339

<b>FACILITY:</b> Gales Ferry School	<b>ROOF SECTION:</b> ALL	<b>DATE:</b> 01/16/2025
-------------------------------------	--------------------------	-------------------------

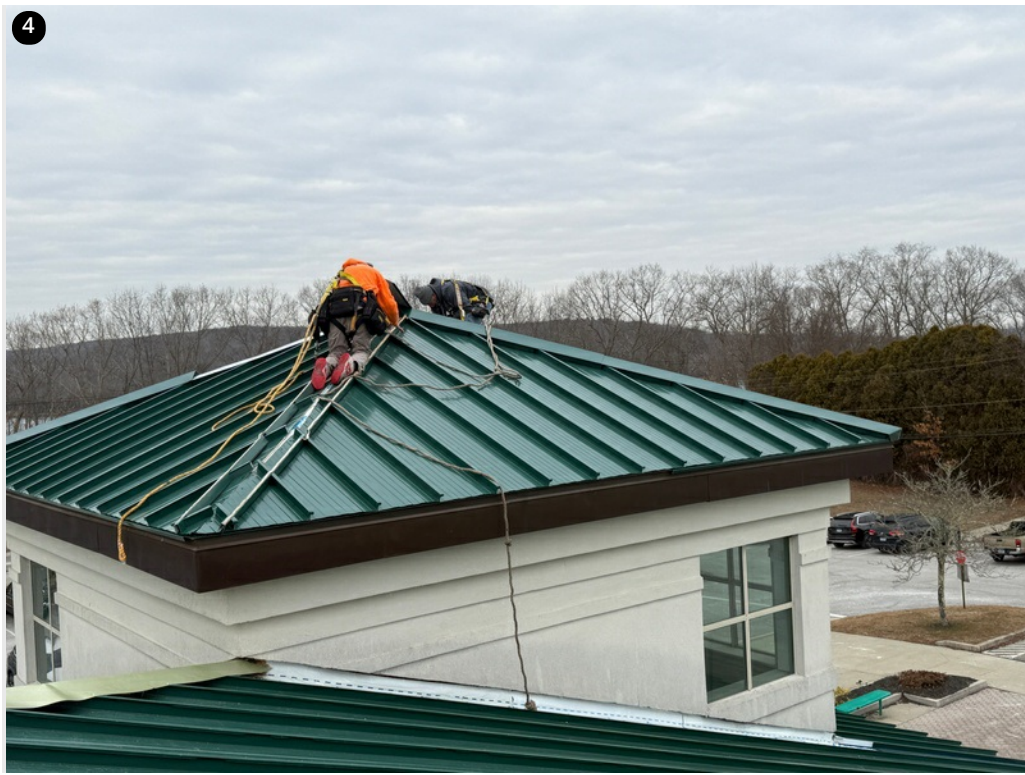
4

Crew installing enclosures on large copula-  
1/13/25

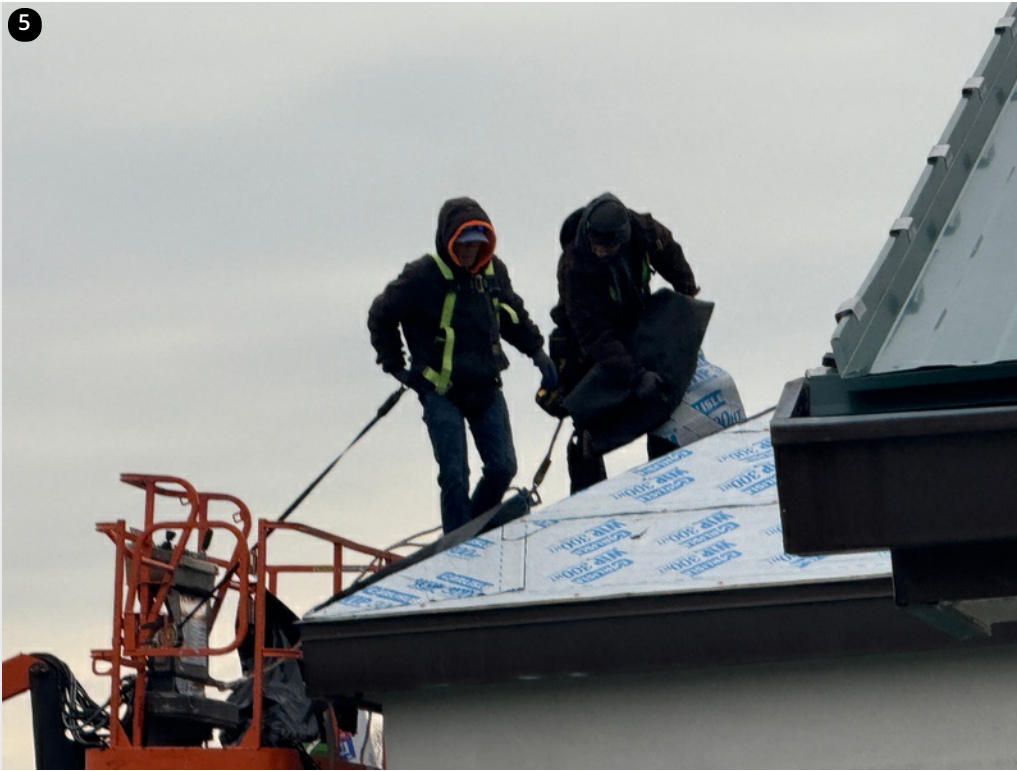
5

Crew removing loose and expired ice and water layer on small copula- 1/13/25

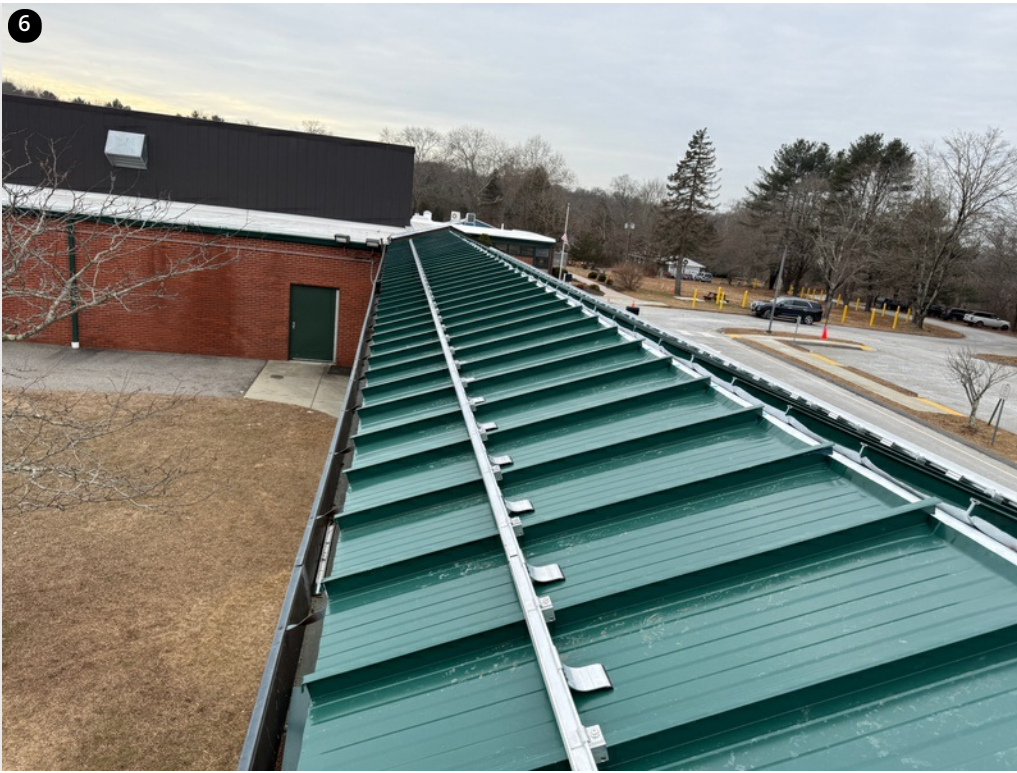
6

Snow guards installed on walkway roof- 1/13/25

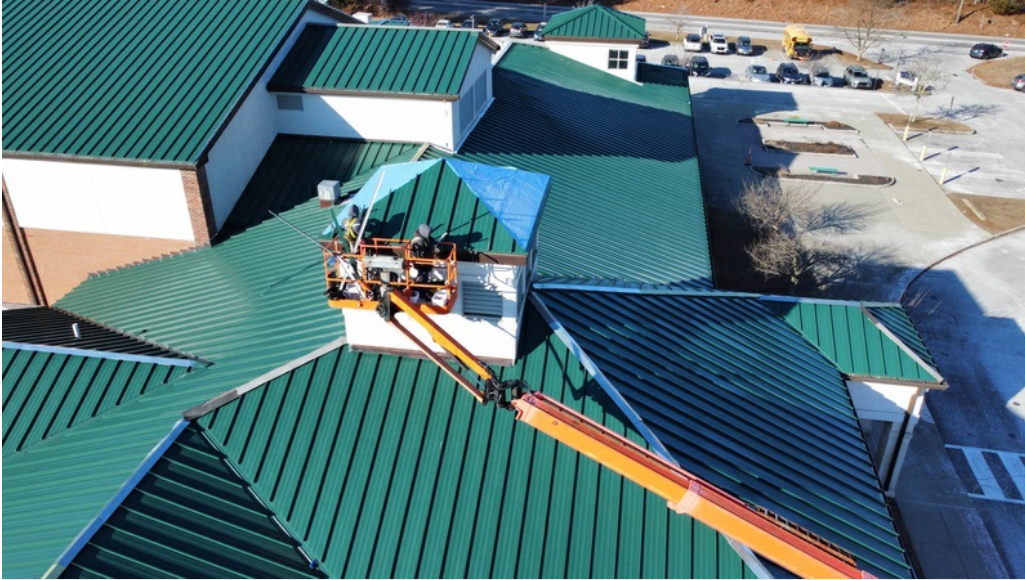
7

Crew installing panels on small copula-  
New ice and water layer adhered- 1/14/25

Both copula areas have been completed this week. A new ice and water layer was installed on the smaller copula as well as in the valley area above the boiler room.

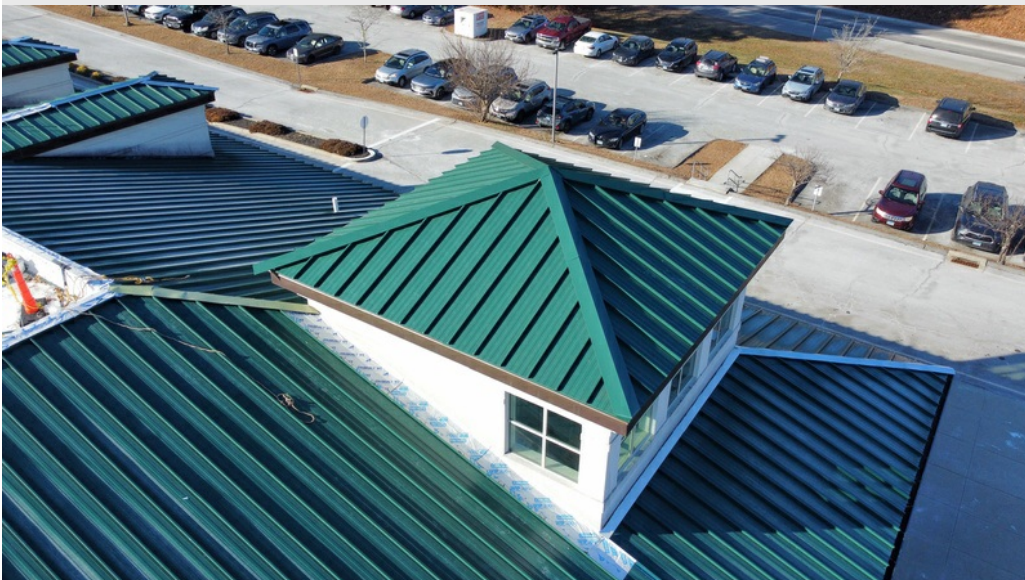
8

Large copula completed- 1/14/25

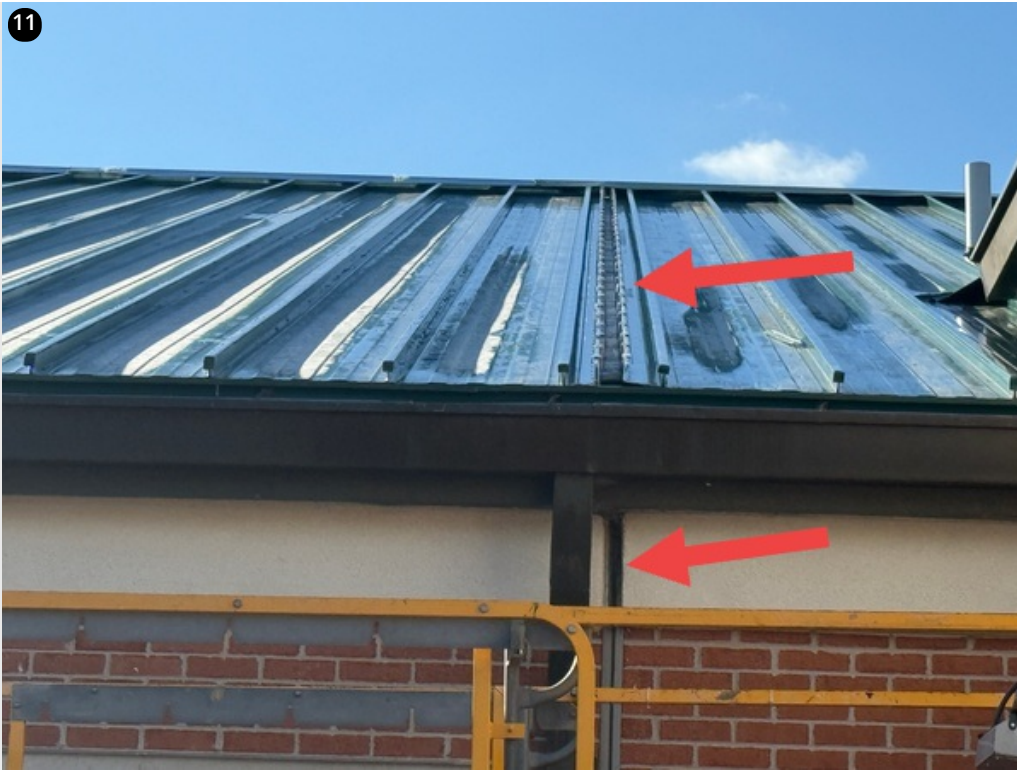
11

Gable clips installed on both sides of expansion joint- 1/14/25

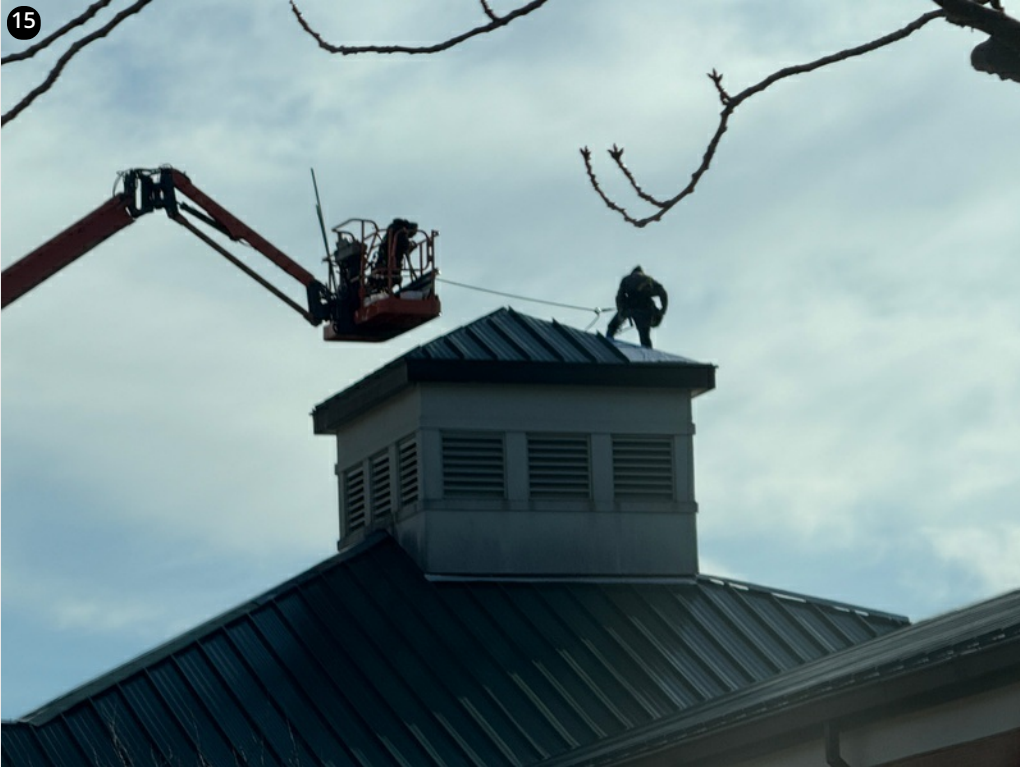
15 Crew installing panels on small copula-  
1/16/25

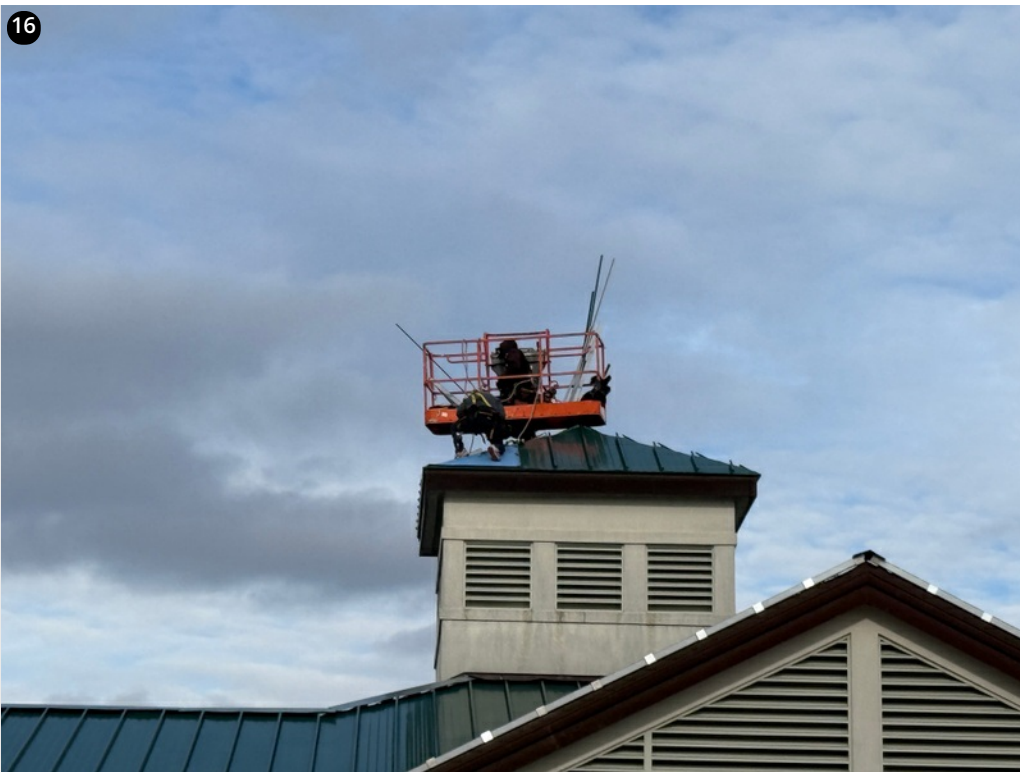
16 Crew installing panels on small copula-  
1/16/25

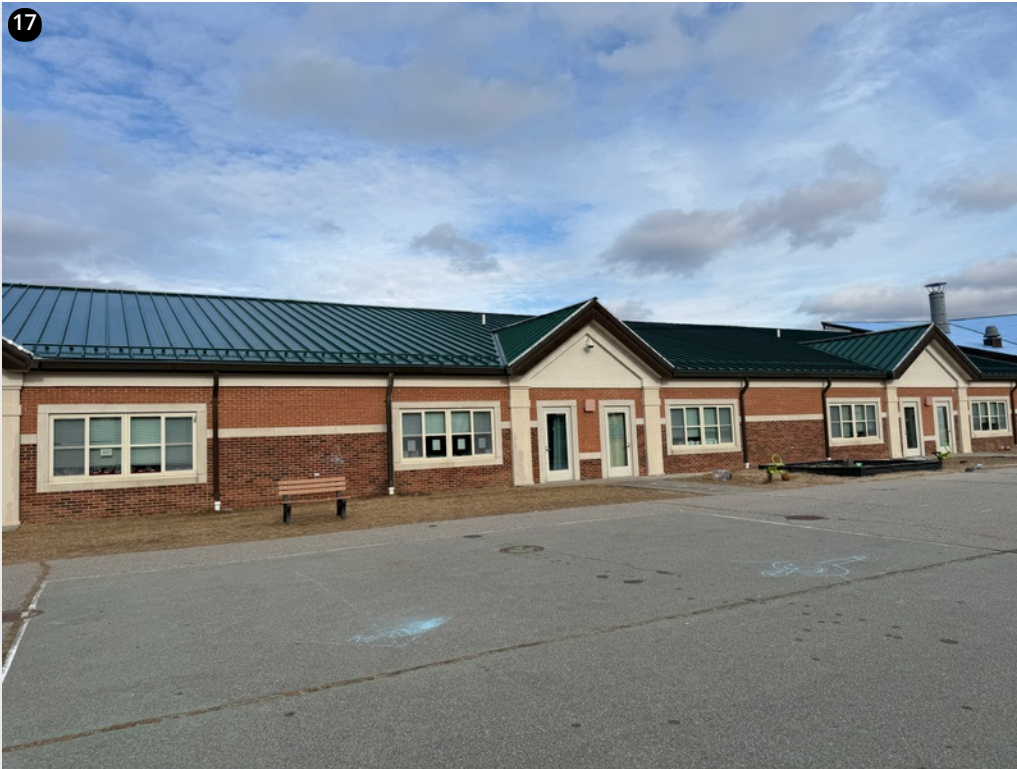
17

Snow guards installed on playground side-  
1/16/25

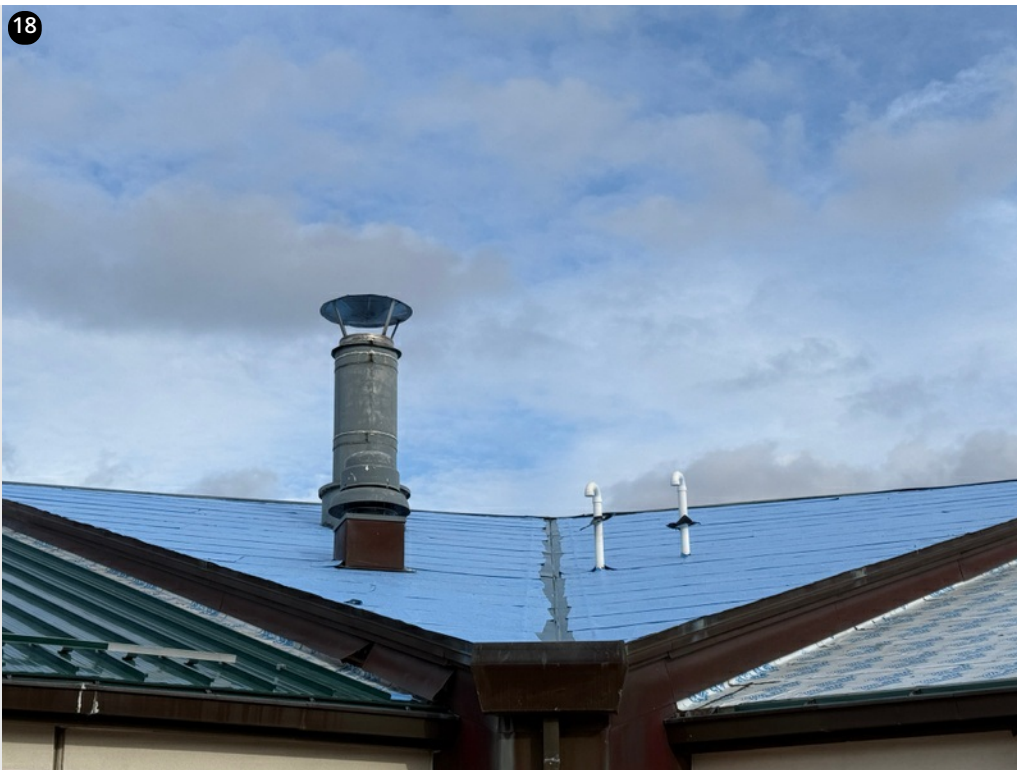
18

New ice and water layer adhered above  
boiler room section- 1/16/25

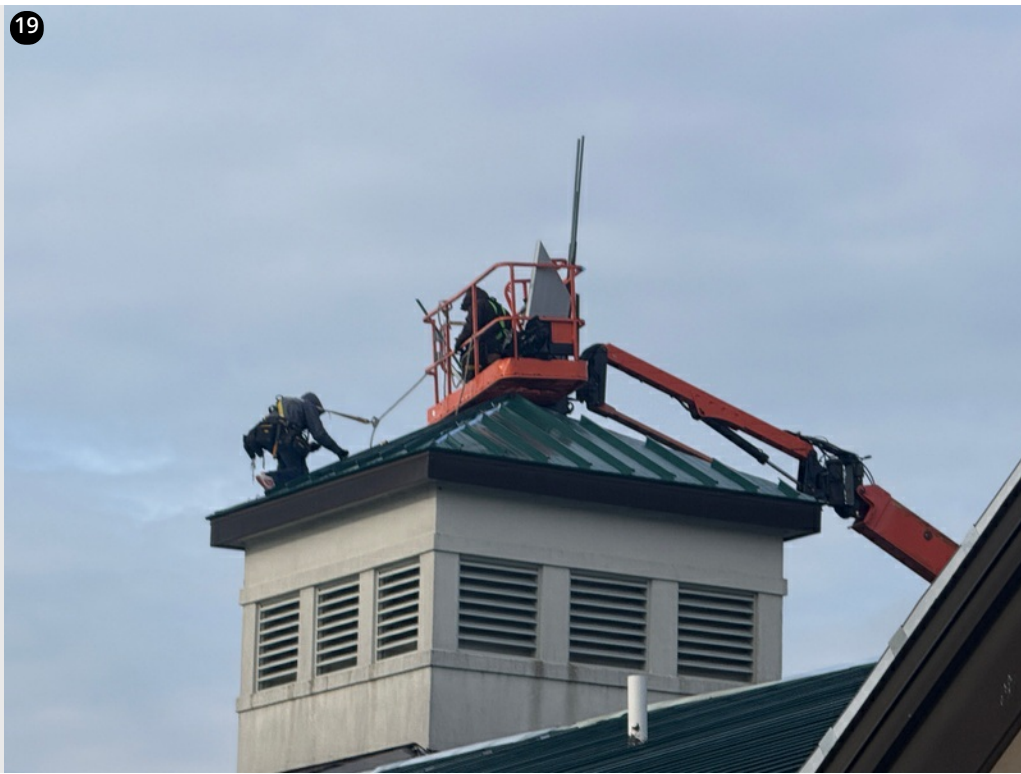
19

Crew installing panels on small copula- 1/17/25

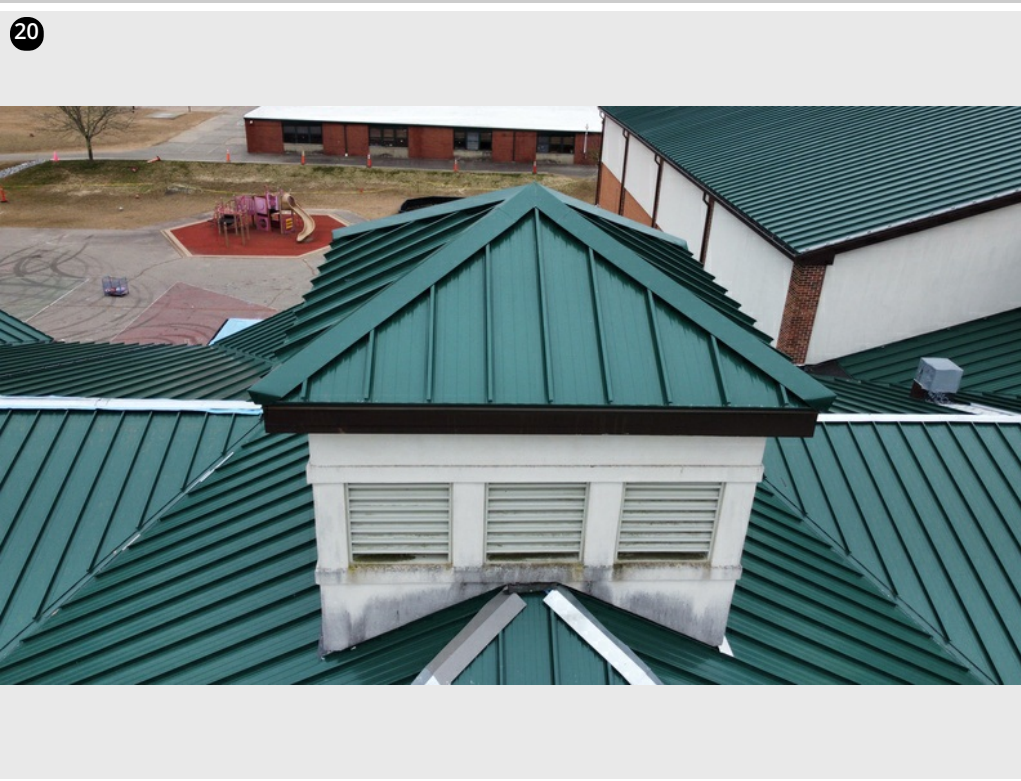
20

Small copula completed- 1/18/25

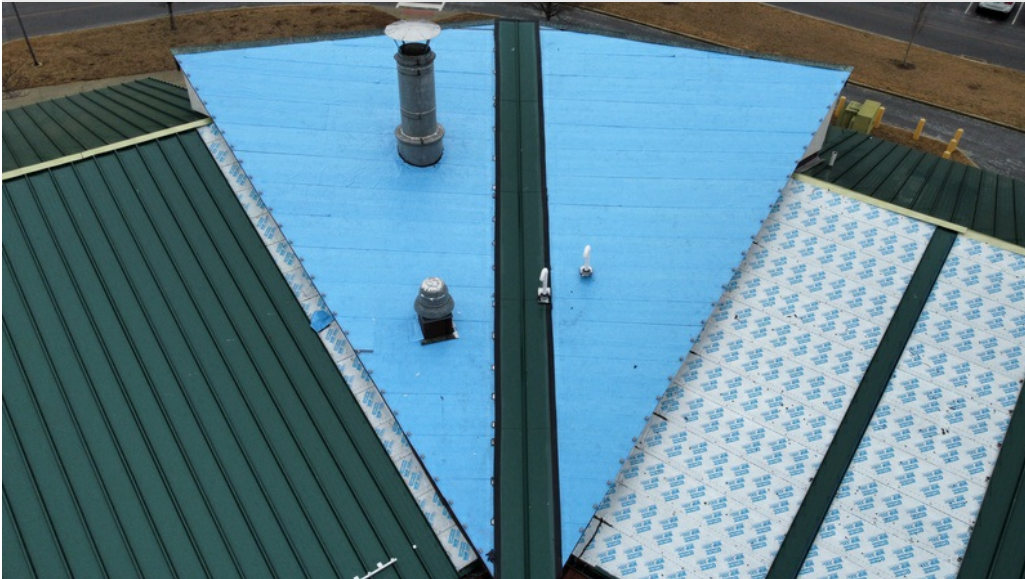
24

Larger valley installed on boiler room section- 1/18/25

A larger valley was also installed on the boiler room section to compensate for increased water flow in the area, due to slope and seam orientation.

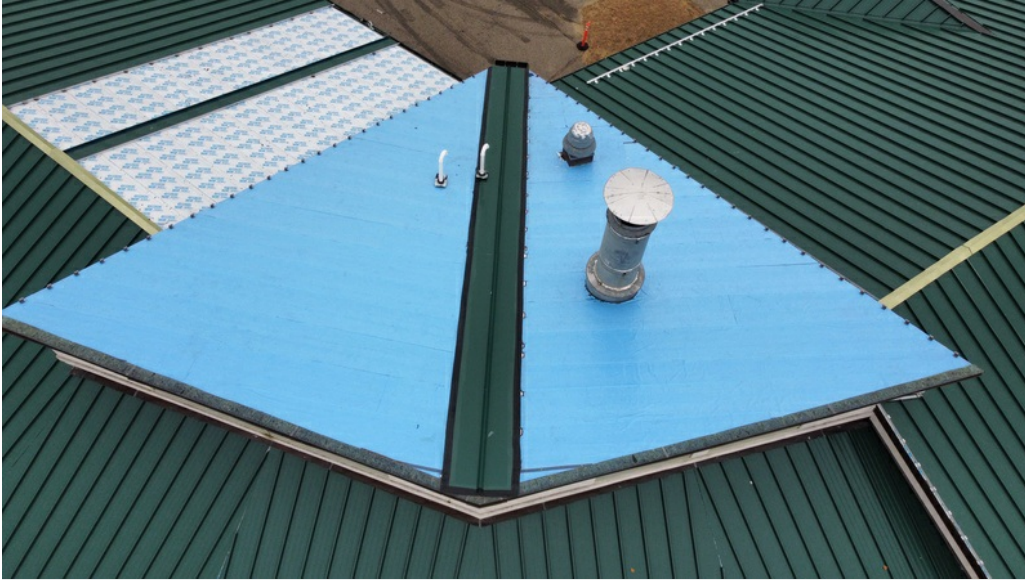
25

Overview- Boiler room section with newly adhered ice and water layer- New valley installed- 1/18/25

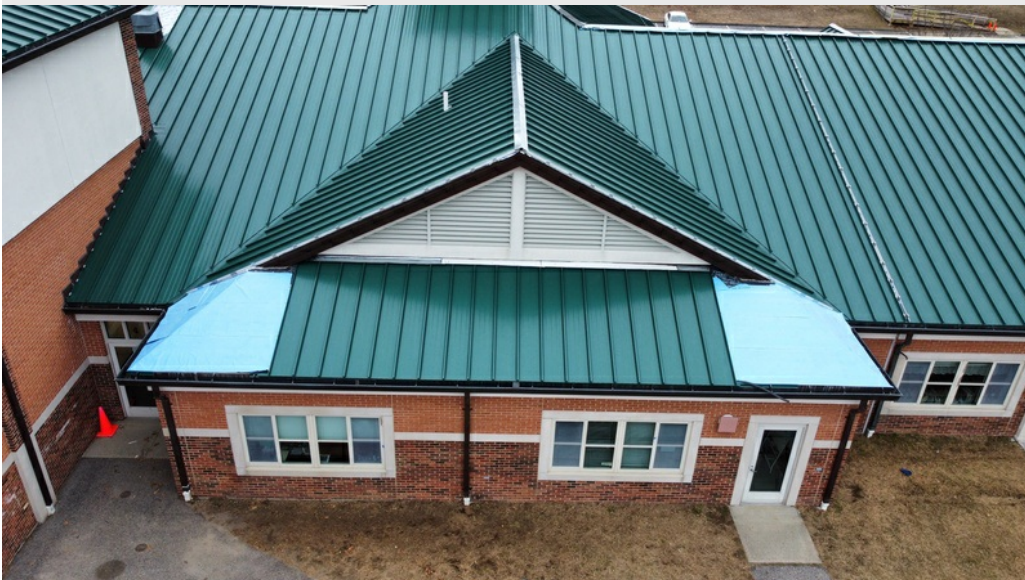
26

New ice and water layer adhered under large dormer area- 1/18/25
