Warranty Inspection Report

Project Ledyard School - Gales Ferry.		This insper	This inspection was performed to determine if any visual deficiencies exist. Work not yet complete or covered that cannot be inspected for compliance is the responsibility of the installing contractor.					
Project No. G-39041 Inspection			For insurance purposes, a copy of this report is being forwarded to the general contractor and					
Inspected by Michael Boland			architect for the project.					
Inst	pection Date & Time Nov 13, 2024 11:00:00	AM STATUS	STATUS UPON COMPLETION OF THIS INSPECTION:					
	aller The Imperial Company	C NO	NO VISIBLE DEFICIENCIES: Report submitted for the record.					
Inst	aller Office Contact Bruce Raulukaitis	e const 7						
Inst	aller Field Contact Bruce Raulukaitis		C MINOR DEFICIENCIES NOTED: See report for details.					
Oth Brue	er attendees at inspection Company ce The Imperial Co.			Car report for d	leteile

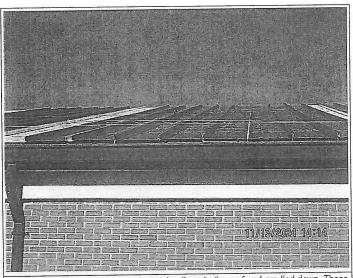
3. Staged panels have one screw securing them to the roof and are tied down. These panels are not considered installed. Staged panels should be installed as soon as possible as this may cause an unsafe condition. Back of main building between dormers. Panel ribs are not formed correctly and will be replaced by Garland.

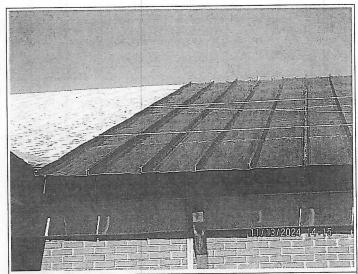
4. Staged panels have one screw securing them to the roof and are tied down. These panels are not considered installed. Staged panels should be installed as soon as possible as this may cause an unsafe condition. Back of main building between dormers. Panel ribs are not formed correctly and will be replaced by Garland.

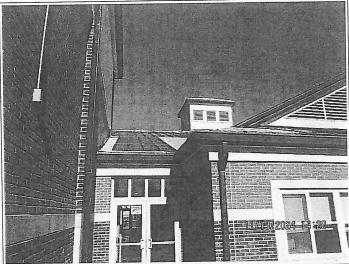
5. Staged panels have one screw securing them to the roof and are tied down. These panels are not considered installed. Staged panels should be installed as soon as possible as this may cause an unsafe condition.

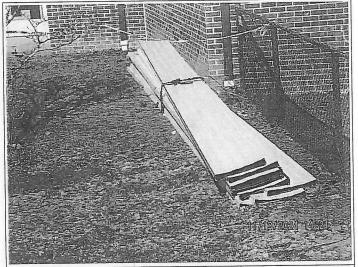
Improperly stored panels that have damage will be replaced at the installer's expense.

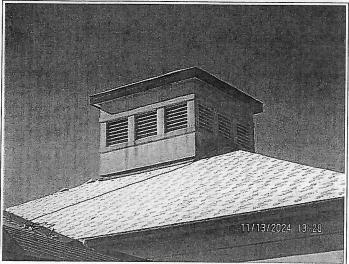
7. Front cupola. Headwall flashing will be tucked under existing flashing. Lined with a continuous bead of sealant and riveted with stainless steel, closed end rivets at 4" oc.. For the front section, a 16 ga plate will be secured to the existing framing. The sidewall/jamb flashing will be set in a continuous bead of sealant and secured to the 16 ga. plate. A new detail will be submitted separately.

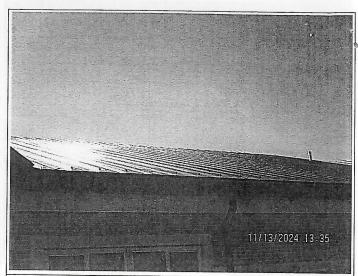
Currently installed panel clip screws must be removed and replaced with new, longer red screws to engage the metal deck at either the high or low flute. The new screws will be verified from below the deck.

All previously installed panel clip screws must be removed due to short length. New red clip screws must be installed at all panel clips to fully engage both high and low flutes of the metal deck. To be verified from below.

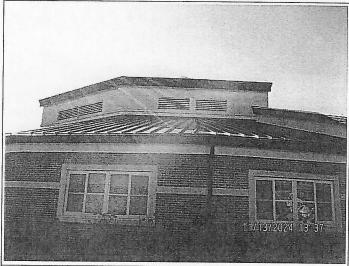
9. Front octagonal roof. Panel ribs do not meet at the hip but are centered as with all similar roof sections. We will wait for direction from Wayne as to whether he wants the ribs to match or the panels to be centered. If the ribs must match at the hip, Garland will send replacement panel. Imperial will supply the labor as this condition should have been discussed previously.

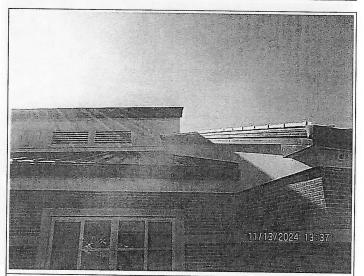
10. Same location. The sidewall/jamb will be sealed using a hip assembly. The new flashing will be tucked under the existing, set in a continuous bead of sealant and riveted with stainless steel, closed end rivets at 4" oc..

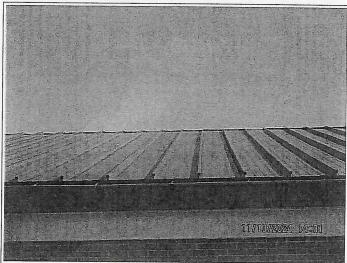
11. Rear wing at playground. Panels must be removed. A chalk line struck and panel clips centered on the chalk line. The panels must be clamped at each clip to remove the existing camber.

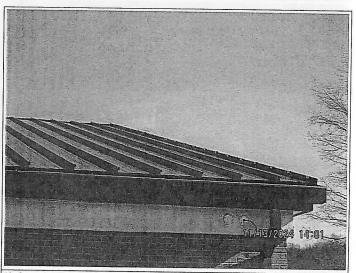
12. Same location. Gable clips must be installed at 17" in the 8' high pressure zone in the upper right corner. The remain gable clips are to be spaced at 20". Refer to the approved shop drawings.

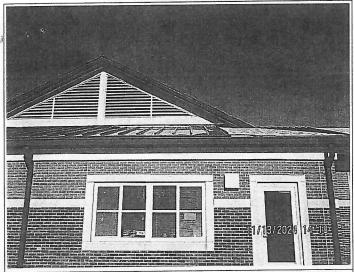
13. Dormer on back of main building. Panels are pan ended in compliance with shop drawings. Headwall flashing will be tucked under existing flashing, lined with a continuous bead of sealant and riveted with stainless steel, closed end rivets at 4" oc..

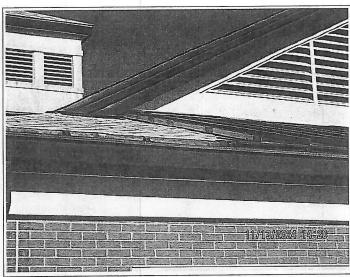
14. Same location. Panel clips are installed in compliance with shop drawings.

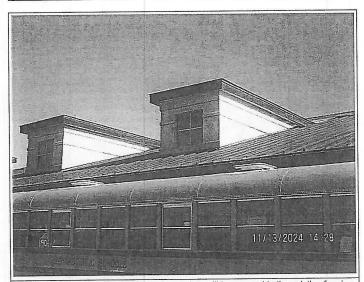
16. Bus loading zone, right dormer. A 16 ga plate will be secured to the existing framing. The sidewall/jamb flashing will be set in a continuous bead of sealant and secured to the 16 ga. plate. A new detail will be submitted separately.

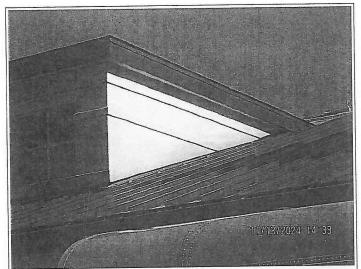
17. Bus loading zone, left dormer. A 16 ga plate will be secured to the existing framing. The sidewall/jamb flashing will be set in a continuous bead of sealant and secured to the 16 ga. plate. The Imperial Company will be responsible for removing EIFS to accommodate the new plate and flashing. A new detail will be submitted separately.

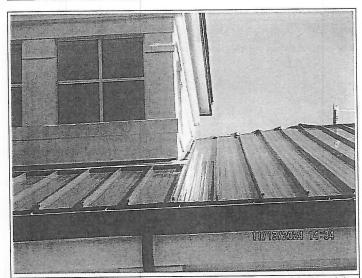
18. Bus loading zone, corner dormer. A 16 ga plate will be secured to the existing framing. The sidewall/jamb flashing will be set in a continuous bead of sealant and secured to the 16 ga. plate. A new detail will be submitted separately. Headwall flashing will be tucked under the existing, set in a continuous bead of sealant and riveted using stainless steel, closed end rivets at 4" oc..

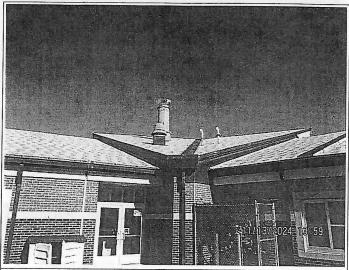
19. Curb flashings and pipe penetration boots will be installed according to the approved shop drawings and supplemental installation guide.

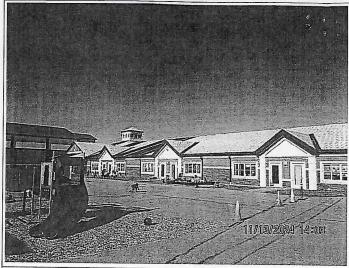
20. Underlayment have been installed on the entire substrate in compliance with the approved shop drawings.

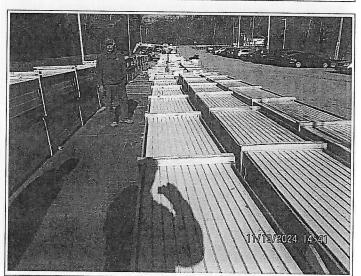
22. Panel crates should be shimmed so they are not resting on the end packing. Panels crates should be kept straight as not to introduce a camber or damage the panels.

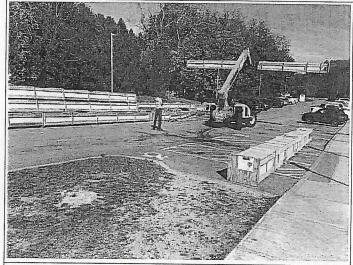
23. Sent by Wayne Donaldson. All panel crates must be moved using a spreader bar and straps wrapped at the crate 2x4 packaging. All damaged panels by mishandling will be replaced by the Imperial Co..

All crates must be moved by means of use of a spreader bar with straps placed on packing frame to avoid damaging the panels in the crate. All panels damaged currently or in the future by mishandling of the crates or panels themselves will be required to be replaced at the handlers expense.

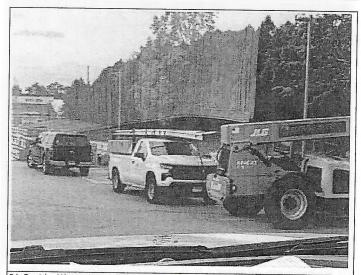
24. Sent by Wayne Donaldson. All panel crates must be moved using a spreader bar and straps wrapped at the crate 2x4 packaging. All damaged panels by mishandling will be replaced by the Imperial Co..

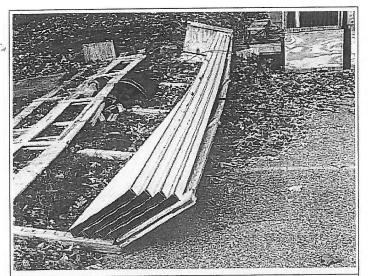
25. Sent by Wayne Donaldson. Panels in open crates must be supported to keep the integrity of the shape of the panel and ribs. All damaged panels by mishandling will be replaced by the Imperial Co..

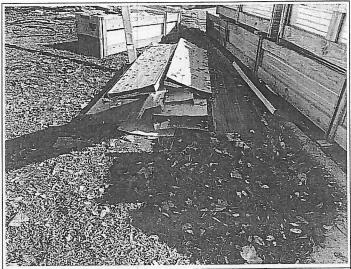
26. Sent by Wayne Donaldson. Scrap panels to be used in small cut conditions must be stacked and secured to maintain panel and rib shape.

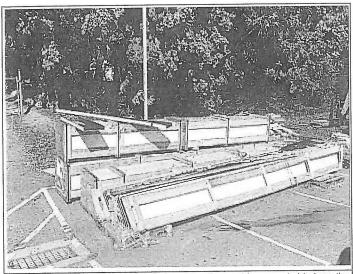
27. Sent by Wayne Donaldson. Panels in open crates must be supported to keep the integrity of the shape of the panel and ribs. All damaged panels by mishandling will be replaced by the Imperial Co..

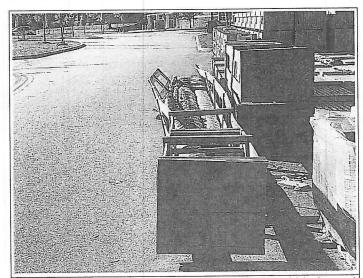
28. Sent by Wayne Donaldson. All materials must be protected to maintain shape and eliminate the possibility of damage.

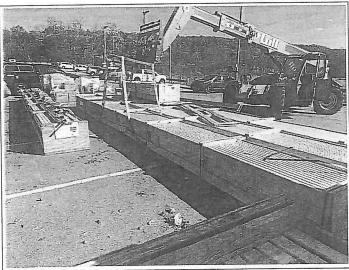
29. Sent by Wayne Donaldson. All panel crates must be moved using a spreader bar and straps wrapped at the crate 2x4 packaging. All damaged panels by mishandling will be replaced by the Imperial Co..

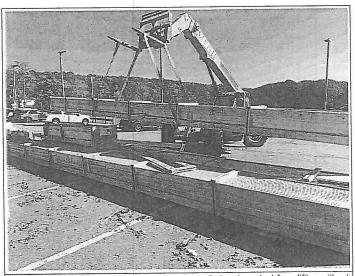
30. Sent by Wayne Donaldson. Crates are mishandled and cracked from lifting without the use of a spreader bar.

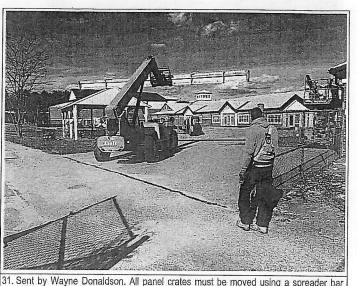
31. Sent by Wayne Donaldson. All panel crates must be moved using a spreader bar and straps wrapped at the crate 2x4 packaging. All damaged panels by mishandling will be replaced by the Imperial Co..

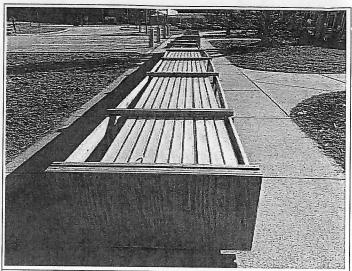
32. Sent by Wayne Donaldson. Crates must be protected from foot traffic.
