# Field Report

| Field Report No.: 17 | | | | | | | | | | | |
| SP&A Project No: 22.331 | | | | | Report Date: 1.03.2025 | | Time: 9:30AM | | | | |
| Project: Gales Ferry School<br>(Name & Location) 1854 CT-12<br>Gales Ferry, CT 06335 | | | | | | | | | | | |

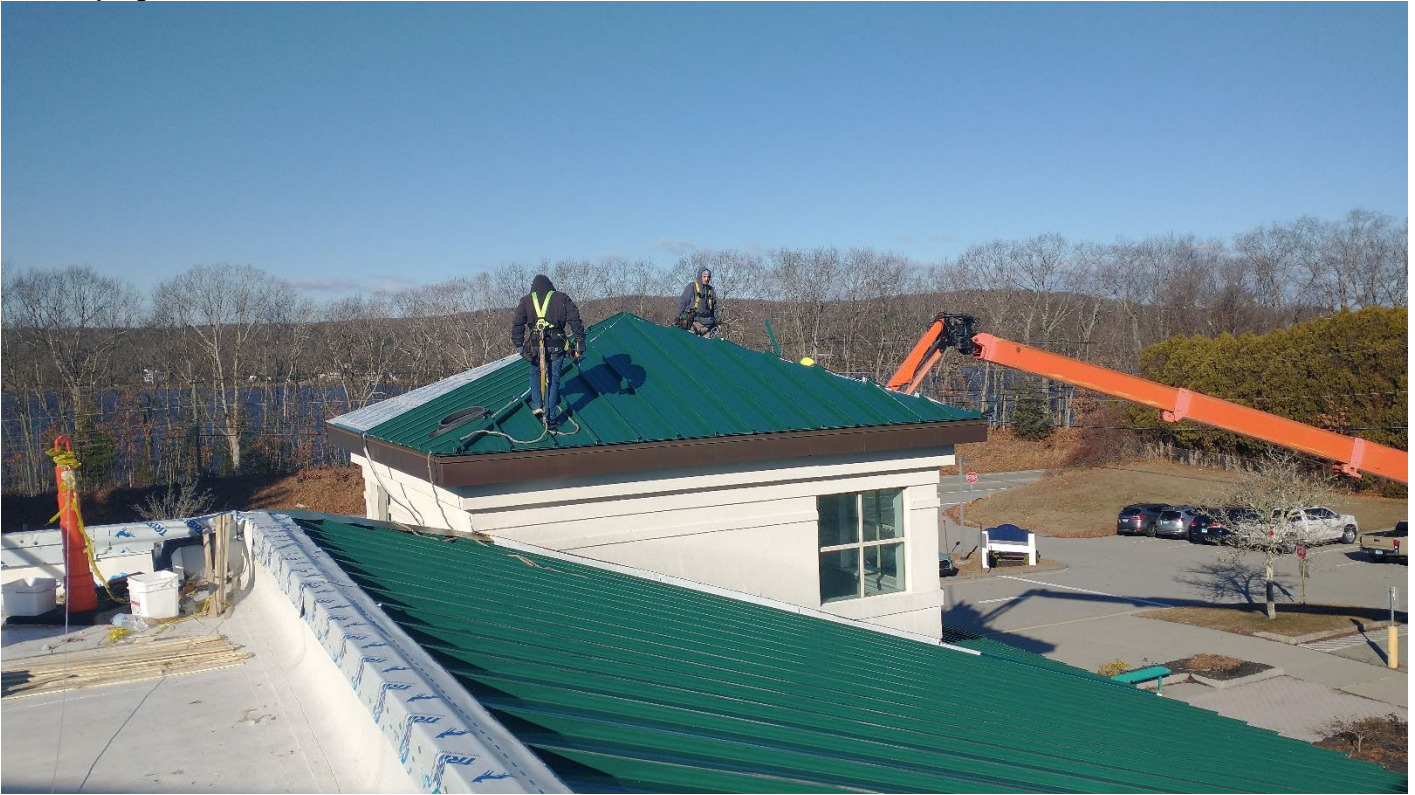
Work in progress on the “tower” of roof A

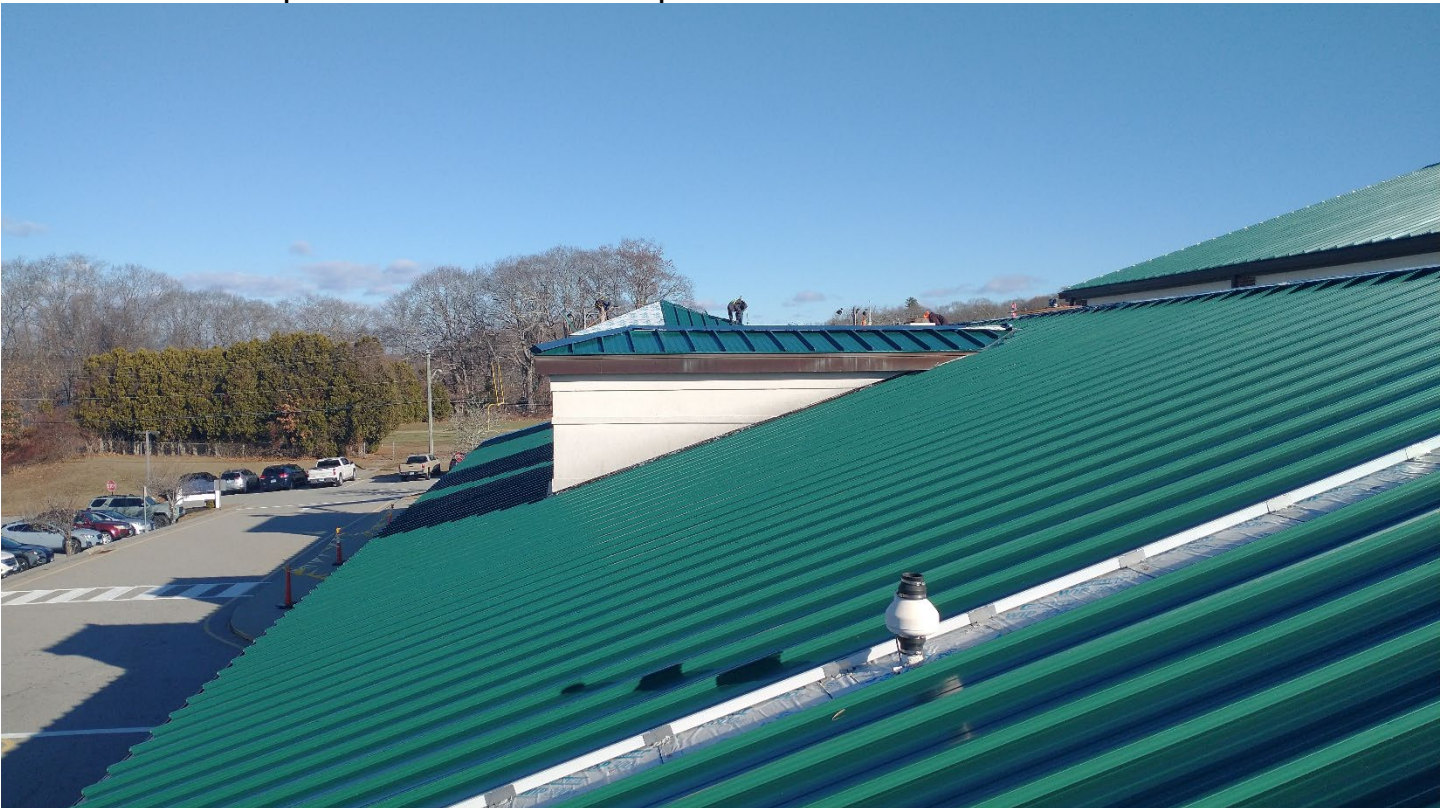
Roof A – Vent needs temp removal to install the new roof panels

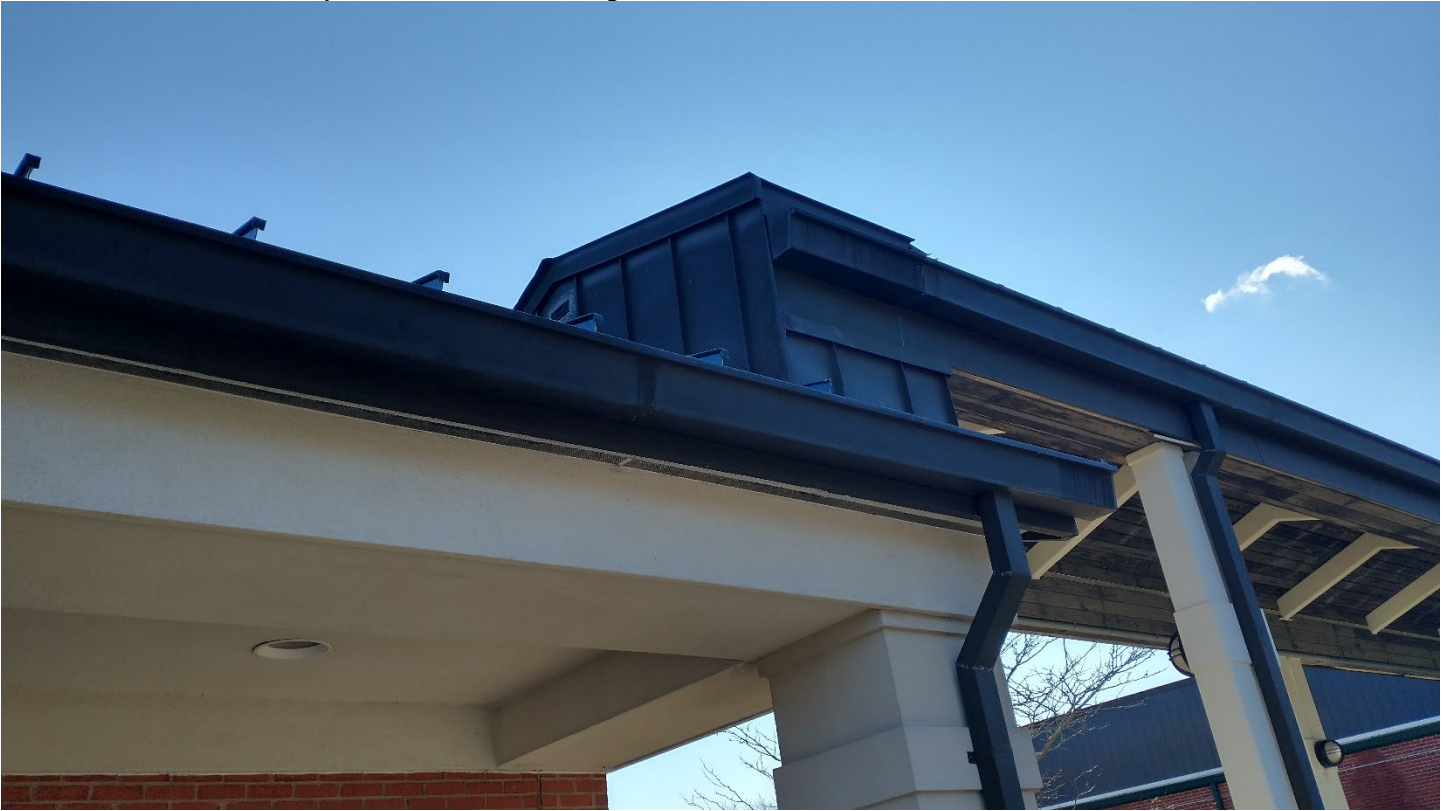
**Roof A – Discussed vertical panel installation on the gable end**

| Field Report No.: 17 | | | | | | | | | | | |
|---|---|---|---|---|---|---|---|---|---|---|---|
| - Roof A – Gable end of walkway cover needs the lower 8” of the vertical panels (all three sides) removed for investigation of how to secure the new vertical panels to the existing structure and height requirements. | | | | | | | | | | | |

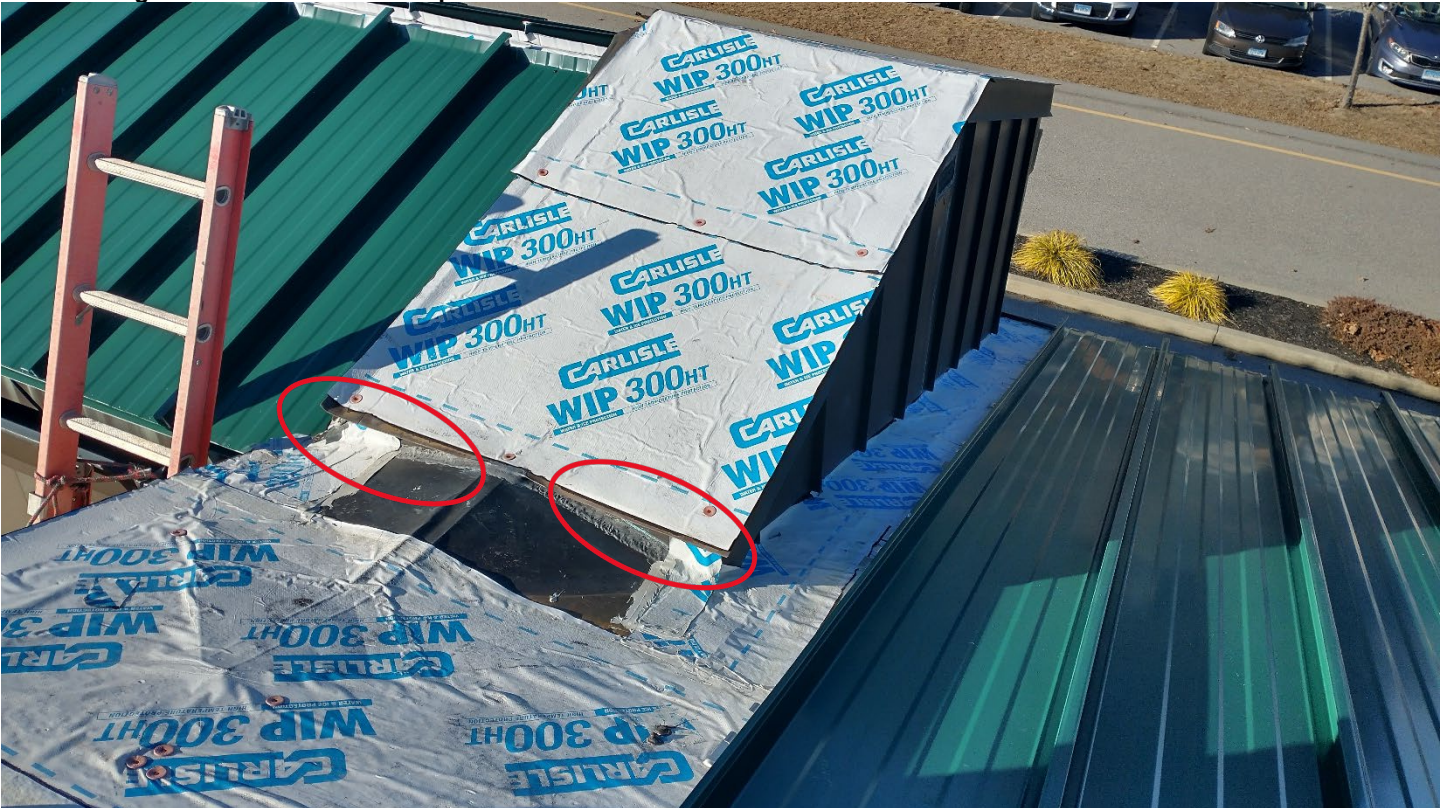
**Roof A – In garland's hands to come up with a solution for the cricket due to vertical side walls on both sides of the cricket**

| Field Report No.: 17 | | | | | | | | | | | |
|---|---|---|---|---|---|---|---|---|---|---|---|
| - At the gable end of the walkway roof, Garland needs to produce a drawing eliminating the current cricket for better flow of the rain water. Currently the water hits vertical end points at both sides of the cricket. See attached photo. | | | | | | | | | | | |
