| <b>Field Report No.:</b> | | | | <b>16</b> | | | | | | | |
| <b>SP&amp;A Project No:</b> 22.331 | | | | <b>Report Date:</b> 12-13-2024 | | <b>Time:</b> 9:30AM | | | | | |
| <b>Project:</b> Gales Ferry School<br>(Name & Location) 1854 CT-12<br>Gales Ferry, CT 06335<br><br><b>General Contractor:</b><br>The Imperial Company, Inc. | | | | | | | | | | | |

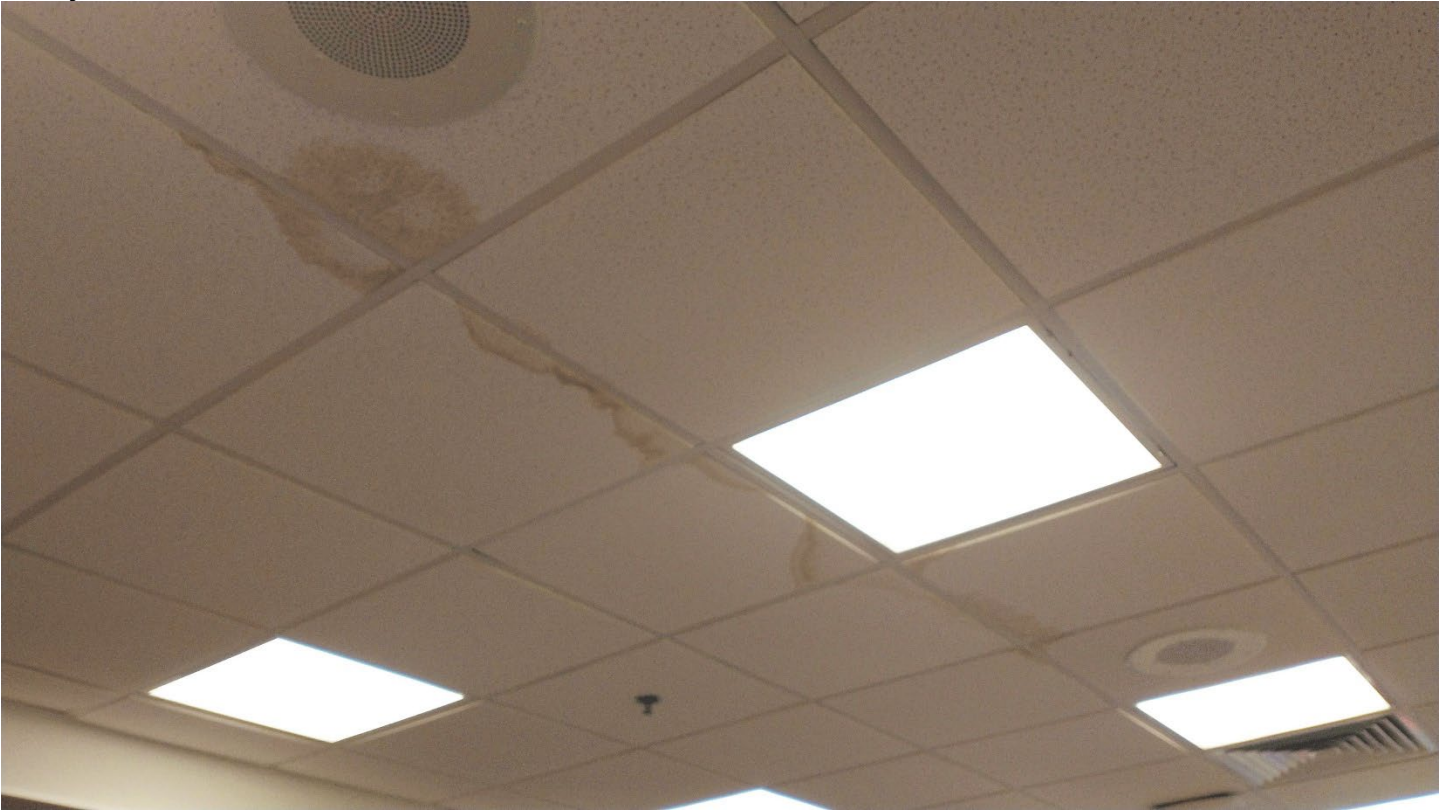
**Library roof leaks**

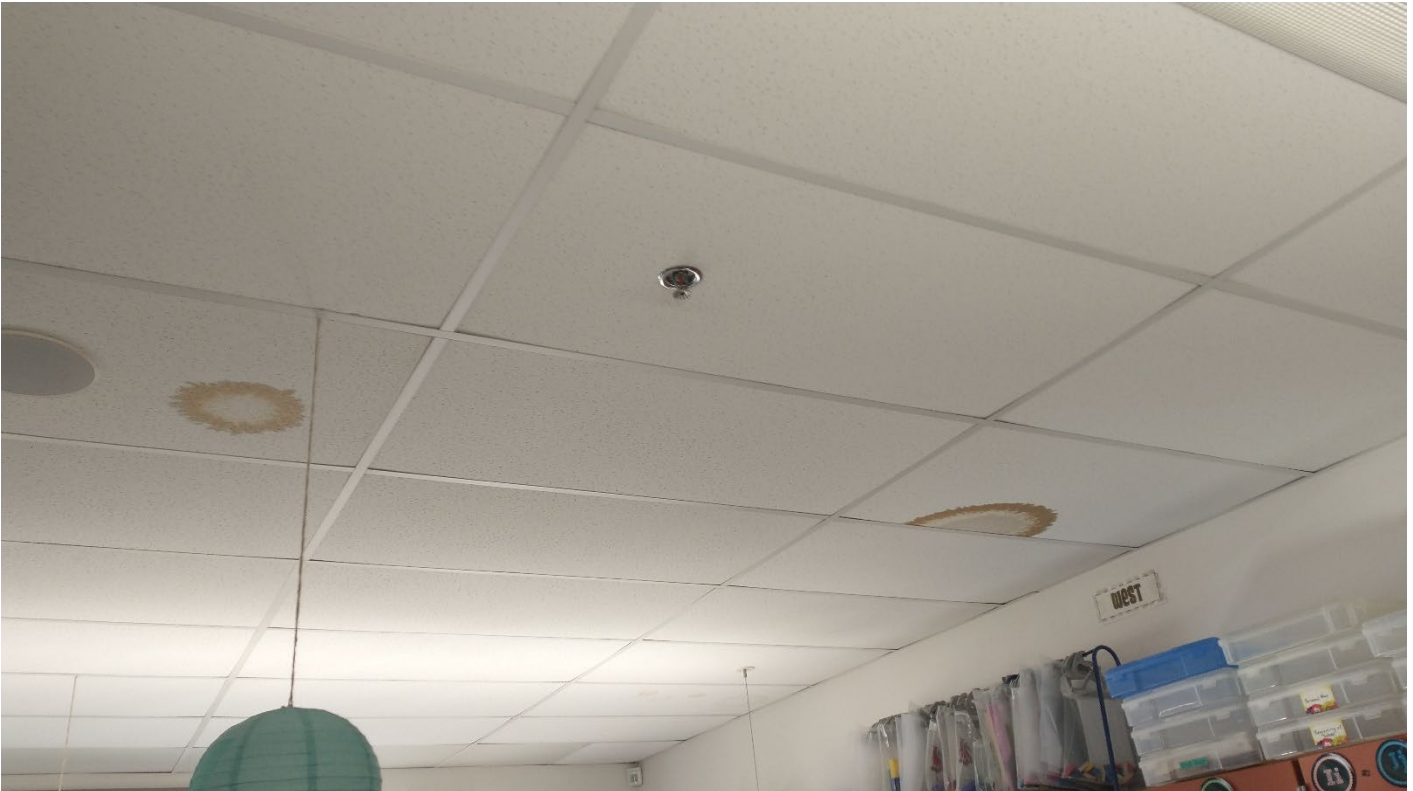
**Room 227 roof leaks**

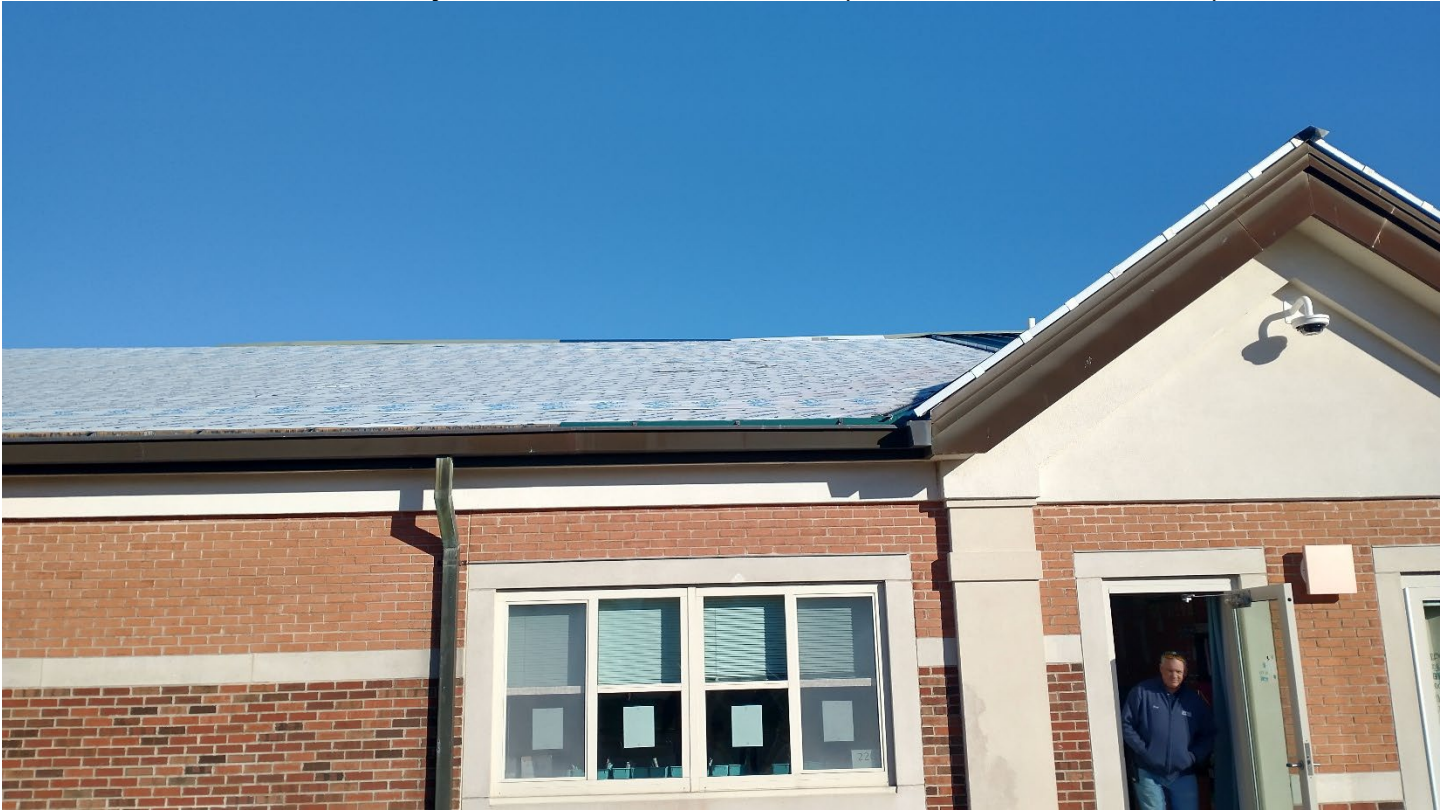
| - Approximate number of workers on site – 4<br>- Installing panels between the Gymnasium & the gable with mechanical louvers on roof D. See attached photo. | | | | | | | | | | | |

**Roof D – Roof D installation tentatively scheduled to continue work 12/21 (see attached tentative schedule)**

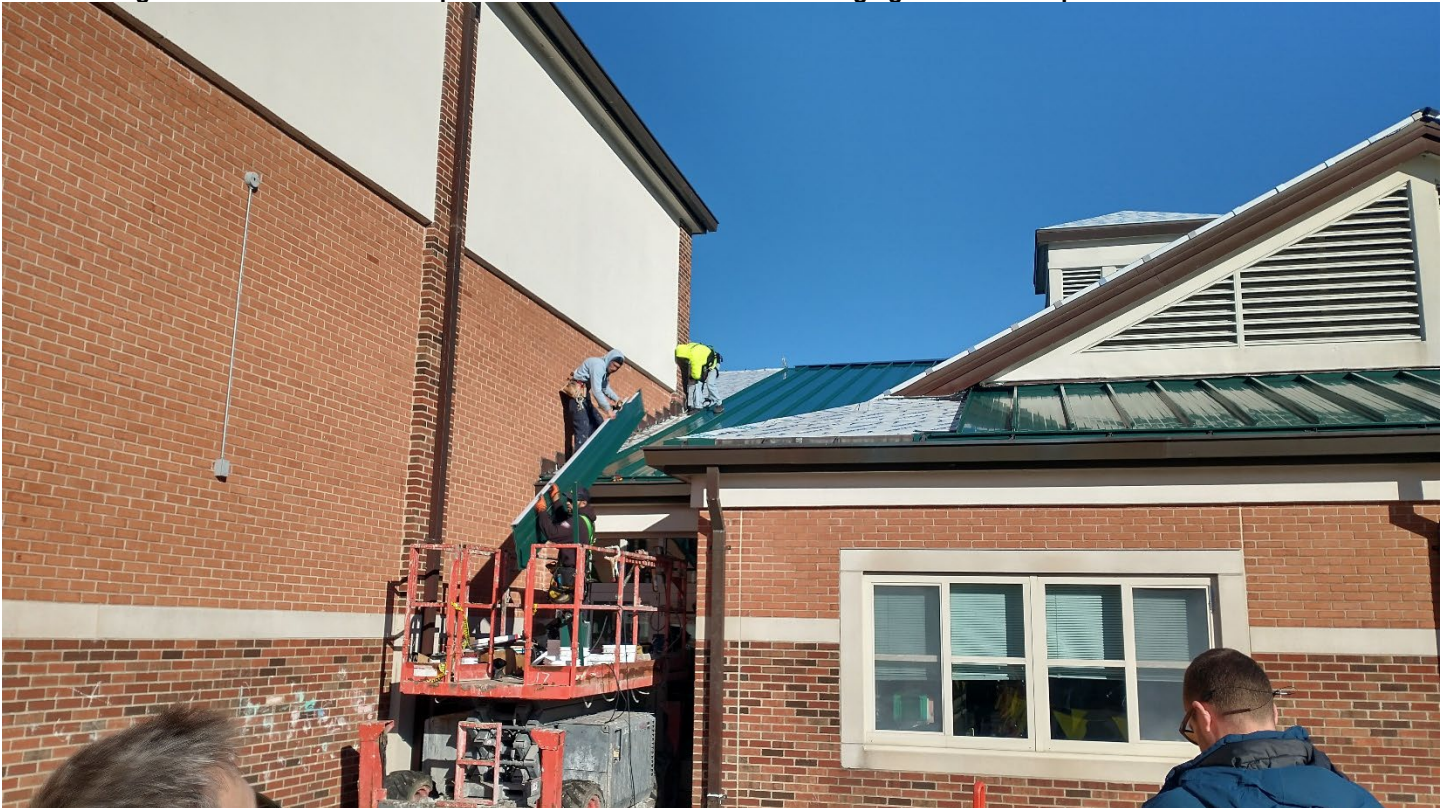
**Roof D – In garland's hands to come up with a solution for the rakes butting against the roof panels**

| - Panels that were installed and have short screws need to be replaced need to be observed for the correct screw length by Garland & SPA in areas where the underside decking is not visible.<br>- Tentative schedule handed at last week's site visit is attached.<br>- Discussed during the site visit was how the rake boards meeting with the new roof panels. Imperial to send an RFI. See attached photo.<br>- For record, the following rooms active leaks and most were reviewed during the site visit – <ul style="list-style-type: none"> <li>• Library (see attached photo)</li> <li>• Hallway near gym</li> <li>• 236 x2</li> <li>• 233</li> <li>• 231</li> <li>• 227 (see attached photo)</li> <li>• 226</li> <li>• 218</li> </ul> | | | | | | | | | | | |
