23-1091 - Ledyard potential sites with maps

Draft Ledyard Proposed Projects List

APRIL 20, 2023

EASTERN CONNECTICUT CONSERVATION DISTRICT
238 West Town Street, Norwich, CT 06360

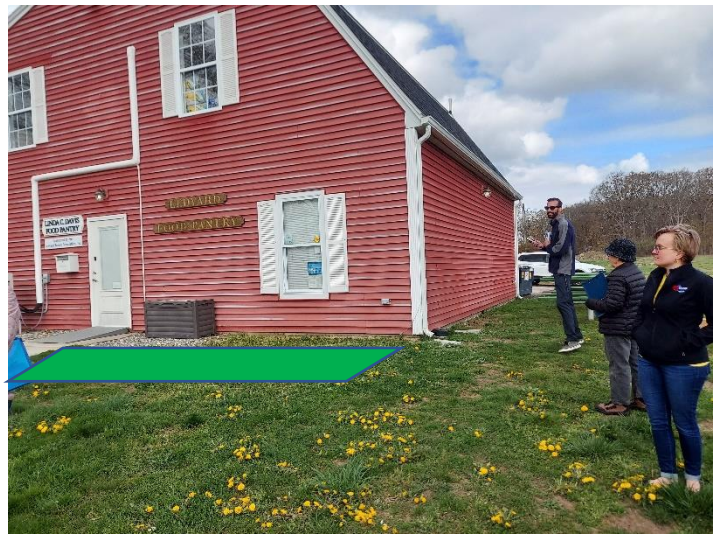
Ledyard food pantry, 740 Colonel Ledyard Hwy Food by the farmers market pavilion

There are existing downspout on all building corners

DPW planning to install a gravel strip around the building foundation. The existing outlet on the building corner would still be accessible.

In rain garden (green polygon in the above image) will be small enough to not interfere with existing uses of the area if designed to be square with the existing infrastructure.

In the above image, based on the roof area that drains to the downspout (blue polygon), the rain garden (green polygon) would be about 60 ft^2, or 6 x 10 feet.

The garden would be highly visible area near farmer's market.

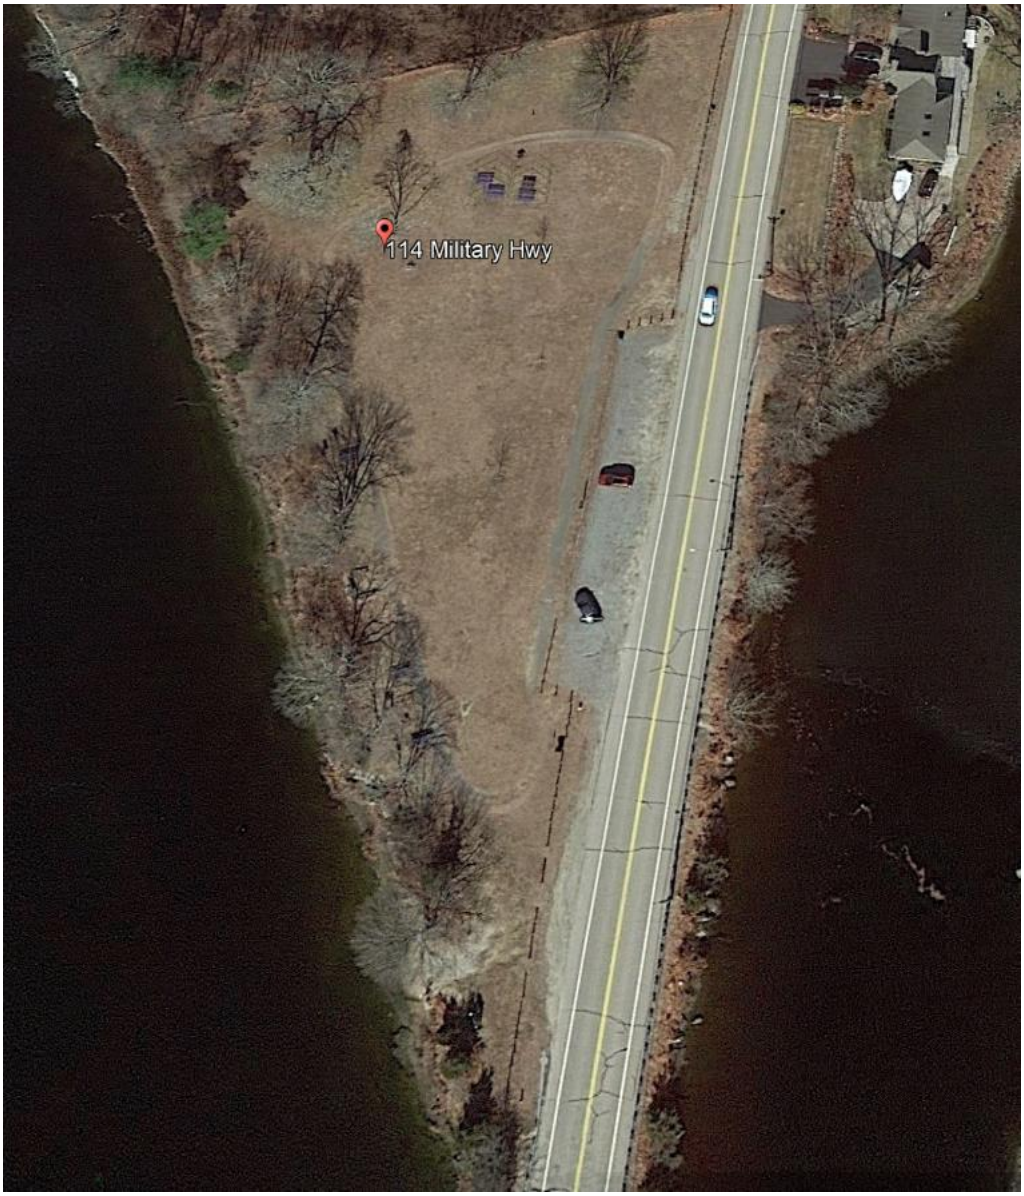
Erikson Park Boat Launch area

This park was not reviewed.
