## 23-1091 - Ledyard potential sites with maps

## **Draft Ledyard Proposed Projects List**

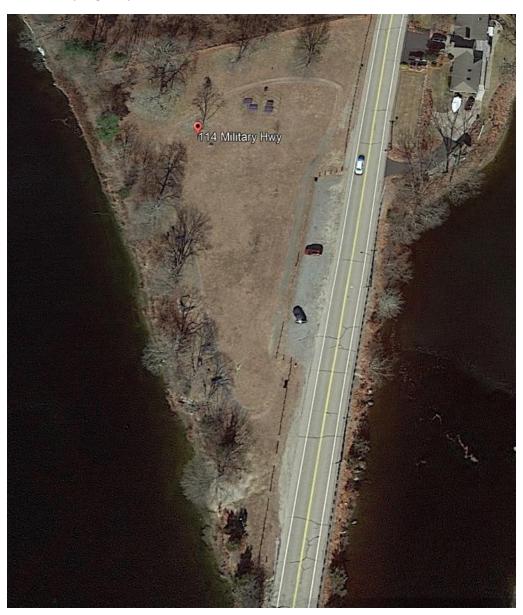
## Erikson Park Boat Launch area

This park was not reviewed.

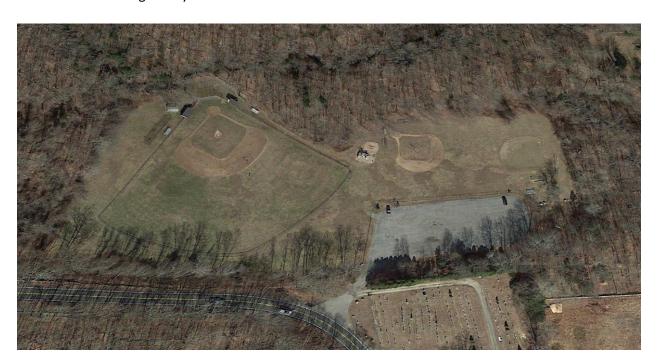
Pfizer's Field 212 Stoddard Wharf Road Gales Ferry

Proposed by UCONN Climate Corp students Details not available at this time. Drains towards Billings Avery Brook
