Field Report Page 1 of 4

SP&A Project No: 22.331 Report Date: 1.03.2025 Time: 9:30AM Project: Gales Ferry School 1854 CT-12 Gales Ferry, CT 06335 General Contractor: The Imperial Company, Inc. Weather Site Conditions Day of Week Temp. Range: 32°	Field Report No.:												ort No.:	17		
Concrete Site of Nasony 10 Flooring 15 Steel/Misc. Metals 11 Pool Flooring 15 Steel/Misc. Metals 11 Pool Flooring 16 HVAC 22 Tester (Tri-state) Flinishes Temperature 23 Audio Vis/Low Volt SPA in areas where the underside decking is not visible. Name & Location 18 Acceptable SPA SPA in areas where the underside decking is not visible. Roof Ac Cale and Pools and the vertical end points at both sides of the cricket. See attached photo.	SP&A Project No: 2			22.331							Report Date	e: 1.03	.2025		Time:	9:30AM
Temp. Range: 32°		(Gales Ferry School 1854 CT-12 Gales Ferry, CT 06335 General Contractor:									·			
Clear															of Week

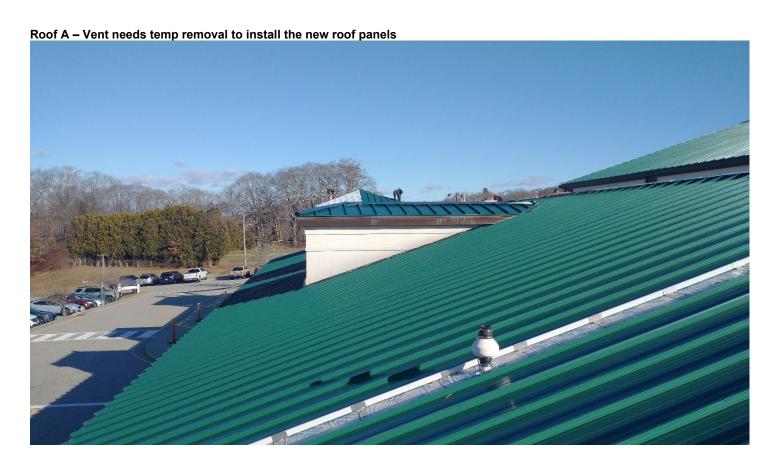
Work in progress on the "tower" of roof A

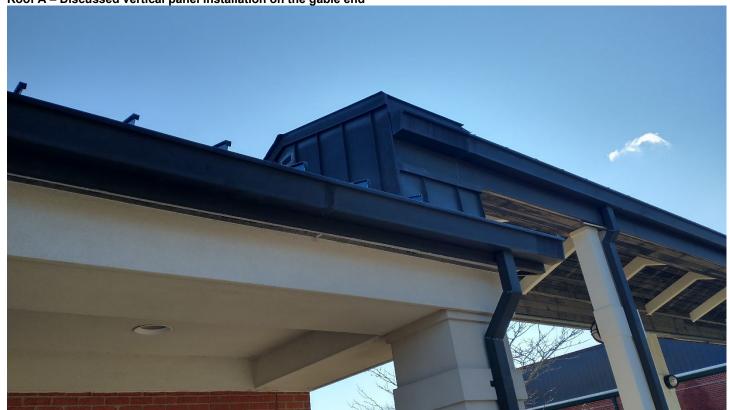
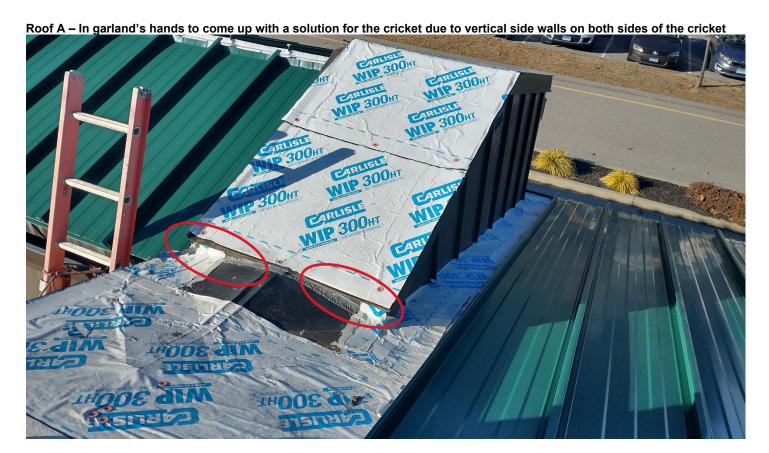
- Installing panels on the "tower" of roof A. See attached photo. General Remarks: - Panels that were installed and have short screws that need to be replaced need to be observed for the correct screw length by Garland & SPA in areas where the underside decking is not visible. - Roof A – Gable end of walkway cover needs the lower 8" of the vertical panels (all three sides) removed for investigation of how to secure the new vertical panels to the existing structure and height requirements. - At the gable end of the walkway roof, Garland needs to produce a drawing eliminating the current cricket for better flow of the rain water. Currently the water hits vertical end points at both sides of the cricket. See attached photo. Visitors: - None.																
 Panels that were installed and have short screws that need to be replaced need to be observed for the correct screw length by Garland & SPA in areas where the underside decking is not visible. Roof A – Gable end of walkway cover needs the lower 8" of the vertical panels (all three sides) removed for investigation of how to secure the new vertical panels to the existing structure and height requirements. At the gable end of the walkway roof, Garland needs to produce a drawing eliminating the current cricket for better flow of the rain water. Currently the water hits vertical end points at both sides of the cricket. See attached photo. Visitors: None.
