MEMORANDUM

Date: May 15, 2025

Re: Visual Dam Evaluation
Lee Brook Pond Dam (CT Dam ID #7219)
Ledyard, Connecticut

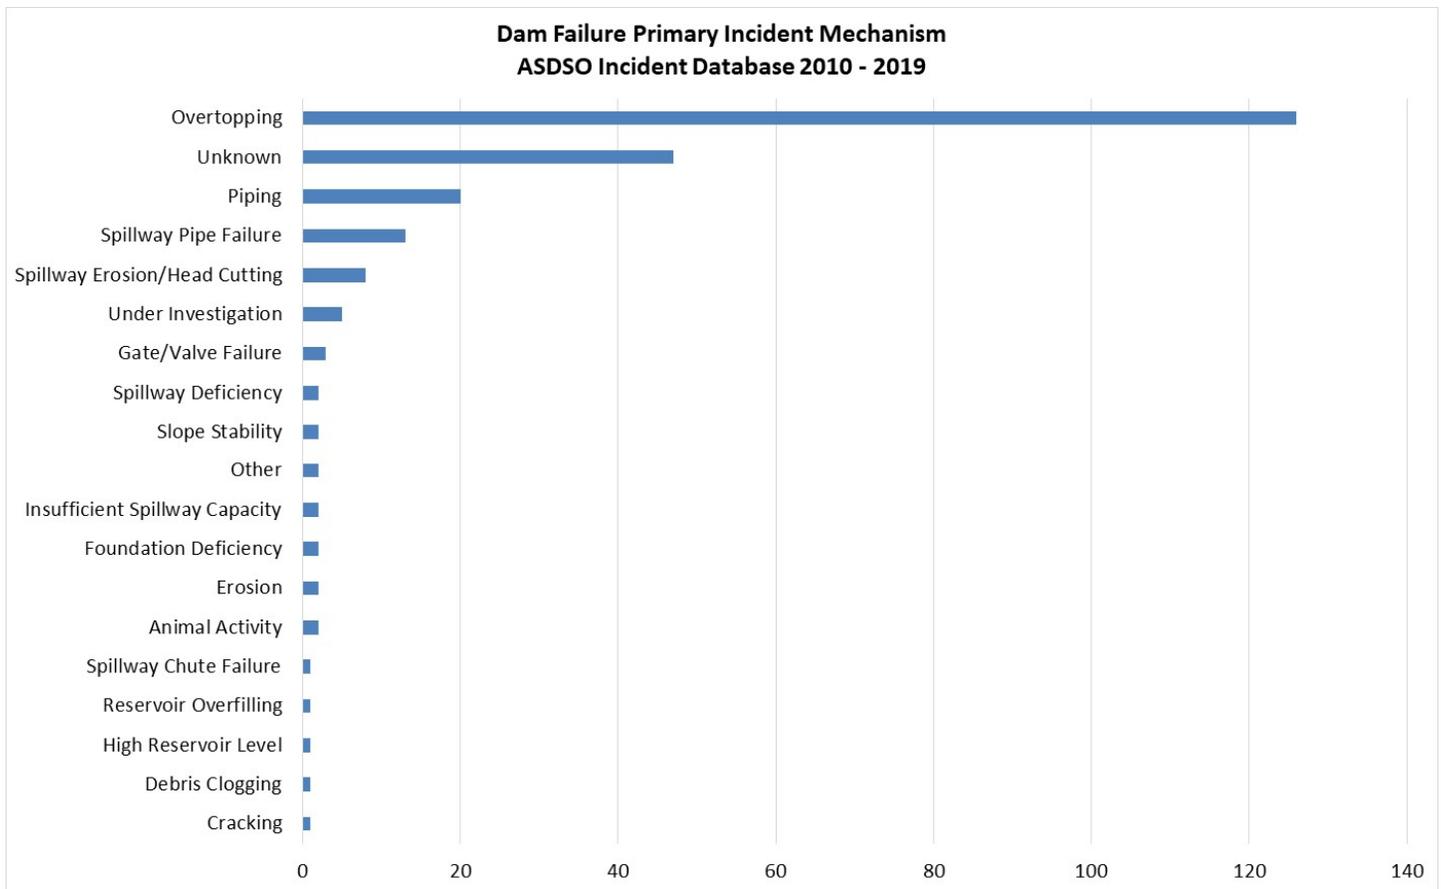
The dam has reportedly overtopped 8 to 10 times in the past 25 years, including twice during the winter of 2023-2024. At least 3 times since 2000, the overtopping water has flowed through the foundation of the mill building which has resulted in voids in the downstream embankment wall / building foundation. During an overtopping event in March 2010, water reached the door of the sawmill building.

Overtopping of an earthen and stone masonry dam is a serious dam safety concern that, left unaddressed, is likely to lead to dam failure. The Association of State Dam Safety Officials (ASDSO) states the following¹:
