| <b>Field Report No.:</b> | | | | <b>21</b> | |
| <b>SP&amp;A Project No:</b> 22.331 | | <b>Report Date:</b> 1.28.2025 | | <b>Time:</b> 9:30AM | |
| <b>Project:</b> Gales Ferry School<br>(Name & Location) 1854 CT-12<br>Gales Ferry, CT 06335<br><br><b>General Contractor:</b><br>The Imperial Company, Inc. | | | | | |

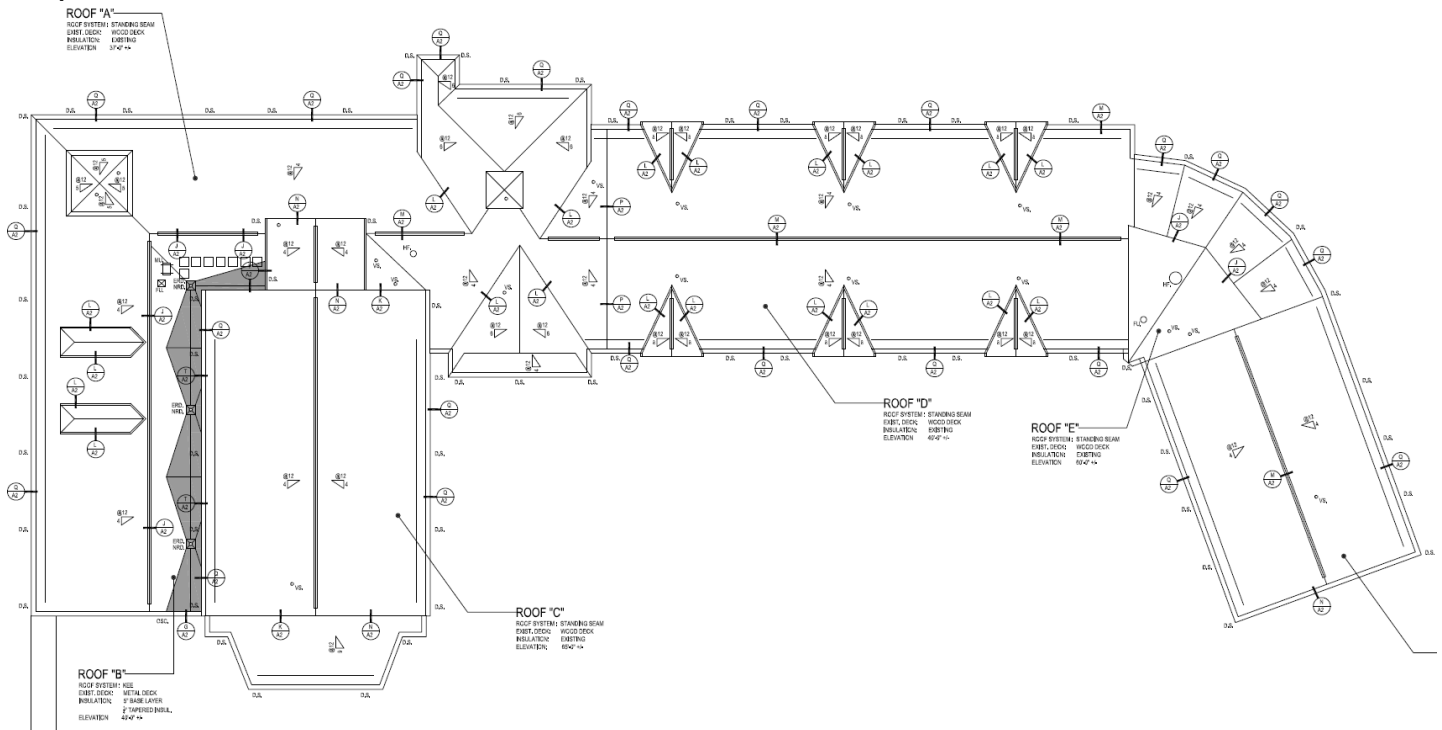
### Roof plan

Location marked as location 5 was found to have 8" screws and was picked by random by SPA for verification -
