LEDYARD UP-DOWN SAWMILL

HISTORIC PROPERTY STRUCTURAL AND CONDITION ASSESSMENT

Ledyard Up-Down Sawmill
172 Iron Street
Ledyard, Connecticut

March 2, 2023, *Revisions April 14, 2023 (noted in blue text)*

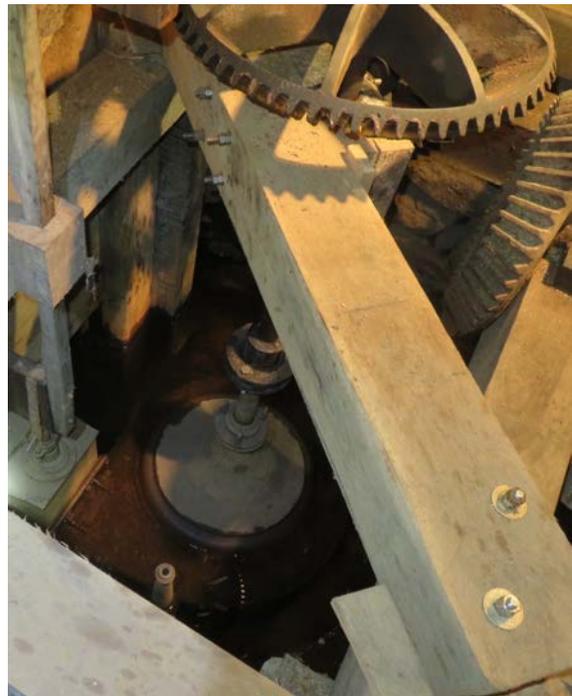
Left: 1870 advertisement for the Tyler Turbine; Right: Top of turbine in-situ.

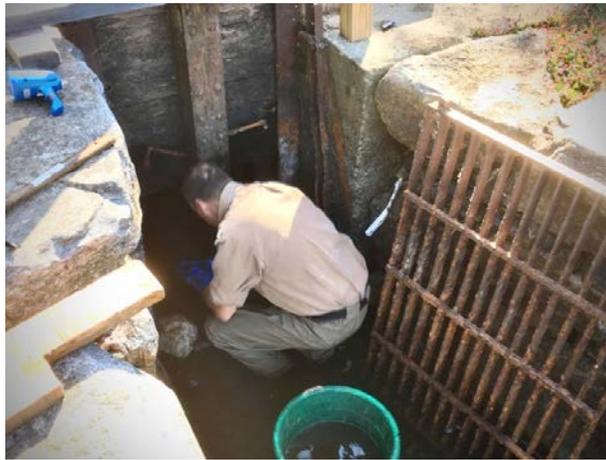
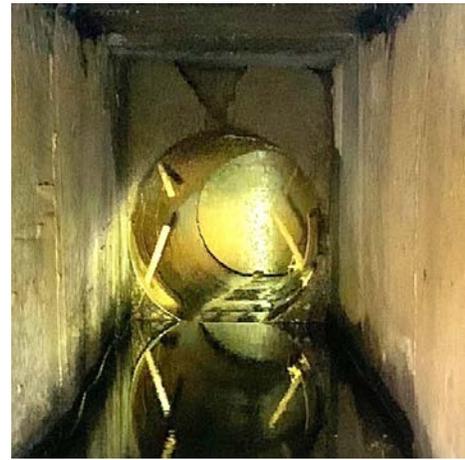
Left: investigation of the gate showing structure behind gate assembly; Right: concrete culvert between grate and penstock (penstock beyond). Both images courtesy of Ledyard Up-Down Sawmill Facebook page.

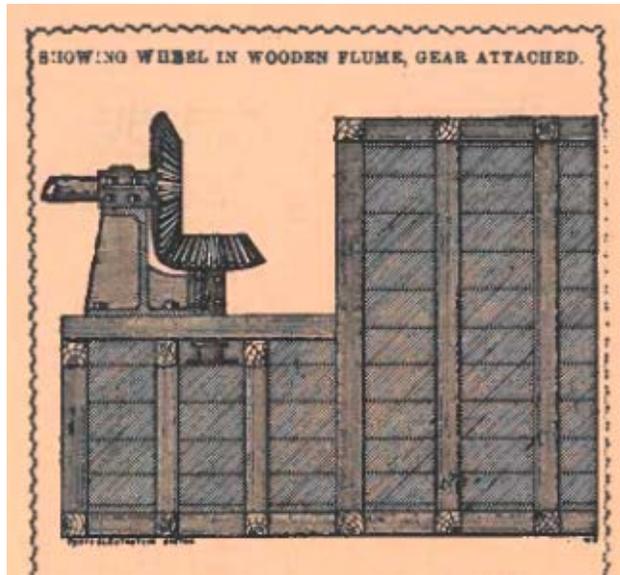
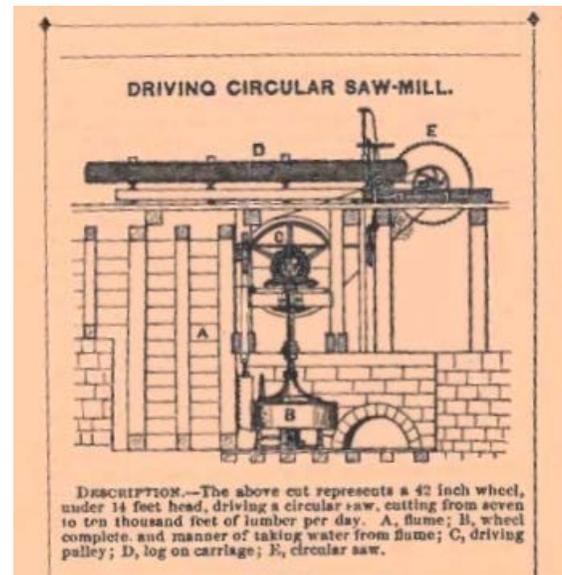
Eighteenth century turbine catalog diagrams showing arrangement of square wooded flumes. Images collected and provided by Tom Kelleher.

Recommendation: Per historic examples, the design concept that the group coalesced around is of a rectangular flume (penstock) constructed of 2" or 3" pressure-treated plank with groove edges connected with 3/4" or 1" spline slightly oversized and lined with rubber to make it watertight. The planks would be braced by 4x4 (or bigger) frames every few feet with possible mortise and tenon joints. The frames could be wedged against the planks with shingles to pre-tension / pressurize against water pressure. The bottom of the interior of the flume / penstock would epoxy coated to extend its longevity. The downpipe connecting the flume to the turbine would also be square and of similar construction. We have provided a conceptual sketch of a cross-section through the flume of this assembly below. A full design is outside the scope of this project and would require exact head dimensions and detailed measurements of the area. Tom Kelleher suggests that making the supply 50% bigger than gate offers a less rigorous engineering analysis of the final design.

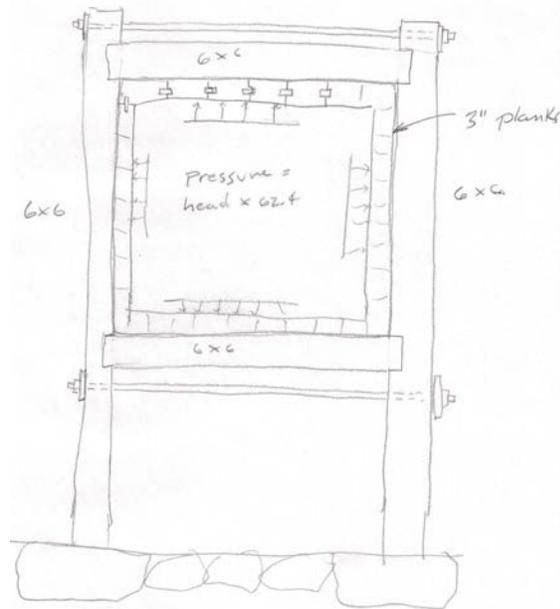
Conceptual Design of Flume Replacement, Cross-Section

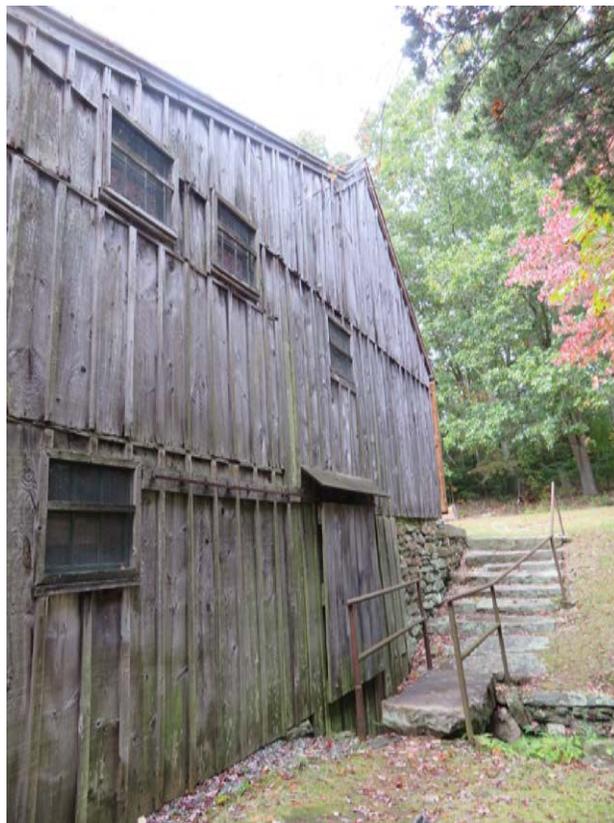
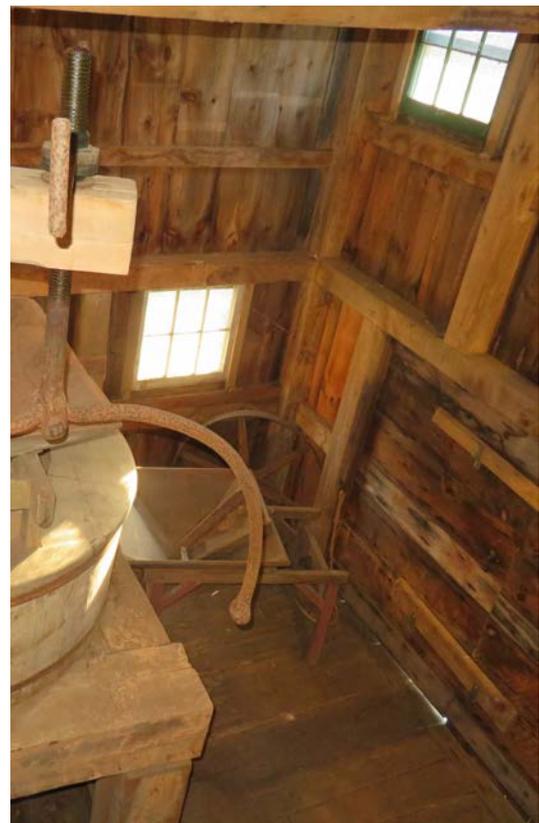
Left: Exterior of east elevation; Right: interior of south east corner showing horizontal girts and board supports.

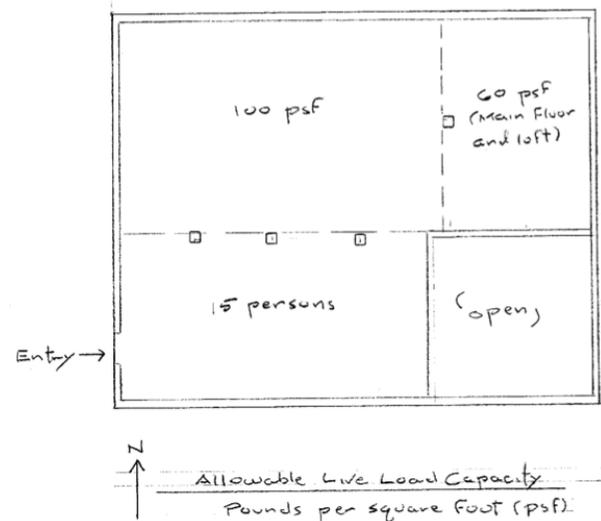
indicating that they may be overstressed. We recommend that additional support be added by adding posts beneath each of the beams. If the supports are added, the south east area could be rated for a 60 psf live load.

When the saw mill is open to the public, a total occupancy limit for the building of 20 persons seems to be a reasonable limit to assure that the northwest area is not loaded excessively while still allowing a reasonable number of observers for demonstrations. See graphic representation of areas below.
