LEDYARD UP-DOWN SAWMILL

HISTORIC PROPERTY STRUCTURAL AND CONDITION ASSESSMENT

Ledyard Up-Down Sawmill
172 Iron Street
Ledyard, Connecticut

March 2, 2023, *Revisions April 14, 2023 (noted in blue text)*

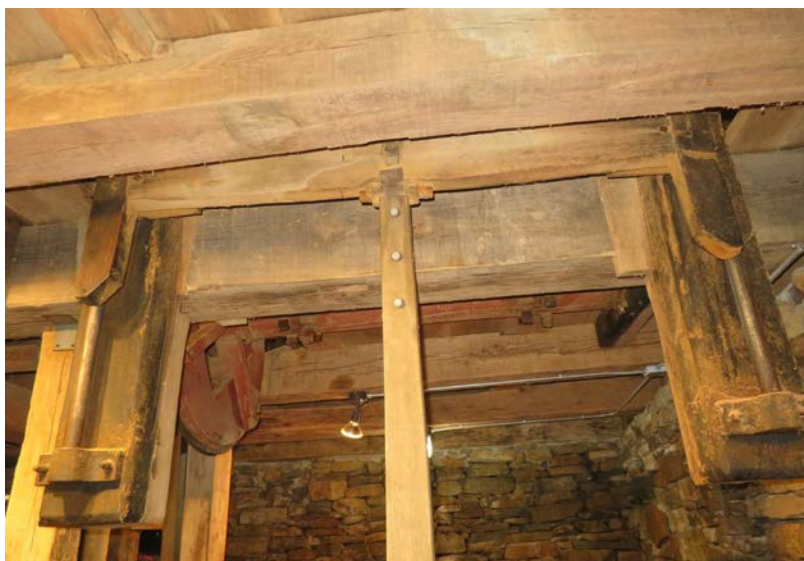
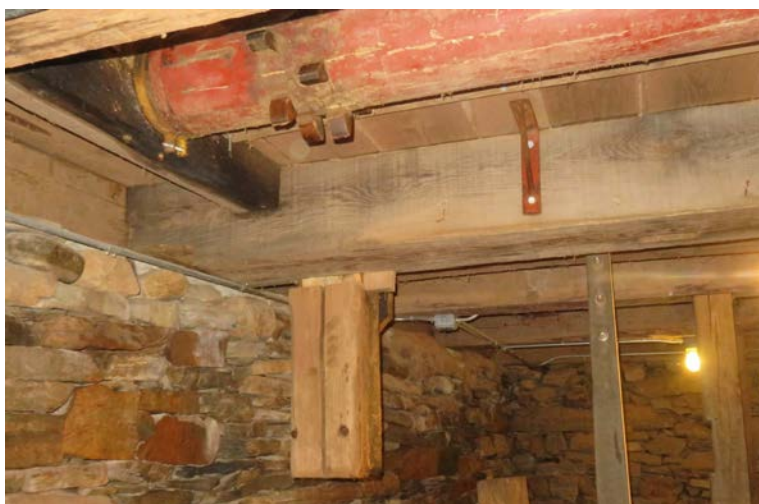
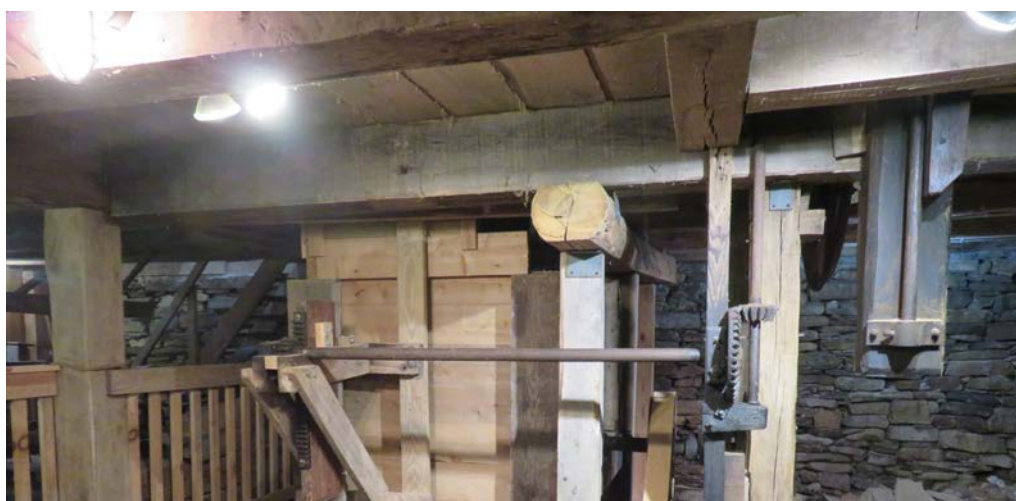
Analysis: The fender beam and end connections do not appear to show any signs of distress; however, the authors did not have adequate load information to perform a numerical analysis to check the capacity of the fender beam relative to its demand.

*Top: overall view of fender beam from the east showing two saw guides extending below;
Middle: north end of fender beam; Bottom: south end of fender beam including newer
intermediate post supported on north raceway wall below.*

Recommendation: The authors would be happy to undertake a more rigorous analysis should it be desired.

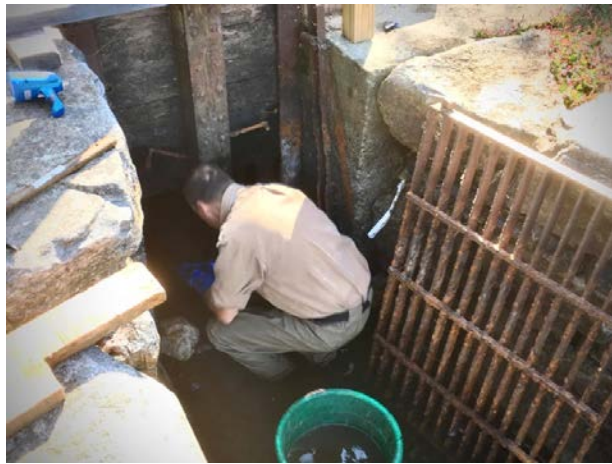
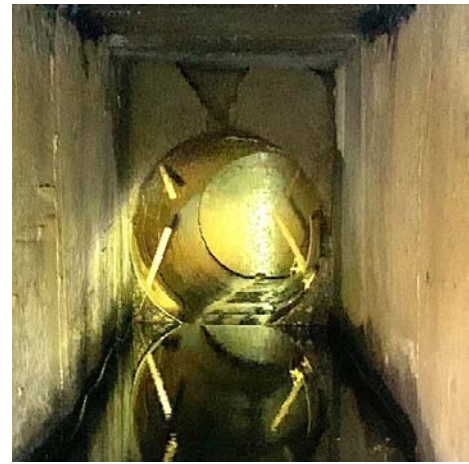
Left: investigation of the gate showing structure behind gate assembly; Right: concrete culvert between grate and penstock (penstock beyond). Both images courtesy of Ledyard Up-Down Sawmill Facebook page.

Recommendation: Per historic examples, the design concept that the group coalesced around is of a rectangular flume (penstock) constructed of 2" or 3" pressure-treated plank with groove edges connected with $\frac{3}{4}$ " or 1" spline slightly oversized and lined with rubber to make it watertight. The planks would be braced by 4x4 (or bigger) frames every few feet with possible mortise and tenon joints. The frames could be wedged against the planks with shingles to pre-tension / pressurize against water pressure. The bottom of the interior of the flume / penstock would epoxy coated to extend its longevity. The downpipe connecting the flume to the turbine would also be square and of similar construction. We have provided a conceptual sketch of a cross-section through the flume of this assembly below. A full design is outside the scope of this project and would require exact head dimensions and detailed measurements of the area. Tom Kelleher suggests that making the supply 50% bigger than gate offers a less rigorous engineering analysis of the final design.

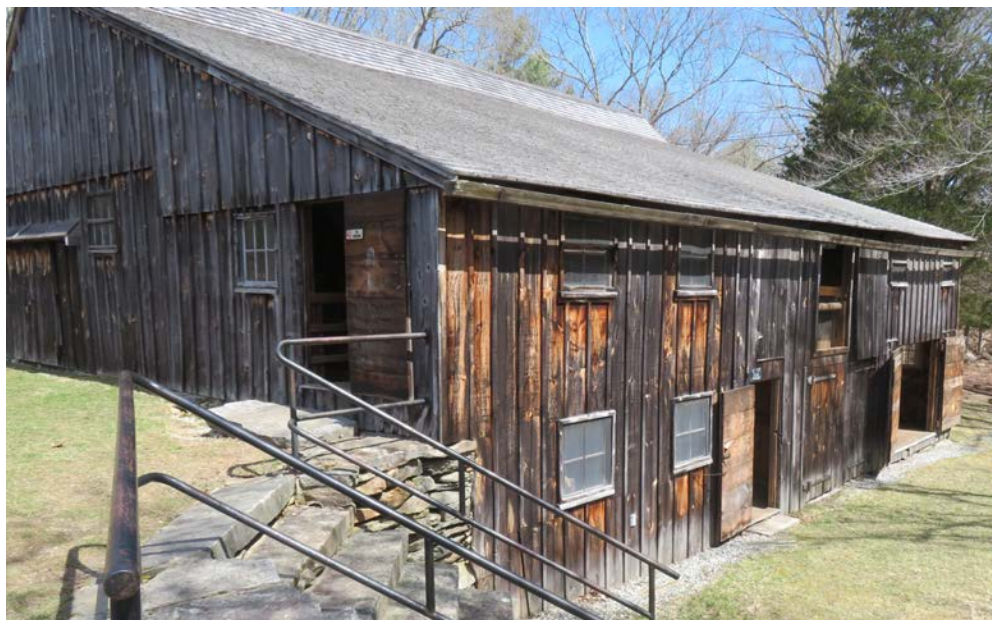
West and south elevations.

For a long term repair, it is recommended that the existing siding be removed and replaced with new wood batten siding, using at least either a pressure treated pine or cedar, and following industry recommended batten siding installation practices. This includes components such as the addition of a water table at the base and Z-flashing along the top. If stacking wood batten siding vertically, it is recommended that a Z-flashing be installed at the upper termination and a space of $\frac{1}{4}$ " left before another piece of siding installed above.

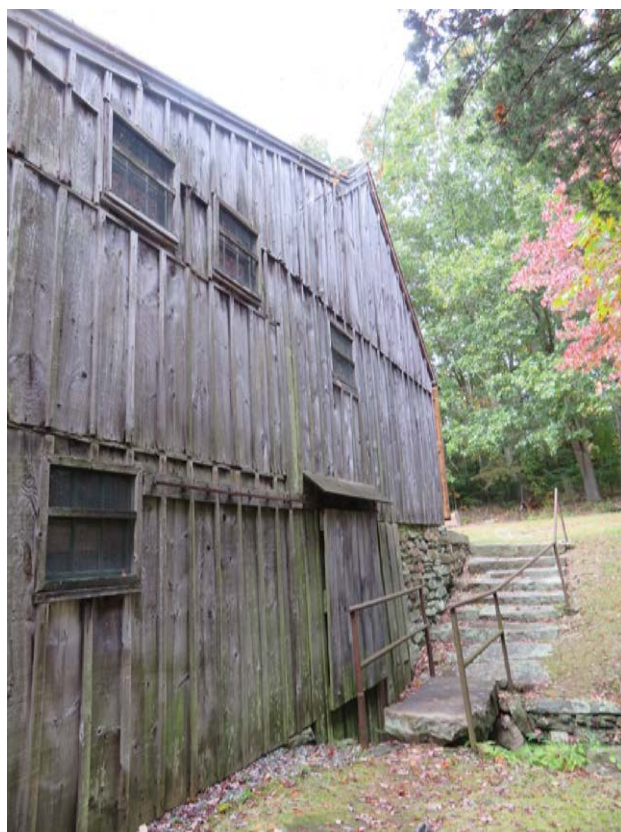
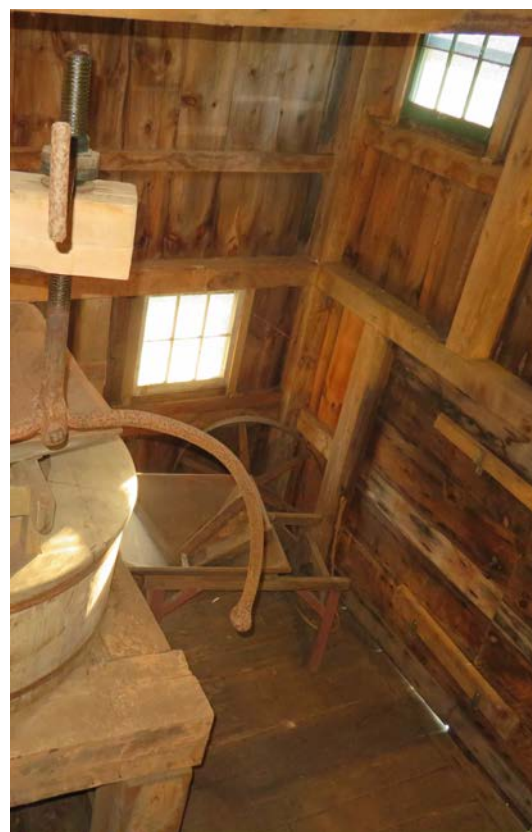
Left: Exterior of east elevation; Right: interior of south east corner showing horizontal girts and board supports.

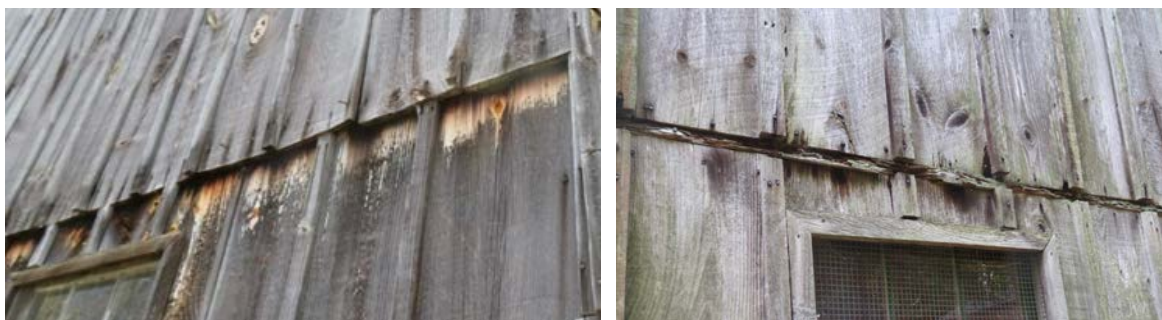
Left: Overlapped detail at board joints on west elevation; Right: Butt joint detail at board joints on grist mill portion of east elevation.

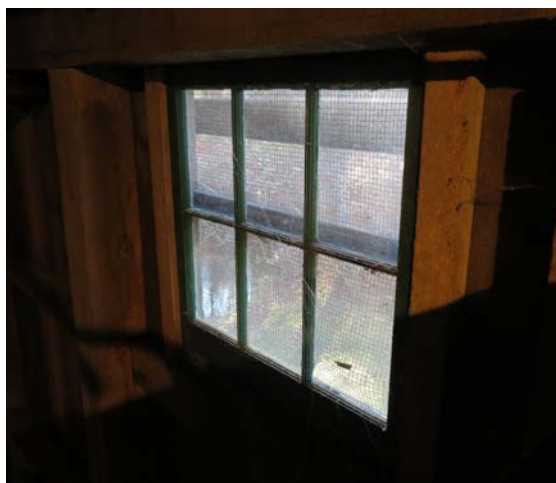
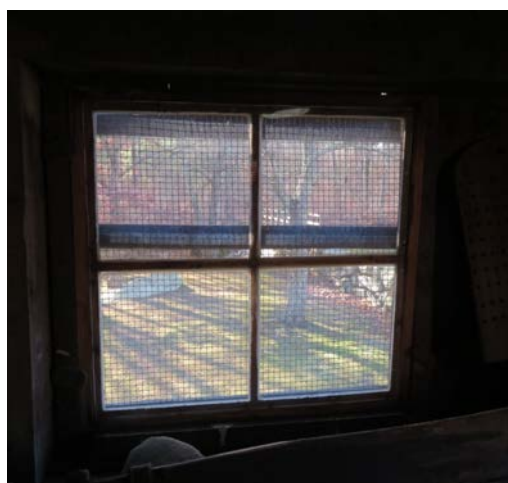
Interior view; Left: painted salvaged window in grist mill addition; Right: south lean-to window with plexiglass replacement

With respect to the window sashes, it seems that there are two options for window sash restoration: one option (least invasive) is to restore all the existing sashes (historic and non-historic) via maintenance repairs such as replacement of failed glazing putty, repair of wood defects, and repainting. The second option is to further review the existing windows to identify the various vintages of the windows, and identify which (if any) windows may be original/fall into the Mill's period of historic significance. These windows would then be the prototype and all non-appropriate windows would be removed and replaced with appropriate historic replicas to match these.

As part of the window work it is recommended that the existing interior plexiglass enclosures and exterior wood mounted screens be reviewed to assess need for these elements, and whether they should be reinstated, replaced or omitted in the future.

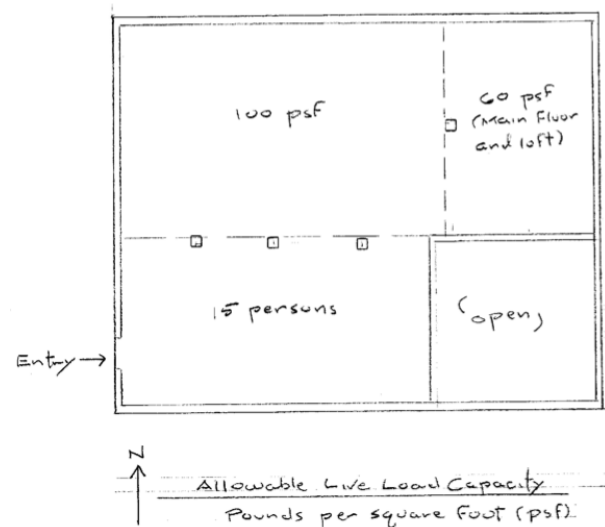
indicating that they may be overstressed. We recommend that additional support be added by adding posts beneath each of the beams. If the supports are added, the south east area could be rated for a 60 psf live load.

When the saw mill is open to the public, a total occupancy limit for the building of 20 persons seems to be a reasonable limit to assure that the northwest area is not loaded excessively while still allowing a reasonable number of observers for demonstrations. See graphic representation of areas below.
