LEDYARD UP-DOWN SAWMILL

HISTORIC PROPERTY STRUCTURAL AND CONDITION ASSESSMENT

Ledyard Up-Down Sawmill
172 Iron Street
Ledyard, Connecticut

March 2, 2023, *Revisions April 14, 2023 (noted in blue text)*

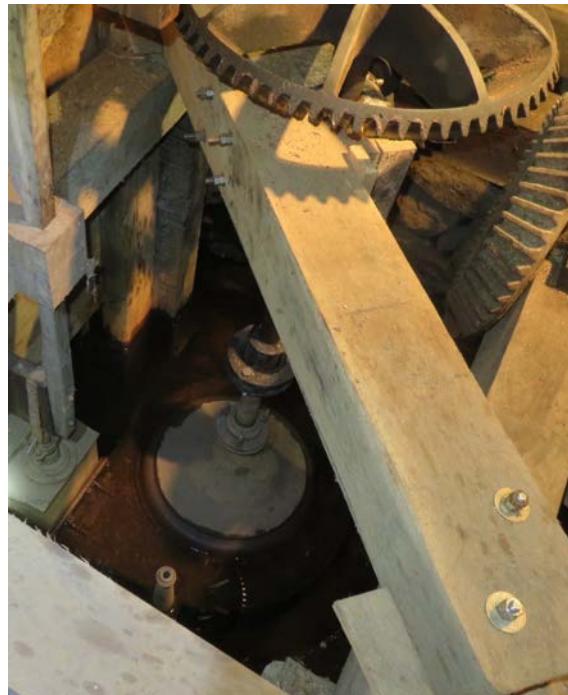
Left: 1870 advertisement for the Tyler Turbine; Right: Top of turbine in-situ.

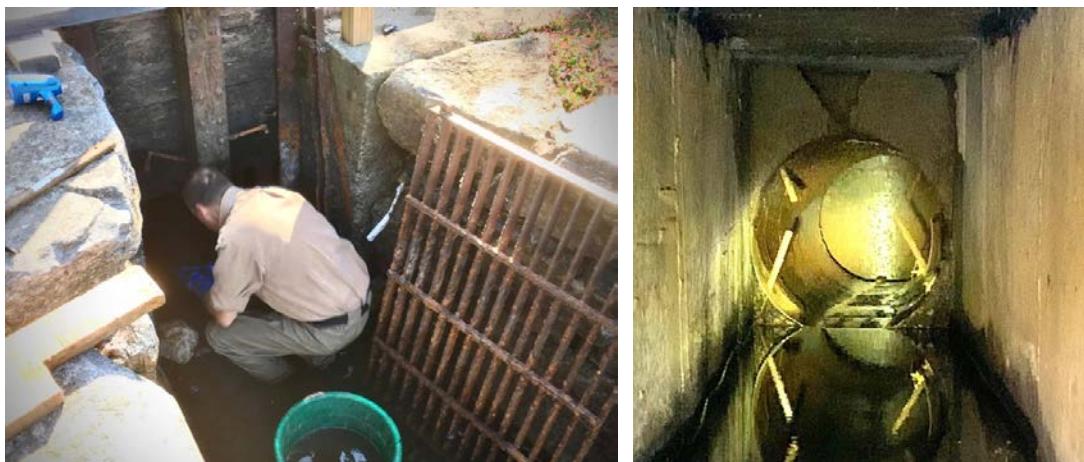
Left: investigation of the gate showing structure behind gate assembly; Right: concrete culvert between grate and penstock (penstock beyond). Both images courtesy of Ledyard Up-Down Sawmill Facebook page.

Recommendation: Per historic examples, the design concept that the group coalesced around is of a rectangular flume (penstock) constructed of 2" or 3" pressure-treated plank with groove edges connected with 3/4" or 1" spline slightly oversized and lined with rubber to make it watertight. The planks would be braced by 4x4 (or bigger) frames every few feet with possible mortise and tenon joints. The frames could be wedged against the planks with shingles to pre-tension / pressurize against water pressure. The bottom of the interior of the flume / penstock would epoxy coated to extend its longevity. The downpipe connecting the flume to the turbine would also be square and of similar construction. We have provided a conceptual sketch of a cross-section through the flume of this assembly below. A full design is outside the scope of this project and would require exact head dimensions and detailed measurements of the area. Tom Kelleher suggests that making the supply 50% bigger than gate offers a less rigorous engineering analysis of the final design.

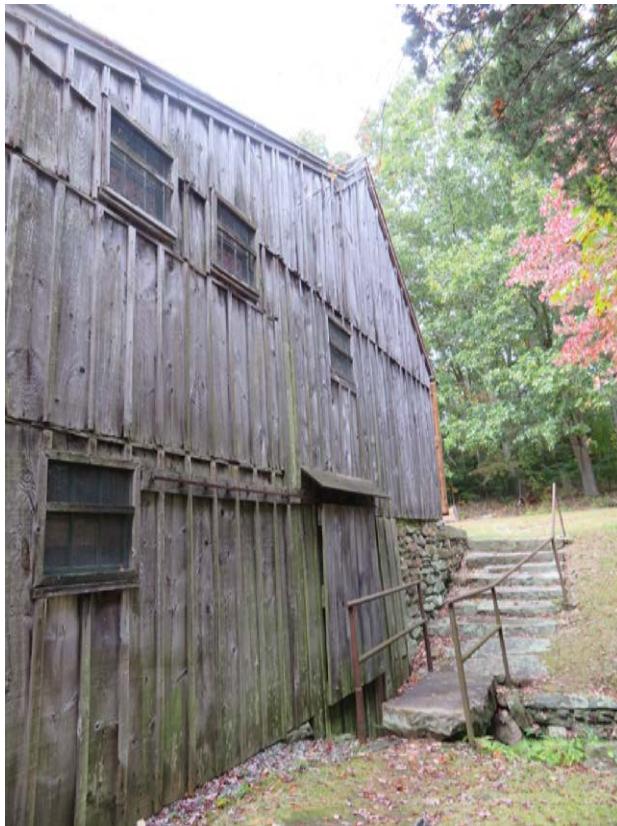
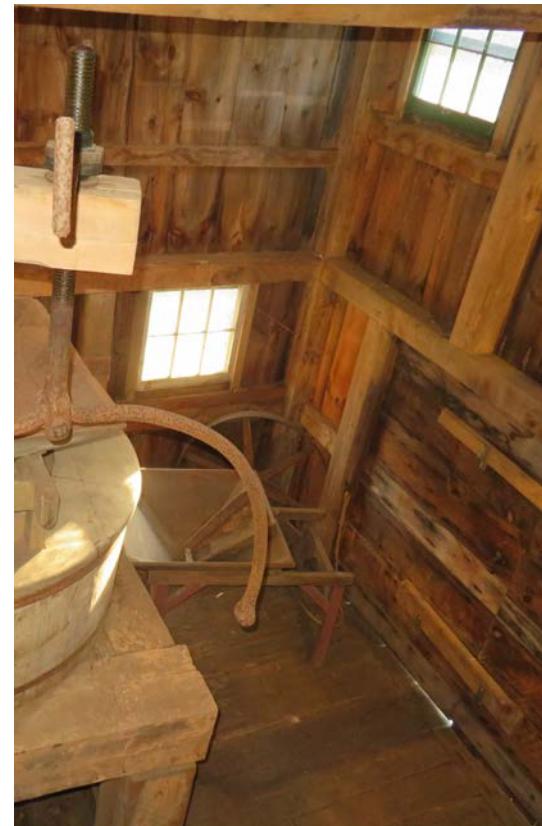
Left: Exterior of east elevation; Right: interior of south east corner showing horizontal girts and board supports.

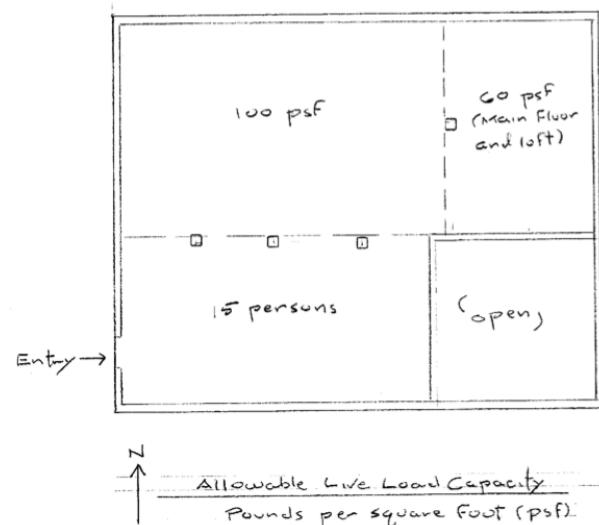
When the saw mill is open to the public, a total occupancy limit for the building of 20 persons seems to be a reasonable limit to assure that the northwest area is not loaded excessively while still allowing a reasonable number of observers for demonstrations. See graphic representation of areas below.

We recommend that additional support be added by adding posts beneath each of the beams. If the supports are added, the south east area could be rated for a 60 psf live load.
