**Southeast Connecticut Road-Stream Crossing
Assessment for Community and Wildlife Resilience:
Findings Report and Restoration Opportunities**

**Prepared by:
Jon C. Vander Werff
Save the Sound
Fisheries Biologist
127 Church St, New Haven, CT 06510**

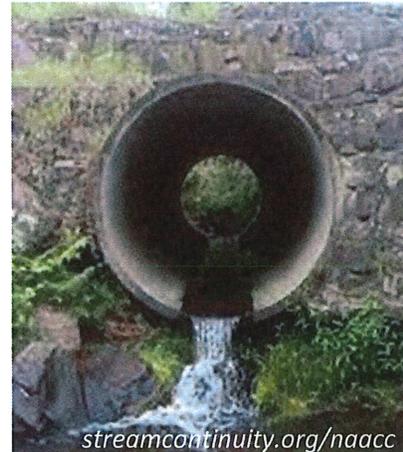
streamcontinuity.org/naacc
 This perched culvert is a dead-end for most wildlife species.

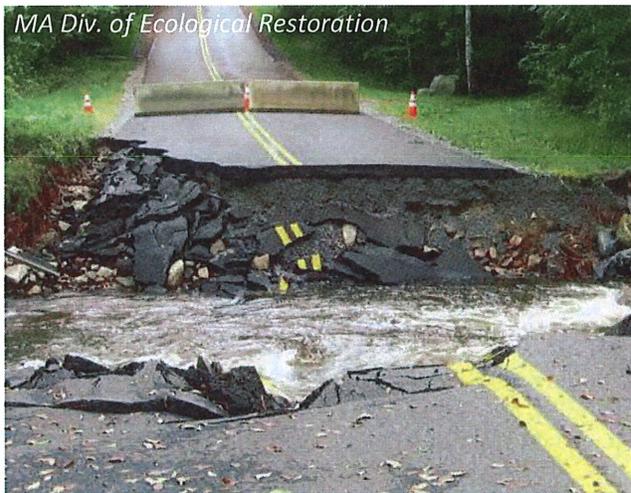
MA Div. of Ecological Restoration
 A culvert “washed out” by a storm in Beckett, MA.

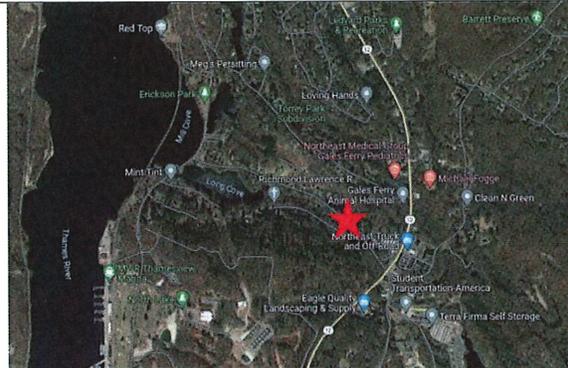
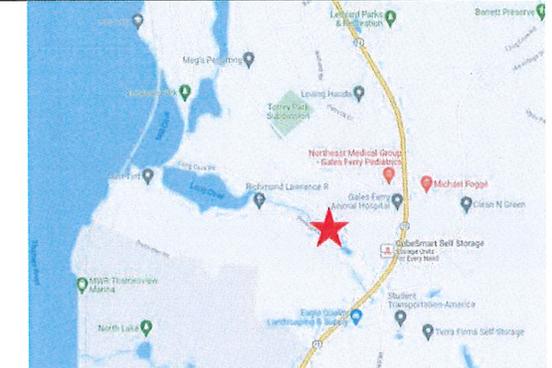
#1 Flat Brook, Pinelock Dr, Ledyard

- Located under a dead-end road, Pinelock Drive
- Two undersized perched, round culverts creating very large scour pool
- Evidence of erosion along Long Cove Road
- Damage to downstream headwall has occurred, large trees growing out of damaged area
- Susceptible to wash out during storm event

- **Crossing type:** 2 round concrete culverts with 4 ft diameter
- **Crossing condition:** Poor
- **Constriction severity:** Severe
- **AOP Coarse Screen / NAACC AOP Score:** Reduced AOP / 0.51

- Close proximity to tidally influenced Thames River
- Downstream side of culvert perched, limiting fish passage
- Spawning habitat potential upstream

- Replace with Stream Simulation Design culvert or bridge: widen and restore stream channel (i) to increase hydraulic capacity and reduce over-topping risk, (ii) restore aquatic organism passage, and (iii) reduce debris accumulation and maintenance.
- Long Cove Road in need of bank stabilization for erosion control and storm resilience

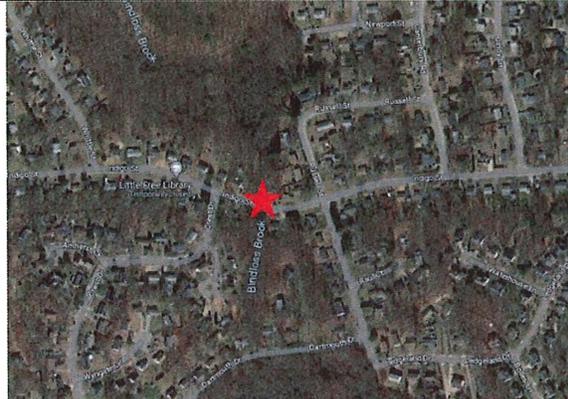
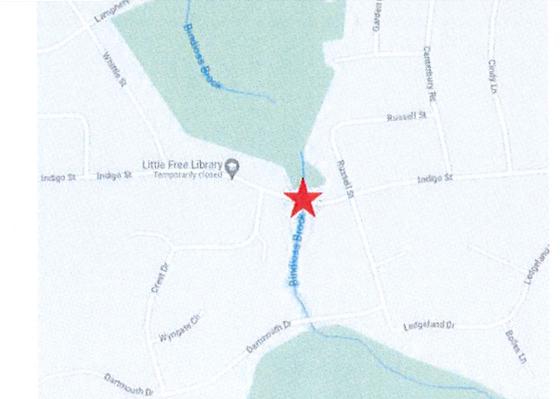
#3 Bindloss Brook, Indigo Street, Groton

- Between 243 and 219 Indigo Street
- Single culvert with shallow water depth likely to limit aquatic organism passage
- Perched downstream side of structure reduces aquatic organism passage
- Secondary storm drain outlet present on downstream side of structure

- **Crossing type:** Single primary concrete culvert with 4.5 ft diameter.
- Crossing condition: OK
- **Constriction severity:** Moderate
- **AOP Coarse Screen / NAACC AOP Score:** Reduced AOP / 0.06

- Replace with Stream Simulation Design culvert or bridge: widen and restore stream channel (i) to increase hydraulic capacity and reduce over-topping risk, (ii) restore aquatic organism passage, and (iii) reduce debris accumulation and maintenance.

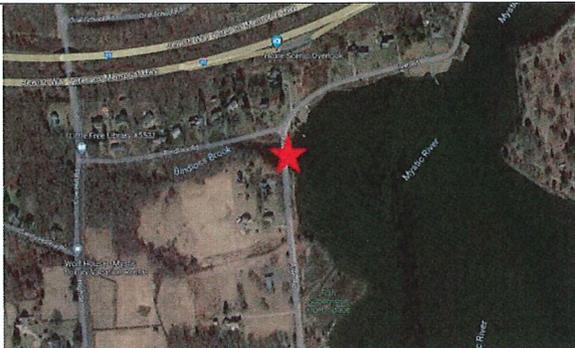
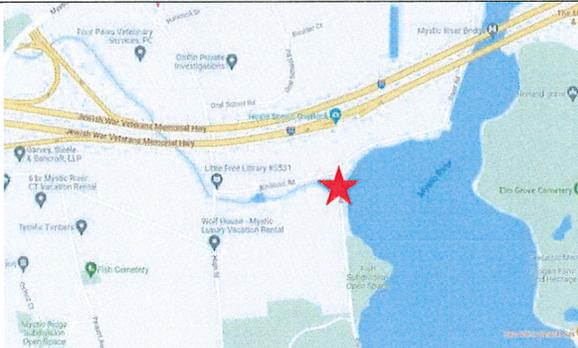
#4 Bindloss Brook, River Road, Groton

- Two round culverts 4 ft in diameter, restrict fluvial and tidal flows
- High tide mark is close to road elevation
- Possible road over topping in storm event
- Restriction in flow path may lead to debris accumulation

- **Crossing type:** 2 round concrete culverts with 4 ft diameters
- **Crossing condition:** OK
- **Constriction severity:** Severe
- **AOP Coarse Screen / NAACC AOP Score:** Full AOP / 0.77

- Replace with wider culvert or bridge (i) to increase hydraulic capacity and tidal fluctuation, (ii) reduce debris accumulation and maintenance

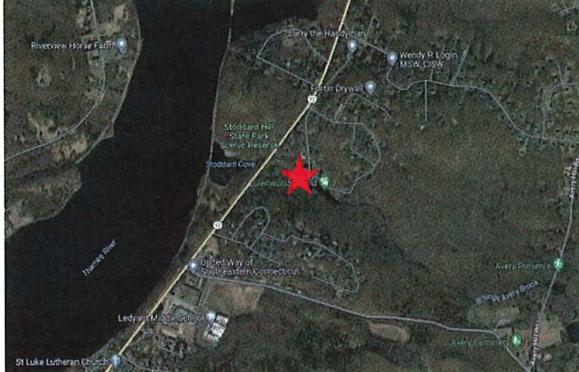
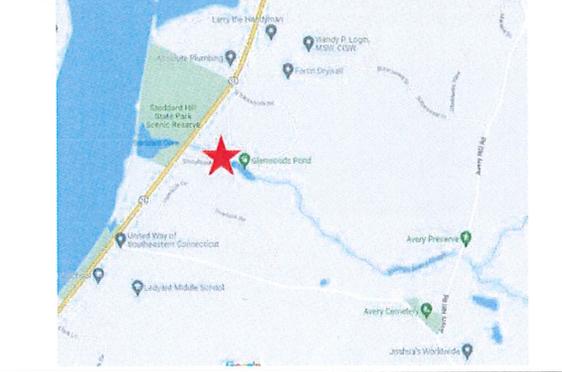
- Fieldstone structure under Stoneybrook Road
- A small spillway immediately upstream of culvert inlet and Stoneybrook Road form the dam of Glenwoods Pond
- CTDEEP Dam Safety database identifies this as Long Pond Dam, #7220, Low Hazard
- Structure curves under the road

- **Crossing type:** single rock / stone box bridge with abutments 6 ft wide 10 feet tall
- **Crossing condition:** OK
- **Constriction severity:** Moderate
- **AOP Coarse Screen / NAACC AOP Score:** Reduced AOP / 0.70

- Consider feasibility of installing technical fishway through crossing to provide diadromous fish access to Glenwoods Pond.
- Consider feasibility for removing the small spillway upstream of crossing, which would likely eliminate Glenwoods Pond, and replace with Stream Simulation Design culvert or bridge: widen and

- Failing masonry in structure should be repaired in any future work.

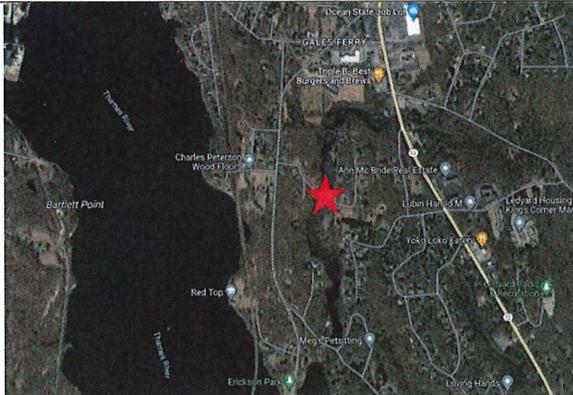
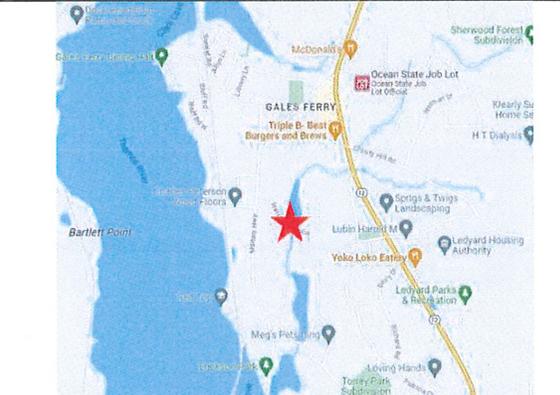
- Road crossing comprises dam of Pine Swamp Pond (aka Avalonia Land Trust Pond).
- CTDEEP Dam Safety database identifies this as Pine Swamp Pond Dam, #7212, Low Hazard
- Perched round culvert with a rusted out dilapidated bottom
- Fall hazard around guard rail and repaired curbing pavement and apron

- **Crossing type:** 1 metal culvert with a 3 ft diameter
- **Crossing condition:** Poor
- **Constriction severity:** Severe
- **AOP Coarse Screen/ NAACC AOP Score:** No AOP / 0.03

- Consider feasibility of installing technical fishway through crossing to provide fish passage to Pine Swamp Pond
- Failing masonry in structure should be repaired in any future work.
- Reduce fall risk for children in neighborhood.

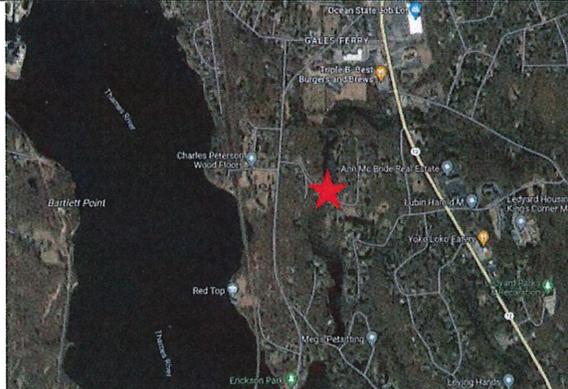
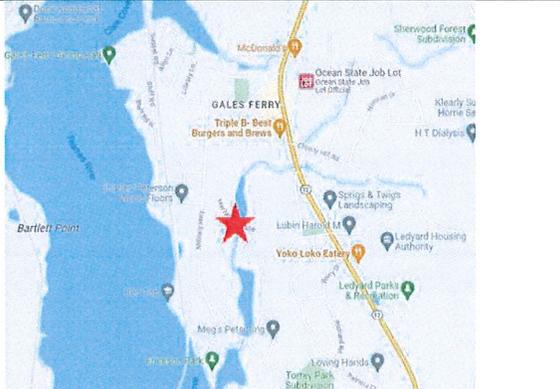
- Under Harvard Terrace Road downstream of Avalonia Land Trust Pond
- CTDEEP Dam Safety database identifies this as Pine Swamp Pond Dam, #7212, Low Hazard
- Inlet drop culvert to square stone outlet
- Fall hazard around guard rail and repaired curbing pavement and apron
- Large metal conveyance structure present to move water away from road creating another safety hazard

- **Crossing type:** Inlet drop to square outlet
- **Crossing condition:** Poor
- **Constriction severity:** Severe
- **AOP Coarse Screen/ NAACC AOP Score:** No AOP / No score

- Refurbish dated and worn areas of structure
- Reduce fall risk for children in neighborhood
