DAM SAFETY PROGRAM DAM INSPECTION REPORT FORM – FOR REGULATORY INSPECTION

| Dam Name: | Pine Swamp Brook Pond Dam | Inspection Date(s): | December 18, 2024 |
| Alternate Dam Name(s): | none | CT Dam ID #: | 7212 |
| Location (Municipality): | Ledyard | Temperature / Weather: | ±32°, Clear, calm |

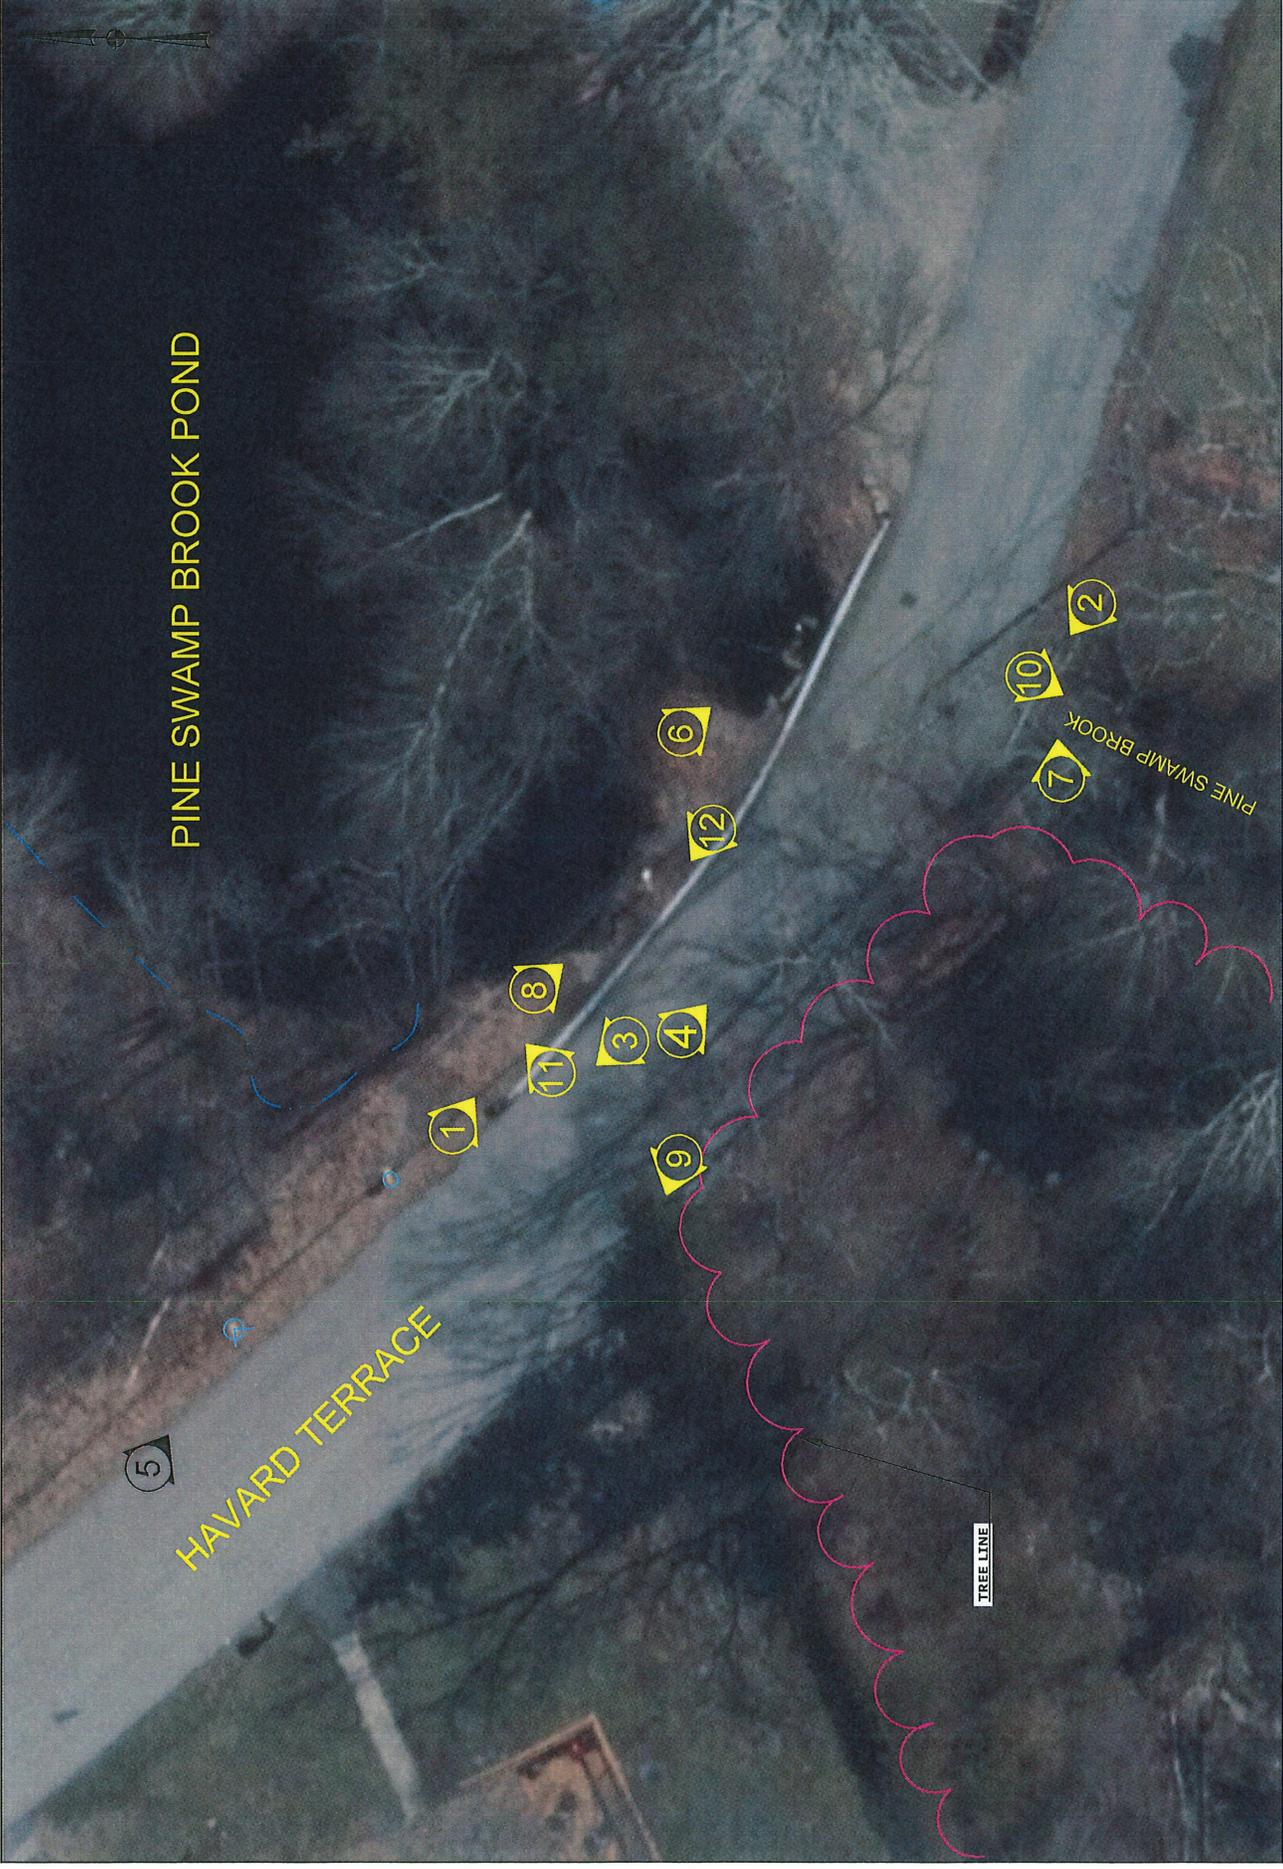
| SUPV. | S.R.M. | <p>PREPARED FOR:</p> <p>TOWN OF LEDYARD</p> <p>741 COLONEL LEDYARD HIGHWAY</p> <p>LEDYARD, CT 06339</p> | PINE SWAMP BROOK POND DAM - #7212 PHOTO LOG MAP SCALE - 1:50 | |

AUXILIARY SPILLWAY -
DAMAGED SEGMENT

1. Clear vegetation from dam and ± 25 beyond. Grubbing of trees requires Dam Safety permit.
2. Replace or repair failing auxiliary spillway pipe.
3. Monitor principal spillway grouted stone walls, and repoint grout as needed.
4. Monitor principal spillway inlet for blockage
