Field Report No.: 21											
SP&A Project No: 22.331					Report Date: 1.28.2025		Time: 9:30AM				
Project: Gales Ferry School (Name & Location) 1854 CT-12 Gales Ferry, CT 06335											
General Contractor: The Imperial Company, Inc.											
Weather			Site Conditions			Day of Week					
<input type="checkbox"/> Temp. Range: 238°			<input checked="" type="checkbox"/> Clear			<input type="checkbox"/> Dusty		<input type="checkbox"/> Monday			
<input checked="" type="checkbox"/> Clear			<input type="checkbox"/> Muddy			<input type="checkbox"/> Windy		<input checked="" type="checkbox"/> Tuesday			
<input type="checkbox"/> Overcast			<input type="checkbox"/> Other					<input type="checkbox"/> Wednesday			
<input type="checkbox"/> Rain								<input type="checkbox"/> Thursday			
<input type="checkbox"/> Foggy								<input type="checkbox"/> Friday			
<input type="checkbox"/> Warm								<input type="checkbox"/> Saturday

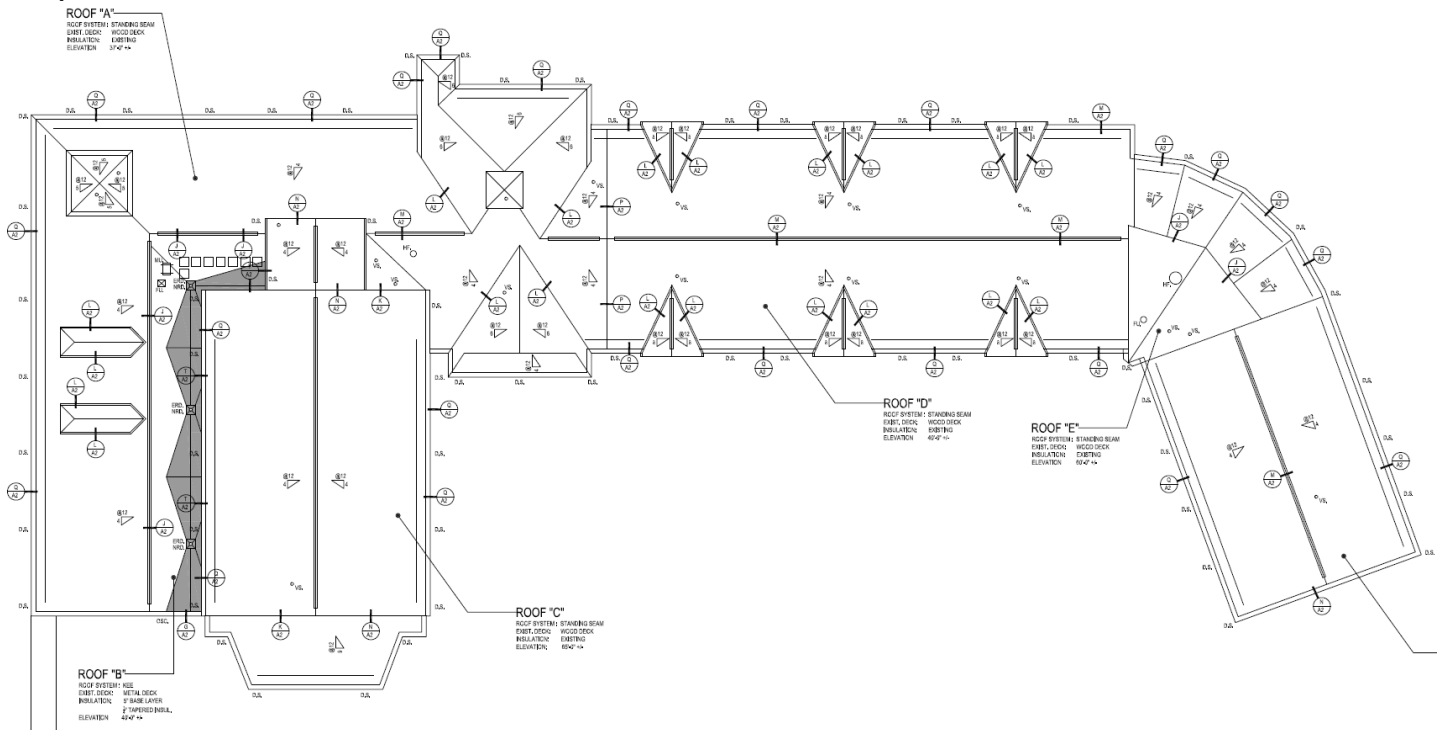
### Roof plan

Location marked as location 5 was found to have 8" screws and was picked by random by SPA for verification -
