OBJECTION RESPONSE PREPARED BY TONY SEVELKA, AACI, P.APP, MAI, AIGRS, SREA, FRICS (JULY 20, 2022, REVISED AUGUST 12, 2022)

Based on the research conducted, it is recommended that the City of Burlington, the Niagara Escarpment and the Ministry of Natural Resources and Forestry (MNR) not support or approve Nelson Aggregate Co.'s application to extend (expand) the existing quarry, as the self-serving proponent-driven studies fail to address and protect the environment and the communities surrounding the quarry from the anticipated adverse effects and deleterious impacts of a blasting quarry operation - a human-made hazard.

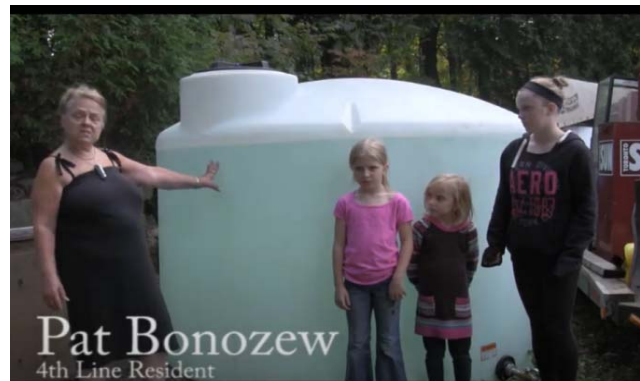
- Neighbouring wells that run dry due to Nelson Aggregate Co.’s quarry blasting operations would require on-site giant plastic tanks like the one pictured for reservoirs to be filled on a regular basis. Besides the inconvenient eyesore of the plastic tank, which does not provide potable water, homeowners would have to purchase bottled drinking water, and endure construction activity when a new well is being

installed. This is what a resident had to endure at the Acton Quarry. There is also no guarantee that Nelson Aggregate Co. would accept financial responsibility for the damage, which means that a costly and time-consuming lawsuit against Nelson Aggregate Co. is the only remedy available to a victimized property homeowner.

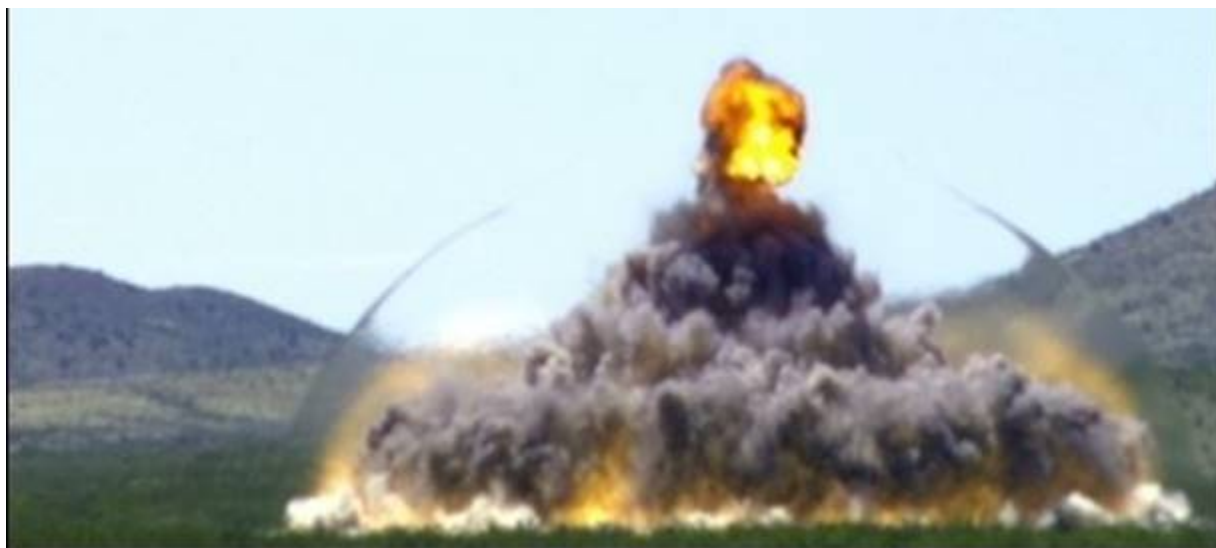
[Quarry blasting is done by drilling blast holes behind the working face of the quarried material to blast it loose for harvesting. The hole size, spacing, and amount of explosive are designed by an experienced blaster. The explosive most often used is ANFO (Ammonium Nitrate and Fuel Oil). When the explosive is detonated a detonation wave moves through the explosive at a speed of about 18,000 feet per second changing the solid material to a gas at a very high rate. This detonation wave and rapidly expanding gas will create a cavity, crushing, cracking and moving the surrounding material. It will also introduce 2 types of waves into the earth around the explosion. First a surface, or Rayleigh wave, that will damp out and disappear in a relatively short distance. And second a body wave that will travel great distances in the bedrock (under any barrier). It is this body wave that will move through the bedrock and cause the earth above the bedrock to vibrate and shake homes, even at large distances from the explosions. **There is no way to mitigate or block the movement of these body waves.**] [evidence presented by Dr. Kiger in connection with an Application for Rezoning and Special Use Permit for a proposed Granite Quarry in Alvaton, Meriwether County, GA]¹⁹⁵ [emphasis added]

In *Miller Paving Ltd. v. McNab/Braeside (Township)*, (2015),¹⁹⁴ Dr. Kiger addressed the high probability of damage to neighbouring structures (homeowners' property) resulting from repeated blasting, even at low ground-vibration levels.

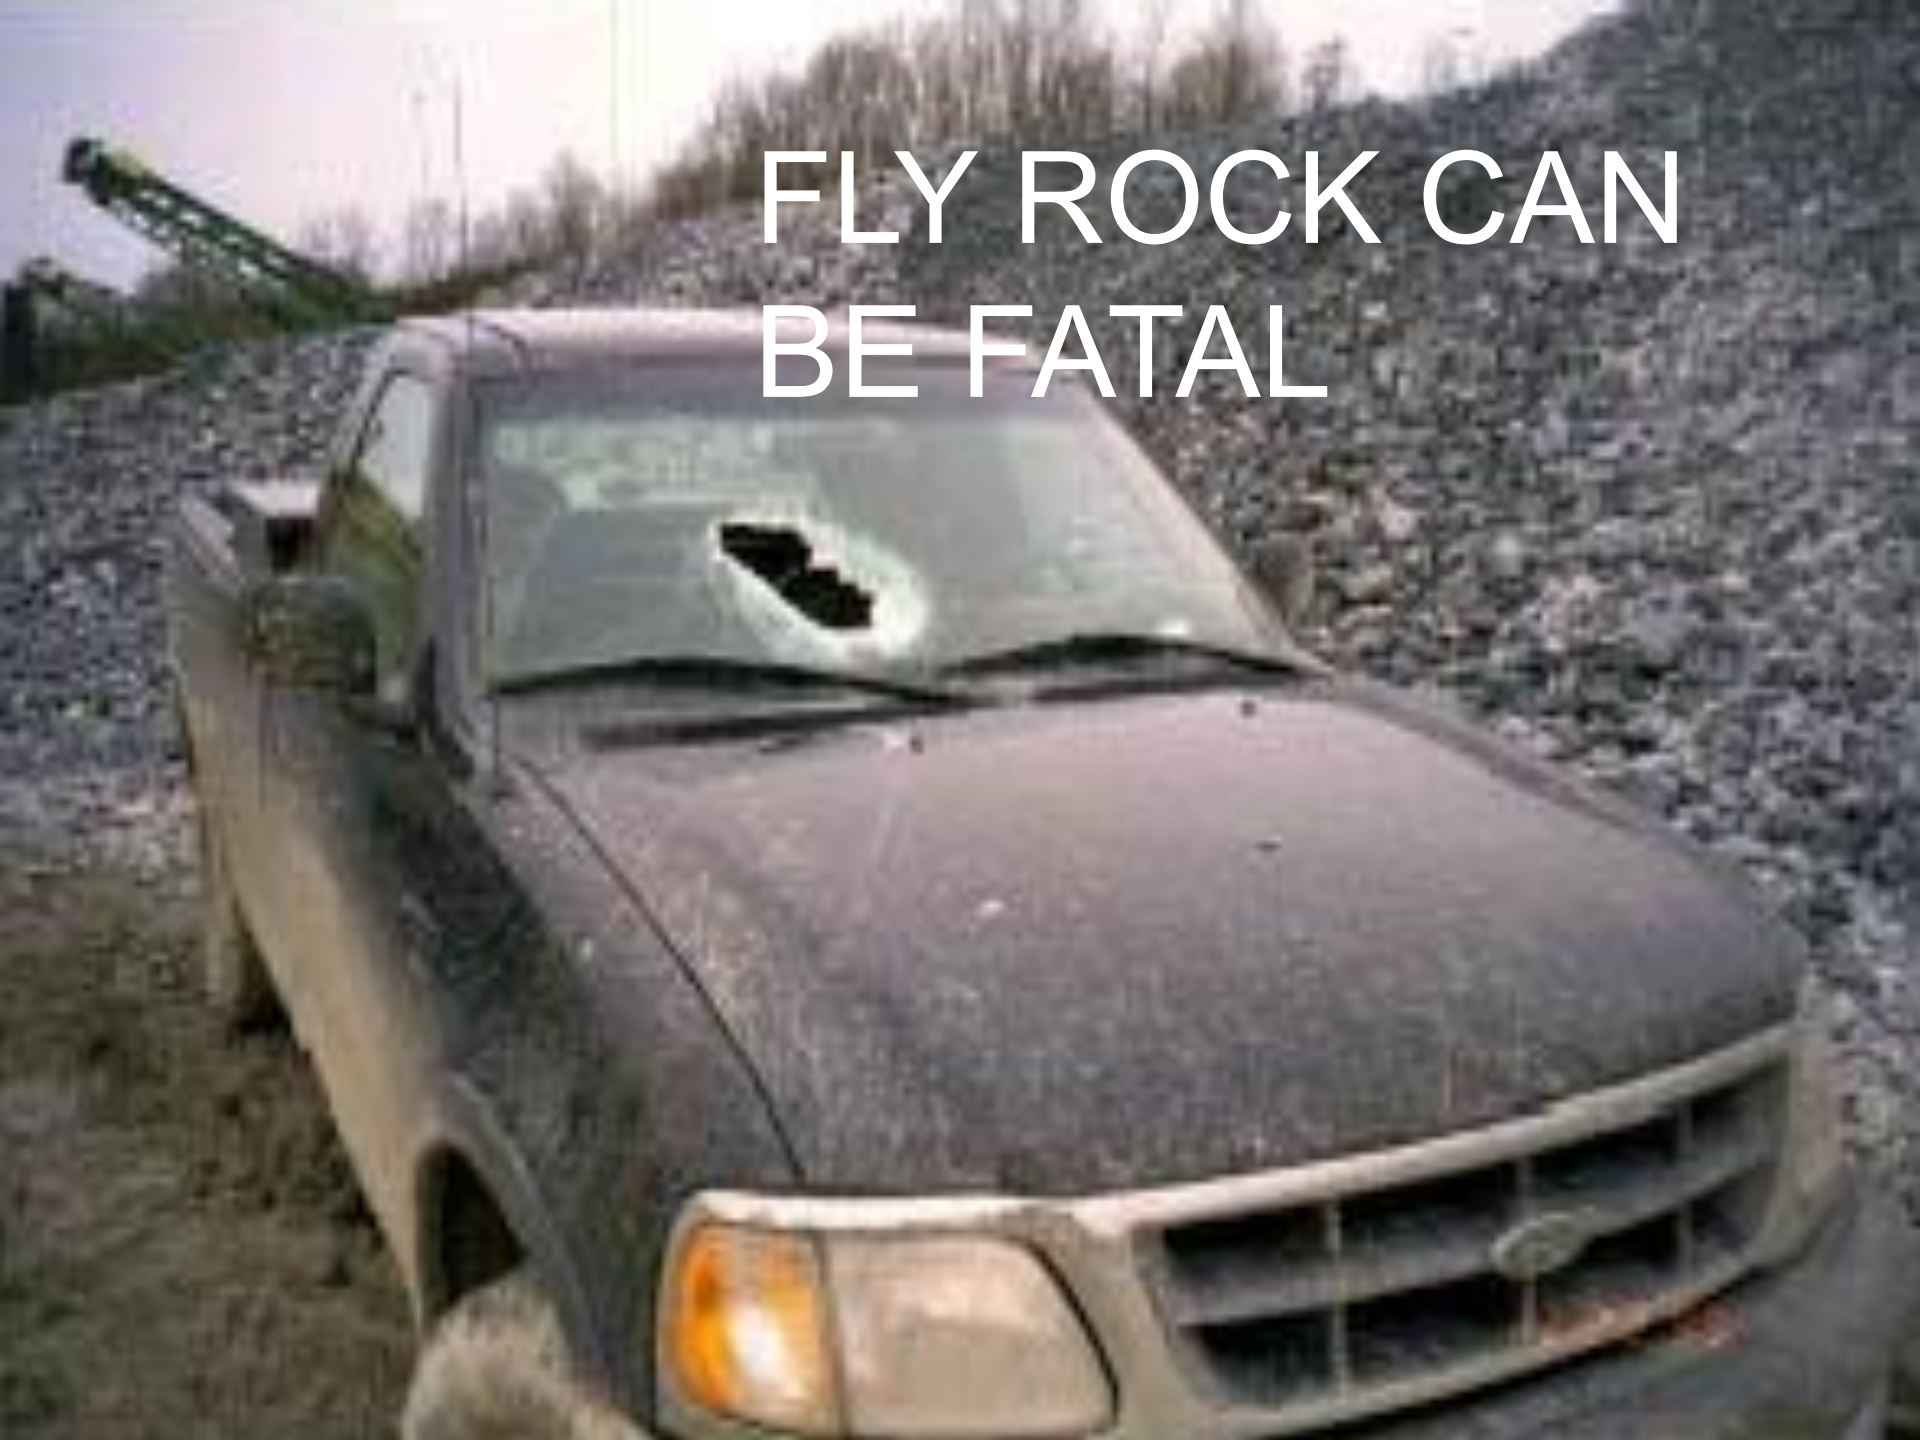
Damage at 350m

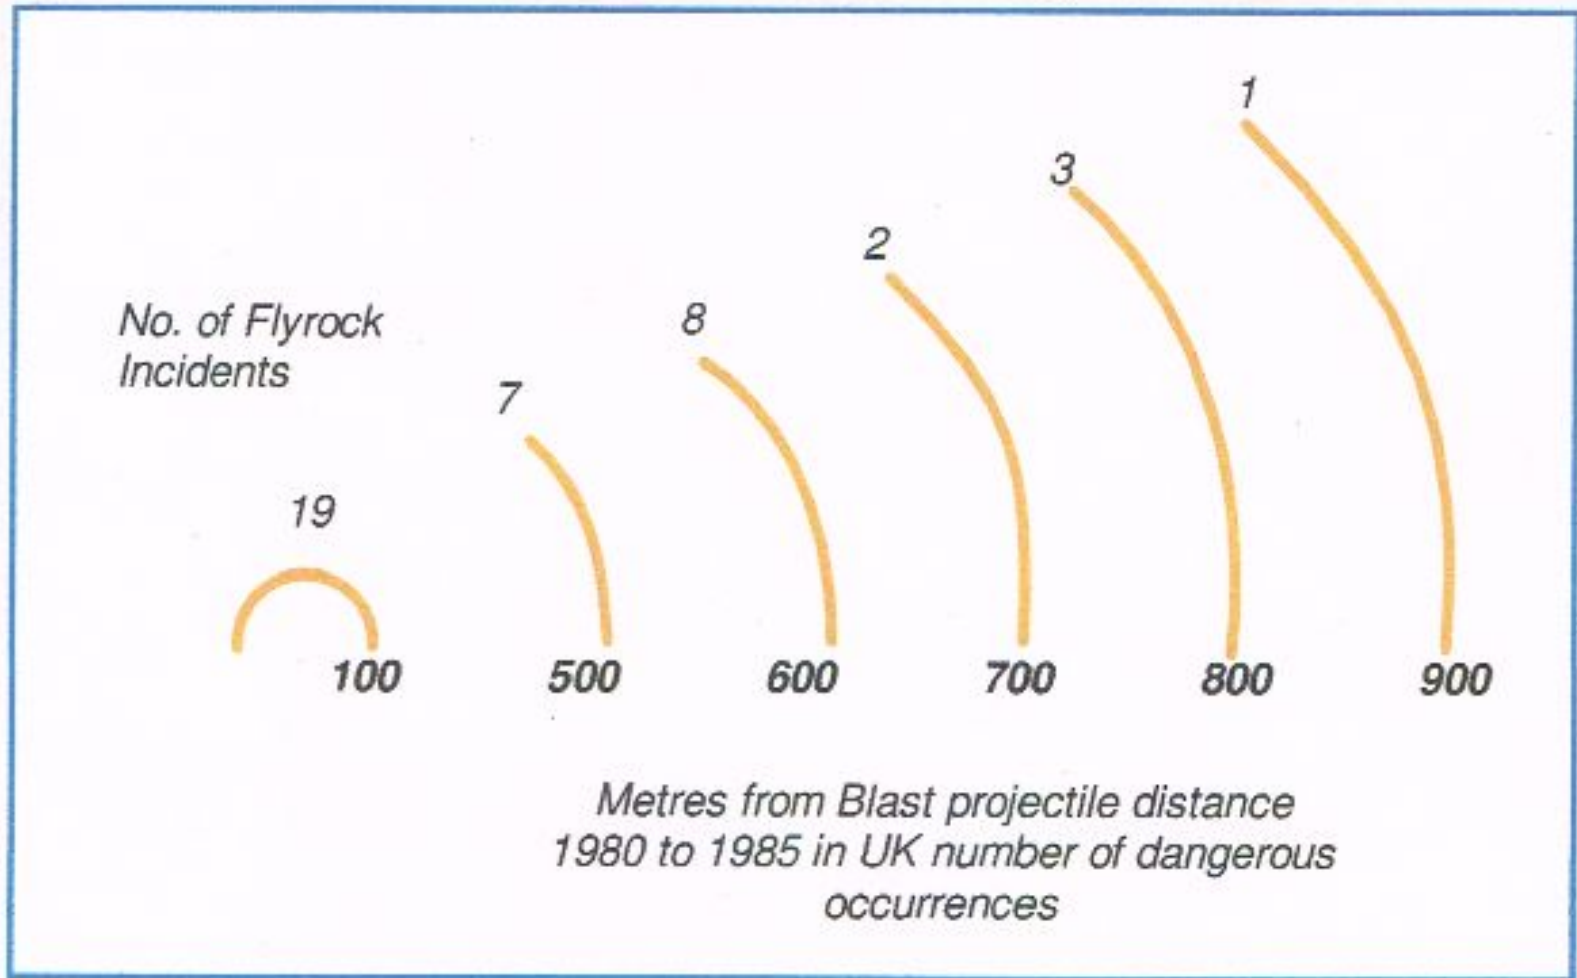
Flyrock - occurrences

We have applied the formulae as developed for the United States Bureau of Mines to predict expected range of fly rock for the products and patterns used on this blast. The validity of these equations for application in Eastern Ontario Quarries was confirmed by the Ontario Ministry of Labour in the early 1990's following a fatality resulting from fly rock at an Ontario limestone quarry.

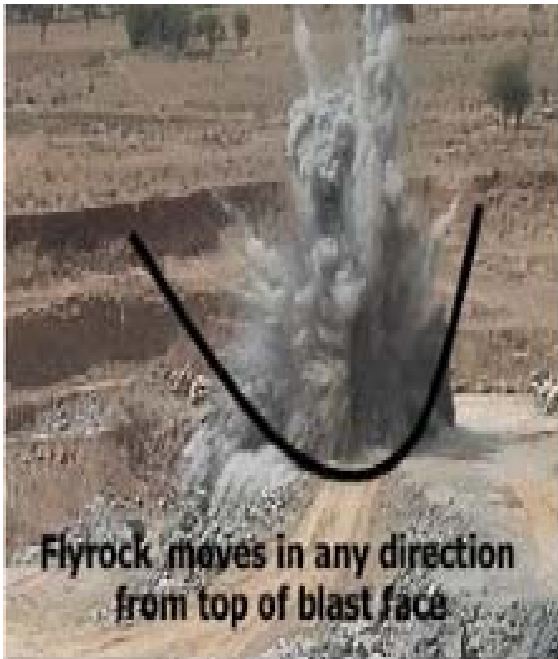
Cratering

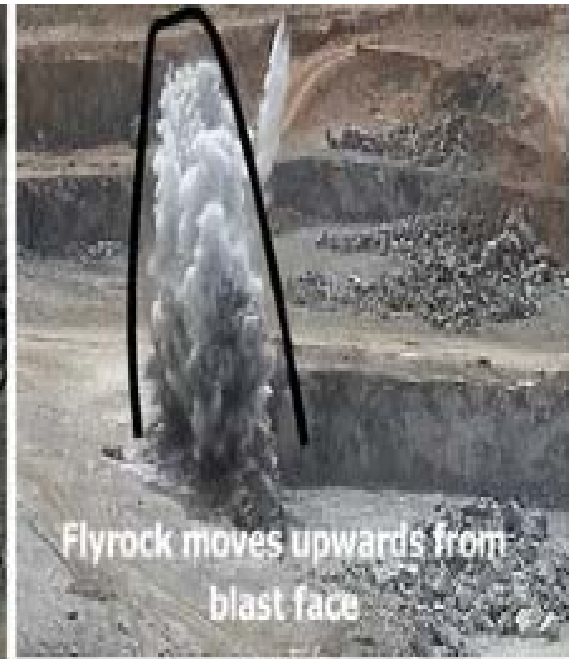
Rifling

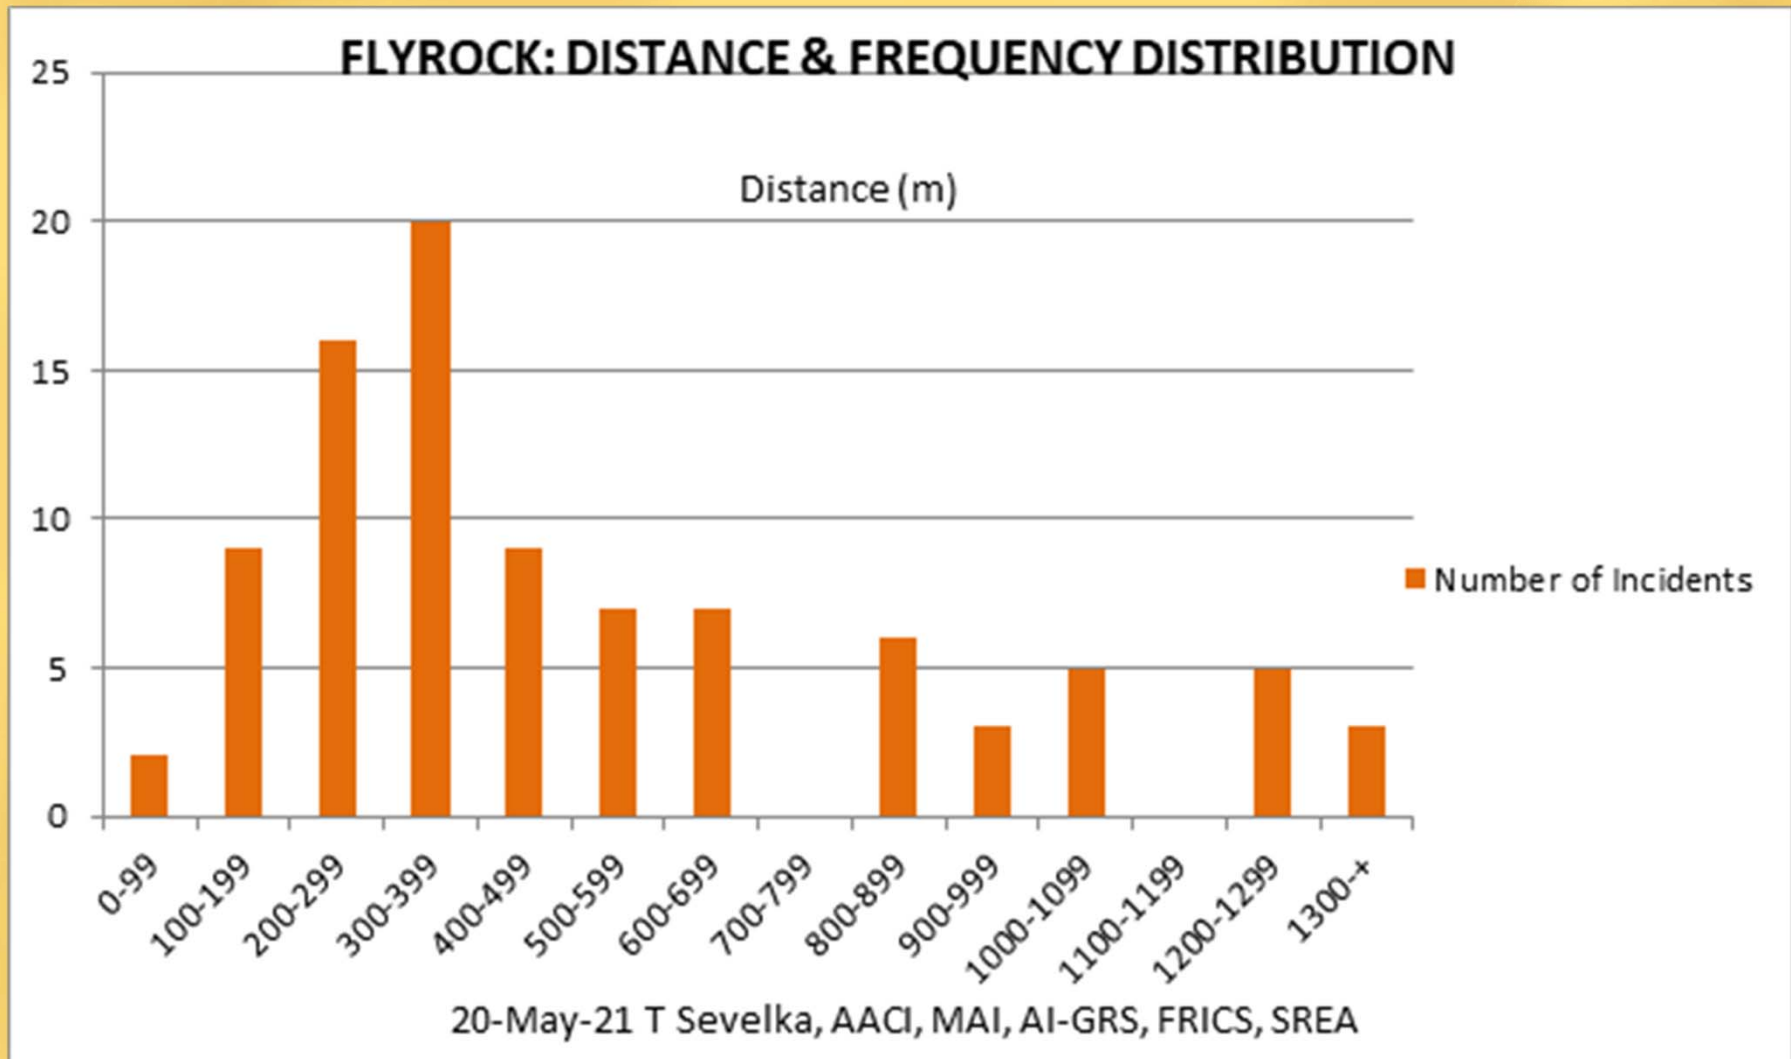
Analysis of Flyrock Travel Distances

An analysis of 92 *flyrock* incidents, where the distance from the blast is known, indicate that 91% (84) of the *flyrock* incidents occurred within 1,099 metres, and 97% occurred within 1,299 metres.

The number of *flyrock* incidents within each interval, starting at between 300 and 399 metres, and the average distance travelled within each interval are summarized as follows:

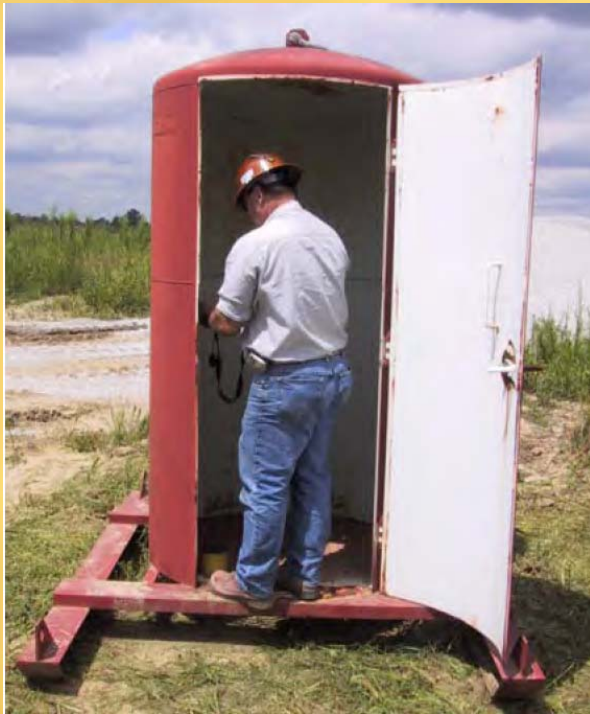
5/8" thick steel construction

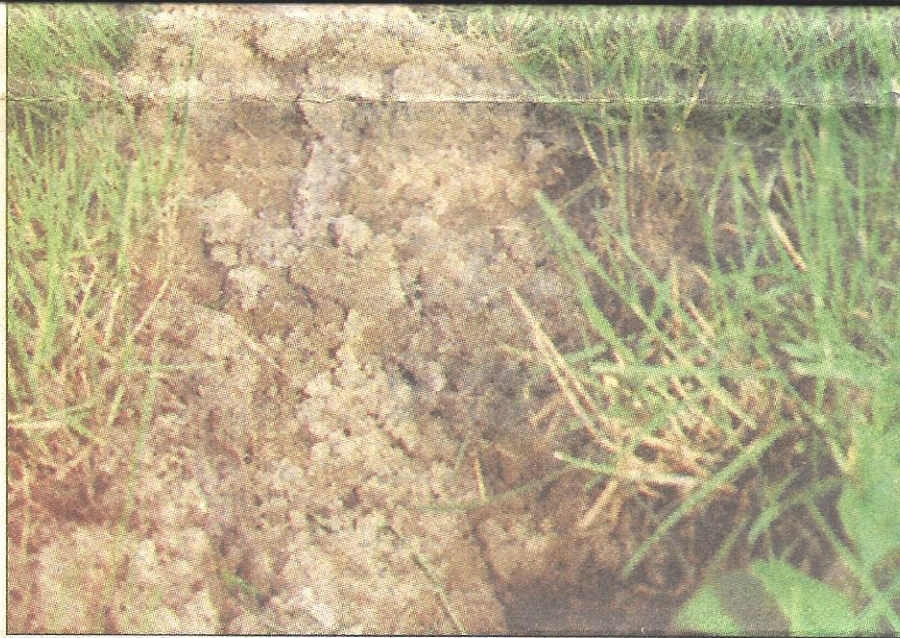
Kirsty Spencer and her 10-month-old daughter survey a hole in their front lawn caused by an 8.5-pound chunk of granite. Kirsty believes the rock came from a nearby granite quarry after a blast.
