**RE: SOILS INVESTIGATION**  
**Northern Property Section**  
1761 Route 12, Gales Ferry (Ledyard), CT  
*REMA Job #23-2596-LED5*

At your request, REMA ECOLOGICAL SERVICES, LLC (REMA), has prepared this brief letter to summarize the findings of our soils investigations within the northern section of the above-referenced site. Specifically, we investigated an area designated as “wet area,” on a plan entitled “*Property and Topographic Survey, prepared for Styron, LLC, Allyn’s Point Plant, 1737 & 1761 Military Highway – Route 12, Gales Ferry, Ledyard, Connecticut*” by CME Associates, Inc., and dated September 2, 2010 (Sheet 1 of 13).

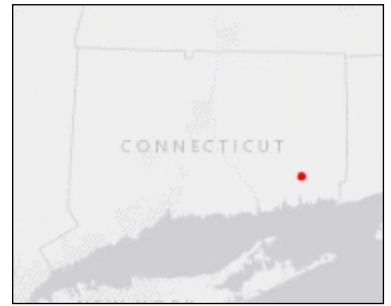
**FIGURE 1:** Location of Soil Test Hole in previously designated "Wet Area"  
1761 Route 12, Gales Ferry, CT

The soil core was advanced with a hand-held soil auger to 42 inches from the ground surface (see Figure 1, attached). Groundwater (free water) was encountered at roughly 36 inches from the surface, with limited moisture in the sandy soils above it. At 38 inches, dark gray, fine textured fill soils (i.e., silt loam) were encountered. Significant soil redoximorphic features (i.e., mottles) were not present in the soils from the ground surface to 20 inches, which would have indicated an active wetland moisture regime (e.g., poorly drained, very poorly drained). Based on observed soil characteristics the soils within the depressional area are moderately well drained.

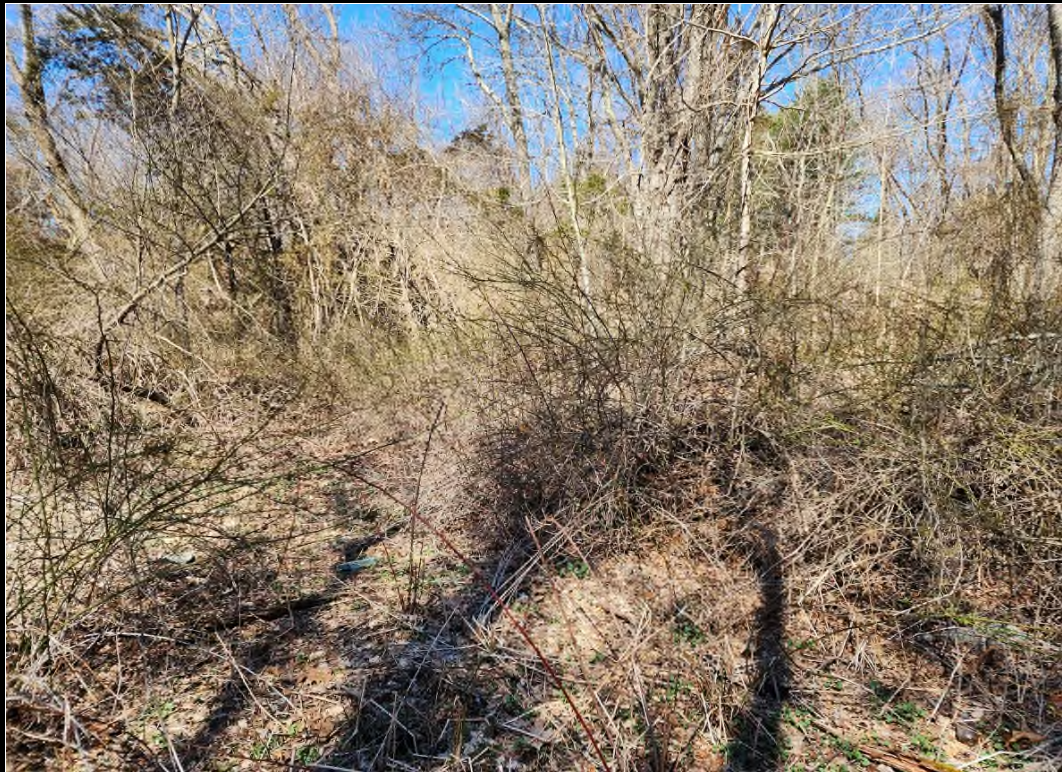
<b>SITE/LOCATION:</b> 1737 & 1761 Route 12 Gales Ferry, CT	REMA JOB NO.: 23-2596-LED5	<b>ANNOTATED PHOTO LOG</b>
	<b>INVESTIGATOR(S):</b> George T. Logan, MS, PWS, CSE		
<b>DATE:</b> March 29, 2023	<b>FACING:</b> NORTHEASTERLY	<b>PHOTO NO.:</b> 1

Moreover, the vegetative community of this depressional area is not dominated by hydrophytes, with the exception of emerging jewelweed, which can also grow in moist areas. Dominant plant species in the understory included multiflora rose, wineberry, Morrow's honeysuckle, black cherry, garlic mustard, and Asiatic bittersweet.

<i>Lowest topographical portion of "wet area;" replete with invasive species (multiflora rose thicket in view) and dominated with non-hydrophytes</i>

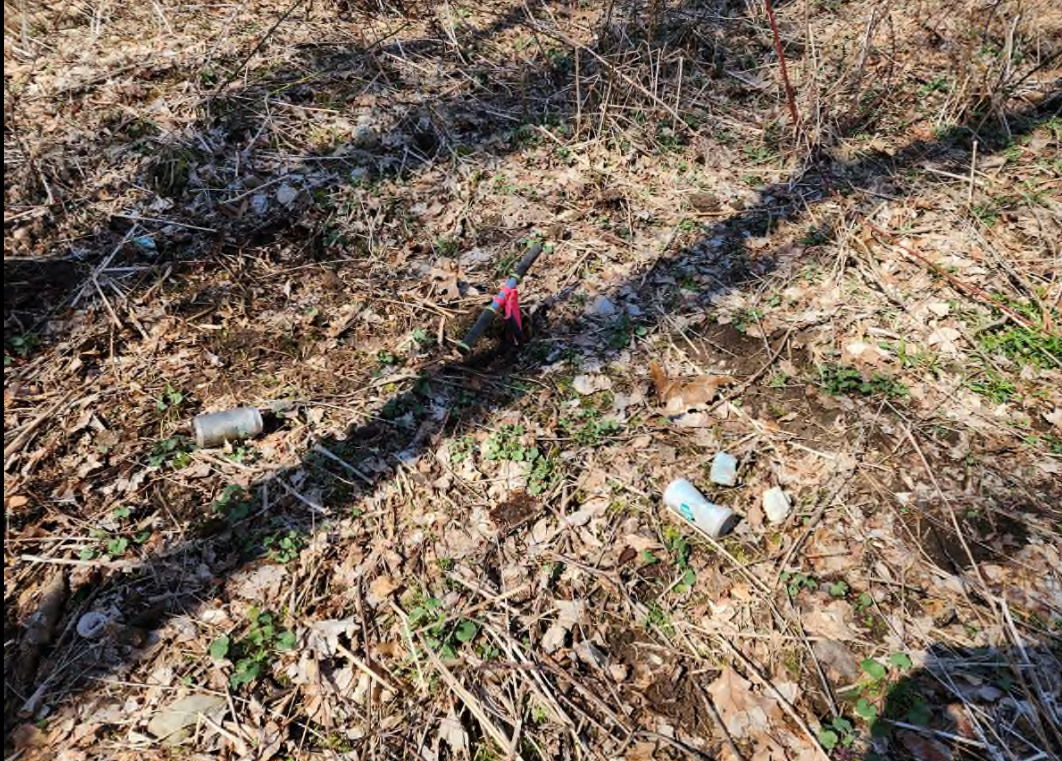
<b>DATE:</b> March 29, 2023	<b>FACING:</b> N/A	<b>PHOTO NO.:</b> 2

<i>Soil boring advanced to 42 inches; free water at 38"; this is a moderately well drained soil type.</i>
