RE: **SITE EVALUATION REPORT** prepared for: DONOCO, LLC – 8-30G Plan- 59 Kings Highway & Christy Hill Road, MBL: 92-1160-59, Ledyard, Connecticut:

WETLAND SITE PHOTOS

APRIL 10, 2024

59 KINGS HIGHWAY

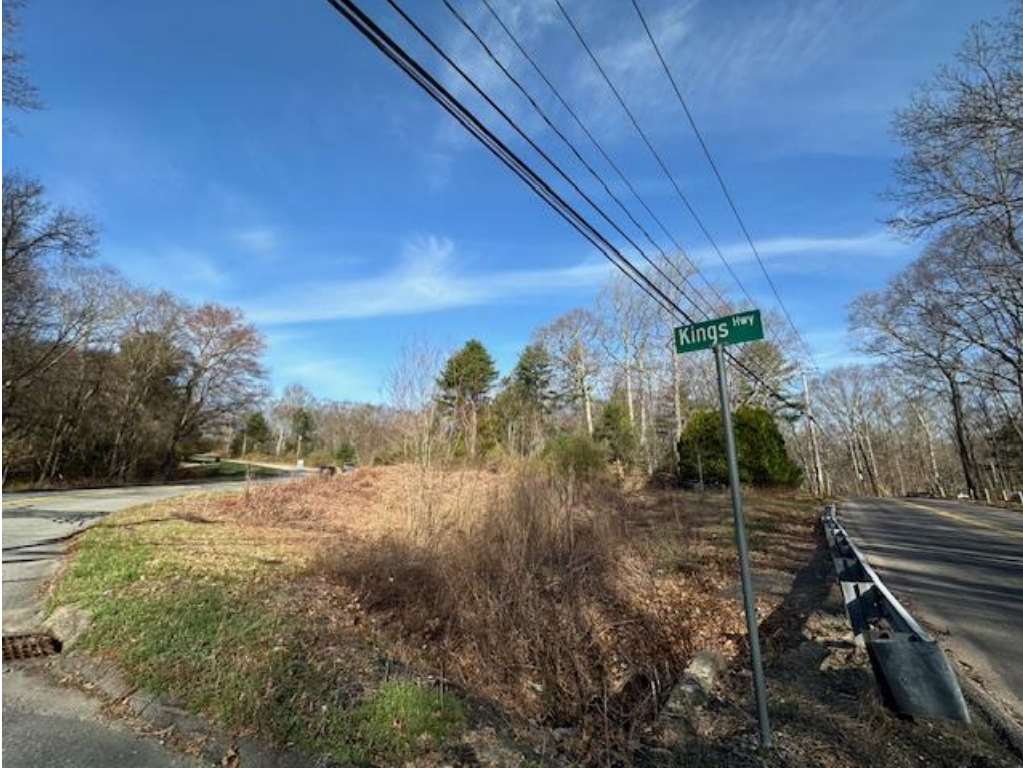
Photo 1: Example of the wetland conditions of the detention basin at the corner of Kings Highway and Christy Hill Road.

In most times of the year the wetland feature is nearly unrecognizable as such, especially to the layperson if it were not for the tall patch of Phragmites that stands above the herbaceous and shrub-scrub vegetation community that surrounds the wetland denoted on the subject site plans by wetland flags 1A to 7A. The basin outlets east to a headwall along the roadside that is in very bad shape and needs repair to maintain proper function (see attached photos). Several paved roadside leak-offs direct untreated stormwater runoff from Christy Hill Road into the basin. The entire basin is located with a drainage easement in favor of the Town. The bulk of the 100' upland review area is

The man-made wetland feature was created to provide water quality renovation functions serving to attenuate, de-energize and store local runoff from the road intersection, and additionally capture and retain sediments and other roadside debris. The wetland feature is both physically and functionally similar to common roadside and parking lot stormwater detention basins. The 100-foot upland review area habitat is of low ecological integrity as it is dominated by a near 100 % cover of invasive Japanese Knotweed.

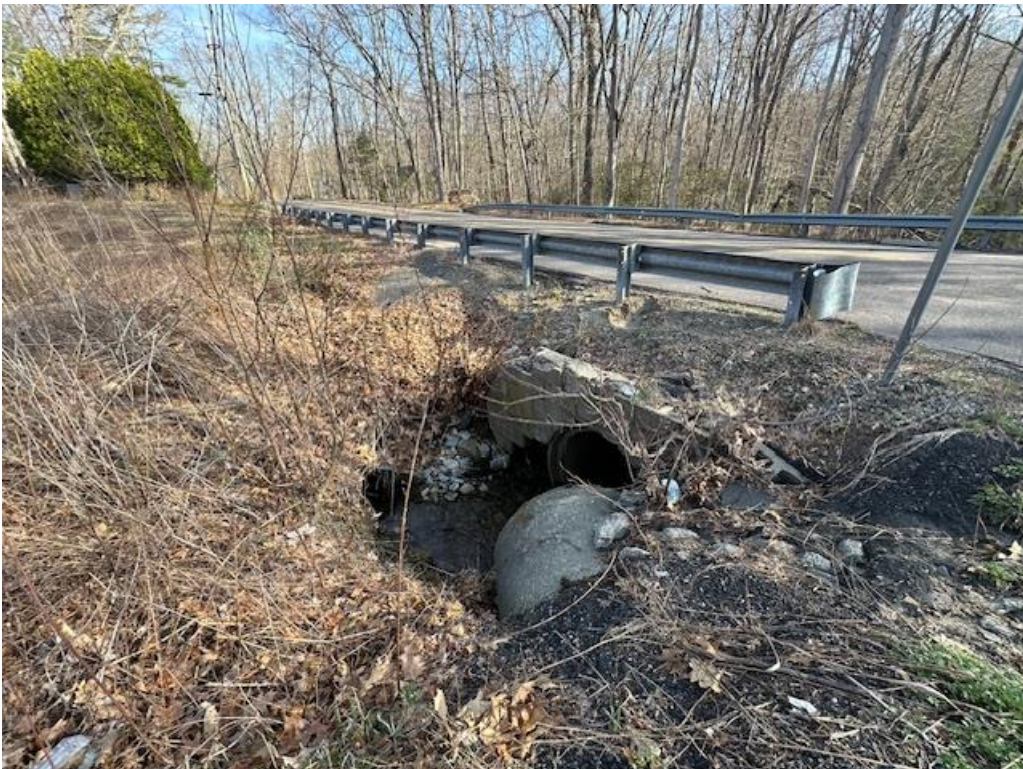
Photo 2: Failing headwall at drainage connection outlet along shoulder of Christy Hill Road.

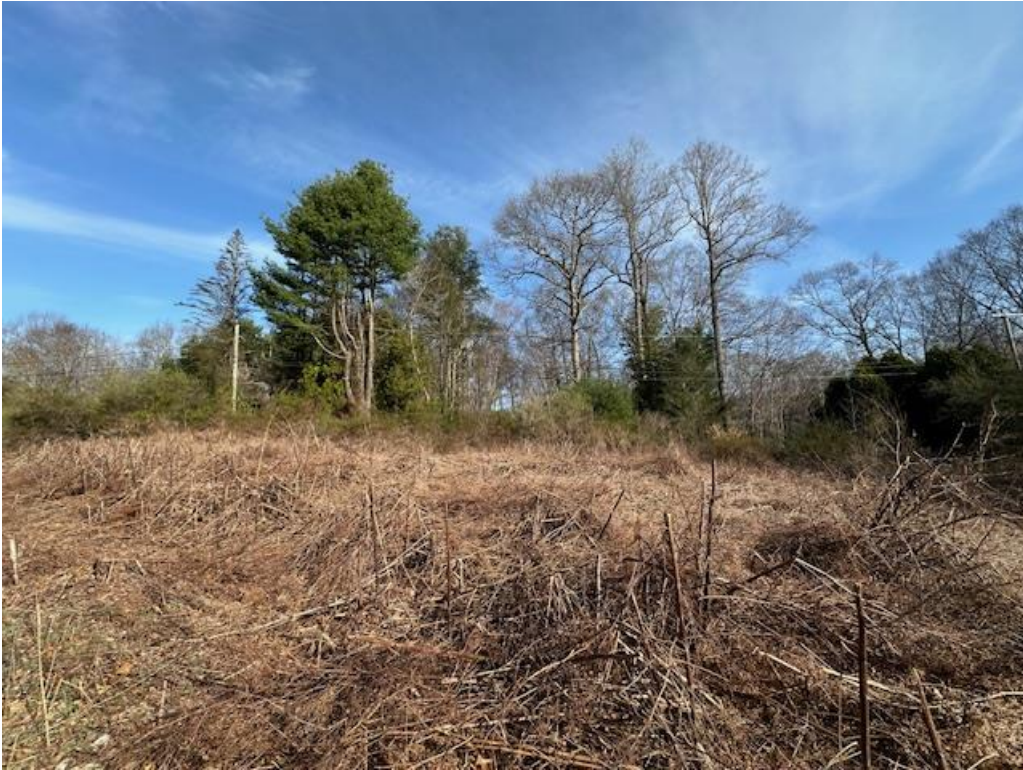
Photo 3: Example of the Japanese Knotweed stand that covers the 100' URA.

dominated by a thick growth of Japanese Knotweed that surrounds the basin. This patch of knotweed has been mowed by the Town several times over the years presumably to maintain access to the basin for maintenance purposes as it was intended.

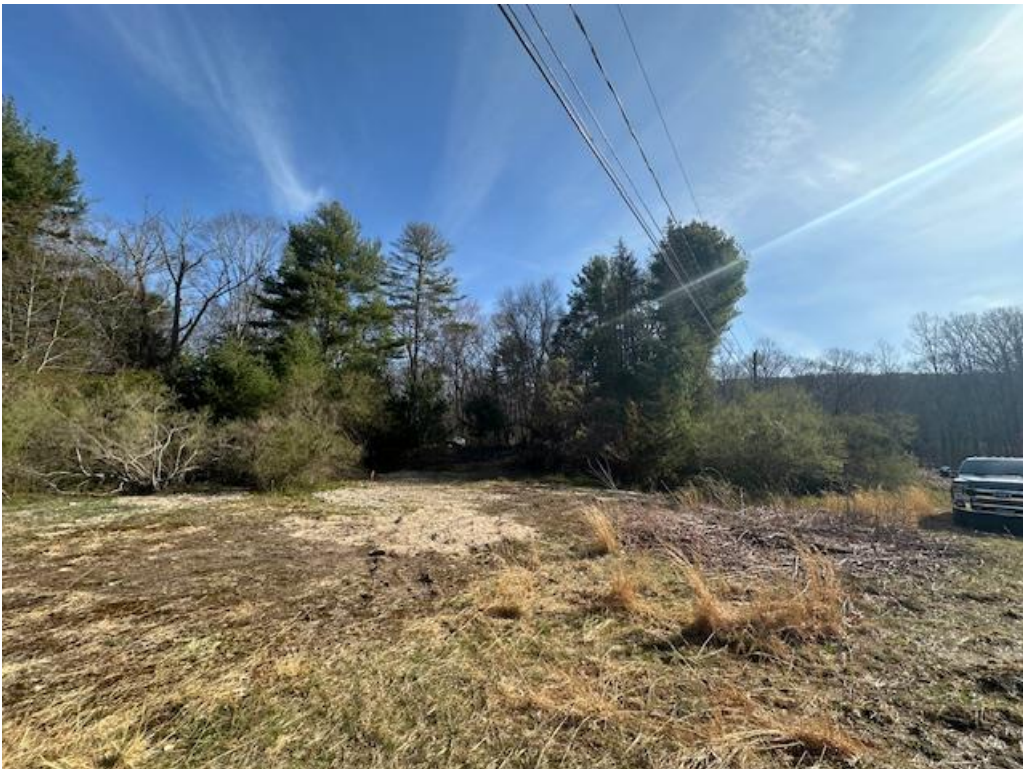
Photo 4: General conditions of cleared upland habitat on the property slated to host the development.

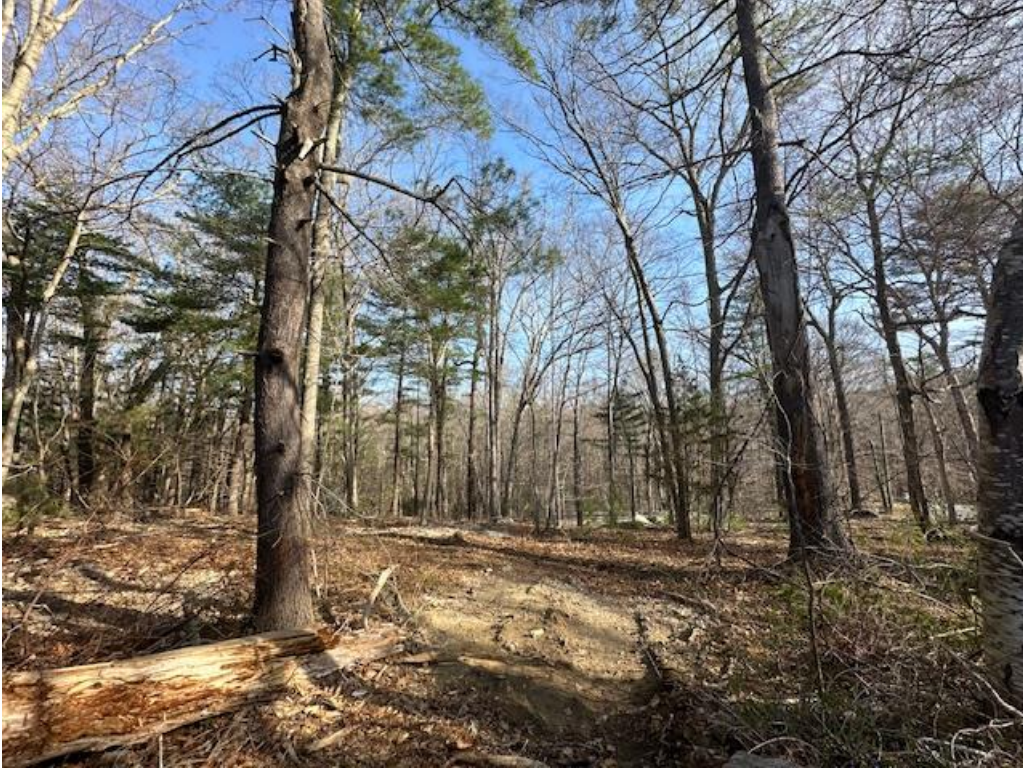
Photo 5: Example of the forested upland habitat that will have selected clearing to facilitate space for the 5 northern clustered dwellings.

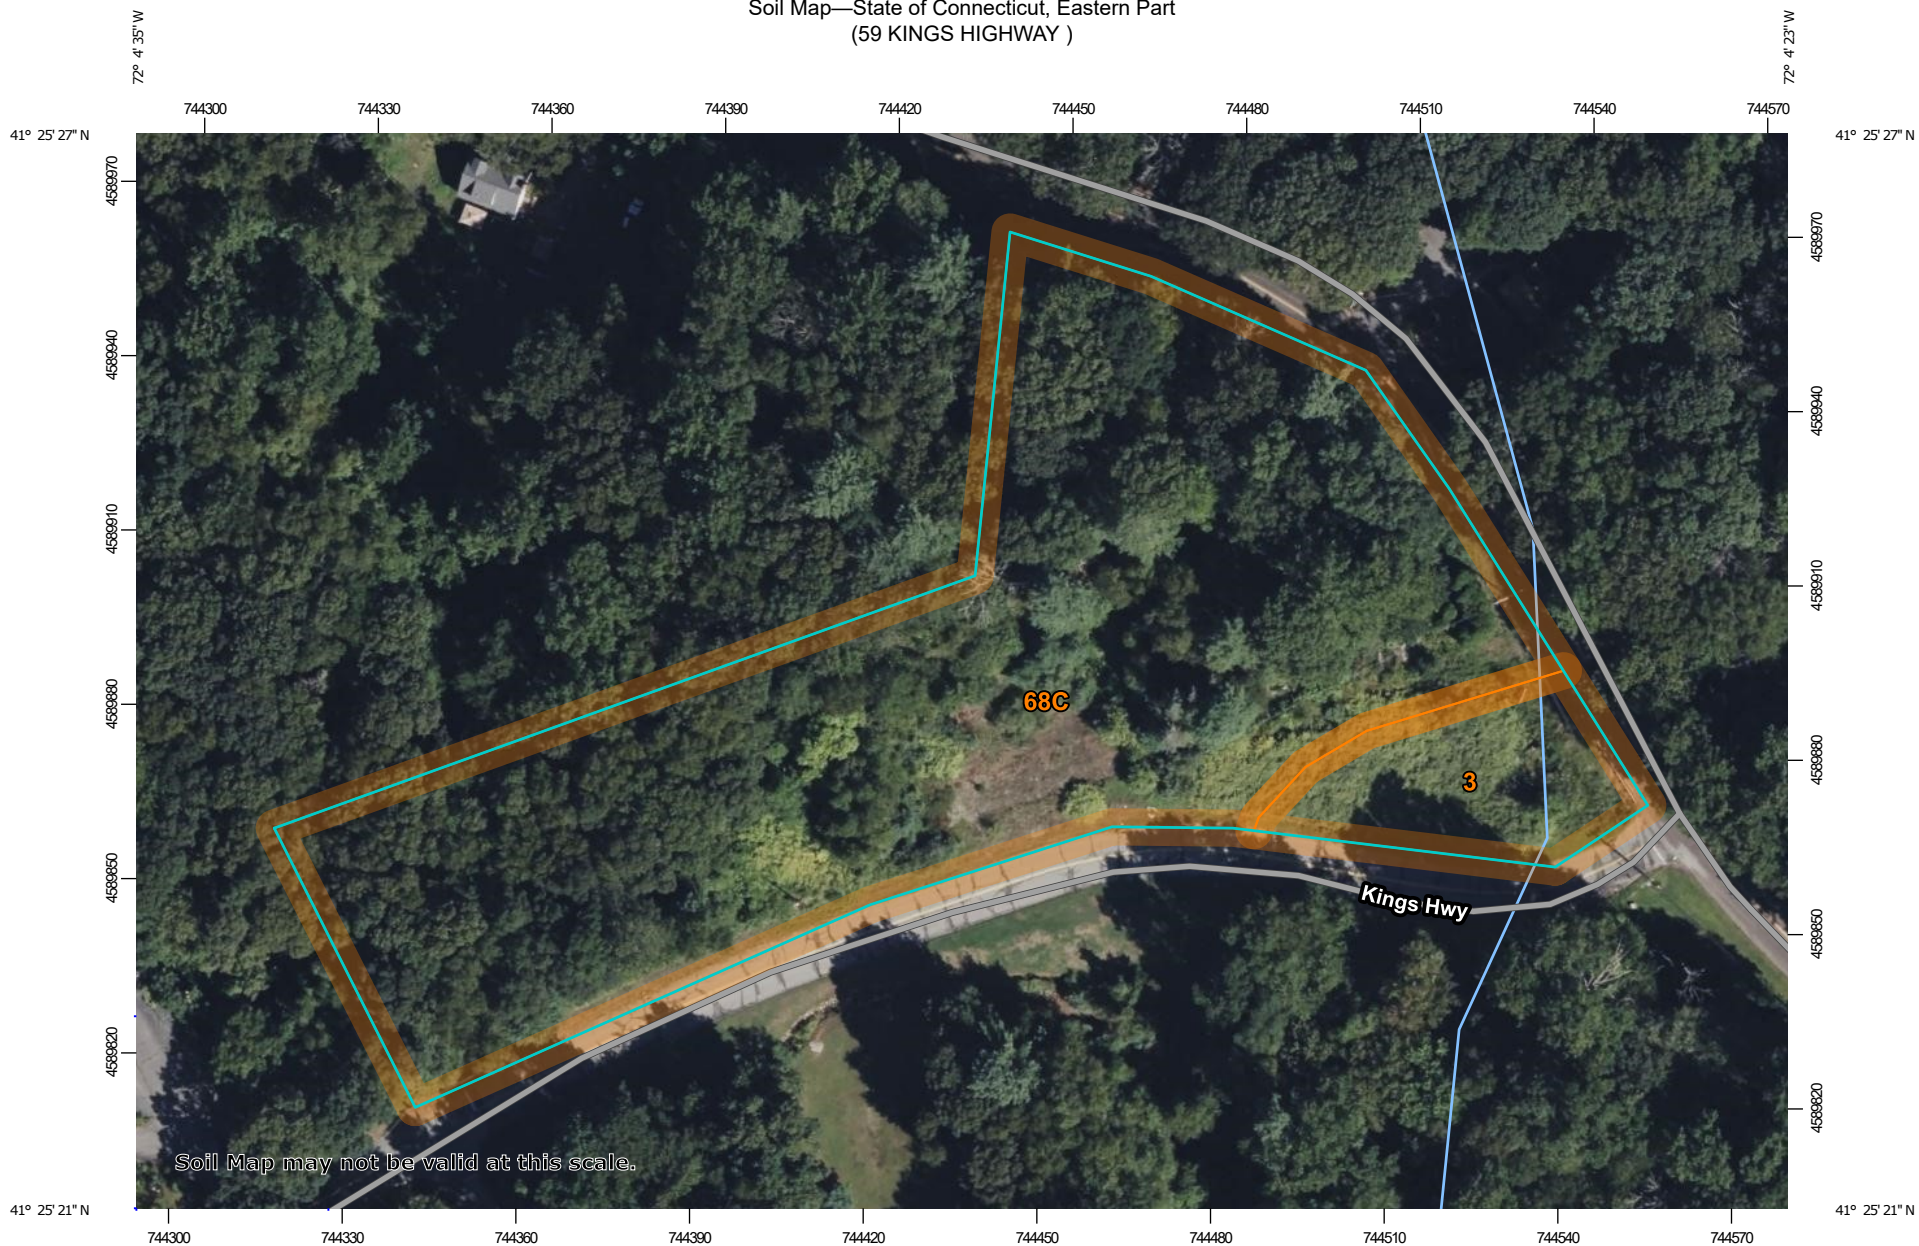
Soil Map—State of Connecticut, Eastern Part
(59 KINGS HIGHWAY)

| Map Unit Symbol | Map Unit Name | Acres in AOI | Percent of AOI |
|---|---|---|---|
| 3 | Ridgebury, Leicester, and Whitman soils, 0 to 8 percent slopes, extremely stony | 0.3 | 9.7% |
| 68C | Narragansett silt loam, 3 to 15 percent slopes, extremely stony | 3.2 | 90.3% |

The primary wetlands soil series along the wetland boundary are classified as (3) Ridgebury, Leicester, and Whitman fine sandy loams. The poorly drained soils along the wetland boundary belong to the Ridgebury and Leicester soil series. Ridgebury and Leicester soils are found within drainageways and depressions on glacial till landscapes. Ridgebury and Leicester soils have a seasonal high-water table at a depth of about 6 inches. A typical soil profile along the wetland boundary consists of approximately 3"-0" of intermediately decomposed organic material (Oi), followed by 0"-5" of a thick dark topsoil horizon (A), underlain by 5-20" of a wet weakly developed grayish subsoil horizon (Bg) with common redoximorphic features (Common medium distinct strong brown mottles, masses) ranging from fine sandy loam to very fine sandy loam. This subsoil is underlain by a saturated sandy loam to fine sandy loam gray substratum (2Cg).

The uplands are mapped as well drained Narragansett silt loams. These upland soils consist of 0-24" of fine textured soils on top of stratified, water sorted sands and gravels are well 3 Wetland Delineations Wetland Evaluations Soil Evaluations suited for development and are generally unrestricted. Surrounding the property are notable pockets of mapped Udorthent soils. These mapping units occur in areas where material was previously mined, evidence of how useful the sandy soil material at the site is for building purposes. A notable pile of chimney bricks was noted, suggesting that the site location may have previously hosted a structure or dwelling since razed. A copy of the NRCS soil map is attached for your reference.
